Artikel: Case studies of structural preservation in Taiwan
Autor: Lee, Horng-Ji / Jiang, Du-Hsin / Lai, Cheng-Hsiung
DOI: <https://doi.org/10.5169/seals-53360>

Case Studies of Structural Preservation in Taiwan

In this paper we take some examples of the removing and reconstruction of the homestead, most of them are wooden structures used for Chinese immigrant clan to Taiwan or the aboriginal cottages, for case study (Fig.1,2). The way of study are thus:

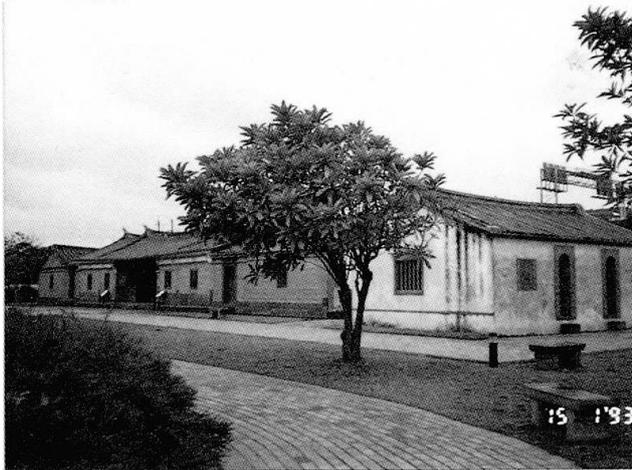
Fig. 1 Old homestead
(Fu Kien style)

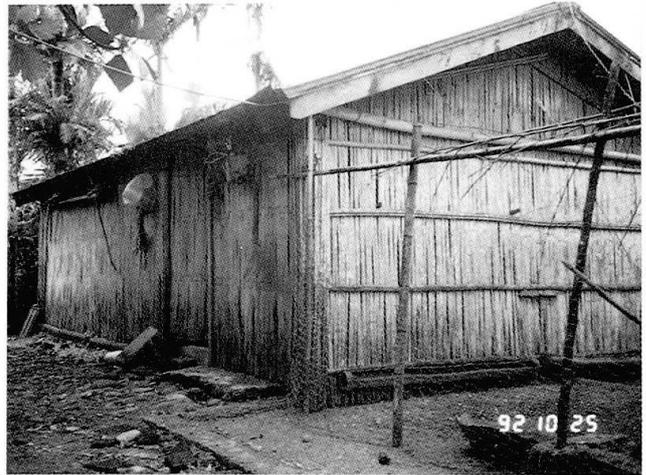
Fig. 2 Bamboo house of an
aboriginal

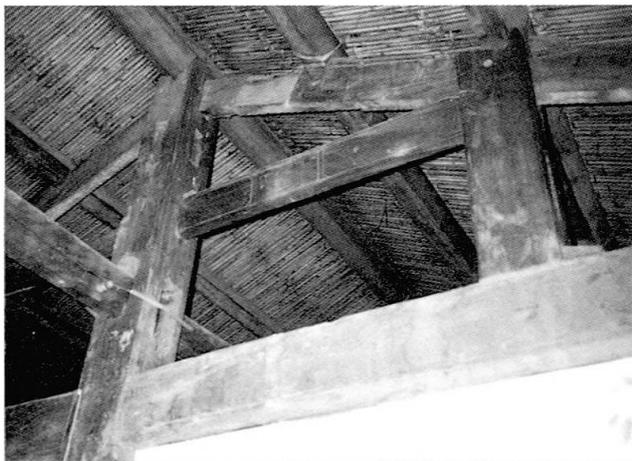
- A. The wooden framework is fitted together with hidden tenons and mortises, and nails. The nail heads are completely covered; apparently most of the nails are made of bamboo. The round gilded pillars are drum-shaped. The square eaves pillars are united smoothly with the stone pillars. The cross beams and purlins are all built with superb craftsmanship. The wooden wedges and the nail heads are all well covered. The locks of the main door are elaborately made double, with one explicit and the other implicit (Fig.3).

Fig. 3 The wooden Framework

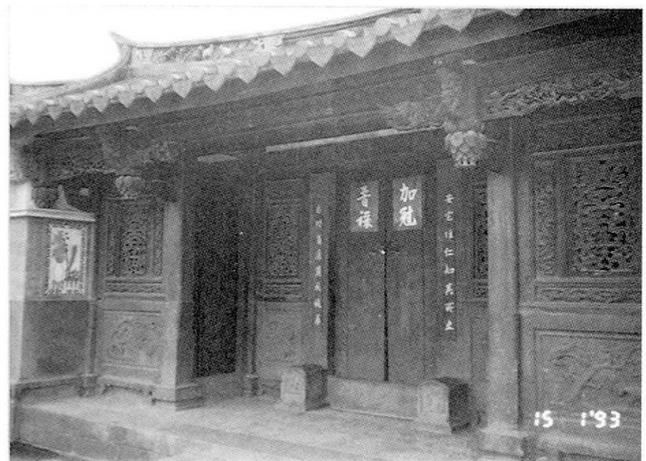
- B. The stone carving part: The stone materials are all connected by using hidden dovetail keys, and the stone materials and the wood materials are also connected by the use of tenons and mortises. The same is true of the doorposts, wainscots, stone thresholds, and pillar bases. With ordinary houses, the stone hinges and the doorpost pedestals are two separate parts, but in the Homestead they are carved as an integrate piece. The same skill is applied to the stone hinges at the bottom. The stone steps, stone wall bases and the friezes are all well proportioned in their dimensions. The igneous stone used in paving the inner court, the open drain, and the front court, though not carved very exquisitely, are well selected, and their sizes are all very accurated. Owing to their old age, the stone slates are no longer very even; but the crevices were adjusted by using copper coins as tools, and ground leveling was secured by melting lead underneath. These all show the great care taken in its construction (Fig.4).

Fig. 4 The stone carving part

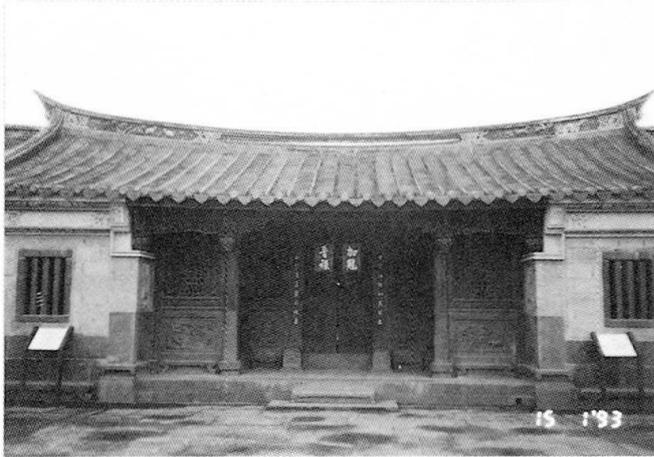
- C. The bricks and tiles: The ridges of the old Homestead are in one single ridge style. The ventilating bricks in the middle of the ridge are double-sliced chute, in the wicker ventilating window style. The tiles on the roof are in the southern Fukien style with a pitch of three to ten. Beneath the tiles are wooden rafters for nailing. The ventilating holes at the midtop of the gables are tracery made of unglazed bricks. The stone place on top of the doorways in the side buildings also have latticed ornamental bricks to give vent to the air within. This not only is logical but also forms different vertical surfaces that add to the beauty of the

Three types of bricks laid horizontally in the facade of the lower building are in the southern Fukien style. Those on the rear part of the building are clay bricks. The face brick walls of the side buildings are engraved with tortoiseshell patterns. These probably resulted from a later addition or repair work. The stone slates below the stone waist piece are rather elaborately engraved in the pattern of tables. The entire facade of the dwelling looks neat and handsome. Although its altitude is relatively low, there is a sense of equilibrium (Fig.5).

Fig. 5 The bricks and tiles

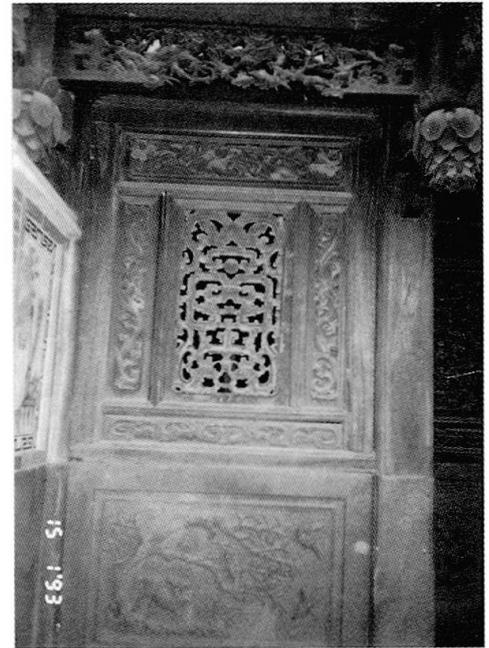
- D. The fine wood carving and the windows and doors: The main gate and the slide windows of the main hall are carved hollow. The ornamented waist panels design and engraving techniques are different from one another. The wainscots and waist panels of the doors and bar windows are all carved in one whole piece. The bar windows are of various designs, and since most of them are composed of many single pieces, they are fragile and not easy to preserve. Most of them have decayed and became loose which makes them rather difficult to repair after they are dismantled (Fig.6).

Fig. 6 The fine wood carving on window and door

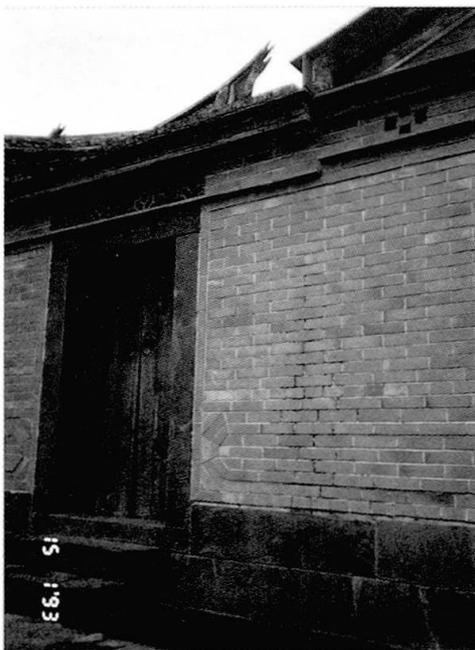
Due to the misunderstanding of the materials used before and bad repairing the rebuilt homestead are being damped and even forming the crack on the corner of the door and window. Even the connection of the main and winged house are also cracked. The door are thus deformed. The rebuilding work are merely less than five years. The reason of those damage are mainly caused by misuse of cement in stead of clay and gypsem. The foundation are used by concrete instead of original stone layer. These are the first presvation works in Taiwan. Experience gain from them will be good for future works (Fig.7-8).

Fig. 7 Unequal settlement between main hall and wing house

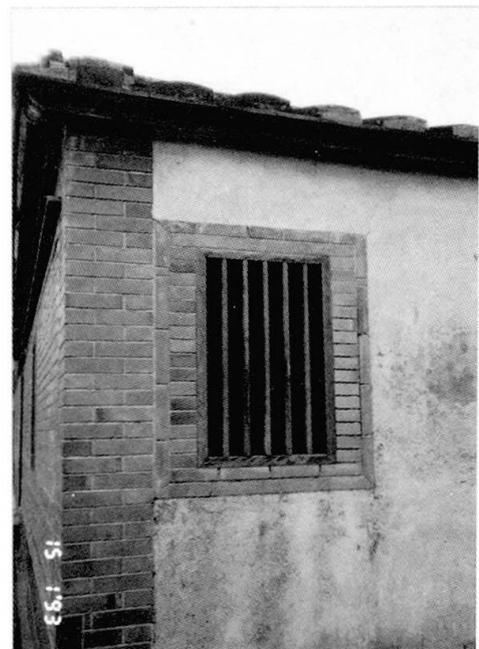
Fig. 8 The damped wall
