Zeitschrift: IABSE reports = Rapports AIPC = IVBH Berichte
Band: 70 (1993)

Artikel: Case studies of structural preservation in Taiwan
Autor: Lee, Horng-Ji / Jiang, Du-Hsin / Lai, Cheng-Hsiung
DOI: <https://doi.org/10.5169/seals-53360>

Case Studies of Structural Preservation in Taiwan

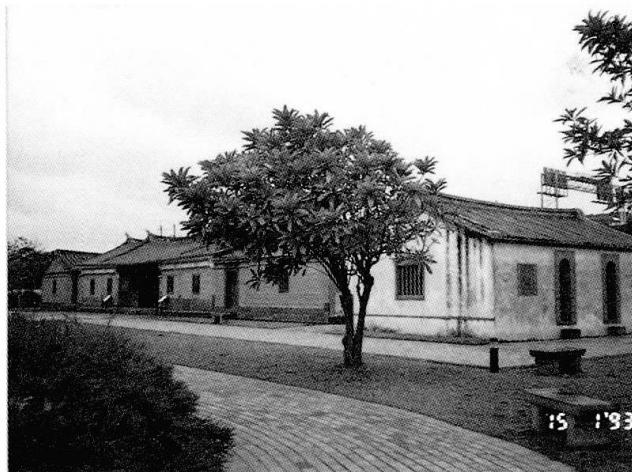
Fig. 1 Old homestead
(Fu Kien style)

In this paper we take some examples of the removing and reconstruction of the homestead, most of them are wooden structures used for Chinese immigrant clan to Taiwan or the aboriginal cottages, for case study (Fig.1,2). The way of study are thus:

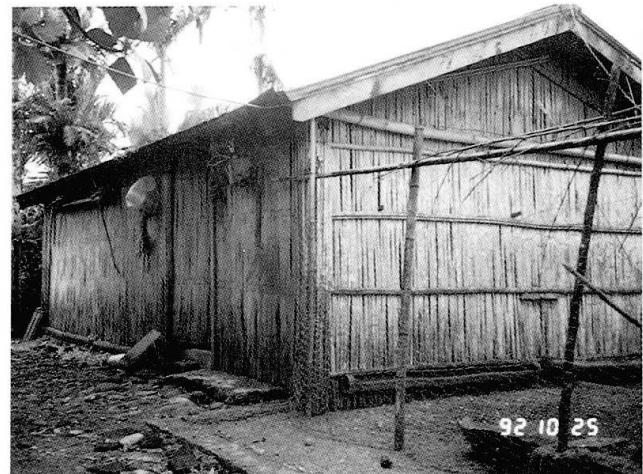
Fig. 2 Bamboo house of an
aboriginal

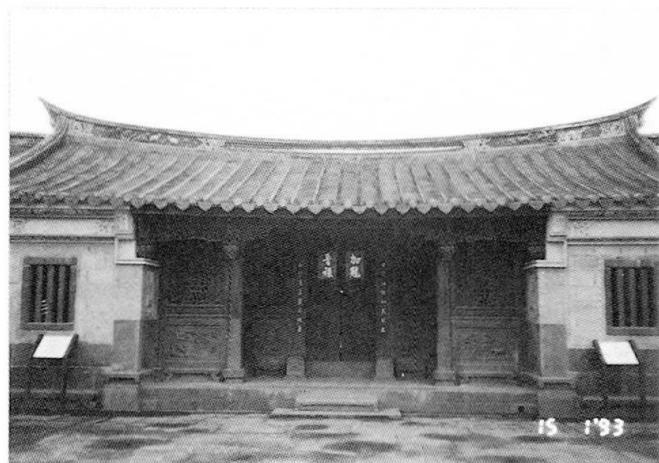
Fig. 5 The bricks and tiles

- C. The bricks and tiles: The ridges of the old Homestead are in one single-ridge style. The ventilating bricks in the middle of the ridge are double-sliced chute, in the wicker ventilating window style. The tiles on the roof are in the southern Fukien style with a pitch of three to ten. Beneath the tiles are wooden rafters for nailing. The ventilating holes at the midtop of the gables are tracery made of unglazed bricks. The stone place on top of the doorways in the side buildings also have latticed ornamental bricks to give vent to the air within. This not only is logical but also forms different vertical surfaces that add to the beauty of the

Three types of bricks laid horizontally in the facade of the lower building are in the southern Fukien style. Those on the rear part of the building are clay bricks. The face brick walls of the side buildings are engraved with tortoiseshell patterns. These probably resulted from a later addition or repair work. The stone slates below the stone waist piece are rather elaborately engraved in the pattern of tables. The entire facade of the dwelling looks neat and handsome. Although its altitude is relatively low, there is a sense of equilibrium (Fig.5).

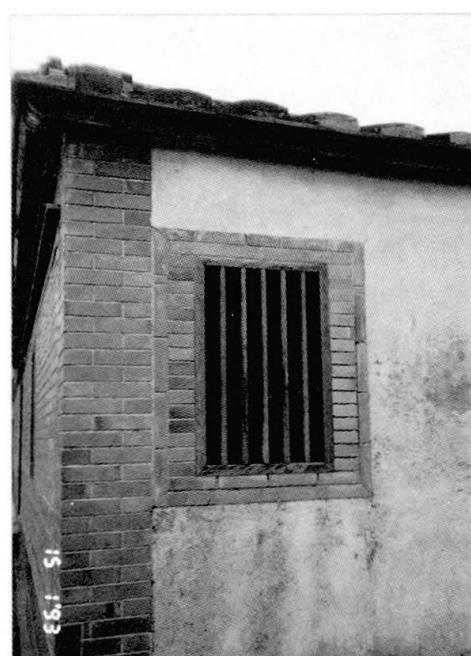
Fig. 8 The damped wall

Due to the misunderstanding of the materials used before and bad repairing the rebuilded homestead are being damped and even forming the crack on the corner of the door and window. Even the connection of the main and winged house are also cracked. The door are thus deformed. The rebuilding work are merely less than five years. The reason of those damage are mainly caused by misuse of cement in stead of clay and gypsum. The foundation are used by concrete instead of original stone layer. These are the first preservation works in Taiwan. Experience gain from them will be good for future works (Fig.7-8).
