Design of Stadium Structures - A Safety First Approach

Bill REID

Director
Thorburn Colquhoun
Glasgow, UK

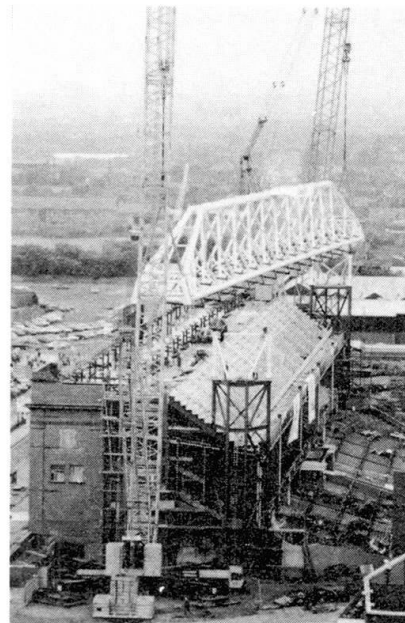
Ibrox Stadium was redeveloped in the early 1980s by the conversion of the standing terraces on the East, West and North sides of the pitch to seated accommodation for 25,000 spectators. In 1989 the Club decided to upgrade the South Stand accommodation by adding an additional seating deck above their existing Main Stand. The new deck, which affords column free viewing to the upper tier spectators, is covered by a new roof supported on a 145 metres clear span tubular steel girder. This is the longest span stadium girder of its type in Britain. The plate opposite shows lifting of the roof girder over Ibrox Main Stand.

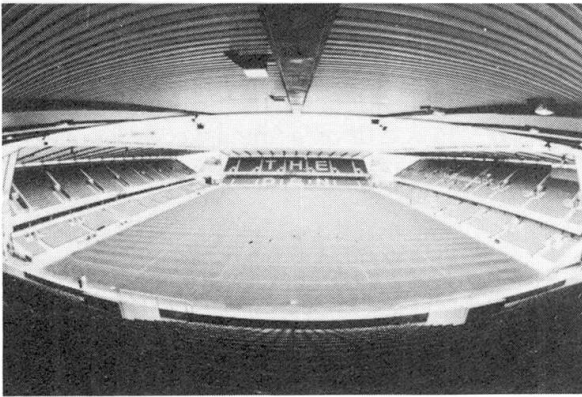
While Ibrox Main Stand Girder is the longest "goalpost" type girder in Britain, the longest cantilever structure is currently at Elland Road, Leeds. This structure has a clear cantilever roof span of 51 metres and provides cover for approximately 17,000 seated spectators on the East side of the ground. The front seating deck is supported directly on the ground while the middle and upper decks are of precast concrete supported on a steel frame structure. The plate opposite shows the stand under construction.

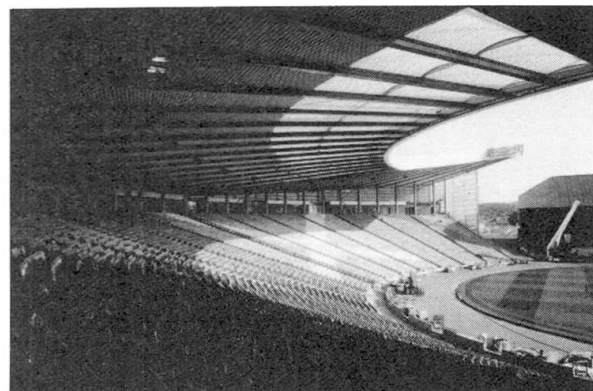
Hampden Park is the traditional International ground for Scottish soccer. In 1937 its terraces accommodated its record crowd of over 149,000 spectators. Since then alterations have reduced the extent of the terraces and stands. Work on converting the terraces to seating commenced in 1993 and by 1996 a 60,000 capacity all seater stadium is programmed to be in place. The Hampden Redevelopment is relatively unique as it has retained the previous terrace profile, but has added roof cover and provided seating. The roof is of cantilever form with a maximum clear span of 42 metres. Plate opposite shows the East Stand nearing completion.
