**Artikel:** Design of stadium structures: a safety first approach  
**Autor:** Reid, Bill  
**DOI:** <https://doi.org/10.5169/seals-54157>

## **Design of Stadium Structures - A Safety First Approach**

**Bill REID**  
Director  
Thorburn Colquhoun  
Glasgow, UK

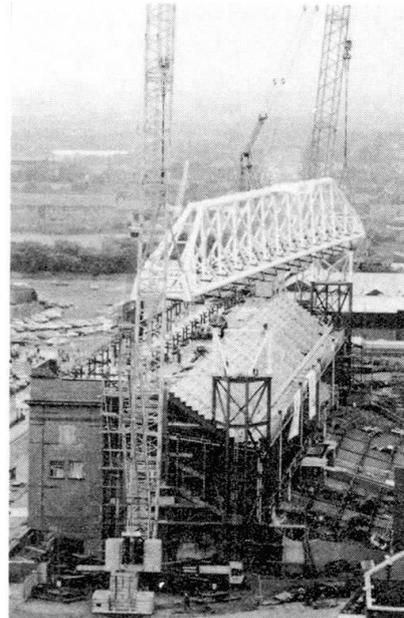
Ibrox Stadium was redeveloped in the early 1980s by the conversion of the standing terraces on the East, West and North sides of the pitch to seated accommodation for 25,000 spectators. In 1989 the Club decided to upgrade the South Stand accommodation by adding an additional seating deck above their existing Main Stand. The new deck, which affords column free viewing to the upper tier spectators, is covered by a new roof supported on a 145 metres clear span tubular steel girder. This is the longest span stadium girder of its type in Britain. The plate opposite shows lifting of the roof girder over Ibrox Main Stand.

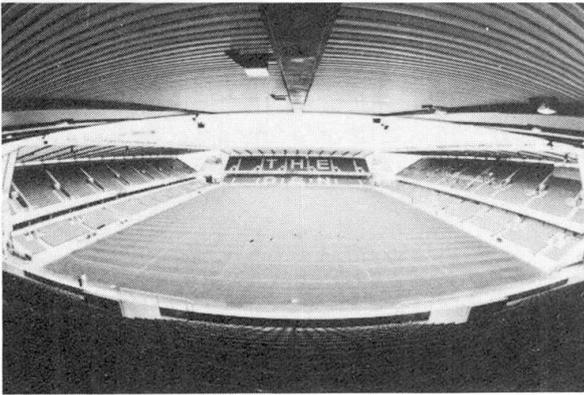
While Ibrox Main Stand Girder is the longest "goalpost" type girder in Britain, the longest cantilever structure is currently at Elland Road, Leeds. This structure has a clear cantilever roof span of 51 metres and provides cover for approximately 17,000 seated spectators on the East side of the ground. The front seating deck is supported directly on the ground while the middle and upper decks are of precast concrete supported on a steel frame structure. The plate opposite shows the stand under construction.

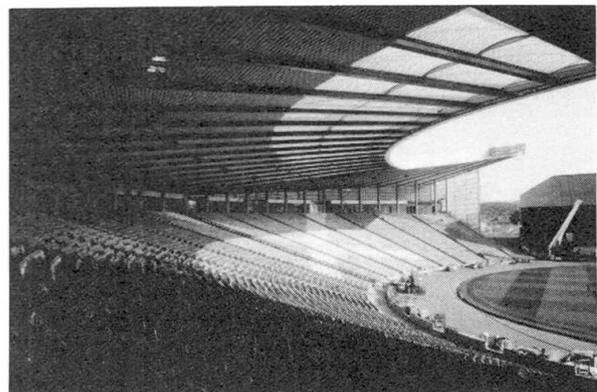
Hampden Park is the traditional International ground for Scottish soccer. In 1937 its terraces accommodated its record crowd of over 149,000 spectators. Since then alterations have reduced the extent of the terraces and stands. Work on converting the terraces to seating commenced in 1993 and by 1996 a 60,000 capacity all seater stadium is programmed to be in place. The Hampden Redevelopment is relatively unique as it has retained the previous terrace profile, but has added roof cover and provided seating. The roof is of cantilever form with a maximum clear span of 42 metres. Plate opposite shows the East Stand nearing completion.
