Artikel: Experience of cupola collapse with a diameter of 237 m

Experience of Cupola Collapse with a Diameter of 237 m

The steel dome of 237 m in diameter collapsed in Russia in 1986. The construction of the dome and its finishing were completed. The load-carrying structure were made as two-layer latticed bar shell. Shortly before the collapse the outdoor air temperature changed from -20°C to +1°C during six hours. Due to the non-uniform heating some of the shell bars lost their stability and this caused the collapse.

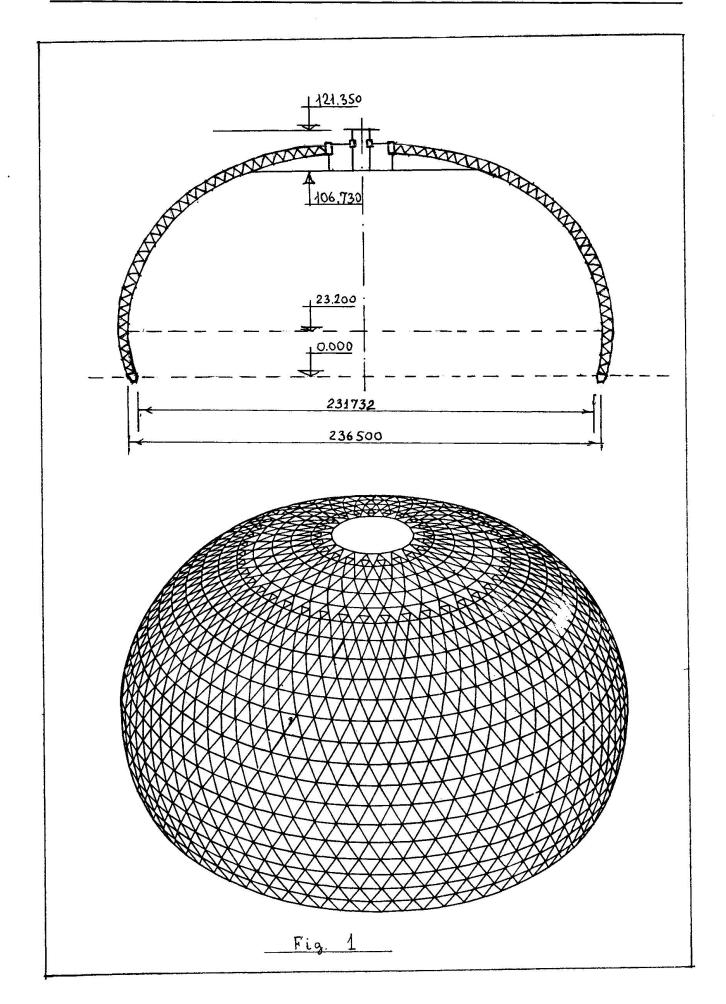
Desigh No 1 elaborated by a team of Moscow civil engineers presented a building shaped as a flattened ellipsoid 237 m in eduator diameter. The building height was 119 m. See Fig.1. The principal load-carrying structures were designed as a two-layer latticed shell at a spacing of 2.5 m between the upper and lower chords. The shell upper and lower chords were made of twin angles. The lattice between the chords was made of tubes welded to the angle flanges. A diaphragm 1,5 mm thick of weatherproof steel was welded to the upper members of the shell. The diafragm served as roofing and made the bars stable. The heat-insulated boards of the suspended ceiling working as fire protection of the carrying structures at the same time were secured to the lower chords of the shell. The erection members were connected by high-strength bolts. The total weight of the steel structures was about 11000 tN.

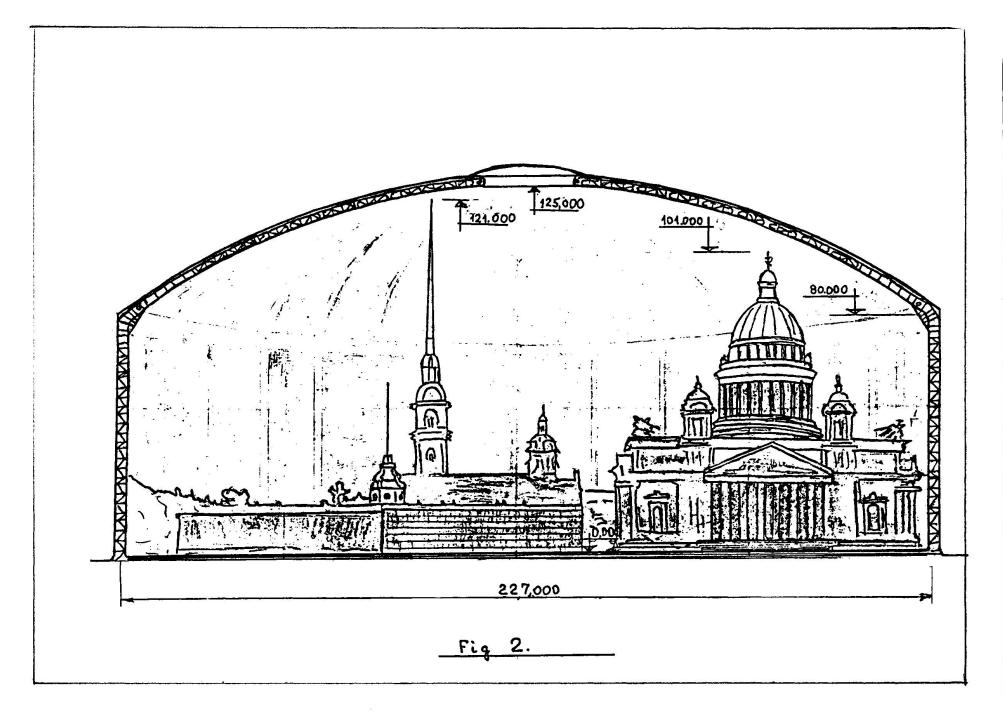
Design No.2 was elaborated by a team of Leningrad (St.Petersburg) engineers. It was a structure 128 m in height made of a cylinder like part 80 m high and a hollow domelike roofing 227 m in dia with a boom of lift 47 m. See Fig.2. The cyliderlike framework was made of columns connected by cross-braces and the dome was designed as a circular ribbed structure. The total weight of the structures made about 11500 th.

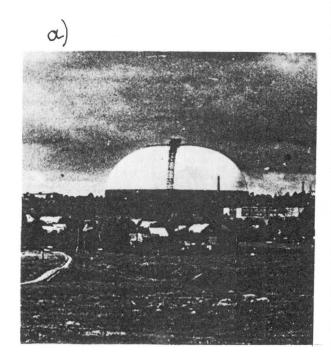
The main structures of the dome were erected by the middle of 1984. See Fig. 3a. The erection and construction work completed in 1985. The overloaded members were checked for force increment at erection of technological equipment premises 600 tN in weight
