**Zeitschrift:** IABSE reports = Rapports AIPC = IVBH Berichte  
**Band:** 73/1/73/2 (1995)

**Rubrik:** Session D4: Strengthening of structures by prestressing

**Strengthening of Structures by Prestressing**  
**Renforcement des structures à l'aide de la précontrainte**  
**Verstärkung von Bauwerken mittels Vorspannung**

## **Repair and Strengthening of Concrete Structures by Post-Tensioning**

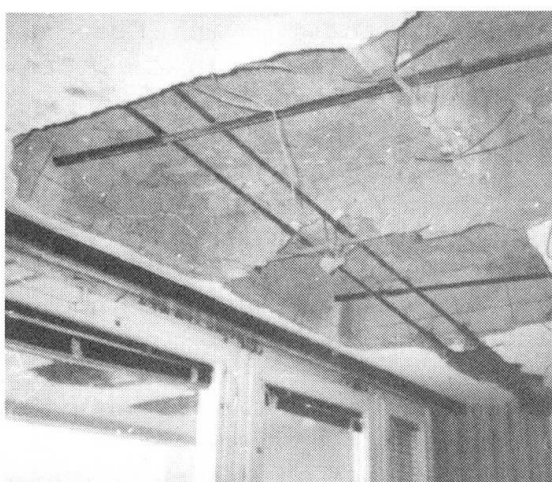
Photos 1. and 2. Structural details

Load bearing capacity of the floor structures failed - especially in the case of multielement systems - can be most favourably guaranteed by supplementary post-tensioning. In order to avoid corrosion failures, tensioning strands in greased polyethylene tube should be used. Supplementary tensioning can be arranged - in function of the building's destination - either in the blocks of the waffle slab or under the floor plane usually by zig-zag strands (Photos 1 and 2).

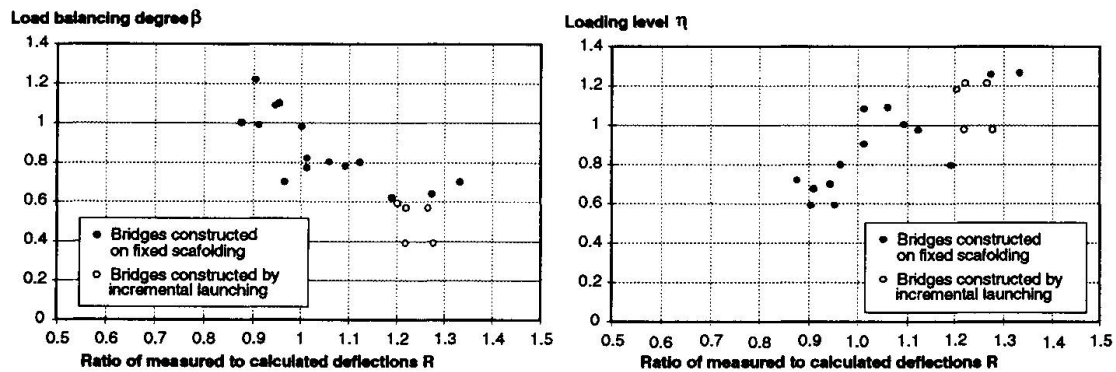
Figure 1: Load balancing degree  $\beta$  and loading level  $\eta$  versus the ratio of measured to calculated instantaneous deflections in state I

Figure 1 shows the correlation between the degree of load balancing and the ratio of measured deflections to those calculated in state I for 20 post-tensioned bridges. The ratio of measured to calculated instantaneous deflections increases when the load balancing degree decreases. This means that a low prestressing level allows cracking in the superstructure which results in deflections that are higher than those calculated in state I without any cracking.
