Zeitschrift: IABSE reports = Rapports AIPC = IVBH Berichte

Rubrik: Session D4: Strengthening of structures by prestressing

Strengthening of Structures by Prestressing
Renforcement des structures à l'aide de la précontrainte
Verstärkung von Bauwerken mittels Vorspannung

Repair and Strengthening of Concrete Structures by Post-Tensioning

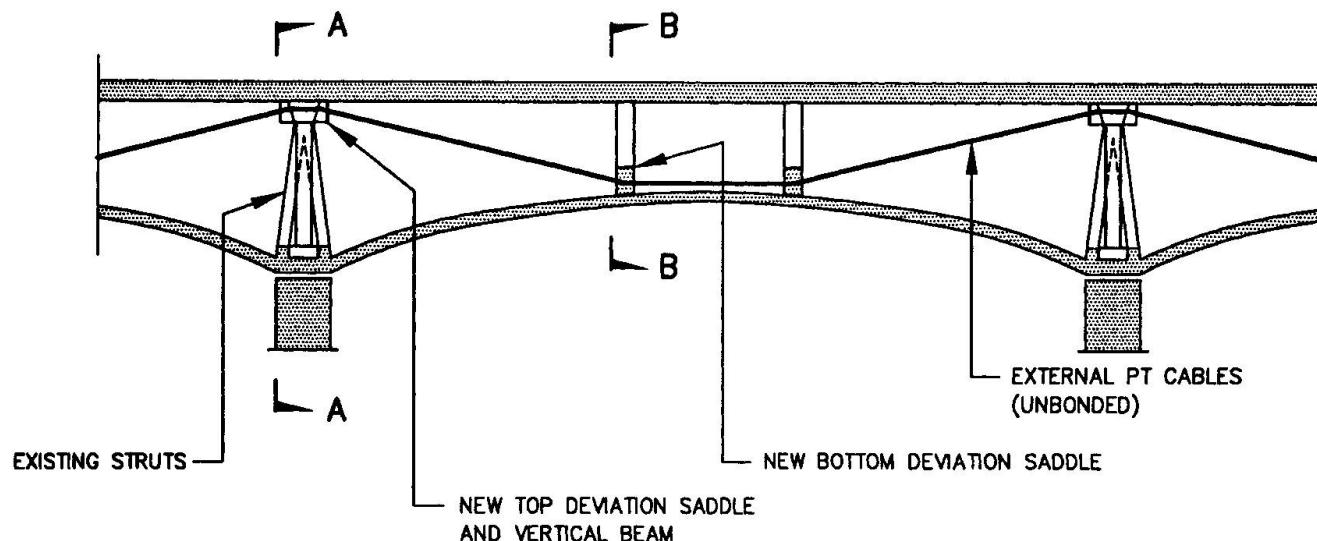
FIG 1 : OLERON BRIDGE : CABLE LAYOUT OF ADDED EXTERNAL POST TENSIONING

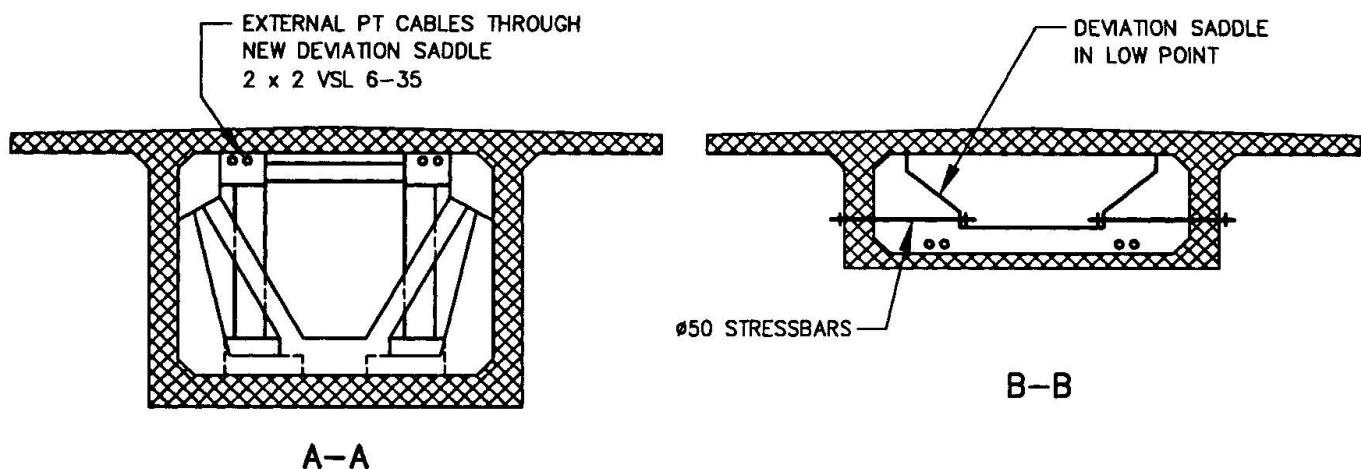
FIG 2 : OLERON BRIDGE :
DEVIATION SADDLE AT PIER

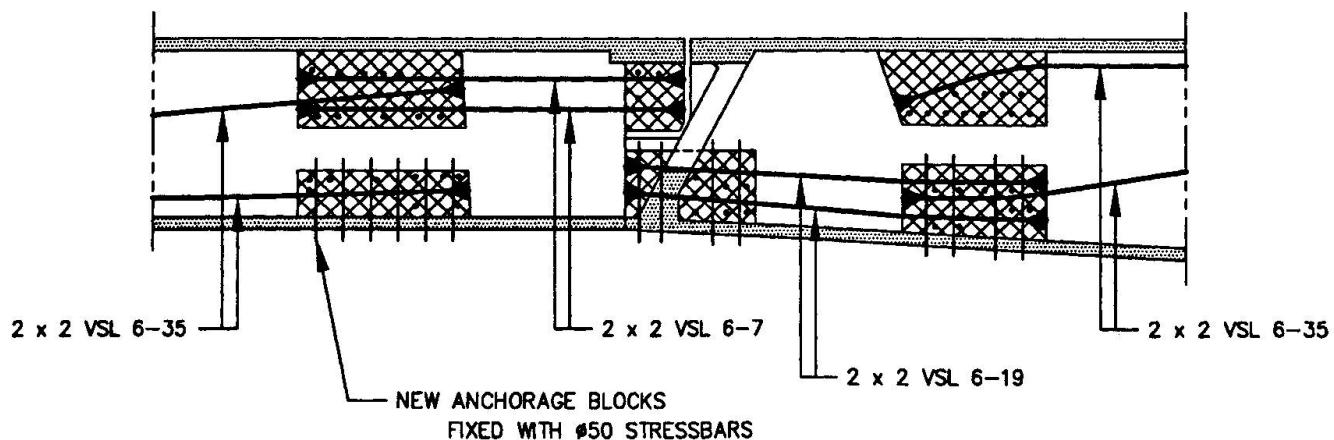
FIG 4 : OLERON BRIDGE : CABLE LAYOUT AT EXPANSION JOINT

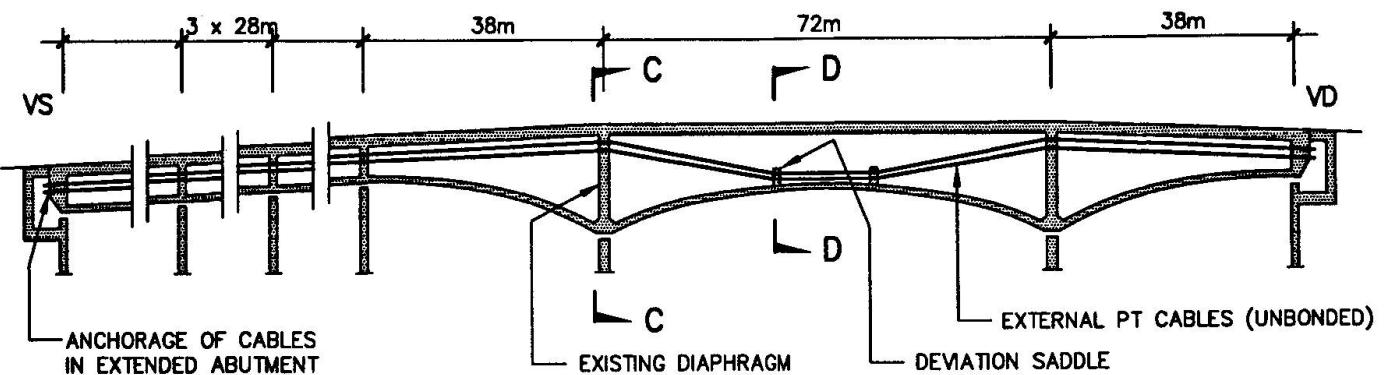
FIG 5 : MASSONGEX BRIDGE : CABLE LAYOUT OF ADDED EXTERNAL POST TENSIONING

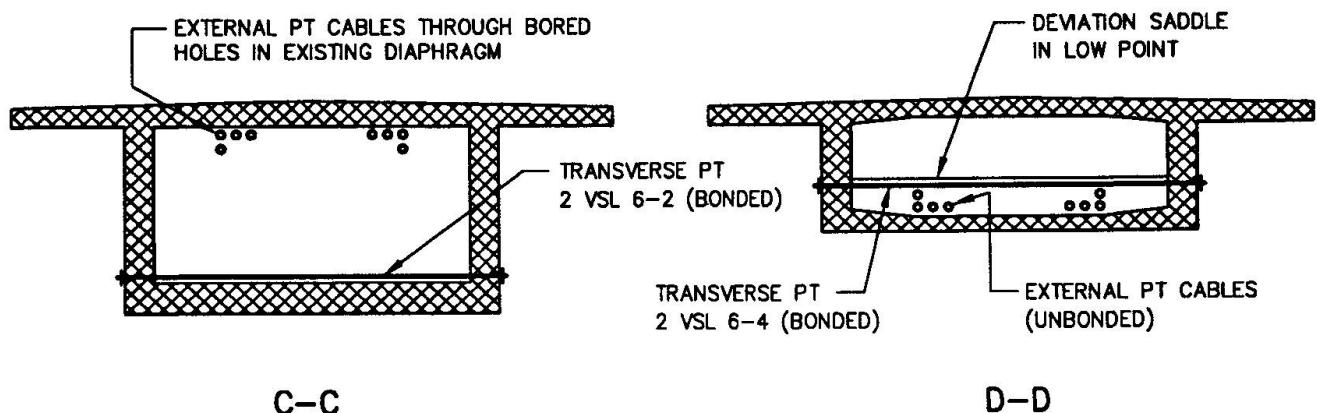
FIG 6 : MASSONGEX BRIDGE :
SECTION AT PIER
WITH DEVIATION SADDLE

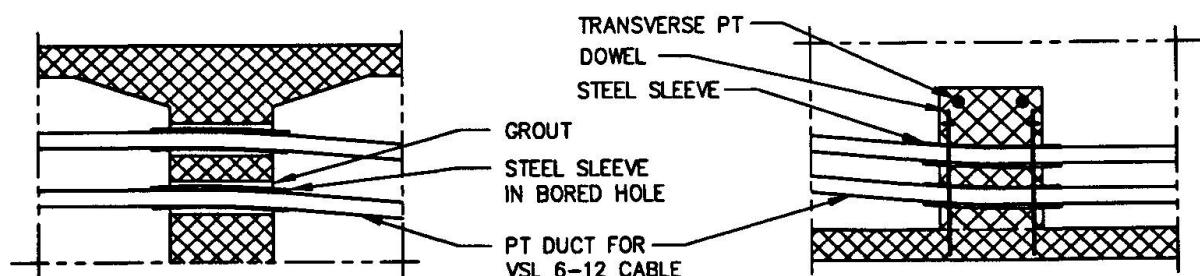
FIG 7 : MASSONGEX BRIDGE :
LOW POINT SADDLE

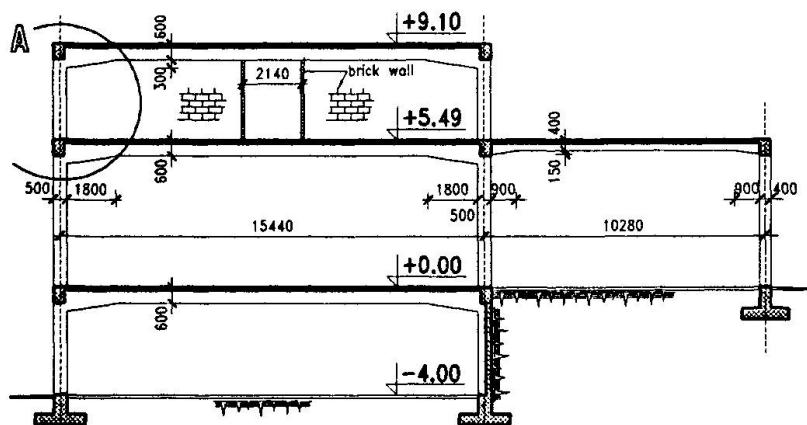
Fig. 1 Disposition of a transverse structure frame

dimensions 400×500 mm are founded on strip foundations. Floor structure consists of semi-prefabricated solid reinforced concrete one-way slab, total thickness 120 mm.

Frame beams are haunched, of rectangular cross-section, dimensions 400×600 mm in the main bay and 400×400 mm in the annex. Frame columns, dimensions 400×500 mm are founded on strip foundations.

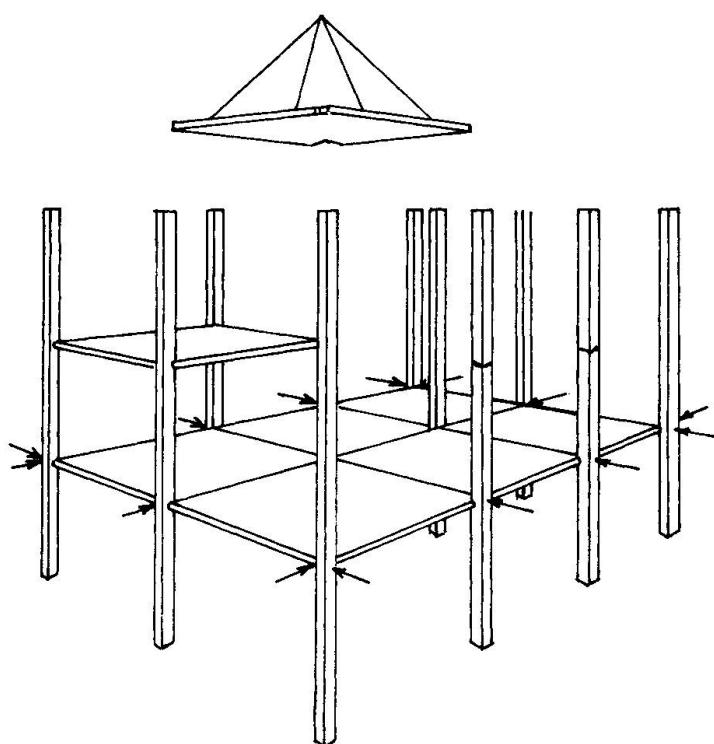
The IMS structural system tensioned together from precast reinforced concrete units is primarily fit for construction of dwellings and public buildings. The system was developed in Yugoslavia the late 1950s, however, it has been used in several countries. Since the middle of the 70s, about 400,000 m² floor has been built using this method. In the original version, in every field, one precast "waffle slab" unit is joined to the columns through the cut-outs at the edges by tensioning the columns together in both directions after filling the joint gaps with a material rapidly hardening (Fig. 1).

Fig.1 The IMS construction system

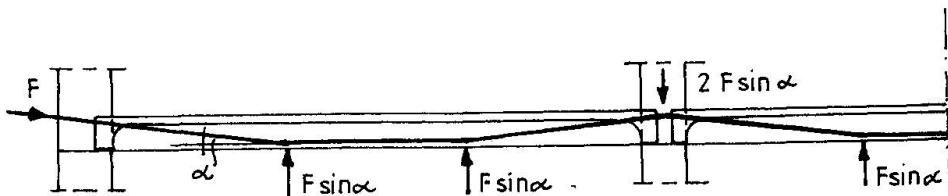
Stresses of the waffle slab floor were computed by a lattice model, effects of the supplementary tensioning were considered as external forces concentrated in anchoring and inversion points of the tensioning tendons [2] (Fig. 2).

Fig. 2 Concentrated external forces equal to tension force

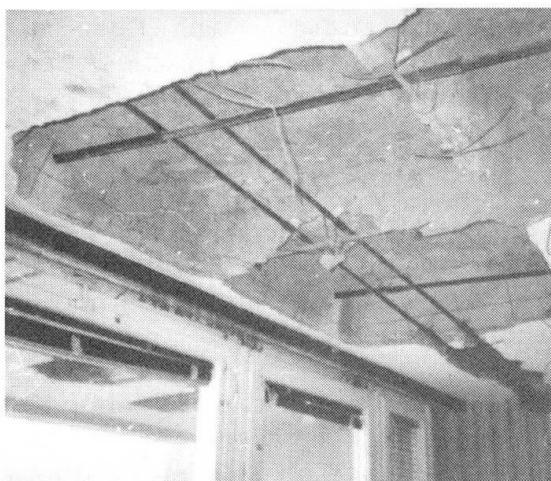
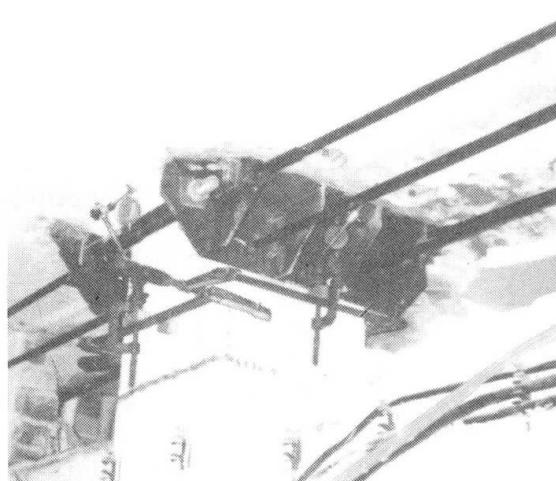
Load bearing capacity of the floor structures failed - especially in the case of multielement systems - can be most favourably guaranteed by supplementary post-tensioning. In order to avoid corrosion failures, tensioning strands in greased polyethylene tube should be used. Supplementary tensioning can be arranged - in function of the building's destination - either in the blocks of the waffle slab or under the floor plane usually by zig-zag strands (Photos 1 and 2).

Photos 1. and 2. Structural details

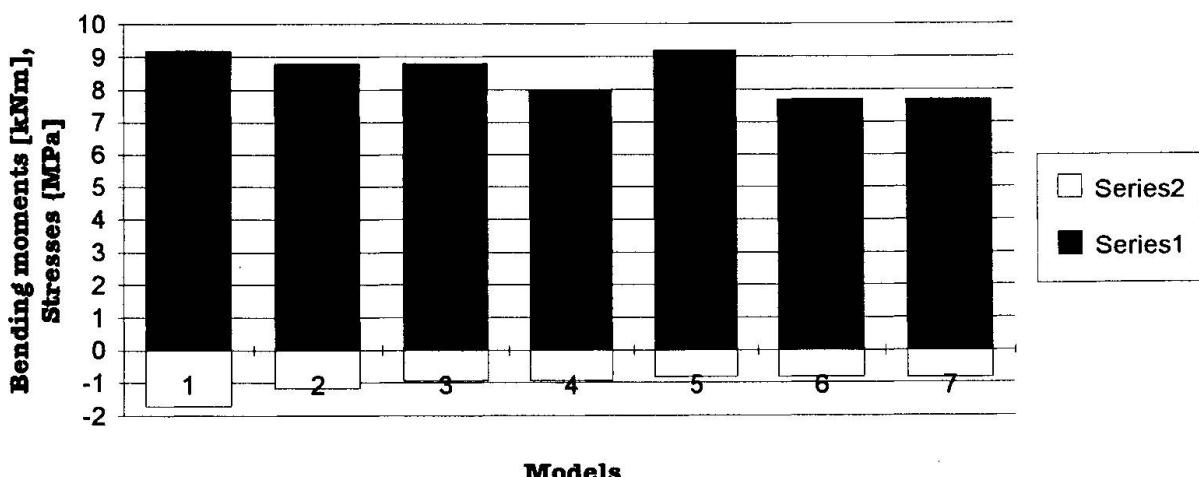
In any model, decrease of stresses computed from normal forces arising in ribs can be observed moving from the application spot of the tension force. Hinged or clamped joint of diagonal stiffening bars in model has no considerable influence, but eccentricity of the 3.5 cm floor slab cannot be neglected. At the column lying farther from the application of the tension force, the different models show an essential difference in the stresses that can be computed from the normal force. The most simple model fully neglecting the influence of the 3,5 cm slab is unfit for modelling, but even the model containing only cover plate ribs overestimates the stresses arising from normal forces (>35-40%) and bending moments that can be computed from tensioning (>15-20%) (Fig. 3).

Fig.3 Effect of the different models. Series 1: Bending moment near the column, Series 2: Stresses computable from the normal force

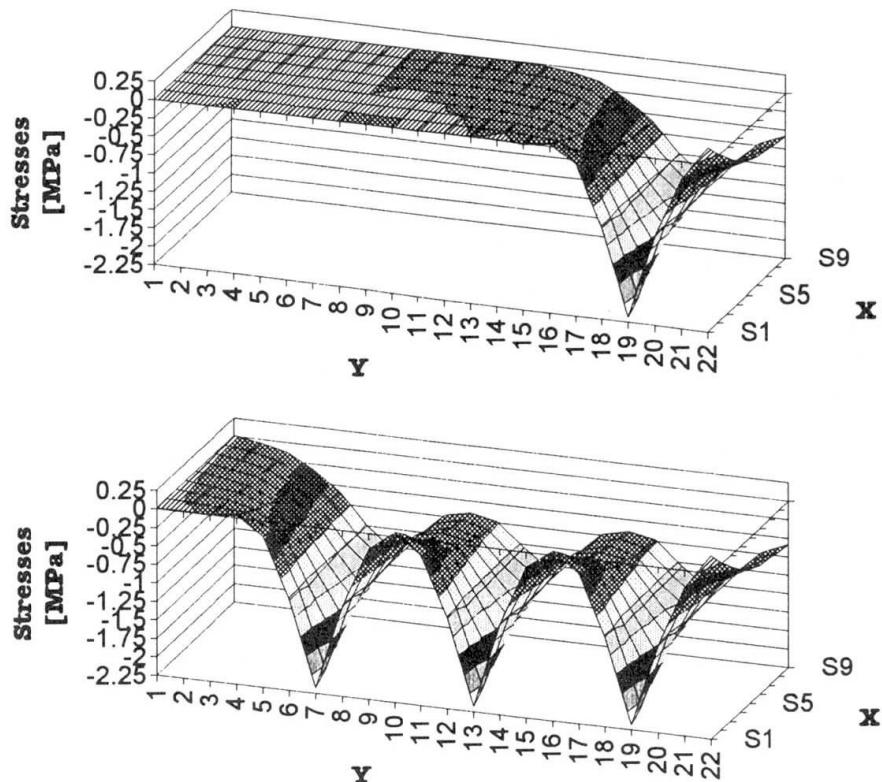
Distribution of the normal force due to the tension force was investigated with the assumption that tensioning occurs symmetrically right and left from the axis of symmetry of the building. Formation of stresses computable from normal forces arising in ribs in direction of the cables is shown in two different steps in Figs. 4. It reveals that the influence of the particular steps of tensioning is considerable only in a zone of about 2 m of the columns - because of the essential in-plane stiffness of the grid. Consequently, the sequence of the tensioning has no particular influence on the final stresses arising from tensioning - in the case of the specific tension force of 1-2 MPa sufficient in practice.

Fig.4 Distribution of stresses computed from normal forces arising in ribs in the cables' direction after the first and third steps of tensioning

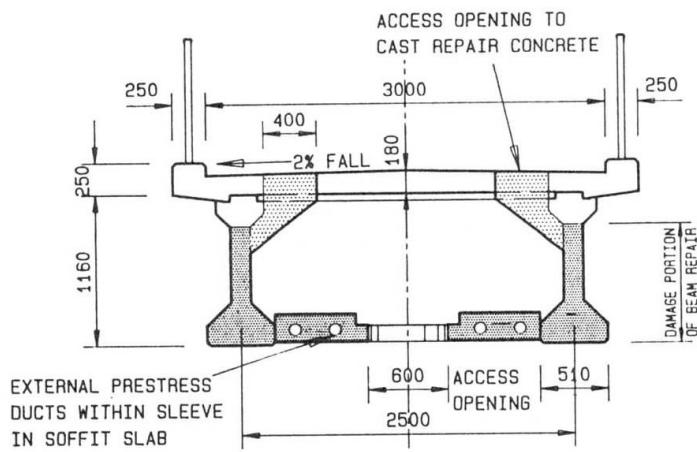
Figure 1 : Seventh Ave deck section indicating beam repair

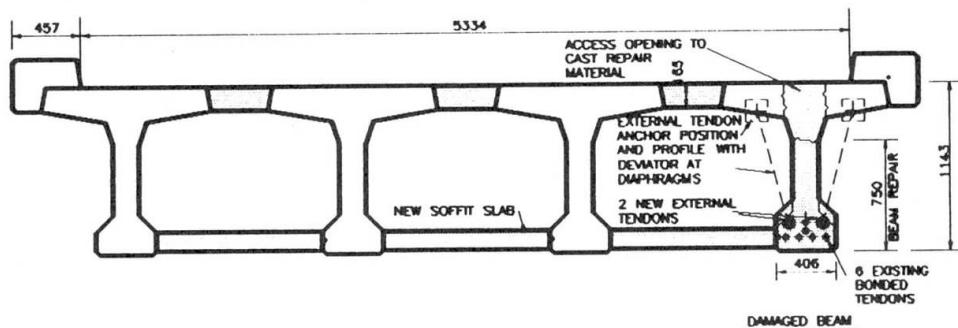
Figure 2 : Candy Cornelia deck section indicating beam repair

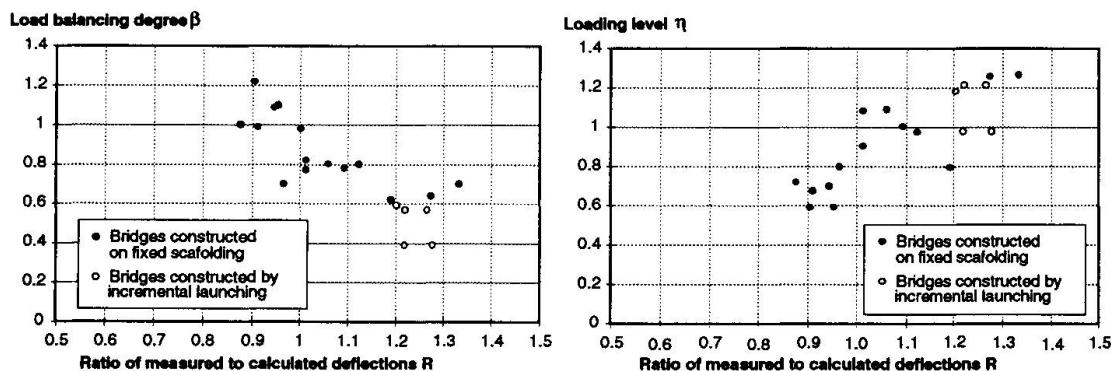
Figure 1 shows the correlation between the degree of load balancing and the ratio of measured deflections to those calculated in state I for 20 post-tensioned bridges. The ratio of measured to calculated instantaneous deflections increases when the load balancing degree decreases. This means that a low prestressing level allows cracking in the superstructure which results in deflections that are higher than those calculated in state I without any cracking.

Figure 1: Load balancing degree β and loading level η versus the ratio of measured to calculated instantaneous deflections in state I

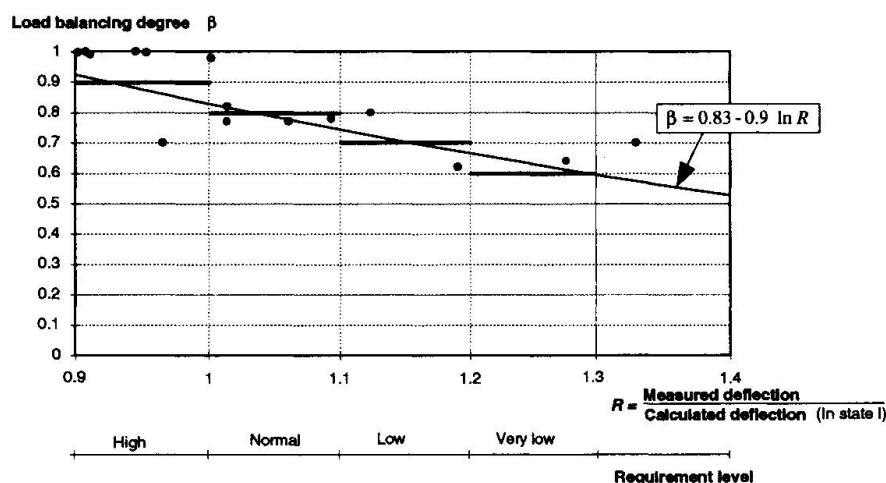
Figure 2: Recommended load balancing degree as a function of requirement level shown with the results of load tests carried out on 15 bridges constructed on fixed scaffolding

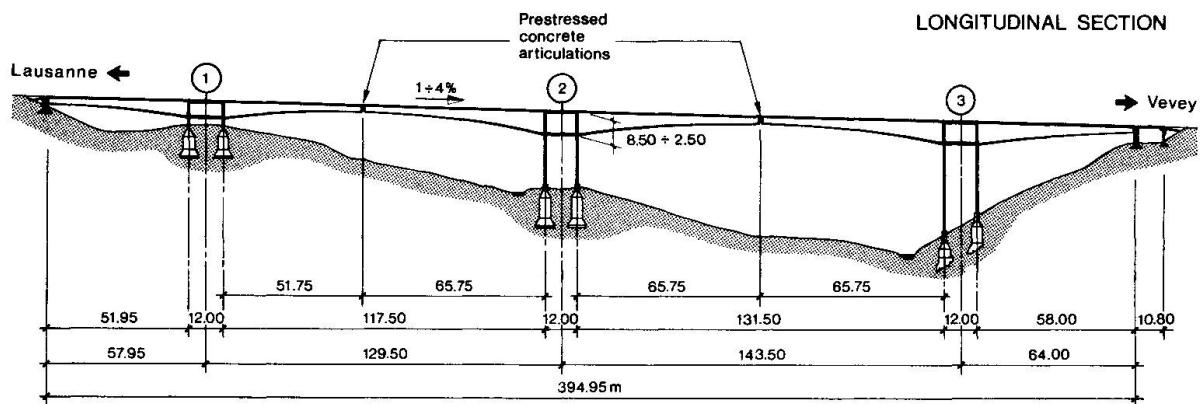
Lutrive bridges (North and South) are two parallel twin bridges. Each one supports one side of the Swiss national motorway RN9 between Lausanne and Vevey. Built in 1971/72 by the corbelling method with central articulations, the two bridges are gently curved ($r = 1000$ m) and each bridge is approximately 395 m long with four spans of: 57.95 - 129.50 - 143.50 and 64.00 m (Figure 3).

Figure 3: Longitudinal section of Lutrive South bridge

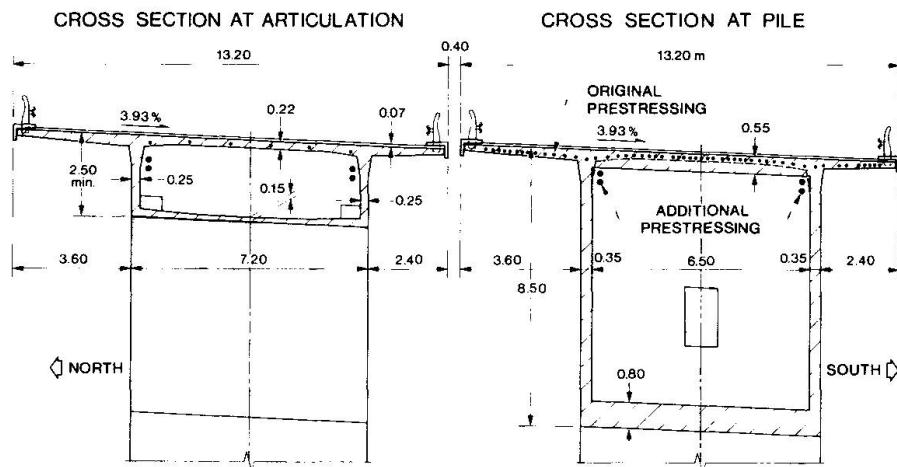
The two bridges have the same cross-section. It consists of a box girder of variable height and two slightly dissymmetric cantilevers, meant to reduce the effect of torsion in the curved bridges (Figure 4).

Figure 4: Cross-section at the central articulation and at the pile

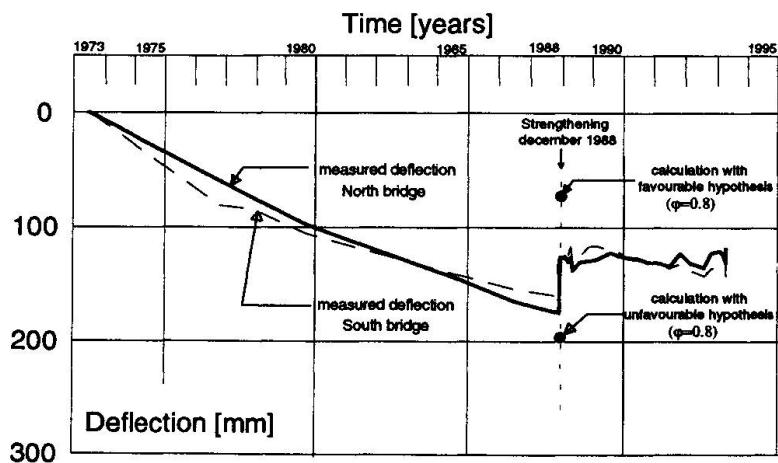
The main span, 143.40 m long, underwent an approximate deflection of 16 cm. However this did not include the initial pre-camber of the span which was not measured but estimated at 11 cm. From 1973 to 1987 the deflection was a continuous downward movement which showed no sign of stabilisation (Figure 5).

Figure 5: Measured and calculated deflections

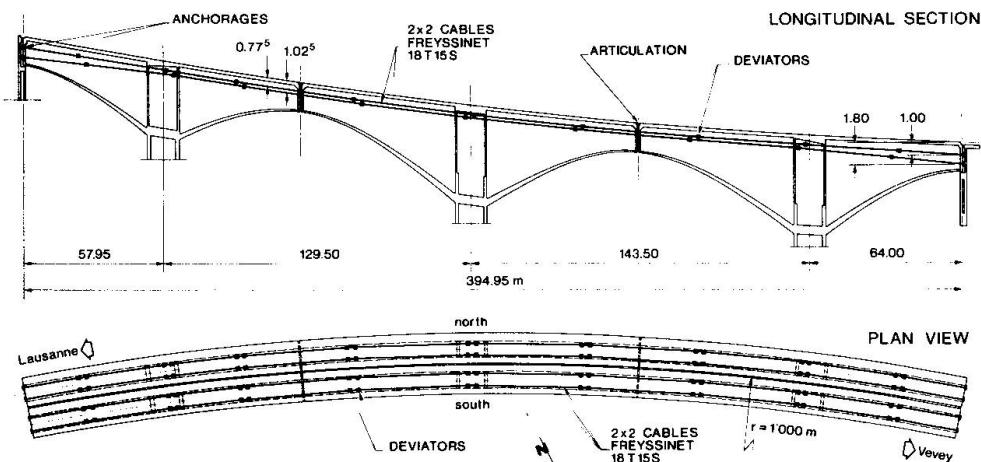
Thus, in 1988 it was decided to « repair » the bridges with an additional external prestressing force of $P_0 = 4 \times 3345 \text{ kN} = 13380 \text{ kN}$ for each bridge (4 Freyssinet cables with 18 strands pretensioned to 0.7 f_{ck} , where $f_{ck} = 1770 \text{ N/mm}^2$). Figure 6 shows the strengthening project.

Figure 6: Scheme of the strengthening additional prestressing

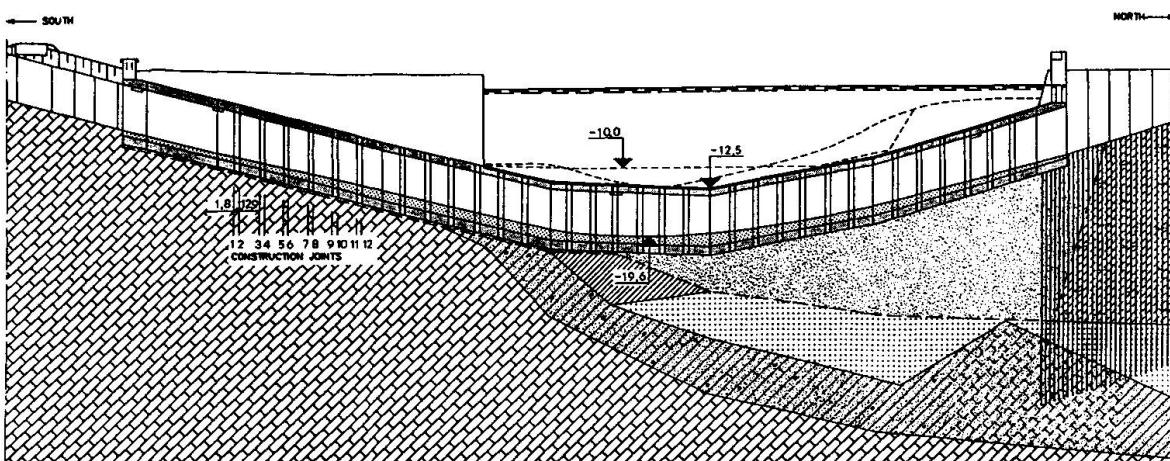
The immersed part consists of five 102 m long precast reinforced concrete units joined together to form a monolithic structure. The units were cast in a dry dock in 12,8 m long sections, separated by 1,8 m wide gaps into which reinforcement bars protruded. The concrete for these gaps was poured after the sections had shrunk.

Fig. 1 Longitudinal section

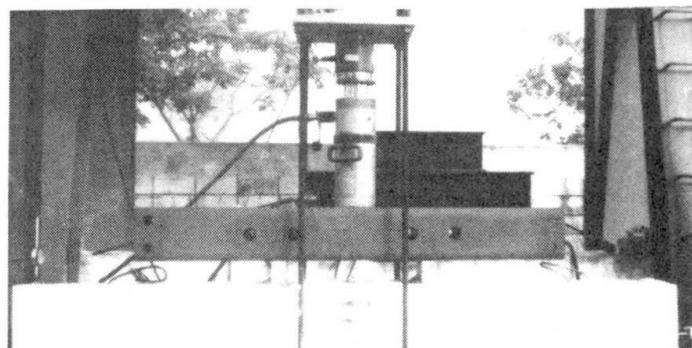
The load points were 533 mm (21 in) apart from the center of the span for Beam-1 and 280 mm (11 in) for the other beams (Fig. 1). Four vibrating wire strain gages were mounted on the concrete beams along the depth at midspan. Dial gages were set up to measure deflections at midspan, support and tendon slip. Static load was applied in 5 to 10 kN increments and monitored by a load cell connected to System 4000 data acquisition system. Concrete strains, midspan and support deflections, and tendon slip were recorded at regular load intervals together with crack pattern.

Fig. 1 Typical beam test setup

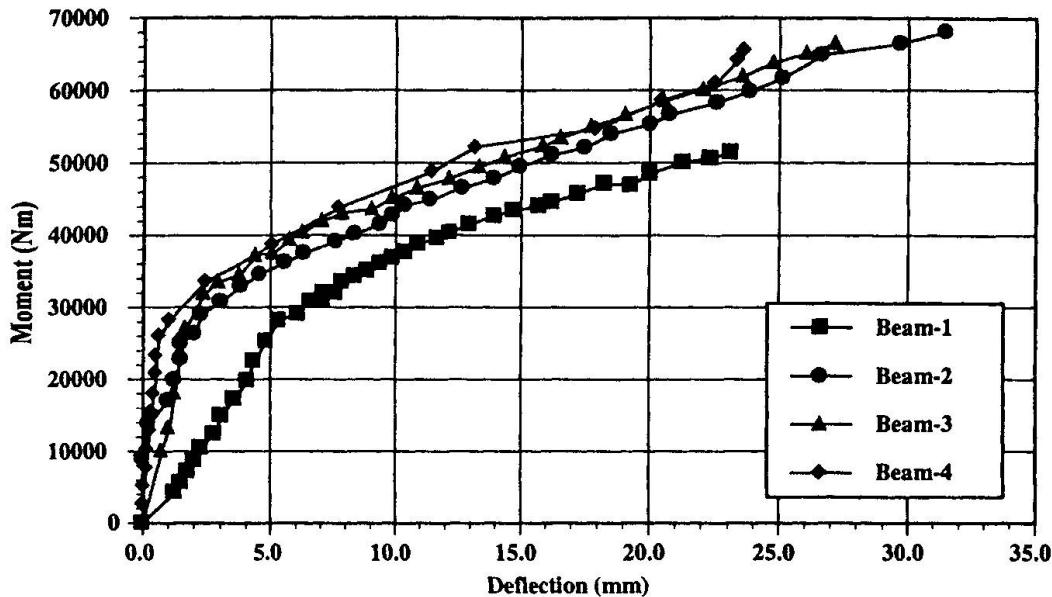
Fig. 2 Moment vs. deflection

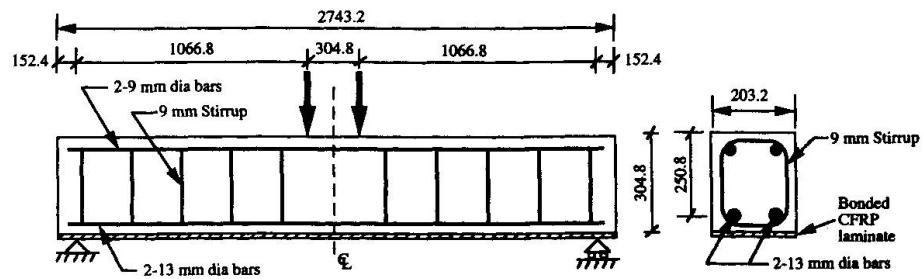
Six reinforced concrete rectangular beams were cast with minimum steel reinforcement according to ACI 318-89 code provisions (Fig. 3). One layer of CFRP laminate was bonded to one reinforced concrete beam. Two reinforced concrete beams bonded with two layers of CFRP laminates and another two with three layers of CFRP laminates were prepared for testing and the remaining beam was used as the control beam. Carbon fiber prepreg laminate with a tensile strength of 2,758 MPa and tensile modulus of 141 MPa was used in the study. The two-part epoxy resin consisted of a main resin and a curing agent with a mixing ratio of 2:1. The cured adhesive had a tensile strength of 60 MPa. The CFRP laminates were bonded to the tension face of the beams following the procedure detailed in ref. 3. The beams were tested under two-point static loading over a simple span of 2438.4 mm (8 ft.). Deflections were measured at midspan, support and section at 609.6 mm (2 ft.) from midspan. Strains and deflections at various locations, crack patterns and the applied load were recorded for every load increment till the ultimate load capacity of the beam.

Fig. 3 Reinforcement details of rectangular beam

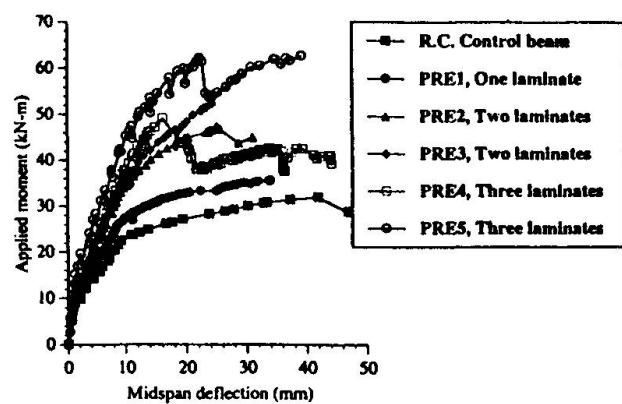
Fig. 4 Effect of CFRP laminates on deflection

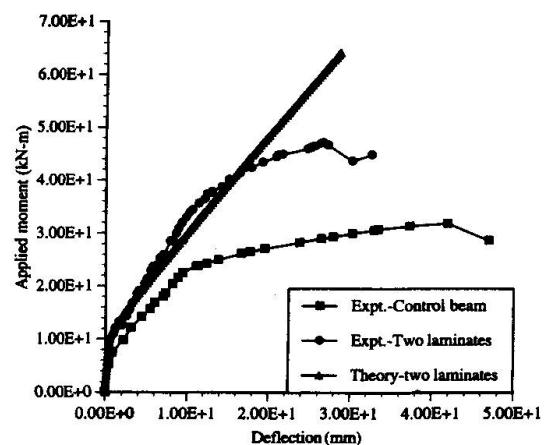
Fig. 5 Moment deflection behavior of control beam and beam with two CFRP laminates

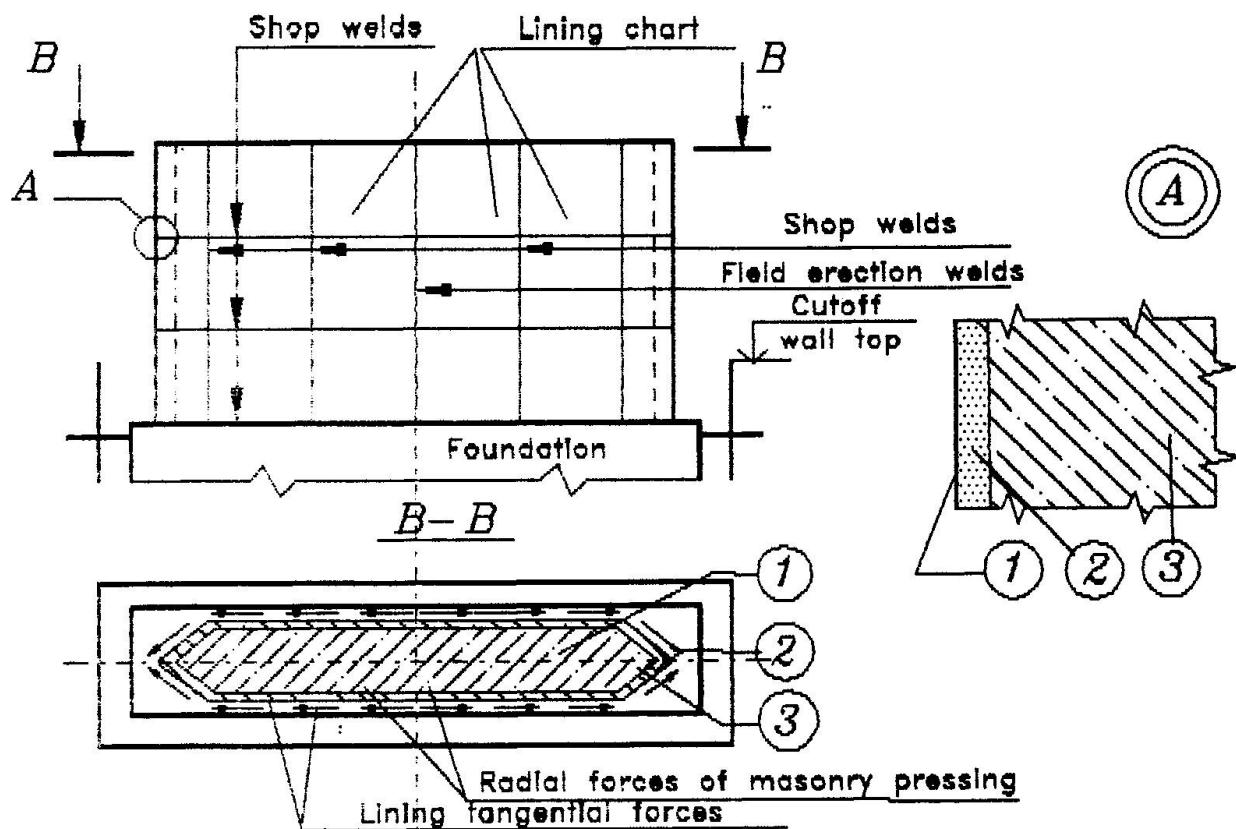
Fig.1 Basic circuit arrangement of steel lining piers

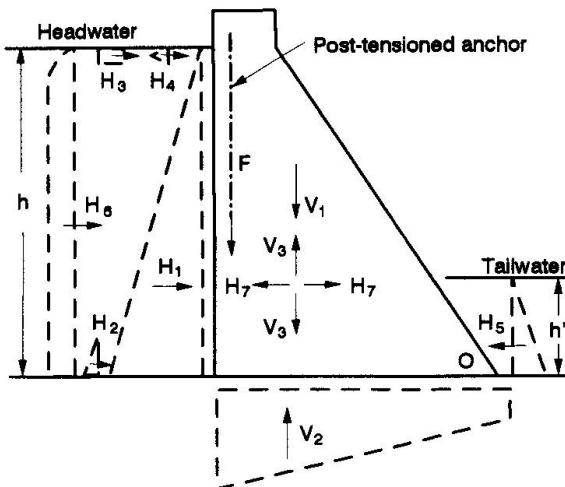
where SF = shear friction factor; A = contact area of the base; c = unit shear resistance at the base; H_t = total horizontal load; V_t = total vertical load; f = coefficient of internal friction at the base; F_s = designated factor of safety; ΣMW = summation of anti-clockwise moments of forces V_1, H_5 about point O ; ΣMV = summation of clockwise moments of forces $H_1, H_2, H_3, H_4, H_6, H_7, V_2, V_3$, about point O ; MF = moment of force F about point O .

Fig. 1 Loads acting on the section of a gravity dam
