**Zeitschrift:** IABSE reports = Rapports AIPC = IVBH Berichte  
**Band:** 73/1/73/2 (1995)  
**Rubrik:** Session E2: Fatigue issues in bridges

**Fatigue Issues in Bridges**  
**Problèmes de fatigue dans les ponts**  
**Ermüdungsfragen im Brückenbau**

## **Cumulative Damage Assessment in Structural Steel Details**

**Survey on Fatigue Damage in Steel Railway Bridges in Thailand**  
Dommages par fatigue de ponts ferroviaires métalliques en Thaïlande  
Ermüdungsschäden an Stahleisenbahnbrücken in Thailand

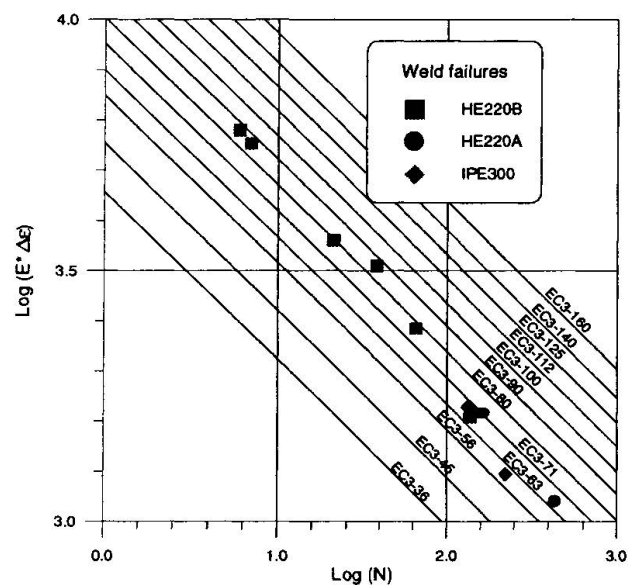
Fig. 2 Fatigue strength of beams failed at weldings [4]

log-log plot) the low cycle fatigue test data,

fatigue resistance category pertinent to each shape, it is important to notice that the slope of the line fitting (in a

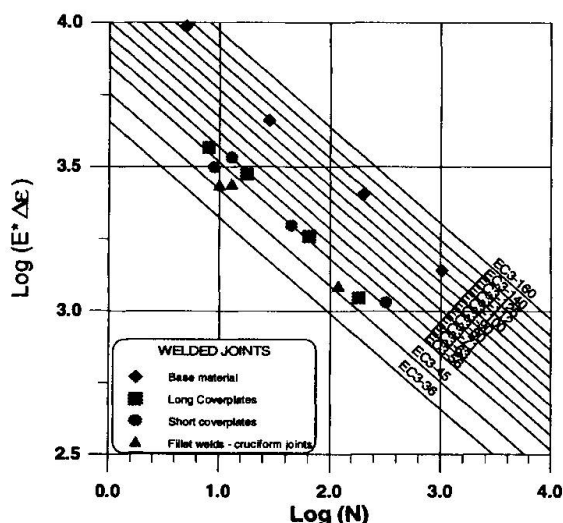
**Fig. 3** Fatigue strength of welded joints

classification of the various details by EC-3, where base material is assigned a fatigue strength category ranging between 125 and 160, coverplates to categories ranging between 45 and 63, fillet welds in cruciform joints to category 36 (40-63 by the Italian C.N.R. 1001/86 Code). Of course, the small number of test data did not allow for any regression analysis. This fact, in addition to the absence of residual stresses (due to the small dimension of the specimens), account for eventual small differences between code classification and the results of the present study.

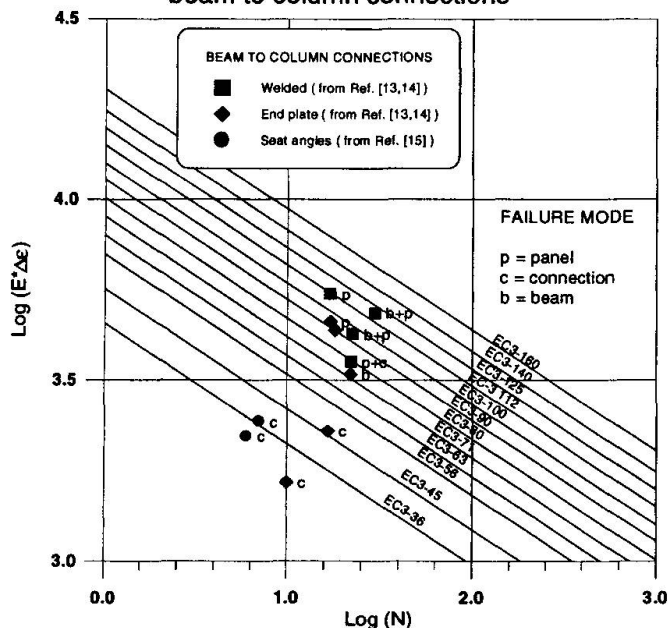
**Fig. 4** Fatigue strength of beam to column connections

It has been tried to apply the same procedure for defining the fatigue strength of beam to column connections [13-15], consisting of welded connections, end plate connections and double seat angle connections. As all these tests were performed under variable amplitude loading according to [6], in order to define the fatigue strength category of each connection re-analysis of test data was carried out adopting Miner's rule, and defining the pertinent EC-3 line a-posteriori, as the one giving, at collapse, a damage index approximately equal to 1.0.

It can be noticed that test data are grouped, depending on the failure mode. The end plate joints from Ref. [13,14] that failed in the connection show a low fatigue strength, similar to that of seat angle connections from Ref. [15]. The other connections (both welded and end plated) show a higher fatigue strength, although the failure mode seems to

influence their fatigue behavior. Presently it is tried to enlarge the data base also by collecting and re-analysing test data presented in the literature. Even from these previous results it can however be concluded that the design of connections is critical for a good performance of structures under low cycle fatigue and that, in order to avoid brittle fracture, it should be tried to induce the formation of a plastic hinge in the members, away from the connections. This is of course in good agreement with other results presented in the literature (e.g. [18]).

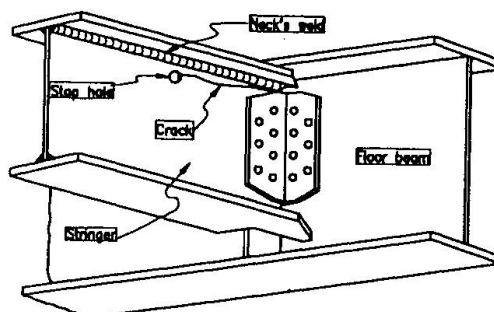
Fig.3 Crack occurring in the beam end

Fig.3 shows a crack occurring in the beam end of a stringer advancing horizontally on the web along the bead toe. At this position, a stop hole is provided at the end of the crack, and found effective to some extent.

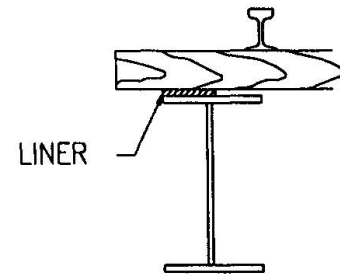
Fig.6 Liner inserted intentionally

- (1) ALSTHOM: (under present conditions: in close contact inside; 0.2 to 0.5 mm apart outside) (See Fig.5)
  - (2) ALSTHOM: (liner inserted intentionally: 2 mm apart inside; in close contact outside) (See Fig.6)
  - (3) new-HITACHI (liner inserted intentionally: 2 mm apart inside; in close contact outside)
- The axle load and spacing of ALSTHOM and new-HITACHI is shown Fig.7.

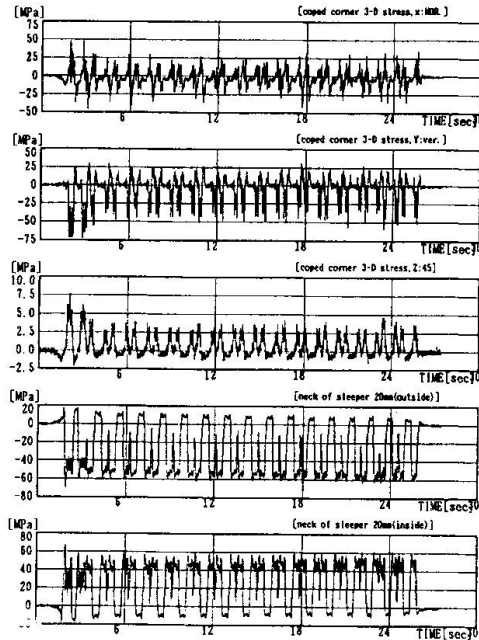
**Fig.9** Triaxial stress in the girder end notch and vertical stress of the web

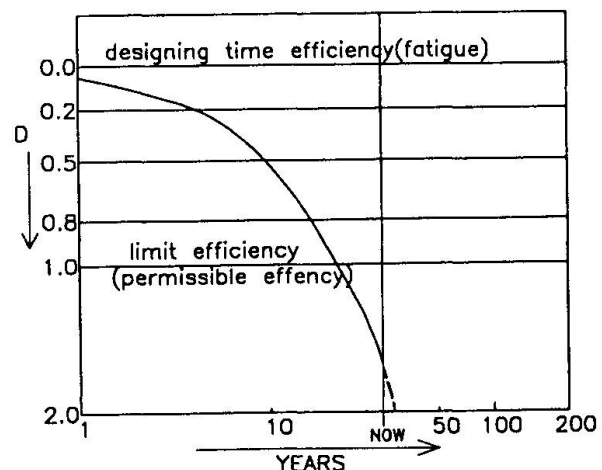
The method and standards for evaluating fatigue were based on the fatigue design guidelines of Japanese Society of Steel Construction<sup>2)</sup>. The result of fatigue damage evaluations is shown in Fig.10 and Fig.11.

**Fig.11** Fatigue crack occurring life of the stringer's neck (liner inserted)

- (1) Vertical stress of about 65 MPa is acting on the neck's weld. It was greater than the stress in the axial direction of the bridge, and was in the reverse phase in the inside and the outside of the web.
- (2) Vertical stress due to out-of-plane bending of the stringer neck was as large as 75 MPa.
- (3) Vertical stress in the notch of the stringer's end was 90 to 100 MPa and main stress was similarly great.
- (4) Fatigue crack occurrence life was calculated to be 9 years for vertical stress acting on the neck's weld. Fatigue crack occurrence life when the sleeper was in loose contact (when the sleeper was completely deviated) was calculated to be 8 years.

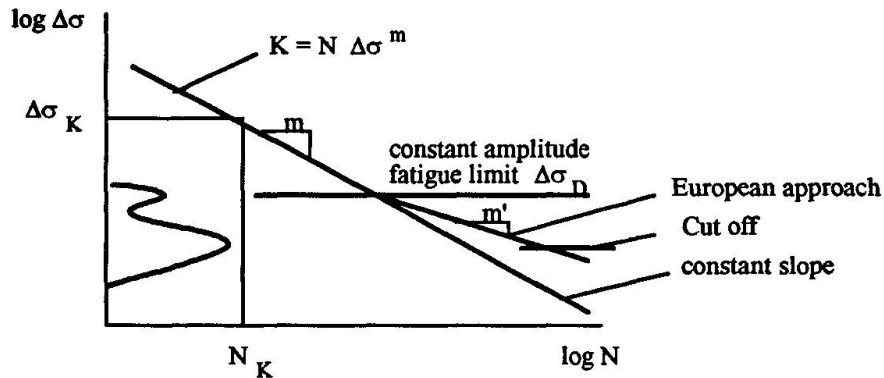
- Constant slope:** The approach used in North America is to calculate the equivalent stress range, using the root mean cube, and compare this to the allowed stress range for a given number of stress cycles.
- European approach:** Below the constant amplitude fatigue limit  $\Delta\sigma_D$  a different slope  $m' = 2m-1$  is taken into account, considering that the stress ranges below  $\Delta\sigma_D$  do not contribute to the damage increase in the same way as the stress ranges above  $\Delta\sigma_D$  do [1].

Figure 1 : Stress range spectrum with different fatigue strength curves

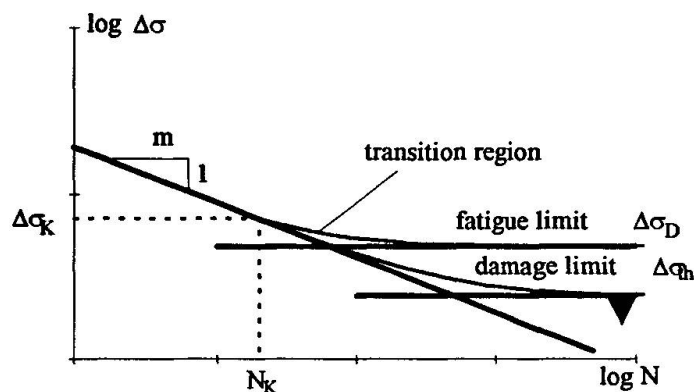
Figure 2 : Decreasing of the damage limit including the rounding of the transition region

The decreasing of the damage limit  $\Delta\sigma_{th}$  is illustrated in Fig. 2. Between the constant slope region above the constant amplitude fatigue limit  $\Delta\sigma_D$  a transition region can be observed. A similar observation can be made in fracture mechanics and therefore the damage increase per stress cycle can be quantified.

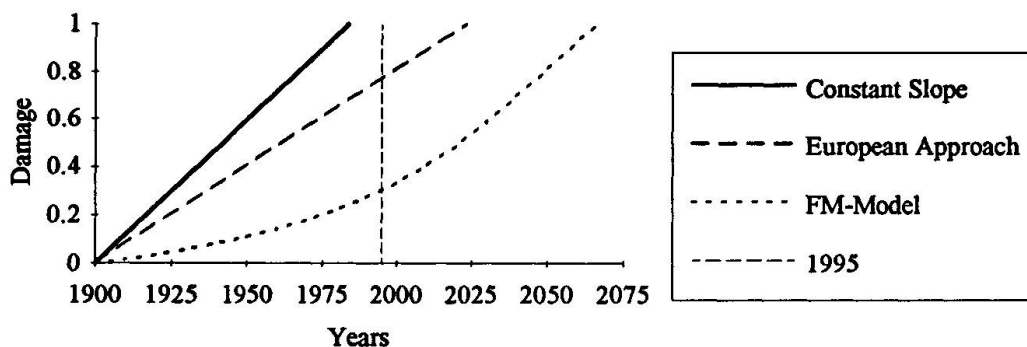
In the following figures the damage evolution of different damage accumulation models is shown. The FM-Model will be compared with the traditional approaches, the Constant Slope and the European model (Fig. 1). In Fig. 3 a constant traffic model is assumed. The traditional damage accumulation models show a constant increase of the damage, in the way it will be expected for design, the FM-Approach has an acceleration in the damage increase, because with increasing damage more and smaller stress ranges contribute to the damage increase. The differences between the three models is obvious because the majority of the stress ranges of the applied spectrum is below the constant amplitude limit. Based on the damage accumulation model used, the fatigue life will be estimated in a range of almost 100 years. If all stress ranges are above the constant amplitude fatigue limit and above the influence of the transition region the three curves are identical.

Figure 3 : Damage evolution for a constant traffic model

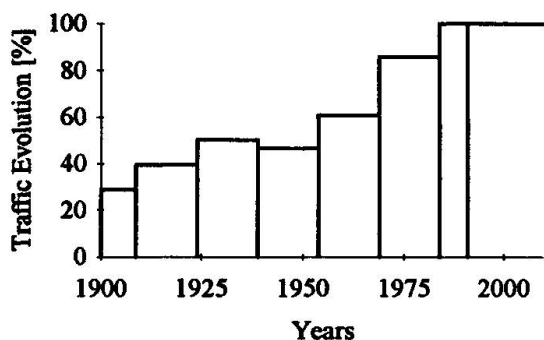
**Figure 4 :** Traffic evolution corresponding to UIC

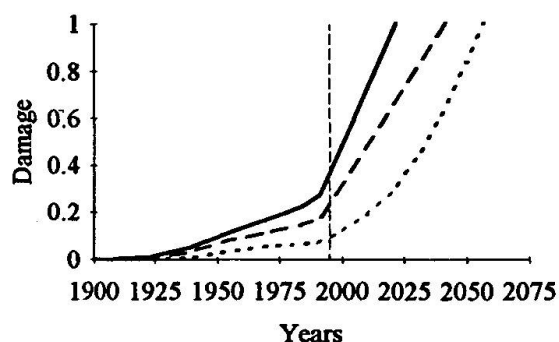
For the traffic in the past it is normally appropriate to consider a traffic evolution, where the increase of axle loads and the increase of the number of passages will be taken into account. For railway bridges the UIC (Union Internationale des Chemins de fer) proposes a traffic evolution like shown in Fig. 4. For each time period an other number of trains per day and other trains must be considered. The correspondent damage evolution is shown in Fig. 5. Due to the traffic evolution even the traditional methods change now the slope. Nevertheless, for each defined traffic model the damage increase is constant. However, the FM-model shows a continuous increase of the damage.

**Figure 5 :** Damage increase for a given traffic evolution (legend see Fig. 3)

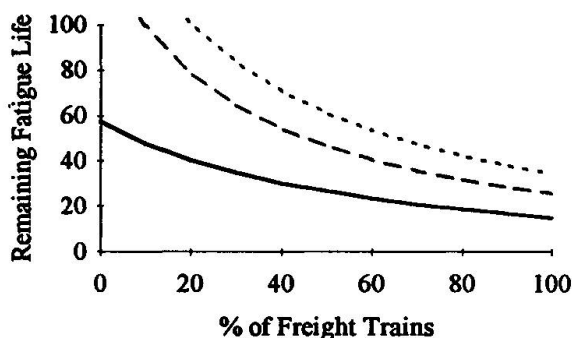
**Figure 6 :** Influence of the percentage of freight trains (legend see Fig. 3)

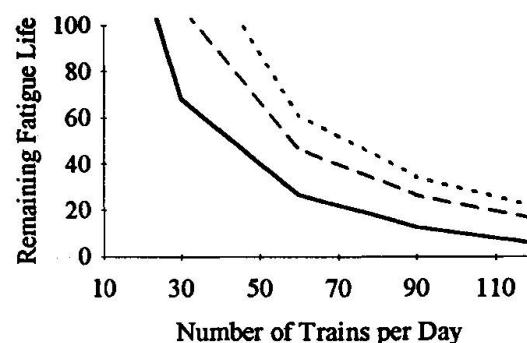
Fig. 7 shows the influence of the traffic volume, expressed by the number of trains per day. Even when the number of trains must be estimated and an uncertainty of  $\pm 10\%$  must be assumed, the calculated remaining fatigue life will not change significantly.

**Figure 7 :** Influence of the traffic volume (legend see Fig. 3)

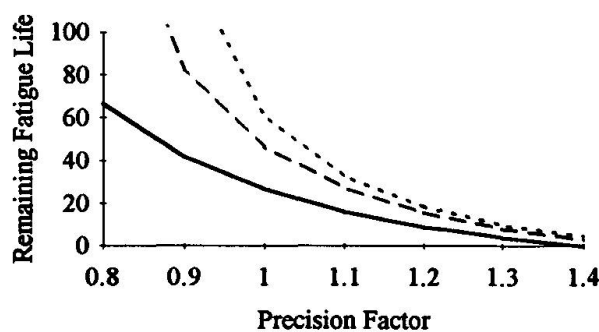
**Figure 8 :** Influence of the precision factor (legend see Fig. 3)

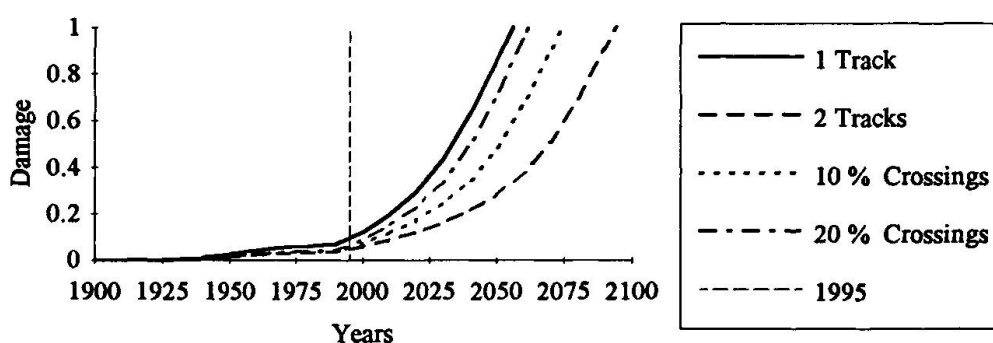
In Fig. 9 the influence of a second track is shown. In all cases the total number of trains will be assumed to be the same. The first assumption corresponds to a bridge where the total traffic in both directions is on the same track. This is compared to a second assumption that corresponds to a bridge with two tracks where on each track 50 % of the original traffic will be assumed. The influence of the stress ranges on the investigated detail of the second track is due to the lateral distribution 80 % of the influence of the first track; train crossings are excluded. In a third assumption different train crossings are assumed.

Figure 9 : Influence of parallel tracks and train crossings

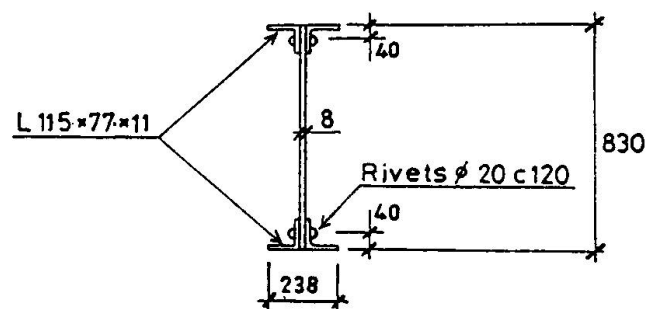
When the old riveted railway bridge over the Vindelälven at Vännäsby (built in 1896) was replaced by the railway authorities in 1993 it was decided that one should take the opportunity to carry out an extensive full-scale fatigue testing programme comprising the stringers and floor-beams from the bridge. In the first series 10 stringers were tested in four-point bending. The stringers were 5,5 meters long (after being flame cut from the bridge) with a depth of 830 mm:

**Fig.1** Dimensions of the built-up I-shaped stringers.

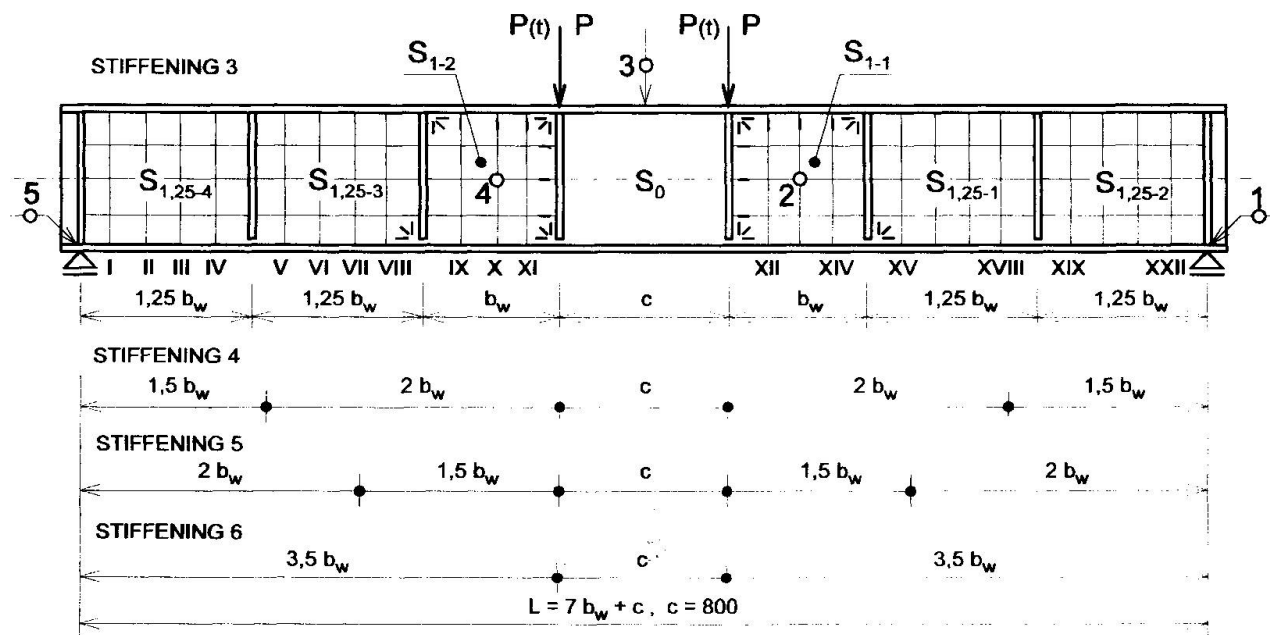
From the point of view of this investigation the information on lateral buckling of the webs in production and their influence on the overall behaviour of girders are particularly significant. Therefore, individually tested girders were investigated for the lateral buckling of the webs in production. Scheme of girders and working arrangement of the tests are shown on Fig. 1.

Fig. 1. Scheme of girders and working arrangement of the tests

The tested girders were sustained by special vertical and horizontal supports to prevent lateral buckling. The loading was realised by two hydraulic jacks. The tests of girders were divided into two parts. First of all, the girder was loaded by successive loading till to  $P_{max}$  and after that about five cycles between  $P = 0$  and  $P = P_{max}$  were repeated. Then the fatigue test could start. During fatigue test the girders were loaded by synchronise pulsate loads

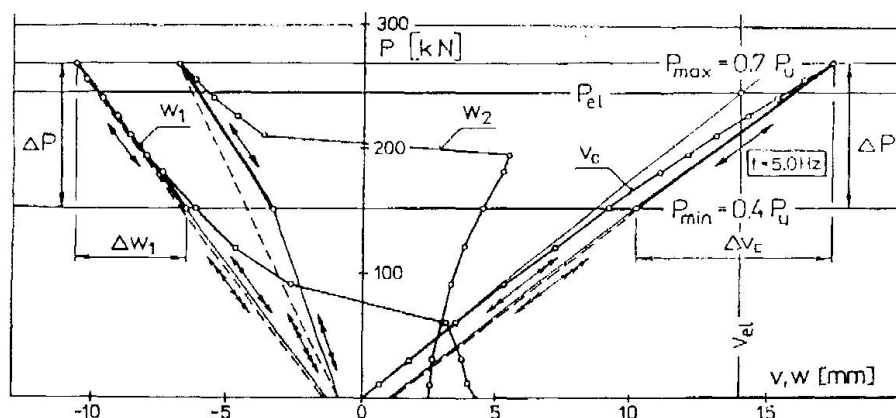
Under the dynamic fatigue loading the thin webs of girders are laterally vibrating. At the beginning of loading process the service shape of web vibration is formed in a similar way to the case of quasistatic loading. During the usual service loading regime in girders the resonant effects do not arise. Therefore, the lateral web deflections which are received at the repeating loading are practically identical with the dynamic lateral web deflections. Under the fixed cyclic loading the levels of deformations, deflections and shape of lateral web vibration did not change at any tested girder till the beginning of fatigue failure. Referred knowledge is presented in Fig. 2.

Fig. 2. Deflections  $w_1, w_2, v_c$  in dependence of load  $P$ .  
Jumps over of the web in the most loaded fields.

The ultimate load of the girder with account of the web buckling and the elasto-plastic postcritical behaviour of the web is  $P_u = 382.2$  kN. During the first loading the sudden jump over appeared in two most loaded web fields - in the web field  $S_{2-1}$  after  $P = 60$  kN and in the web field  $S_{2-2}$  after  $P = 195$  kN. However,

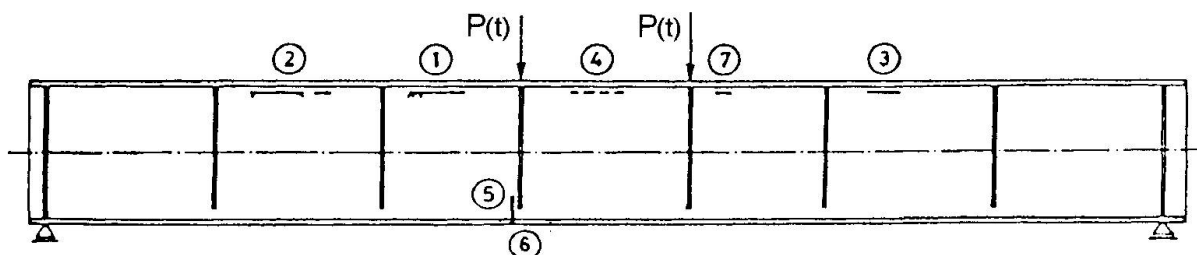
The result of realised experimental investigation proved that the lateral web vibration of steel girders can also cause the formation and successively increasing of the fatigue cracks. Fatigue cracks of the chosen test are presented in Fig. 3.

Fig. 3. Fatigue cracks in the thin web along welded connections with compression flange and transverse stiffener, crack in tension flange.

This girder is especially interesting with fatigue cracks along compressed flange in all internal web fields. The first cracks 1 and 2 had appeared after 300,000 and 400,000 cycles respectively. Later cracks were successively increasing, but only the initiation of the crack 5 along stiffener was decisive for the failure of the girder. The crack had spread very quickly to the tension flange in the form of crack 6 and the total failure of girder was completed after 1,342,000 cycles.

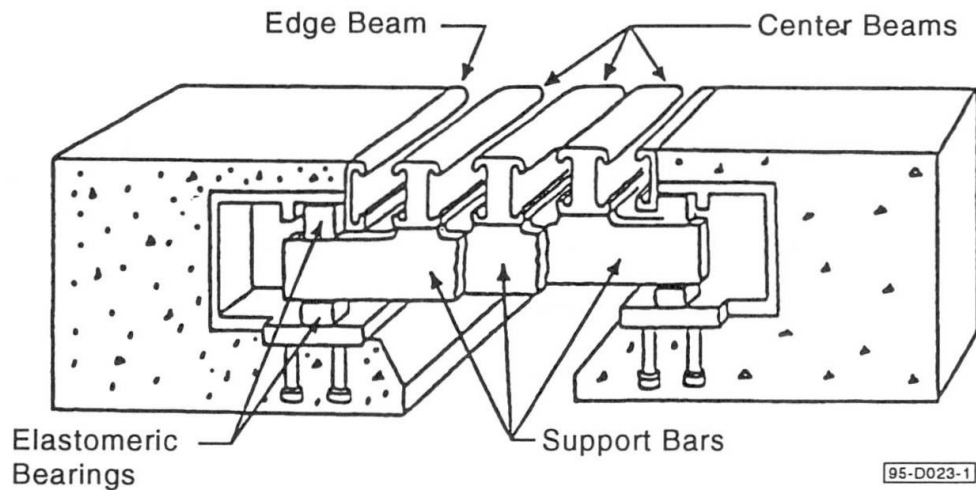
Figure 1: Schematic of modular expansion joint system

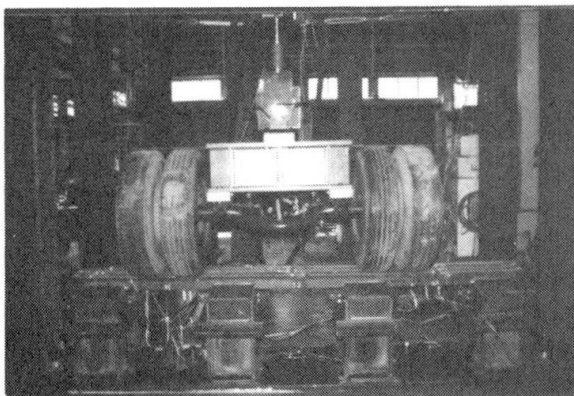
Figure 2: Full-scale system fatigue test

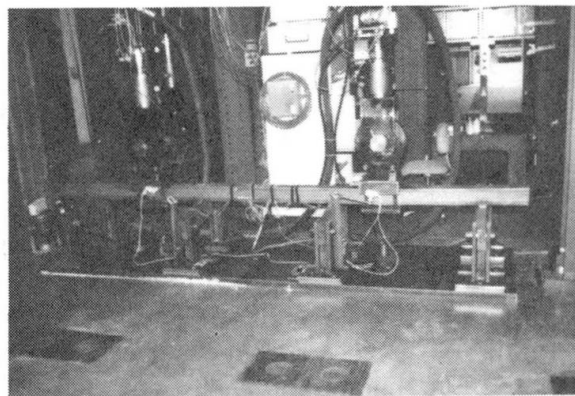
Figure 3: Single centerbeam fatigue test

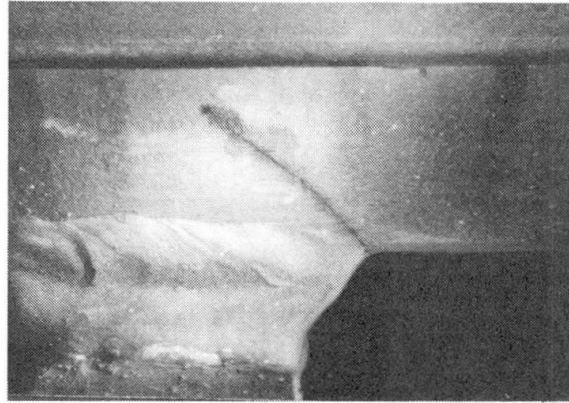
Figure 4: Typical crack in the centerbeam at the full-penetration weld connection.

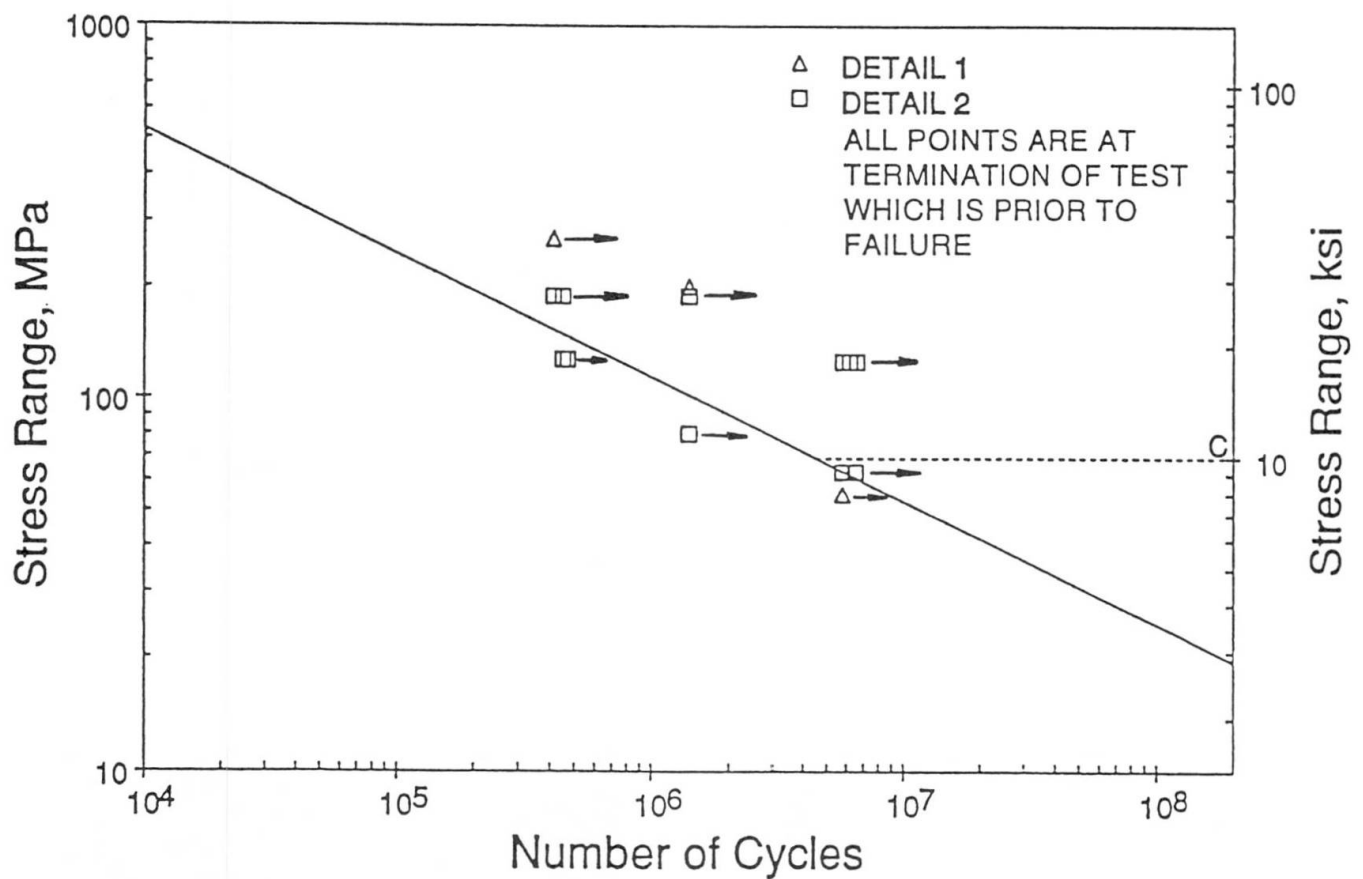
Figure 5: S-N data for cracks at the full-penetration connection detail plotted with theoretical life (Category C). Notes: 1) Detail 1 is cracking in the centerbeam at the connection (as shown in Figure 3) while detail 2 is cracking in the support bar at the connection. 2) The specimens had not actually "failed" and the cracks were still growing at the number of cycles indicated.
