Zeitschrift: IABSE reports = Rapports AIPC = IVBH Berichte
Band: 73/1/73/2 (1995)

Rubrik: Session E3: Dynamic testing and analysis

Dynamic Testing and Analysis
Essais dynamiques et analyse
Dynamische Versuche und Berechnung

Stabilization of a Cable-Stayed Footbridge
Stabilisation d'une passerelle haubanée
Stabilisierung einer Schrägseil-Fussgängerbrücke

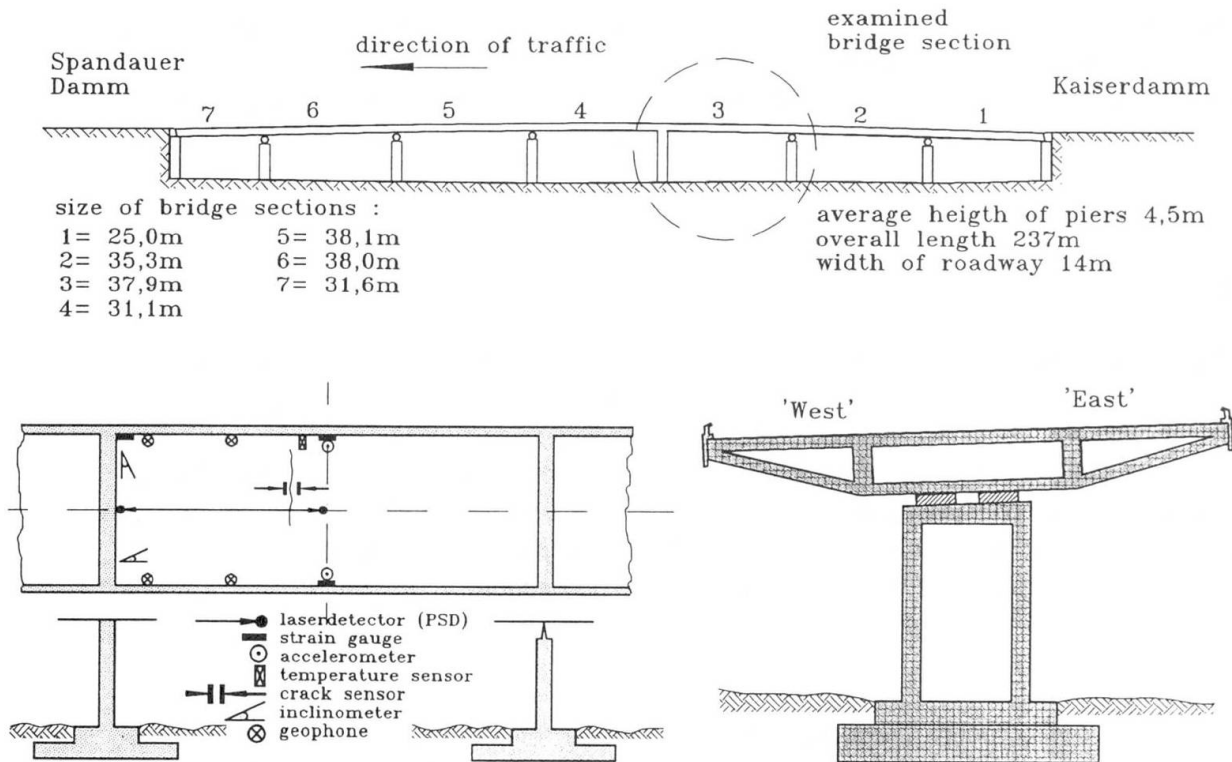
Figure 1: Highway Bridge Westend

Profile of the bridge (above), Location of sensors (left), Cross-section (right)

This 30 year old prestressed bridge (figure 1) has had a lot of cracks occurring at the floor slab of the hollow box, at the cross girder above the columns and at the longitudinal main beams. There was no clear explanation for these cracks. So the supervising authority decided to repair the bridge first and then to install a monitoring system to surveille the bridge by measuring the service loads and the conditional behaviour permanently. Positions and types of 15 sensors attached inside the bridge is shown in figure 1. The traffic loadings are measured with strain gauges attached at the middle of the main beam and above a support.

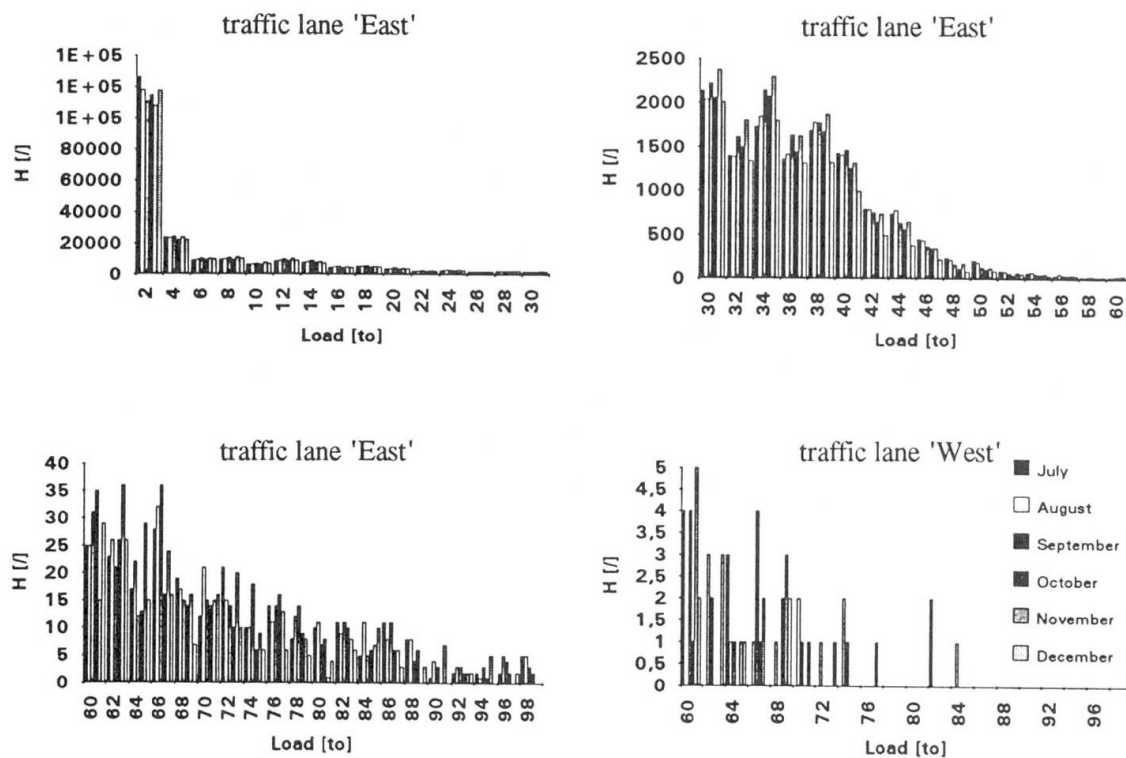
Figure 2: Frequency H of static traffic loads P_{stat} from 6 months (July - December 1994)

From the amount of existing monitoring data some selected results will be discussed. At first we discuss the results of loading control. The common approach to simulate traffic loads, Riera et. al. described in [3], is a composition of assumptions about vehicle characteristics, mean velocities and traffic composition. In connection with a numerical model this loads result in desired dynamic responses. In our approach we directly measure the dynamic responses and then based on this data develop an artificial loading model for the bridge. Assuming linear conditions the bridge was calibrated first by measuring the maximum midspan strains at the girders of the described span due to a heavy truck of known weight travelling along the bridge on different lanes. The monitoring system then is measuring continuously the loading conditions under normal traffic. Within a certain time window the maximum value of measured strains is stored. This will be done before and after a low pass filtering of the signal. In relation to the results of the calibration data each of these strain values belong to an artificial vehicle load due to each traffic lane. So in certain periods of time an averaged passage frequency classified by vehicle loads is developing, which is as stable as the measuring time is long enough. Figure 2 shows representative results of the load density function for a observation time of 6 months.

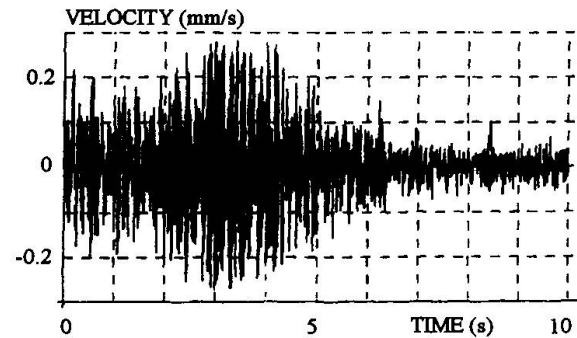
Fig. 2 Velocity at the top
(Arco di Costantino)

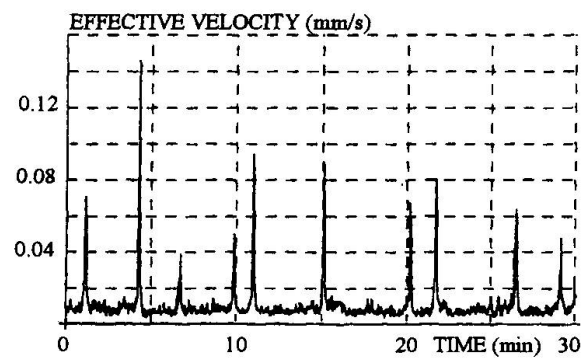
Fig. 4 Effective velocity at the top

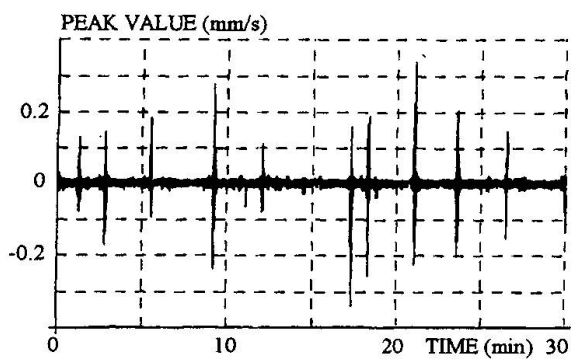
Fig. 5 Peak value on the basement

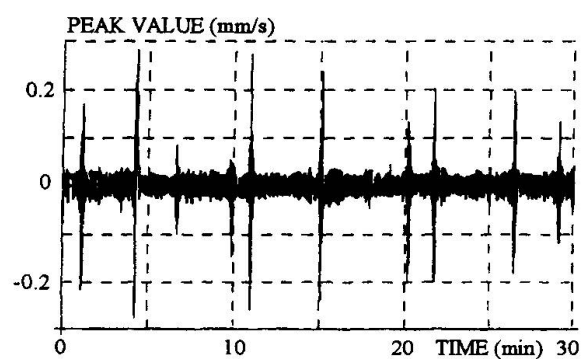
Fig. 6 Peak value at the top

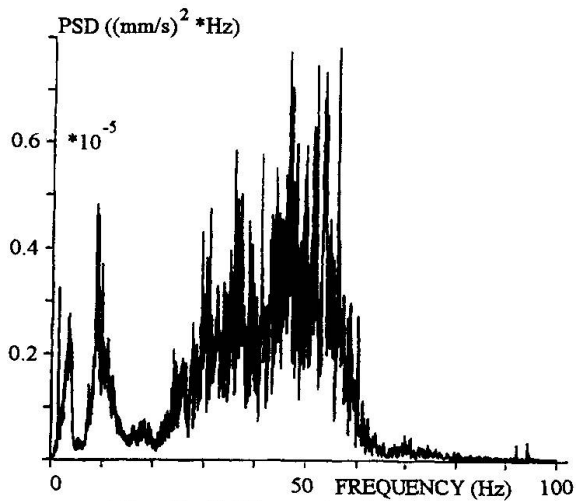
Fig. 7 PSD on the basement

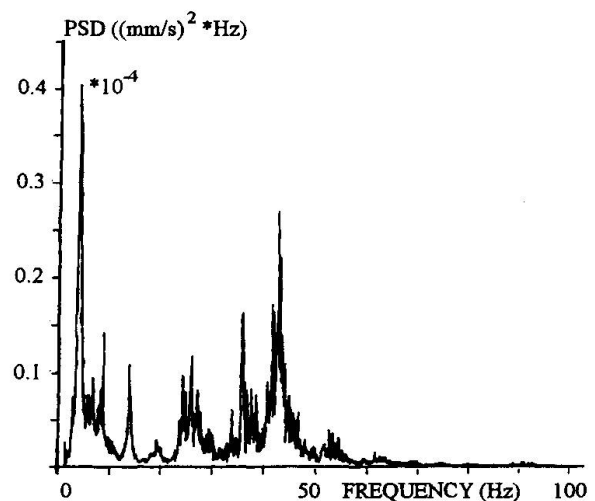
Fig. 8 PSD at the top

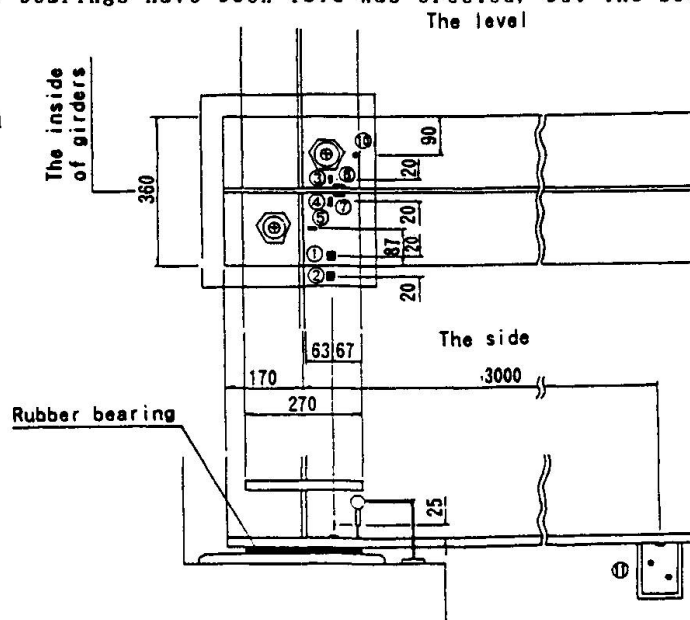
Figure 1 Measurement position (①-⑪ in figure corresponds to No. in Table 1)

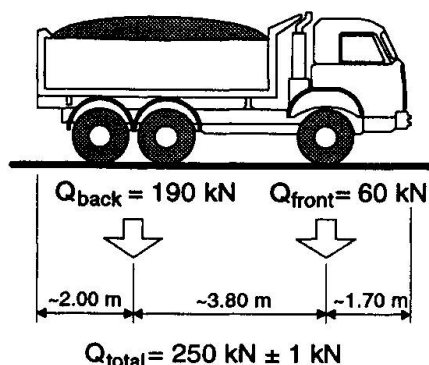
Figure 2: Typical truck used in dynamic load testing

The trucks used for the dynamic excitation of the bridge are usually 3-axle trucks, as shown in Figure 2, with a total weight of 250 kN (total mass of 25 metric tons), traveling on the bridge at several speeds. The effect of a deterioration of the pavement is simulated by the introduction of a normalized plank on the path of the truck. This induces a strong impact when the trucks passes at mid-span, that represents the effect of a pothole in the pavement, or the irregularity of the surface caused by packed snow. Figure 3 shows the location of the instruments and the results for the dynamic testing of the Riddes-Leytron bridge. Absolute displacement sensors are used for the measurements, and therefore only components with a relatively high frequency (larger than 0.2 Hz) are recorded, as shown in Figure 3a (vertical displacement at mid-span as a function of the truck position). The static influence line of the truck passing on the bridge is then added to obtain the complete dynamic influence line shown in figure 3b.

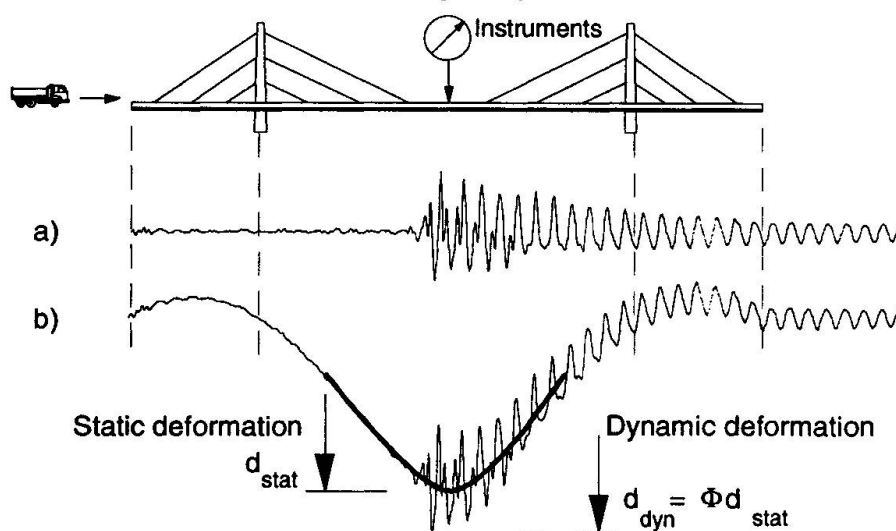
- Relative vertical deflection at mid-span caused by the passage of the truck
- Dynamic influence line of the passage of the truck. Determination of the dynamic amplification factor.

Figure 3: Description of the dynamic load test

Because a lot of information is gathered in the course of dynamic load testing, the results are usually presented graphically. First, as shown in figure 3b, the dynamic influence line of the bridge subjected to the passage of a truck is drawn for all travel speeds, with and without plank. This allows a simple visual determination of the dynamic amplification factor Φ . The natural frequency of the bridge is obtained from acceleration spectra performed by the FFT analyzer. The logarithmic decrement is obtained from the decay of

the bridge free oscillations, after the truck has left the bridge, or at least when it is far enough from the instruments (figure 3a).

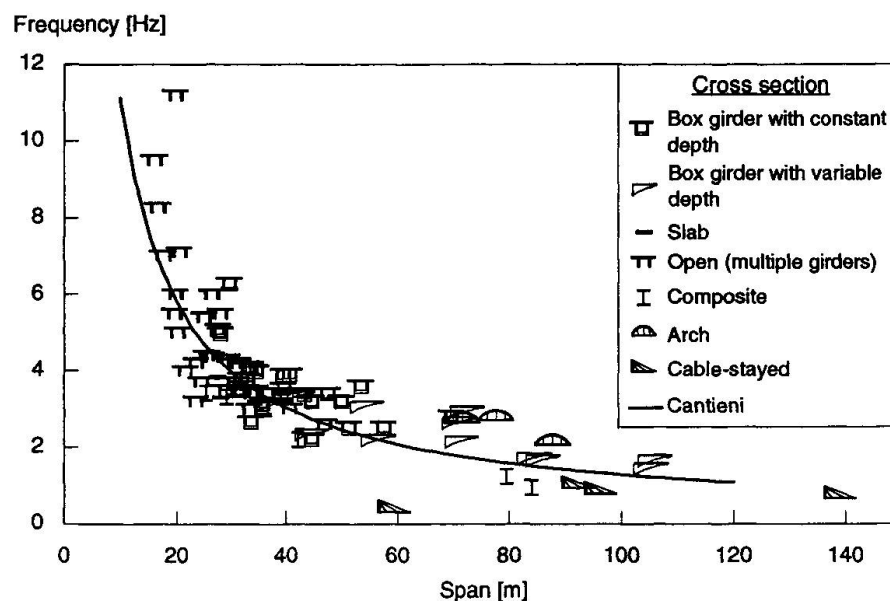
Figure 4: Natural frequency as a function of bridge span

Figure 4 shows the natural frequency as a function of bridge span for approximately ninety bridges tested by IBAP. The regression line was proposed by Cantieni in [5, 6], based on over 200 dynamic load tests of Swiss bridges. A good correlation has been found between his data and data gathered by IBAP. Figure 5 shows histograms of the dynamic amplification factor for the bridges tested over the past twenty years. Some bridges are not included in the graphs because of incomplete measurements in the early years of dynamic testing. The Swiss code for bridges specifies a constant dynamic amplification factor for bridges of 1.8. It is interesting to note that a significant number of bridges indicated higher values. Most bridges had a small damping, with logarithmic decrements smaller than 0.1.

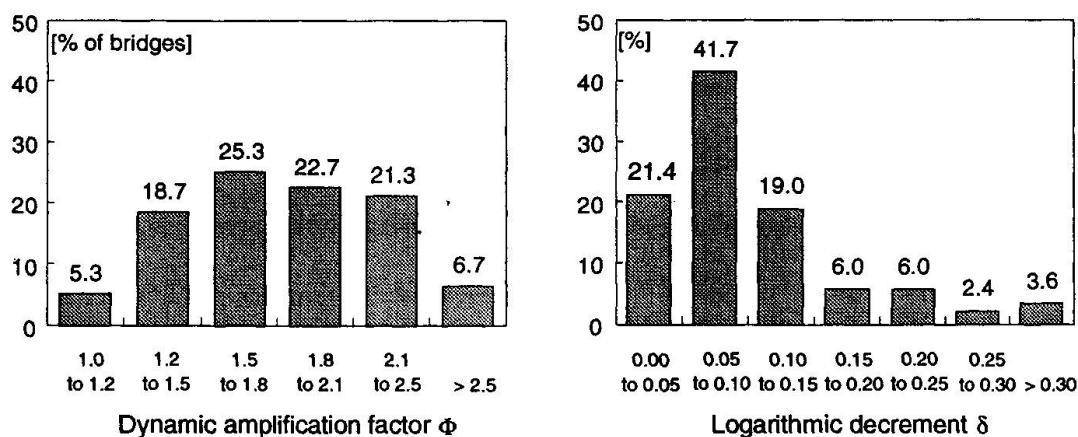
Figure 5: Histograms of the dynamic properties

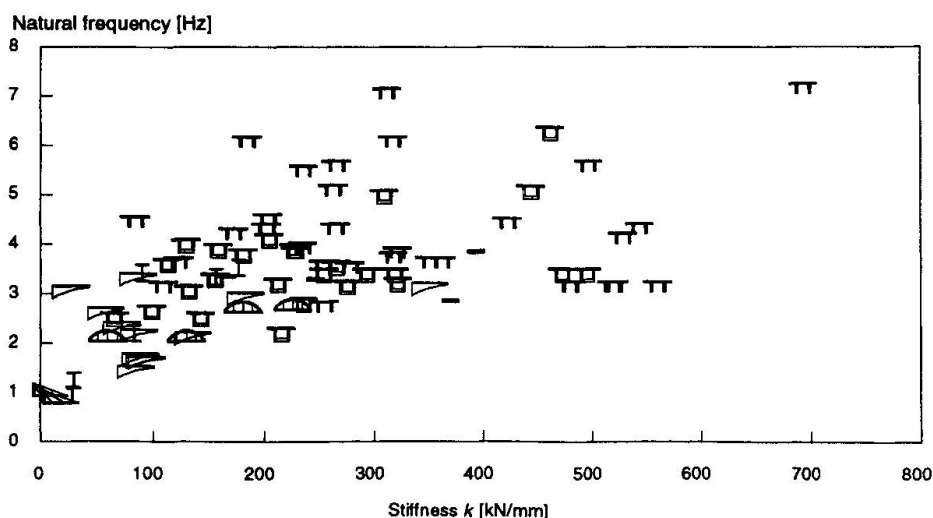
Figure 7: Natural frequency of the bridge as a function of the bridge stiffness

Because dynamic loading testing is usually performed on bridges that have also been subjected to static load testing, comparisons can be made between the behavior of a bridge under static and dynamic loading. Clearly, the two behaviors are related, in that the bridge stiffness, or spring constant k appears in both the static load test and in the components of the natural frequency. Figure 7 shows the fundamental frequency of

each of the tested bridges as a function of its stiffness obtained from a static load test. As expected, there is on average an increase in natural frequency with an increase in stiffness. However, the scatter is rather large, especially for concrete bridges, as their mass strongly depends on the construction method and cross section. A similar scatter can be observed when looking at the correlation between the dynamic amplification factor and the bridge span or natural frequency. While some tendencies can be observed, the scatter of the data makes the derivation of a simple approximate formula impractical.

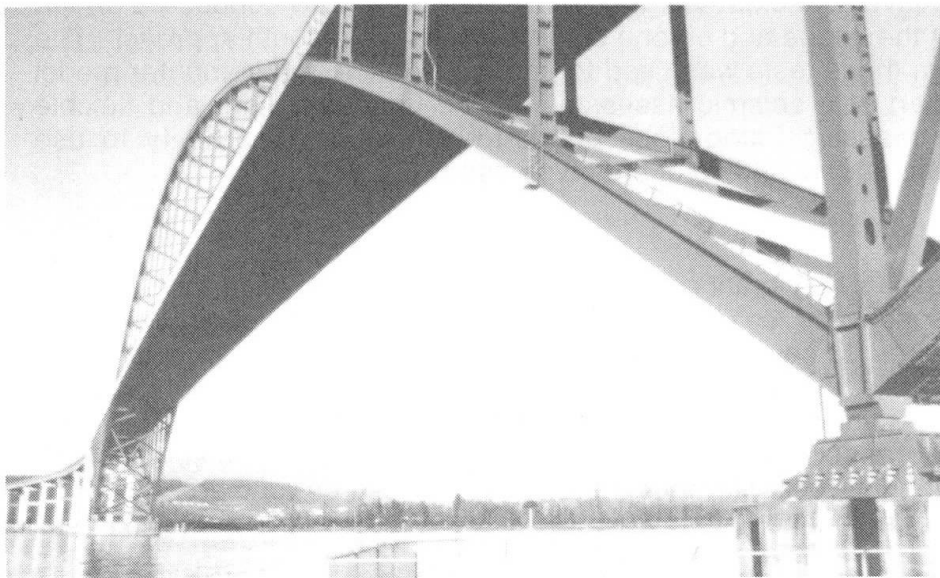
Fig. 1 Underside View of the Port Mann Bridge

A general overview of the Port Mann Bridge is shown in Fig. 1. The bridge crossing is located where the Fraser River is about 900 m wide and consists of three structures: the Main Span and the North and South Approaches as shown in Fig. 2. The Main Span crossing the navigational channel is formed by two three-span steel stiffened tied arches that provide a 44 m vertical clearance above high water level and a 365 m clear centre span for shipping. The side spans are 110 m long. The arches, in combination with the stiffening girders, were designed to act as a funicular polygon with no bending moments under dead load. The arch supports were pinned at pier N1, on longitudinal rollers at S1 and on rockers at N2 and S2, permitting longitudinal movement.

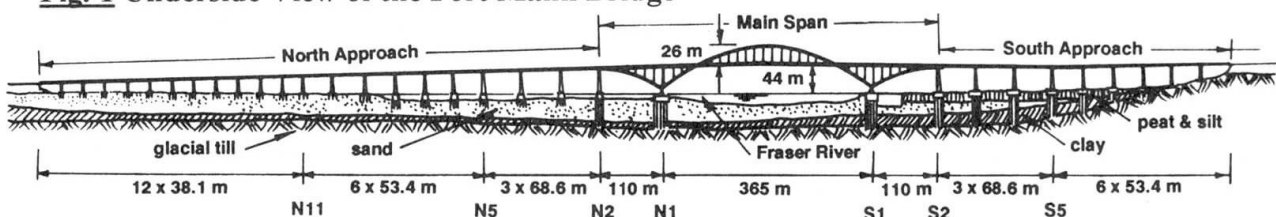
Fig. 2 Elevation View of Port Mann Bridge

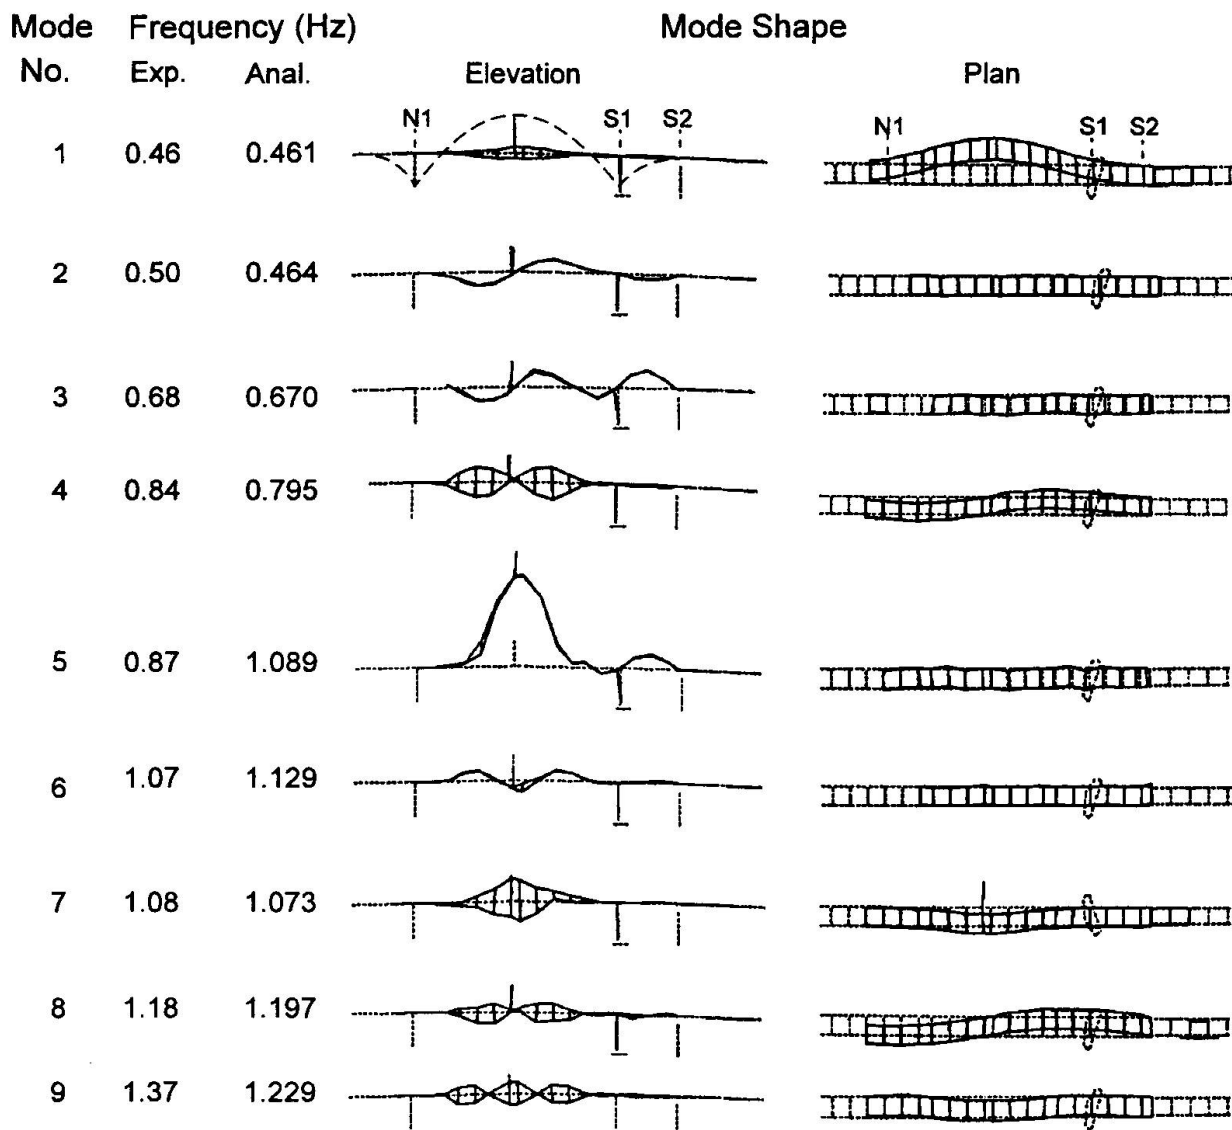
Fig. 3 First Nine Natural Modes of the Main Span of Port Mann Bridge

The fundamental frequencies of the calibrated model correlated well with the experimental frequencies and are shown in Fig. 3. The associated mode shapes matched very well the experimental modes, but are not shown here due to space limitations.

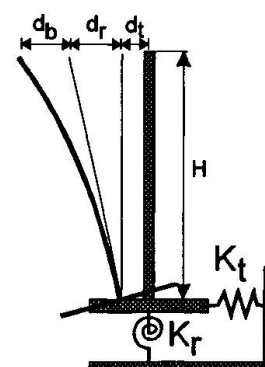
Fig. 5 Pier-Foundation Model

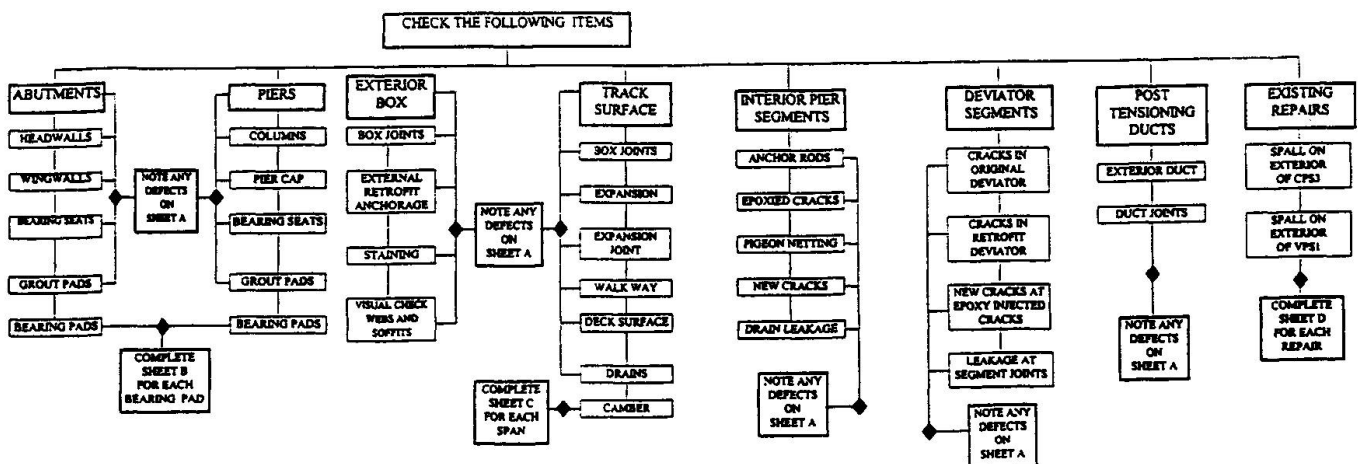
Fig. 2 Flowchart used for inspection of J-2e Aerial Structures

All elements assessed by the inspection team are assigned a numerical rating (0-5 scale, with 5 indicating good condition) to assess their condition. Upon completion of the inspection all items rated 3 or below must be reviewed by a WMATA Engineer. Additionally, the entire inspection package, including all checklists, must be reviewed by the Engineer to complete the inspection of the J-2e structures. This system will allow the inspection to be conducted by WMATA field personnel with a built in review by a WMATA Engineer.
