**Zeitschrift:** IABSE reports = Rapports AIPC = IVBH Berichte  
**Band:** 73/1/73/2 (1995)  
**Rubrik:** Poster Session 2: Buildings

## **Poster Session 2**

**Buildings**

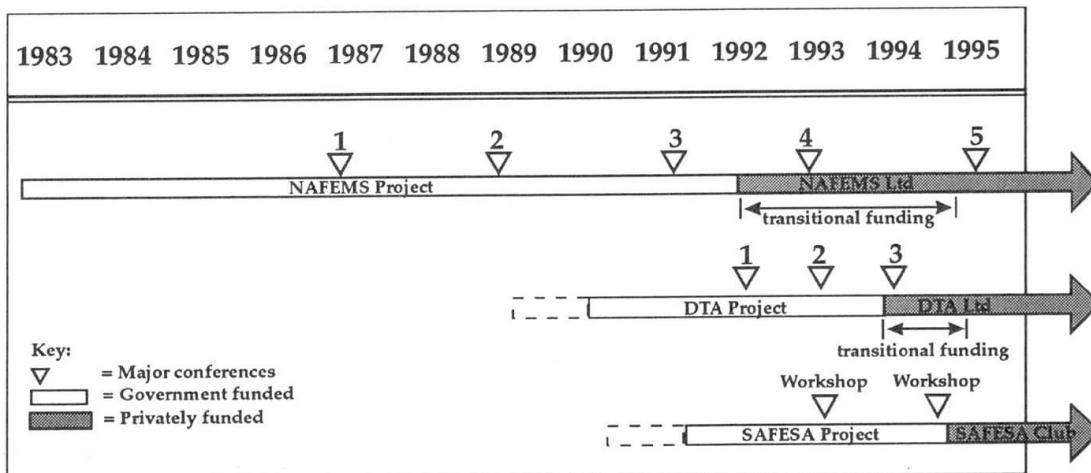
Fig. 1 Chronological development

The chronological development of the three projects is shown in Figure 1. The aims of the three projects are given below.

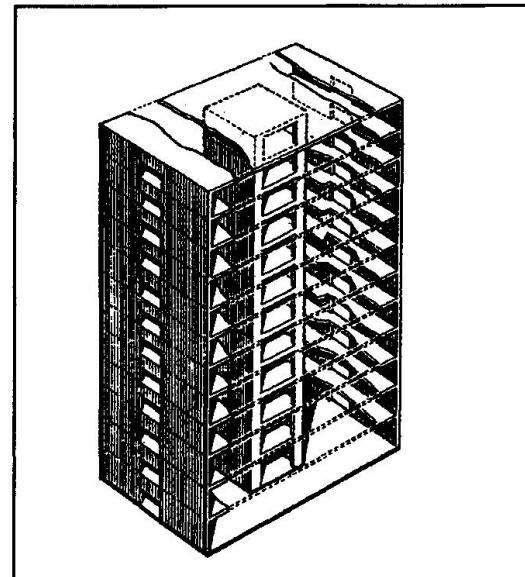
Fig. 2 Exploded Isometric View of Typical Tower Block (with acknowledgements to CIRIA)

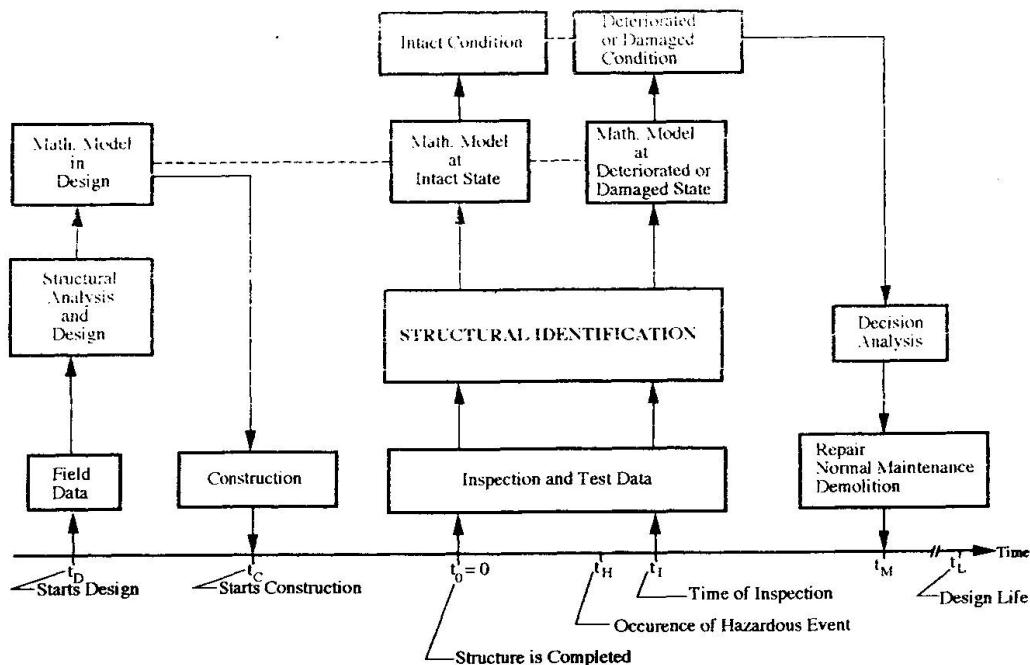
**Fig. 1 Role of structural identification during the lifetime of a structure**

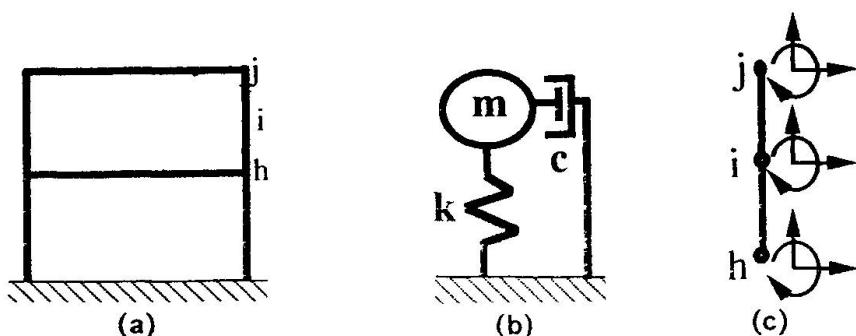
Based on the size of the structural system under consideration, structural identification can be classified into (1) global; and (2) local. Global identification models the complete structure in the deriving the state equation. The representation usually reduces to simple models such as lumped mass models especially when structures with many degrees-of-freedom (DOFs) are analyzed. Fig. 2(b) which shows a spring-mass-dashpot model of a plane frame is an example of a global model. The simple modeling is necessary for an efficient and convergent identification. The models used by Hoshiya and Saito [1] are typical examples of global models in structural dynamics. The unknown parameters involved in global identification are those which affect the overall behavior of the complete structure such as frequency and damping or stiffness,  $k$ , and damping,  $c$ . In damage assessment of structures, global identification can show only that damage has occurred from the changes in the overall response and characteristics of the complete structure. It is difficult, however, to detect the cause of these changes in the behavior of the structure.

Fig. 2. (a) Plane frame; (b) Global model of plane frame;  
(c) Local model of frame member

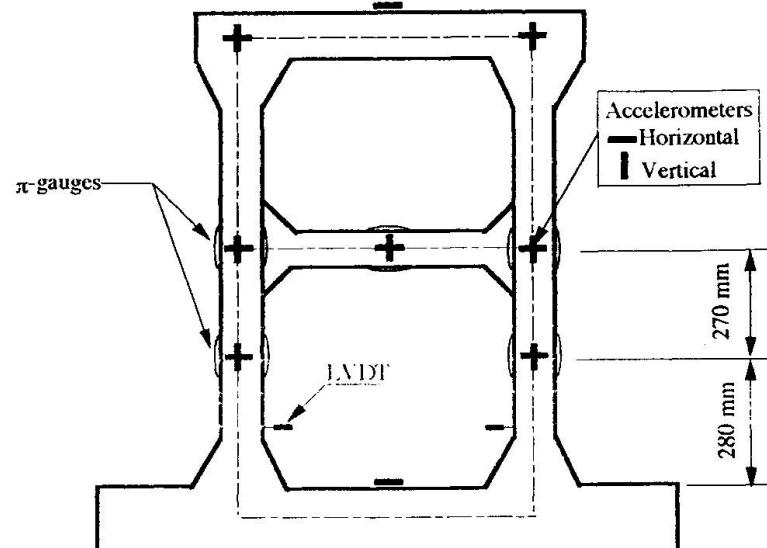
Fig. 4. Location of sensors

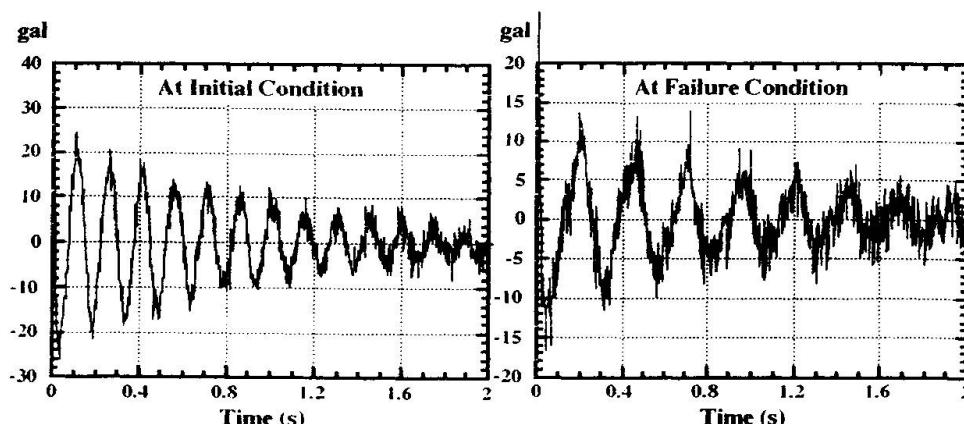
Damping (%)	Frequency (Hz)
Initial Condition	2.568	6.718
After 200 gal	2.565	6.231
After 400 gal	2.369	5.722
After 600 gal	2.796	5.083
Failure Condition	2.524	3.968

**Fig. 5. Free Vibration Response**

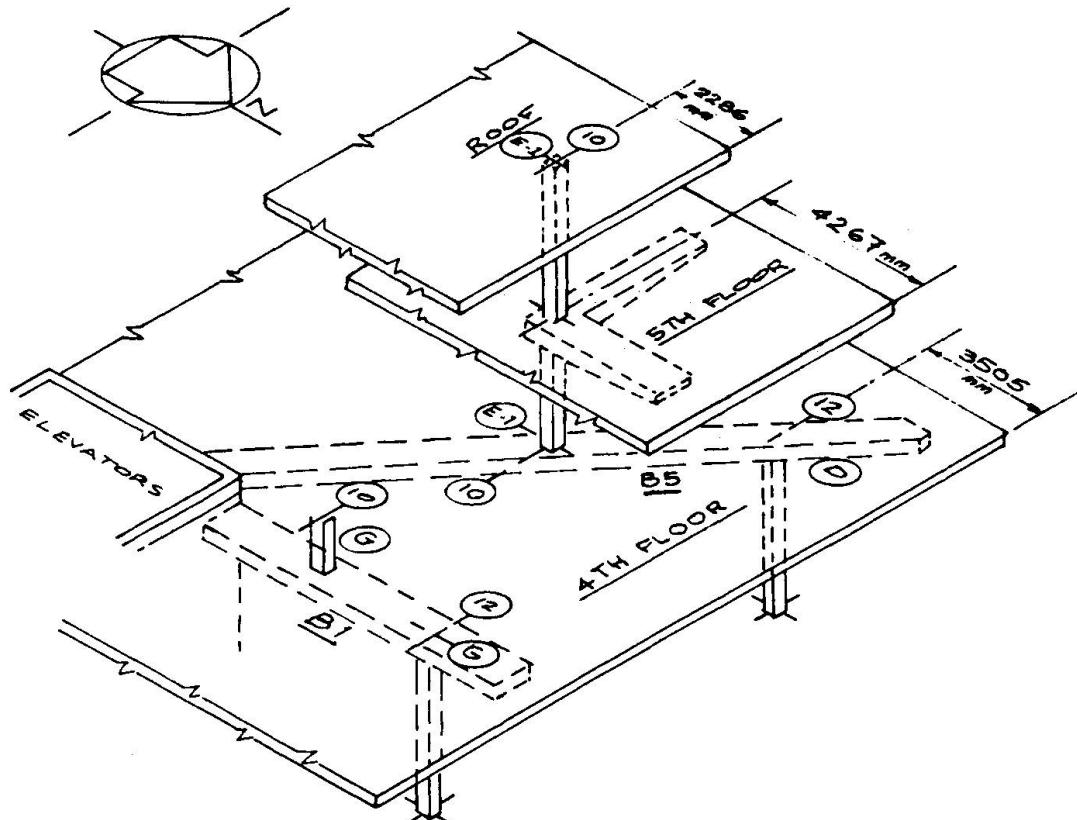
Fig. 1 Schematic view at corner of structure showing upper floors.

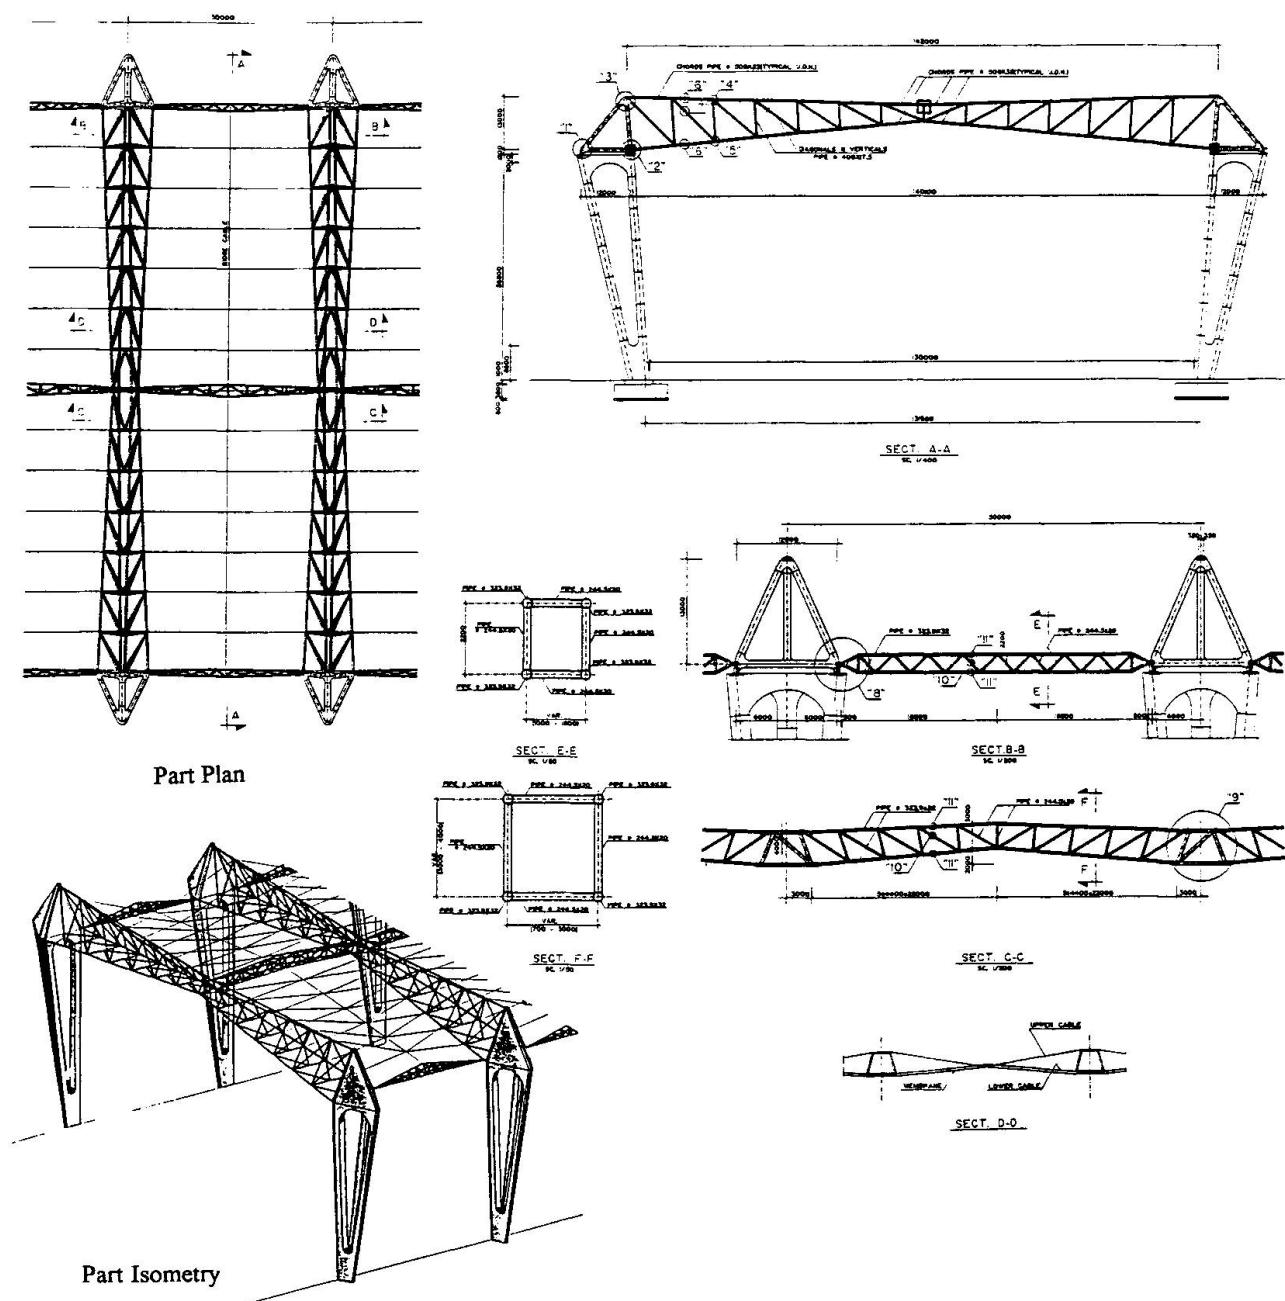
The bearing frame was idealized as a three hinged frame and in order to reduce the moments, and thus to transfer loads mainly through axial forces, a space frame was chosen. The main frame rafter is formed of a three dimensional tubular steel box truss which frames into the 70 m high tripod columns. For stability and for controlled deformations the main frames are connected in the longitudinal direction by means of three trusses every bay.

Fig. 1 Shading structure.

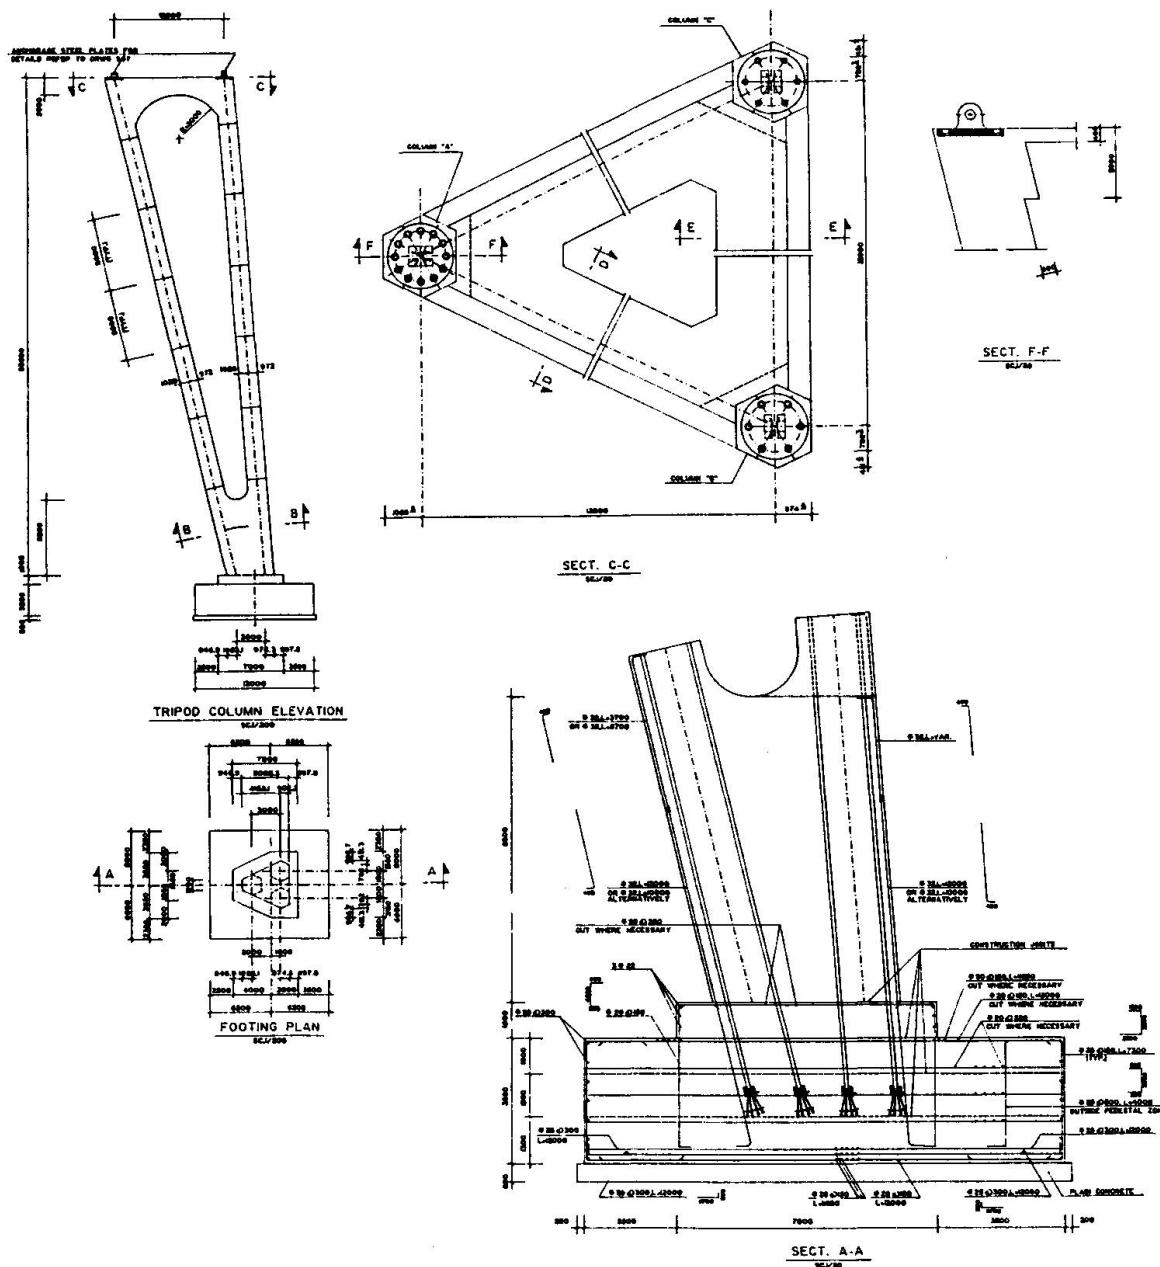
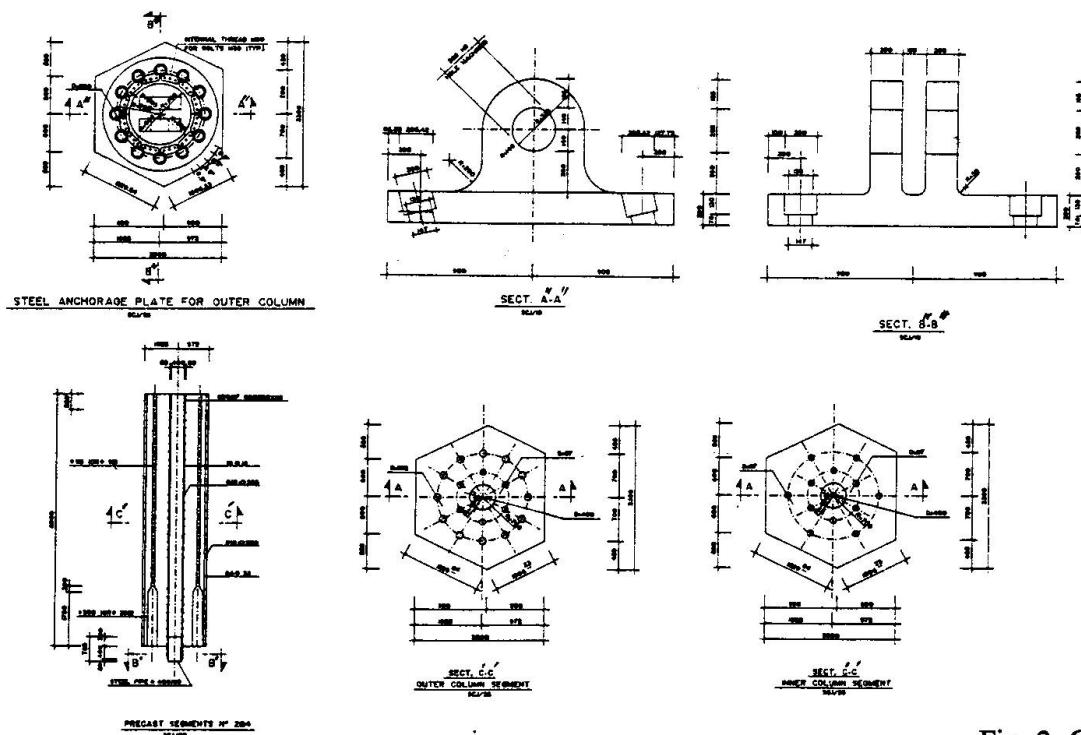
5. The columns of the tripod will be braced together during construction by a temporary system at levels multiple of 8.0 m from the top level of the bottom bulk, Fig. 2, to be removed after the placement of the top platform.
6. After the erection of all the straight segments, the precast platform will be placed on the top of the columns and will be anchored to the straight segments with the final prestressing of the tendons. The prestressing at the top of the platform will be anchored to a system of bearing steel plates with brackets which will carry the main steel truss. All the prestressing will be bonded using non-shrink grout except those anchored against the steel bearing plate will be unbonded in the top 2.0 m in the platform region.

Fig. 2 Prestressed concrete column solution.

Fig. 2 Cont.

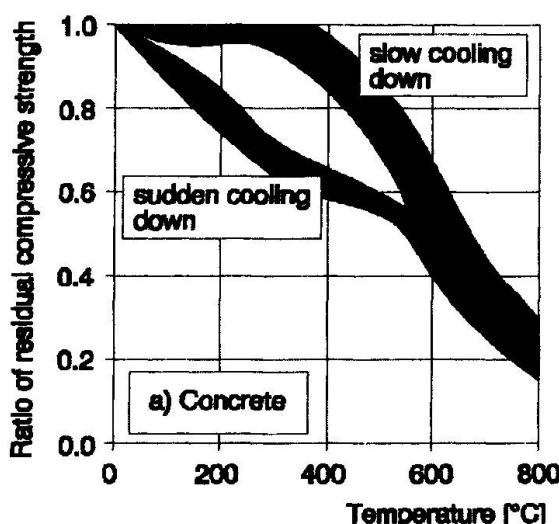
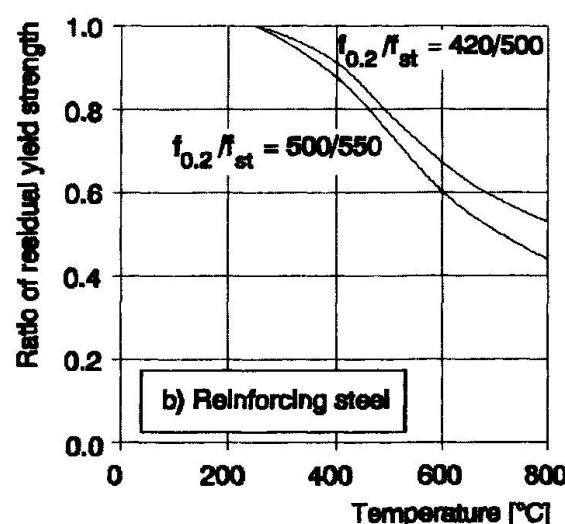
The residual strength of concrete can be tested by the well known measures. The dependence of decreased strength on the temperature reached before as well as on the cooling down conditions can be taken from Fig. 1-a. As a rough solution, the decrease of the elastic modulus versus temperature may be taken as equal to that of strength.

Fig. 1 Residual strengths of concrete and reinforcing steel as a function of temperature reached

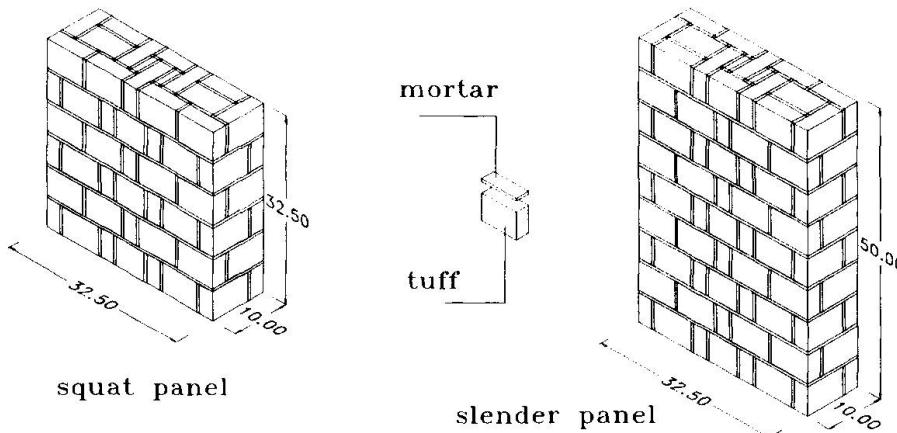
As we have already said the tested specimens represent masonry panels on the scale of one to six. The panels are made of little stones of yellow tuff, which characterizes the old buildings of the Naples area. The stones, whose size is  $7.0 \times 5.0 \times 2.5 \text{ cm}^3$ , are extracted by cutting from the original practical used stones; a cement mortar, with a water/cement ratio equal to 0.5, has also been used. Two kinds of specimens, respectively with the ratio  $B/H=1$  (squat panels) and  $B/H=0.67$  (slender panels), have been considered in order to study the behaviour of characteristic masonry walls. Fig. 1 shows the two models and their size.

Fig. 1 Specimens

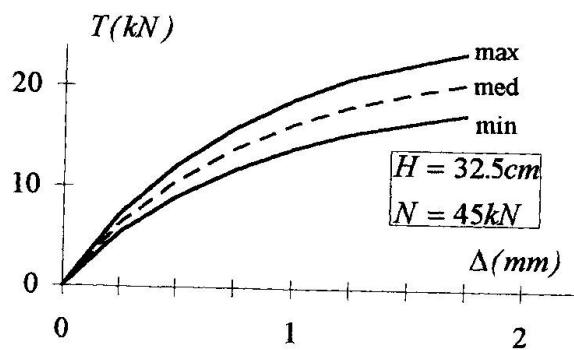
Fig. 2a

The experimental results are summarized in the following. The diagrams  $T-\Delta$  (horizontal force against horizontal displacement) are drawn for both dynamically prestressed and not prestressed panels.

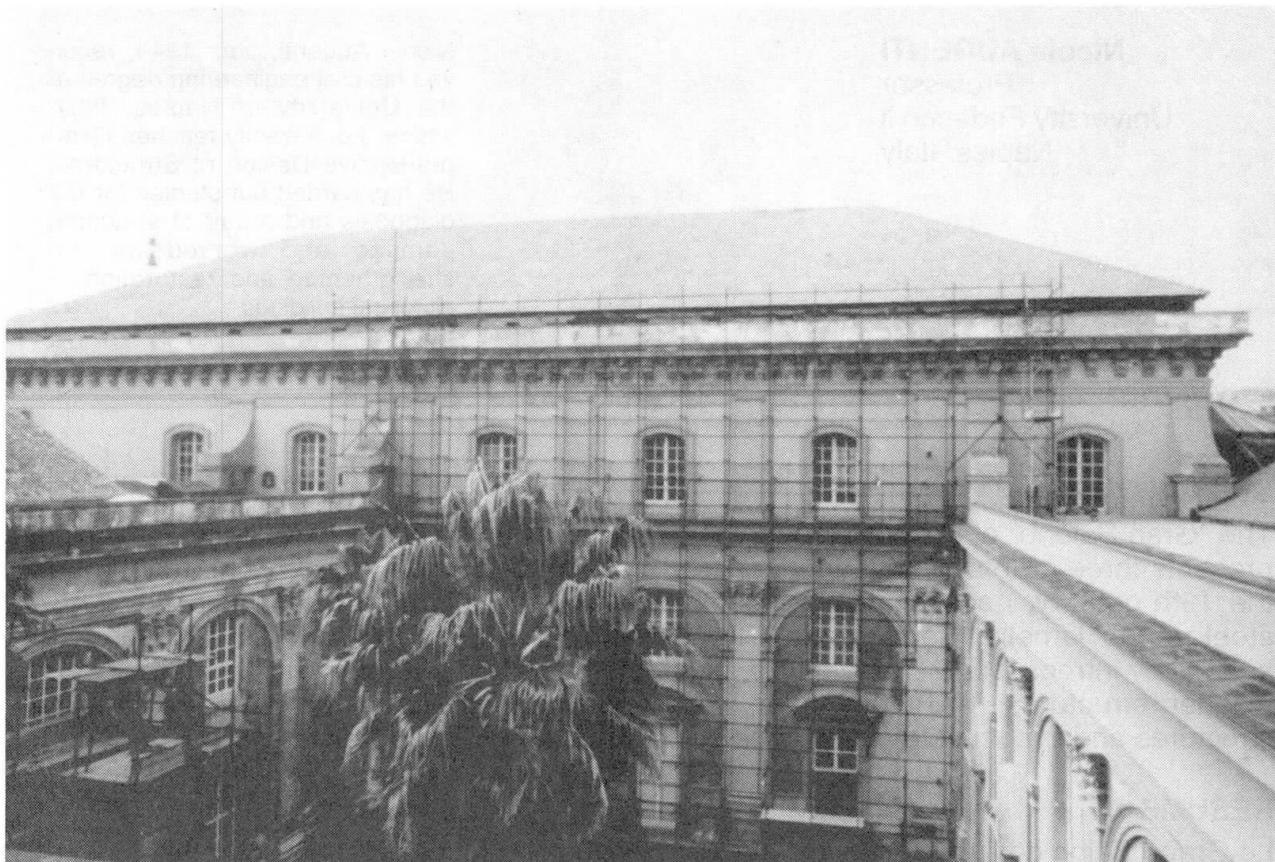
The National Archeological Museum in Naples occupies a building founded in 1582 by the Naples Viceroy Don Pedro Giron. The most representative part of the monument is formed of a stately room of more than 20.000 cu.m. called "Gran Salone", whose roof was rebuilt in 1735 by arch. Giovan Antonio Medrano with three wooden covering orders .

Fig. 1 Outside view of "Gran Salone" covering.

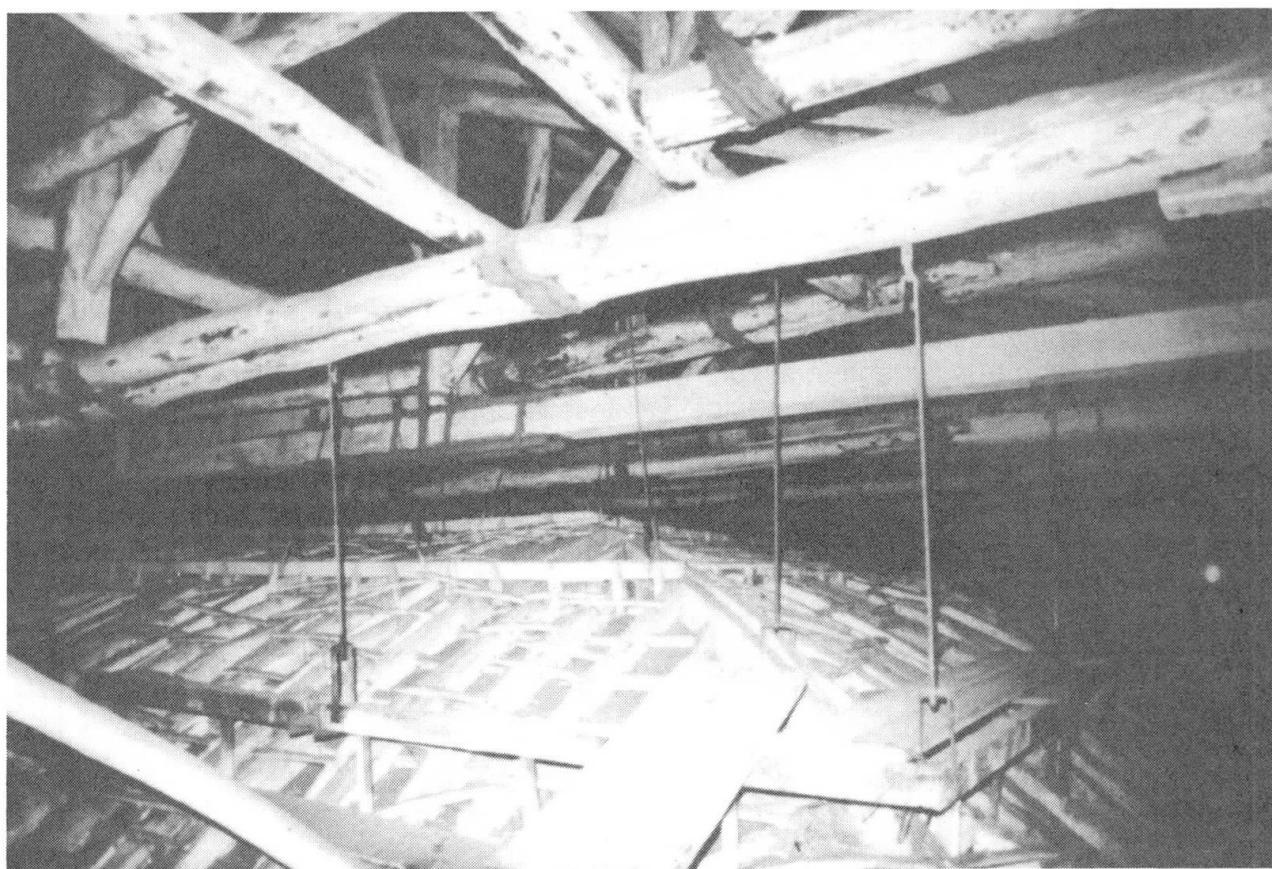
Fig. 2 Inner structure of wooden covering: lower trusses and depressed wooden vault with stiffening ribs before intervention.

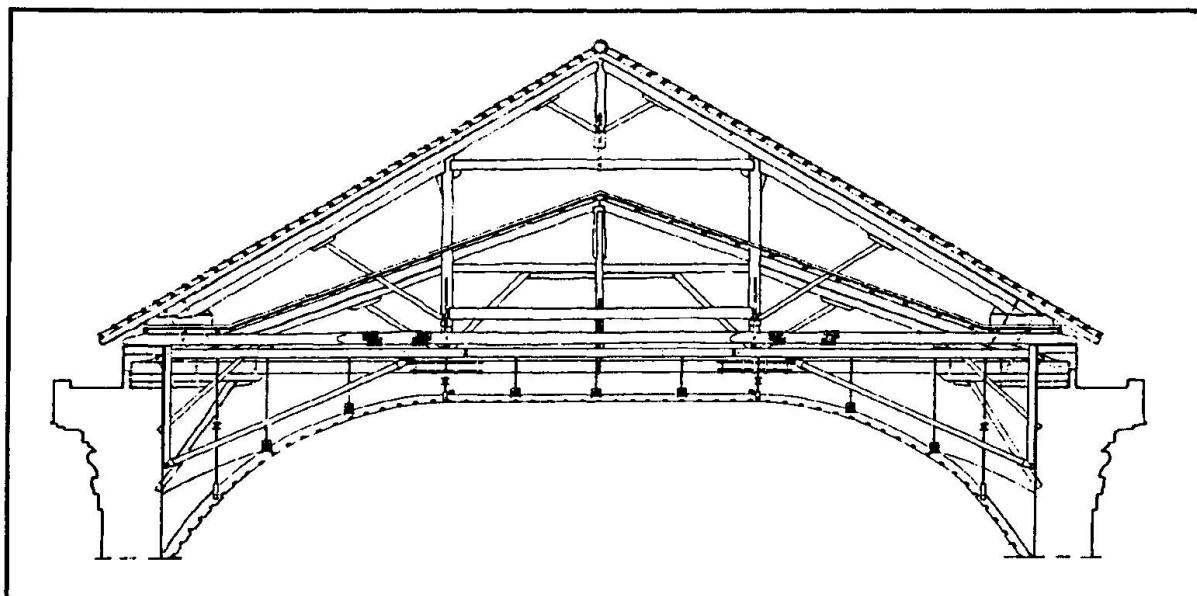
The intervention philosophy consists in making the three structures statically independent. Through the proposed strengthening interventions, the two trusses orders could separately support their own weight and the overloads strictly pertinent to them. On the contrary the vault structure was not even able to sustain itself. Neither it was possible to retrofit the existing trusses and to secure the vault load to them, since it would have upset their original organism. To integrate the vault self-supporting capacity, a spatial steel structure (prosthesis) endowed of adequate resistance and stiffness, but little visible in the structural contest, has been introduced (Fig. 3). It was designed so as to be assemblable on site and compatible with the existing wooden structures. This avoided the demolition of the existing structures which would have disturbed the equilibrium and depreciated the historical value of the covering.

**Fig. 3** Covering section after intervention: in evidence (down from above) upper trusses, lower trusses, steel prosthesis and the wooden vault now suspended to them.

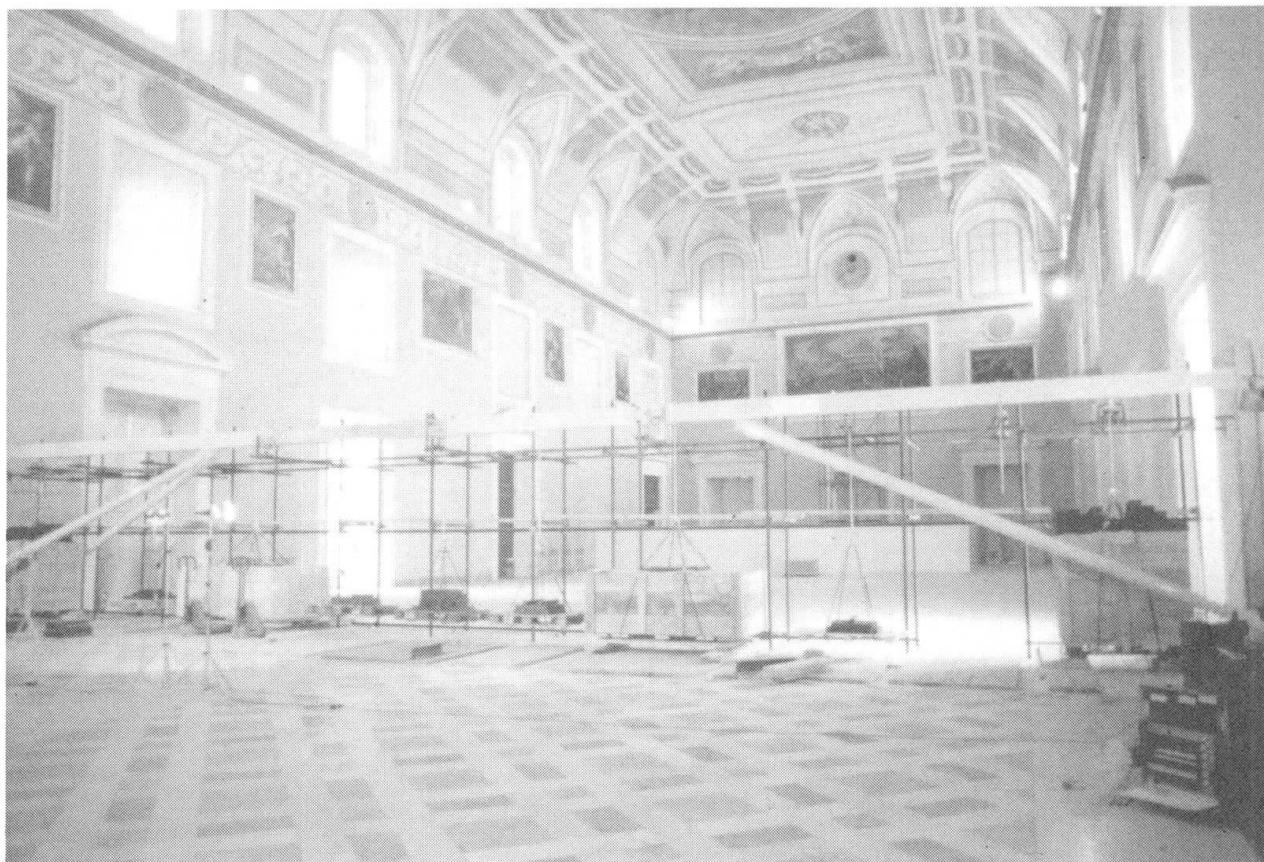
Every prosthesis is made up by two lateral beams (composed with 2 NPU240 and 2 O 159/4) and a central one (composed with 2 NPU240). At first, they were calculated in exercise and breaking conditions under the action of permanent loads, thermic variations and seismic actions. Afterwards, a prosthesis prototype, assembled in the "Gran Salone" temporarily, was subject to a load test.

Fig. 4 Inside view of "Gran Salone" where a prosthesis prototype has been subjected to a load test.

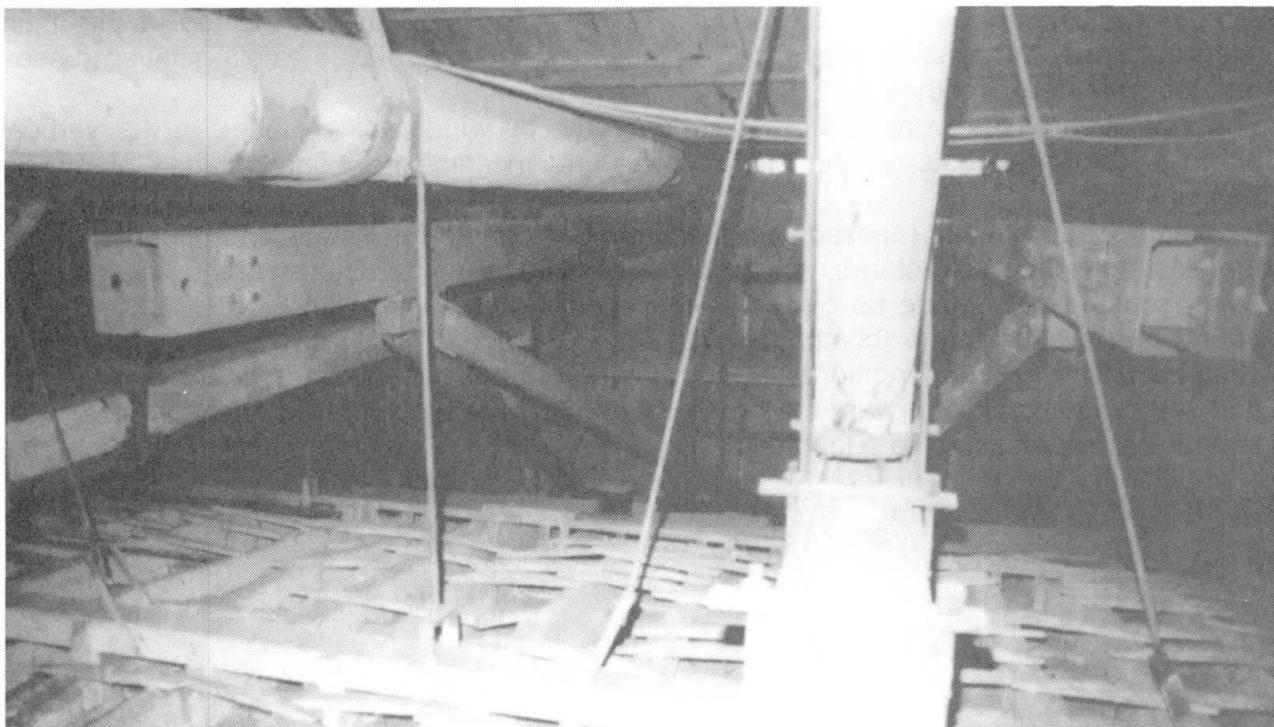
These structures were assembled joining the constraint systems (realized with stainless steel) to the new reinforced concrete beam and to the existing masonry and, subsequently, assembling every prosthesis with pieces lifted and transported one by one. After the assemblage of all the prosthesis, the new suspensions were put under tension checking the painted vault movements by monitoring its strains. In this way, it was possible to eliminate the old joints between wooden trusses and vault. The reinforcement of the existing wooden structures has been obtained by completely restoring the disjointed connections in the trusses, replacing the broken elements, adding braces in the horizontal, vertical and pitch planes, disinfecting all the trusses by wooden parasites.

Fig. 5 Assemblage stages of prosthesis lateral beams.

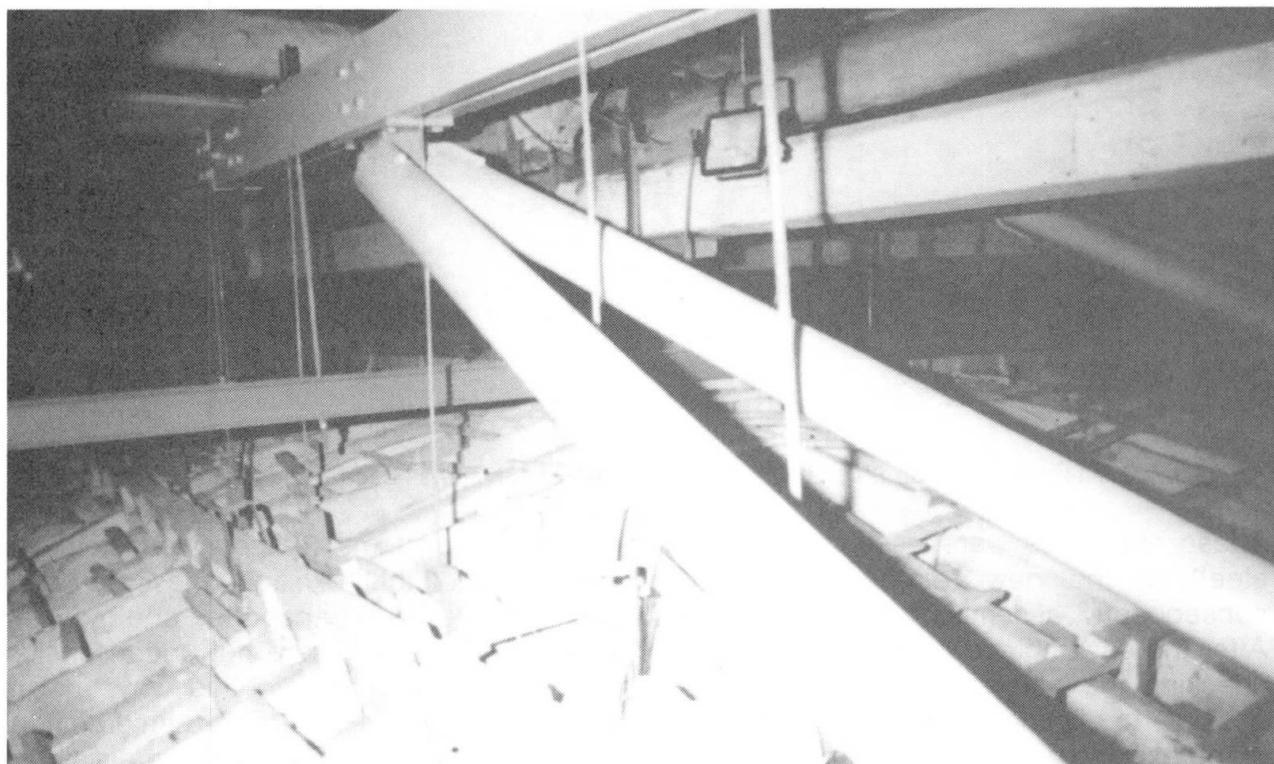
Fig. 6 New suspensions to steel prosthesis of the wooden vault after intervention.

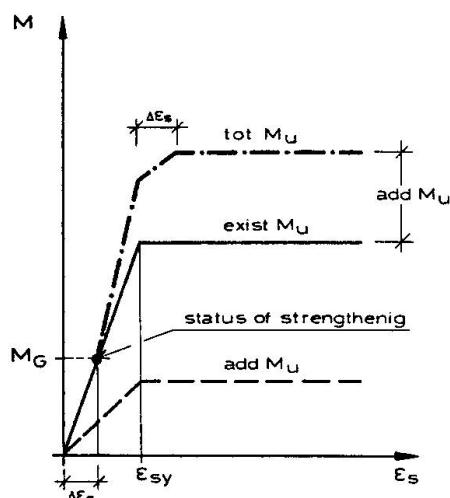
- the load bearing capacity can be calculated as the sum of those of the existing and the additional reinforcement (Fig. 1);
- the cracking behavior of the strengthened concrete member shows no differences to that of the usual one (Fig. 2);
- the necessary anchorage lengths are as usual.

Fig. 1 Ultimate of the strengthened concrete member

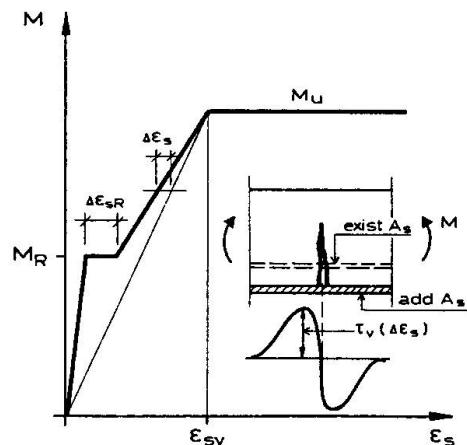
Fig. 2 Changes in steel strains during cracking

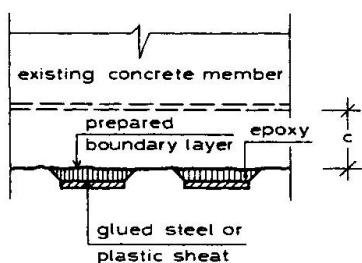
At the early nineties, a new strengthening technique was developed at Essen University in cooperation with a German construction company, using additional reinforcement in grooves, embedded into shotcrete or in case of non-existing shotcreting conditions into high slump concrete with fine coarse aggregate [3, 4].

**Fig. 3** Additional reinforcement at the boundary layer

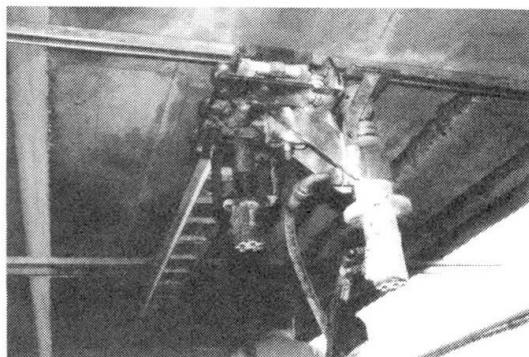
Until now, three bridge superstructures have been strengthened with the new technique. The first case was a hollow slab pedestrian bridge, strongly cracked in the transition zone between the hollow and solid parts of the superstructure at the bottom side. After the crack injection with fine-cement grout, a completely new longitudinal reinforcement was applied in grooves and embedded into shotcrete (Fig. 6). The second use was the partial strengthening of a deck slab. Because of local defects in the insulation, a great number of the transverse prestressing tendons were heavily corroded and in many cases also failed. The function of these tendons was replaced always by two additional rebars of  $\varnothing$  28 mm. A high slump concrete with fine coarse aggregate was used for the embedding of the rebars. The third use was the local strengthening of a prestressed bridge superstructure to remove the resistance of spliced tendons to fatigue fracture in the working zone. The additional longitudinal reinforcement of each joint consisted of two up to eight rebars of  $\varnothing$  20 to  $\varnothing$  28 mm (Fig. 7).

Fig.6 Construction phase of groove preparing

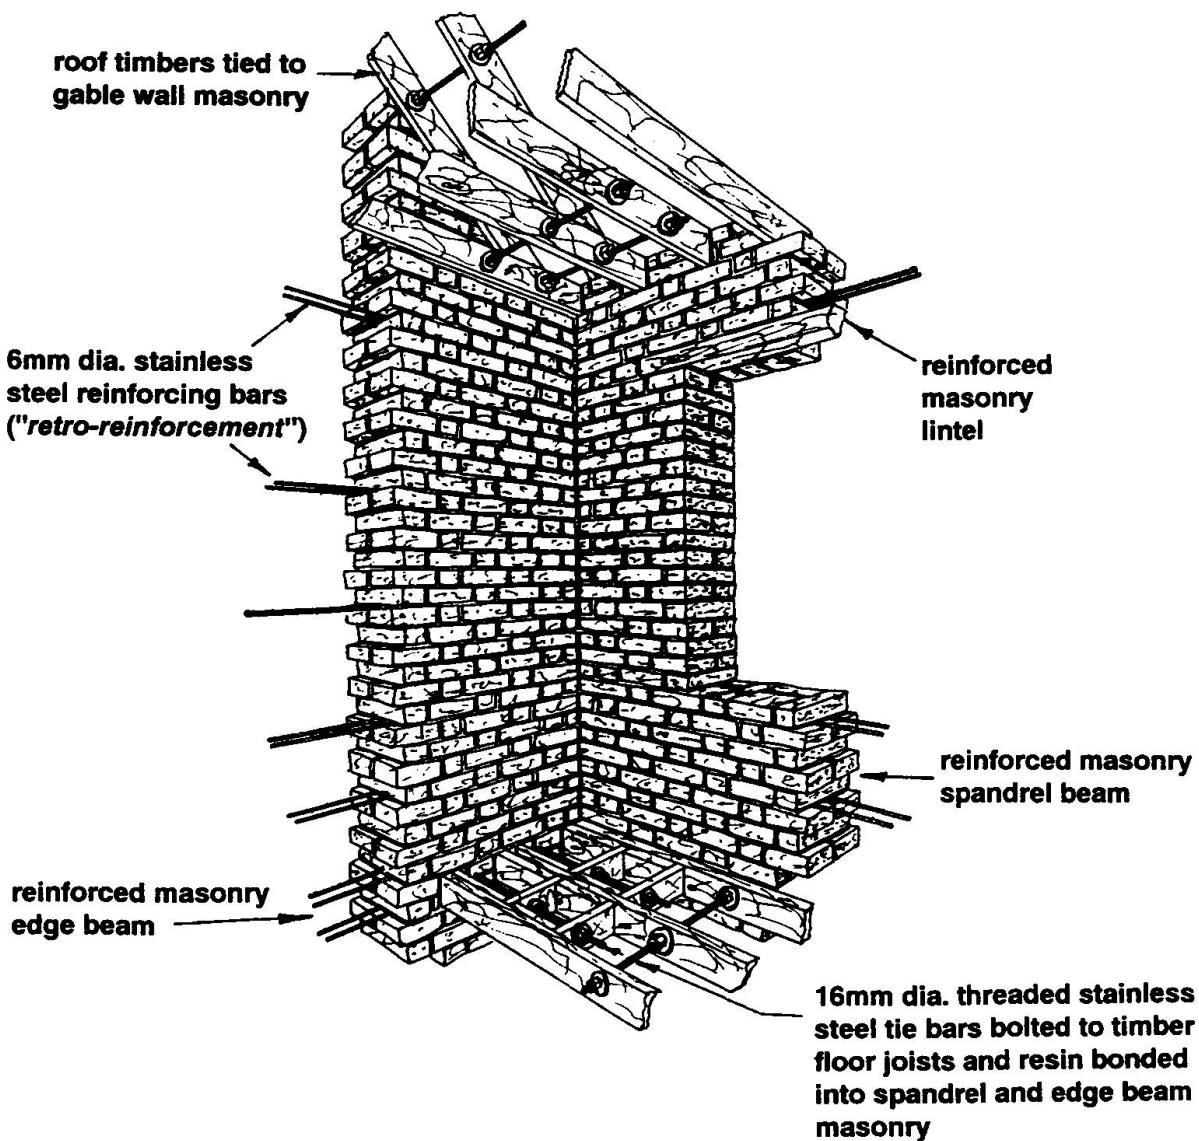
- f) A length of 6mm diameter ribbed stainless steel reinforcing bar is then pushed into the layer of grout. Care is taken to ensure that the bar is fully surrounded by grout. Stainless steel helical rod or flat strips of stainless steel may be used instead of reinforcing bar.
- g) A second layer of grout is then injected over the reinforcing bar.
- h) Additional bars, rods or strips are inserted, as required, and encapsulated in grout. In a 50-70mm deep groove, it is usual to insert only two bars and the outer 15mm is left free of grout for repointing.
- i) The grout is left to cure and the sawn grooves are repointed with mortar to match the existing masonry. In many cases special sands or pigments must be used in the repointing mortar to obtain the required finish.

Fig. 1 Typical retro-reinforcement repairs to low-rise masonry construction

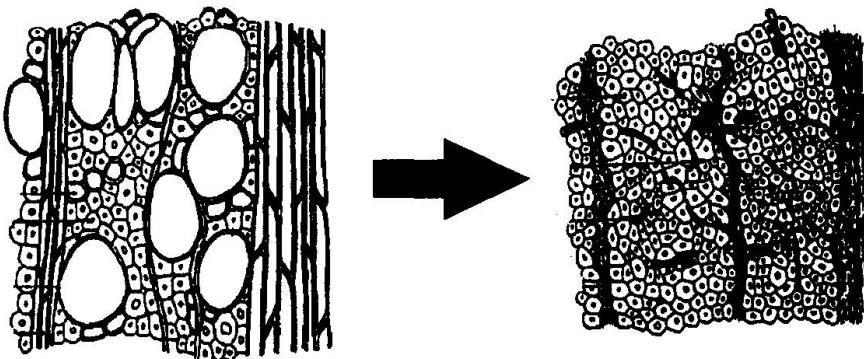
Figure 1: Poplar before and after densification.

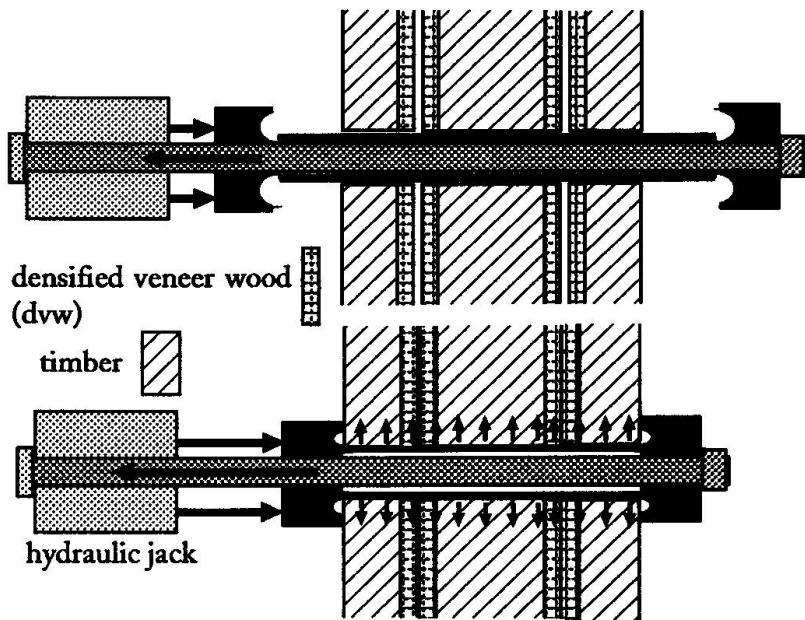
Figure 2: The principle of the prestressing procedure

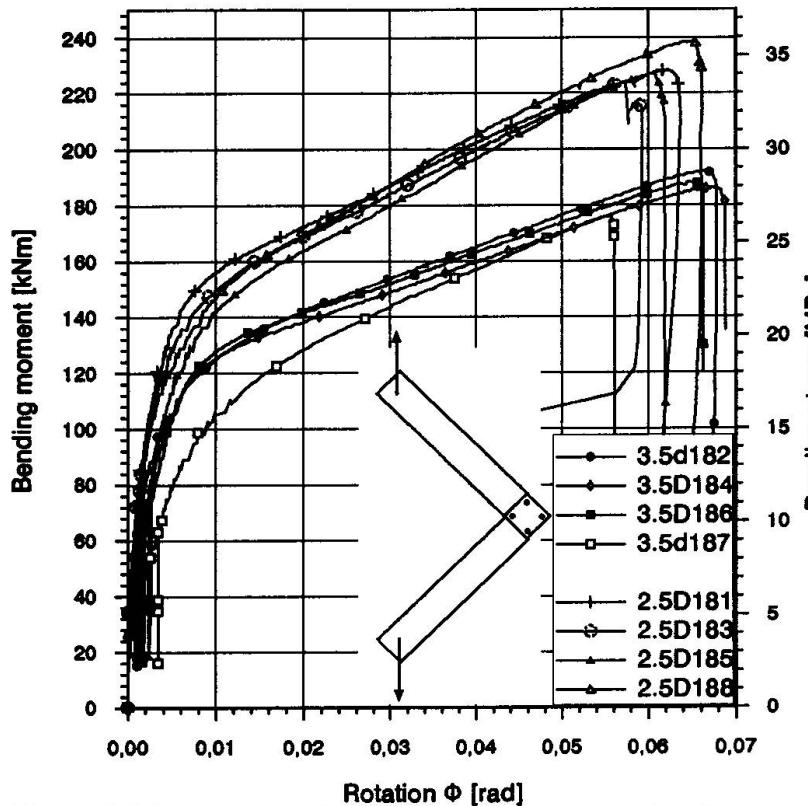
Figure 3: Moment-rotation relation of two tests series dwv reinforced prestressed timber joints, taken from [2].

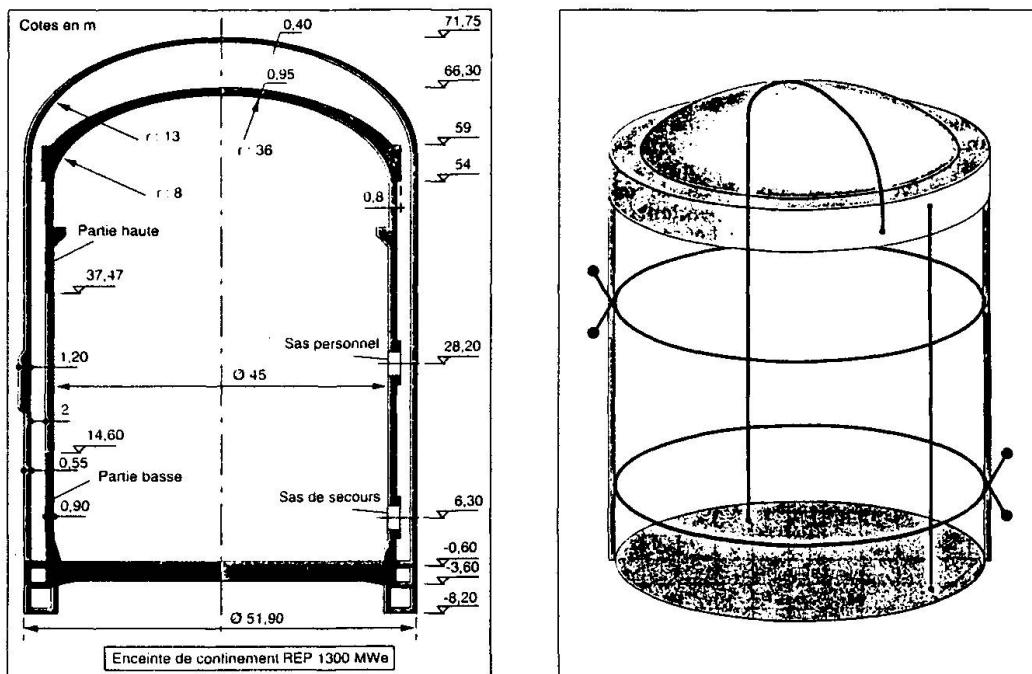
Fig. 1 Simplified diagram of containment and prestress.

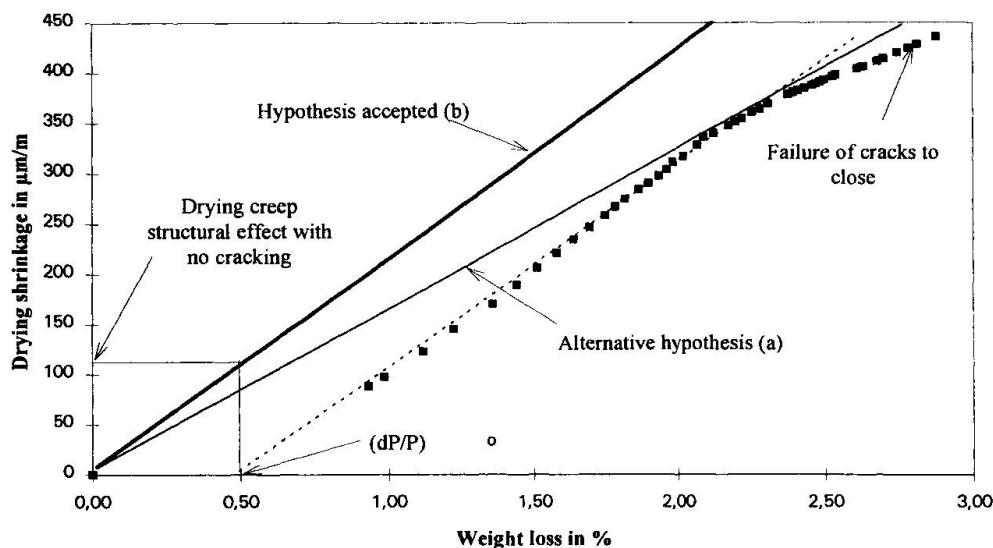
Fig. 2 Drying shrinkage versus weight loss.

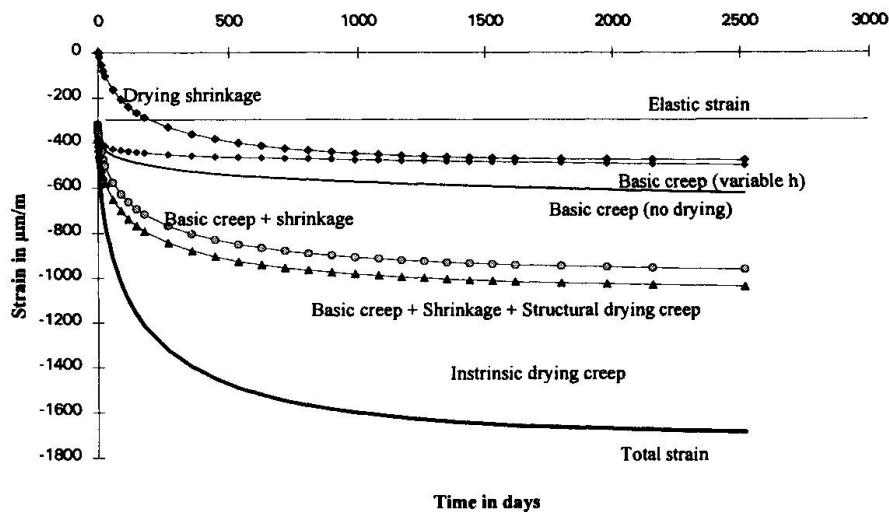
Fig. 3 Breakdown of delayed strains of Paluel on specimen  $\varnothing$  16 cm.
