**Zeitschrift:** IABSE reports = Rapports AIPC = IVBH Berichte  
**Band:** 73/1/73/2 (1995)  
**Rubrik:** Poster Session 2: Buildings

## **Poster Session 2**

**Buildings**

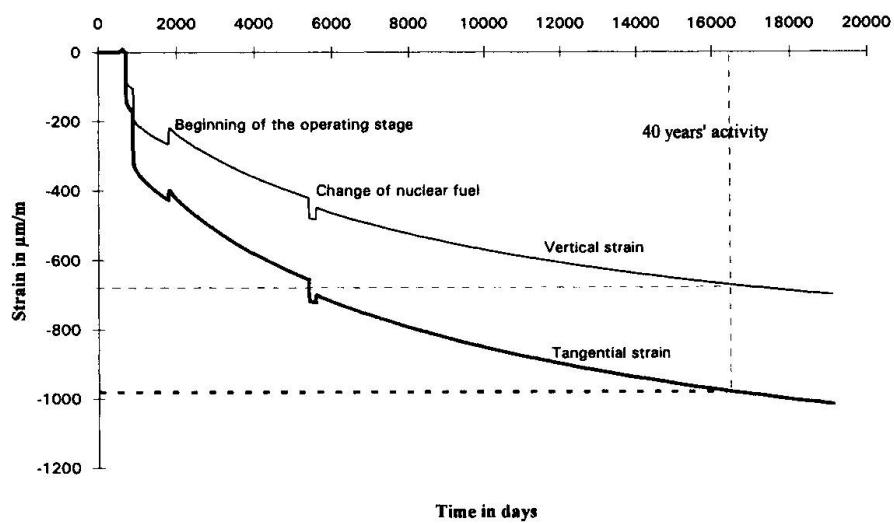
Fig. 4 Simulations of Paluel containment for a constant initial prestress.

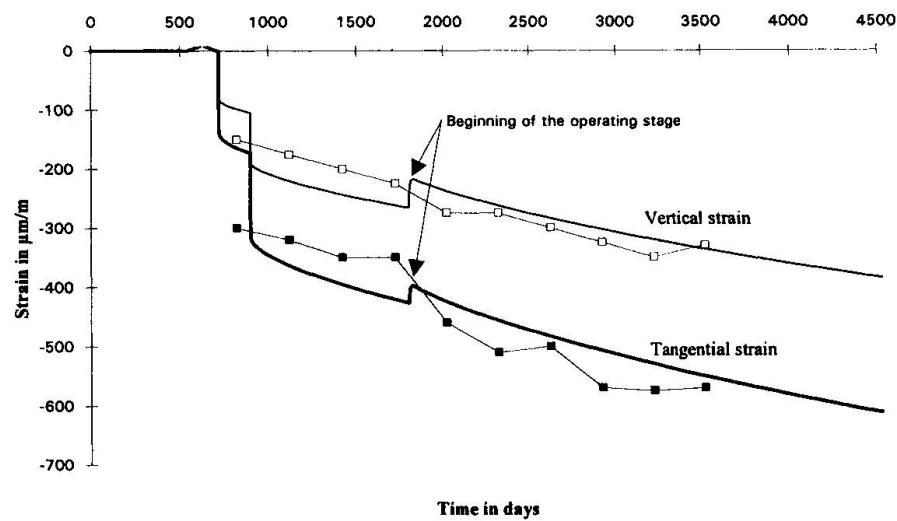
Fig. 5 Comparison between simulations and *in situ* measurements over a 10-year period.

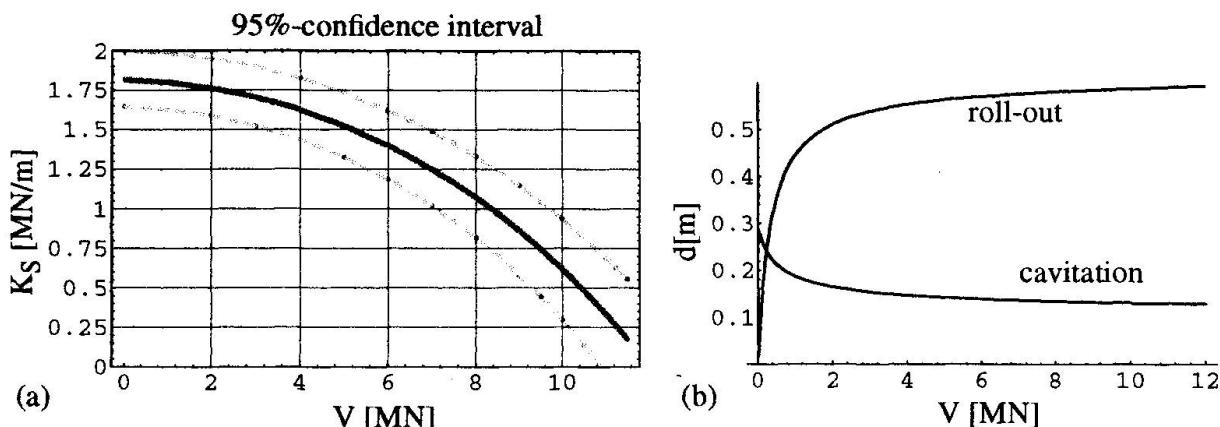
Fig. 2 The scatter of the shear stiffness (a) and critical deflections causing roll-out or cavitation (b).

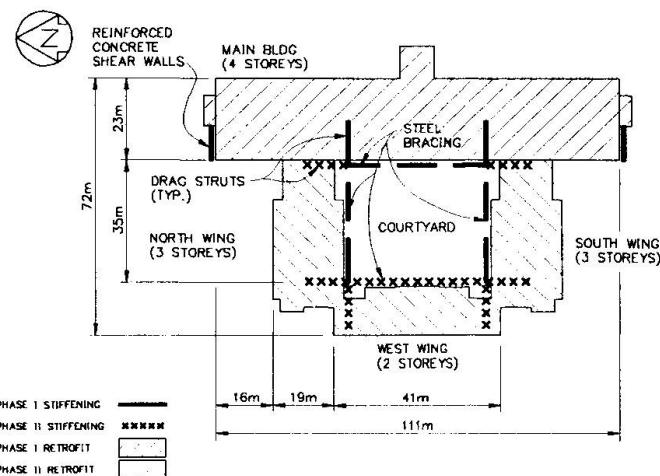
Figure 2 - SW1 Complex Retrofit Plan

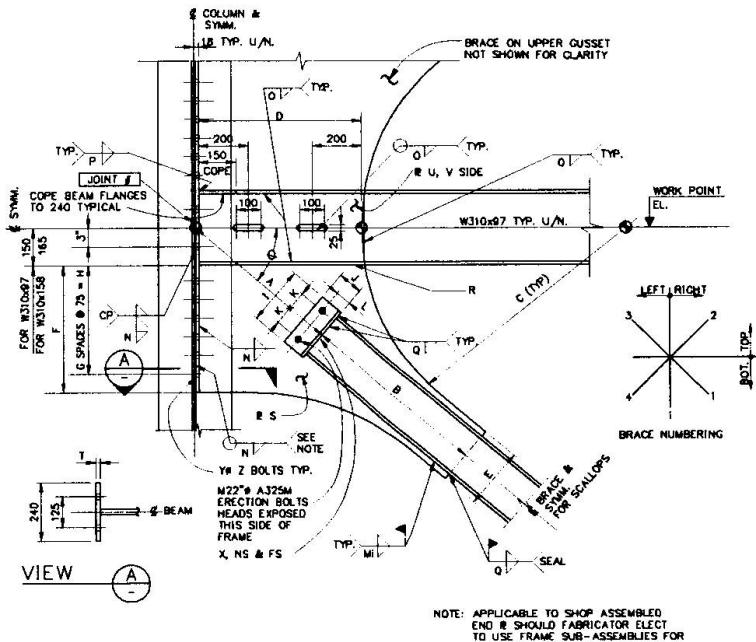
Figure 4 - Generic Bracing to Column Connection Details at Beams

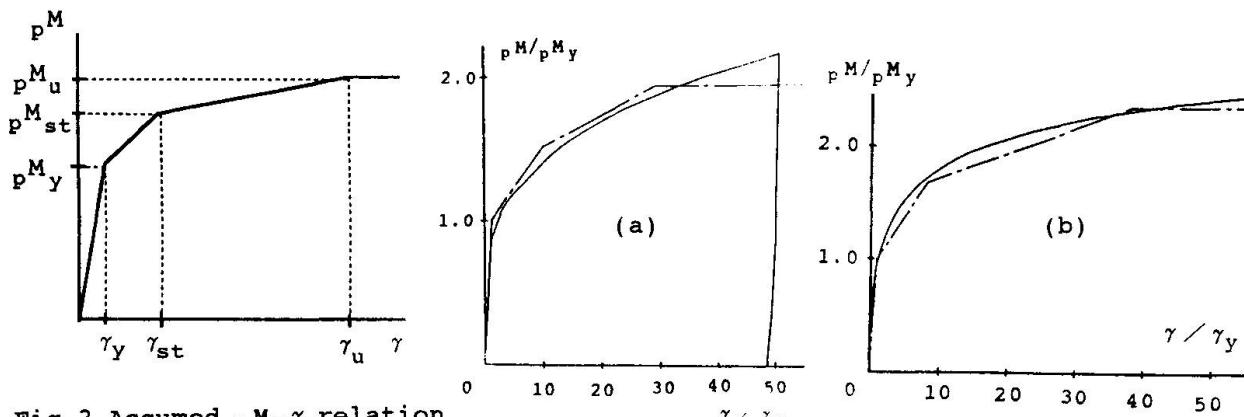
Fig.3 Assumed  $p_M$ - $\gamma$  relation

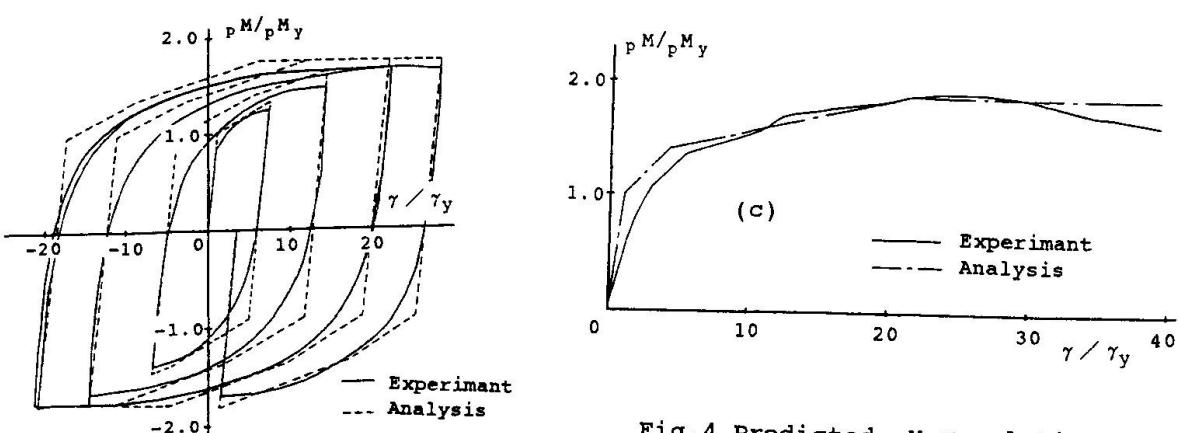
Fig.4 Predicted  $p_M$ - $\gamma$  relations

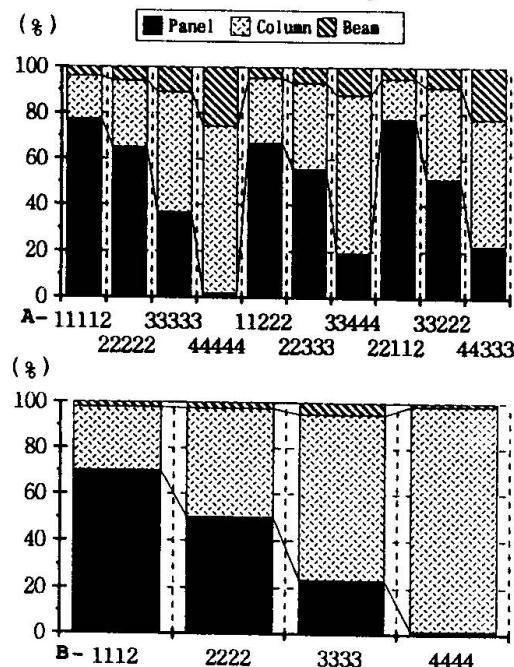
Fig.8 Energy absorbed by each member  
(MIYAGI 350gal)

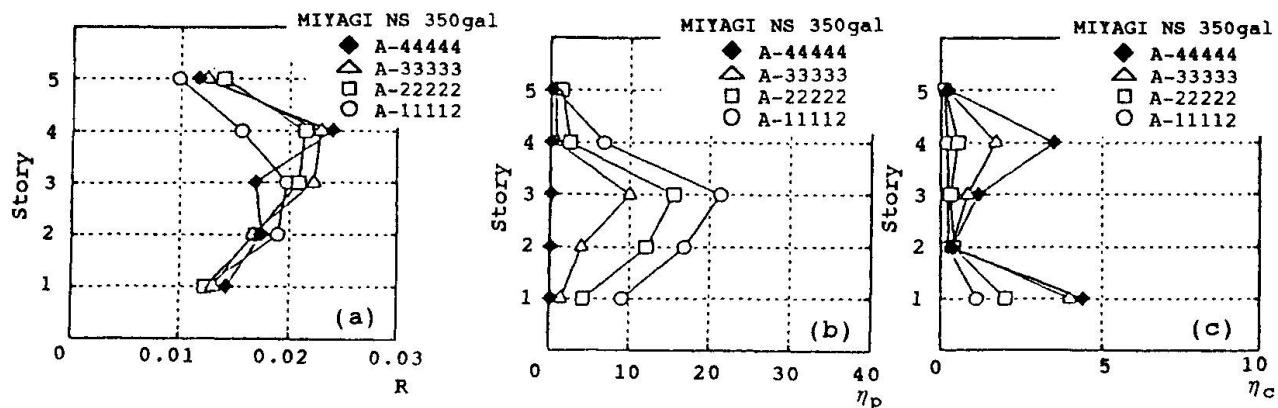
Fig.9 Maximum response of A-frame(MIYAGI 350gal)

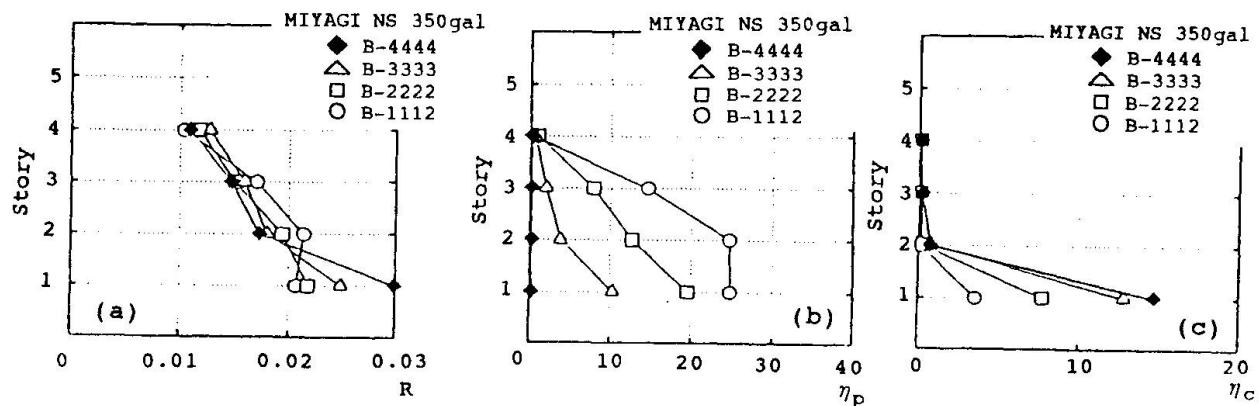
Fig.10 Maximum response of B-frame(MIYAGI 350gal)

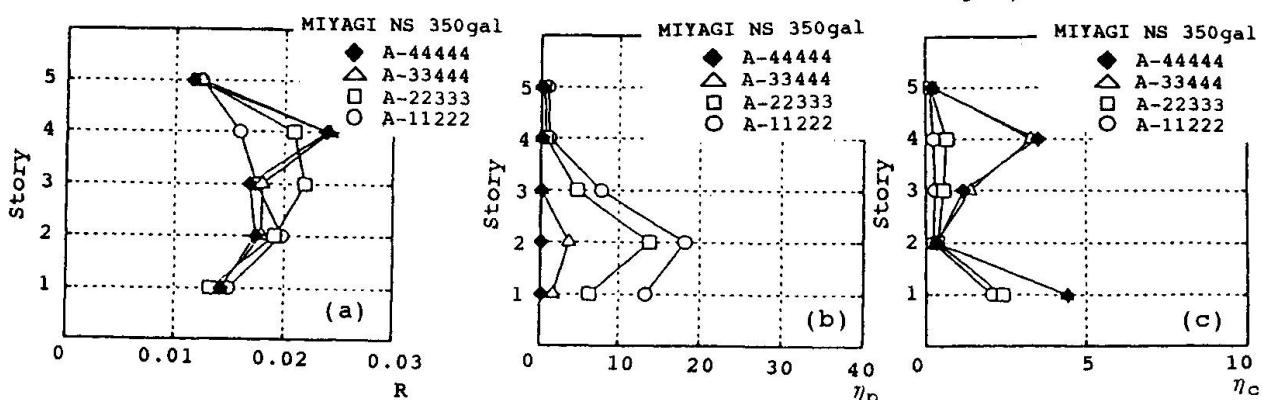
Fig.11 Maximum response of A-frame(MIYAGI 350gal)

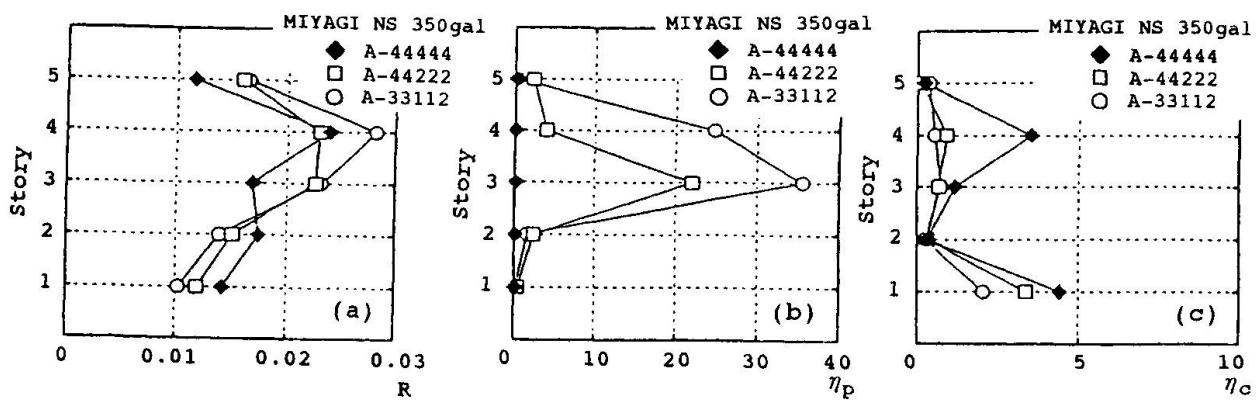
Fig.12 Maximum response of A-frame(MIYAGI 350gal)

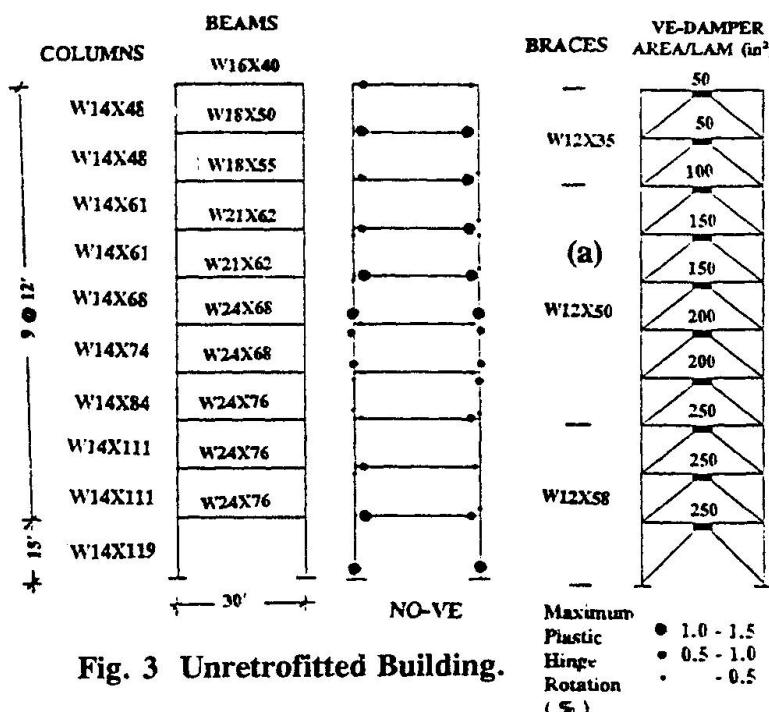
Fig. 3 Unretrofitted Building.

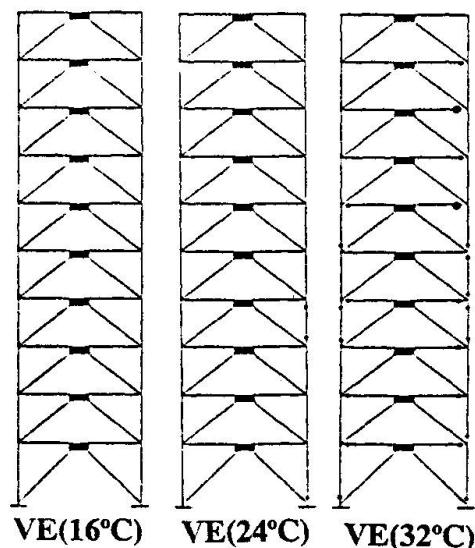
Fig. 4 Retrofitted Building.

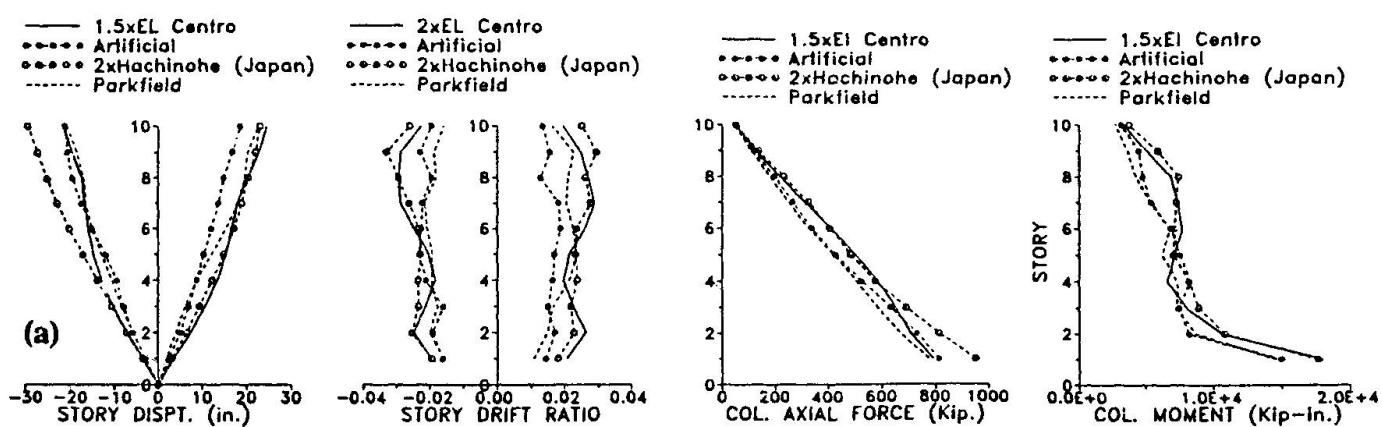
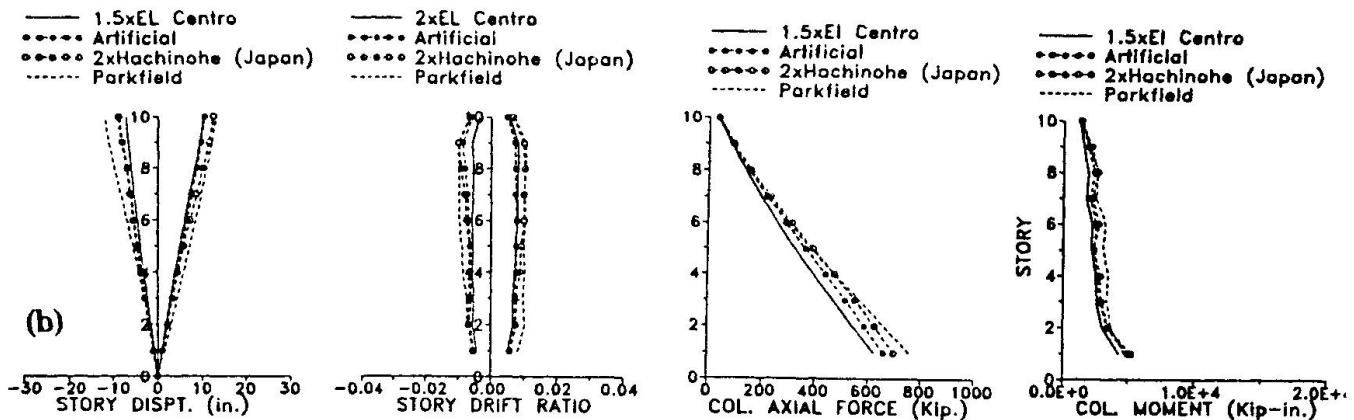
Fig. 5 Elastic Building: Global and Local Responses of (a) Unretrofitted and, (b) Retrofitted Building (Ambient Temperature 24°C).

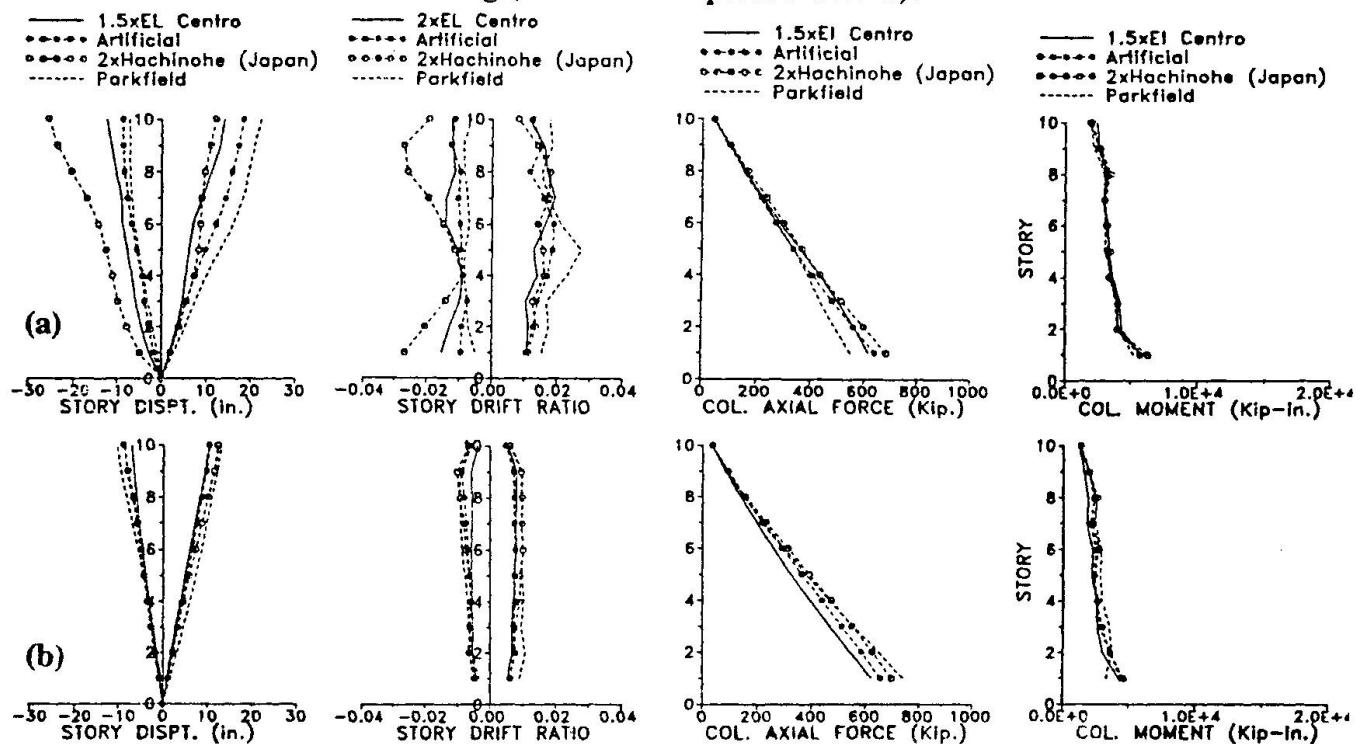
Fig. 6 Inelastic Building: Global and Local Responses of (a) Unretrofitted and, (b) Retrofitted Building (Ambient Temperature 24°C).

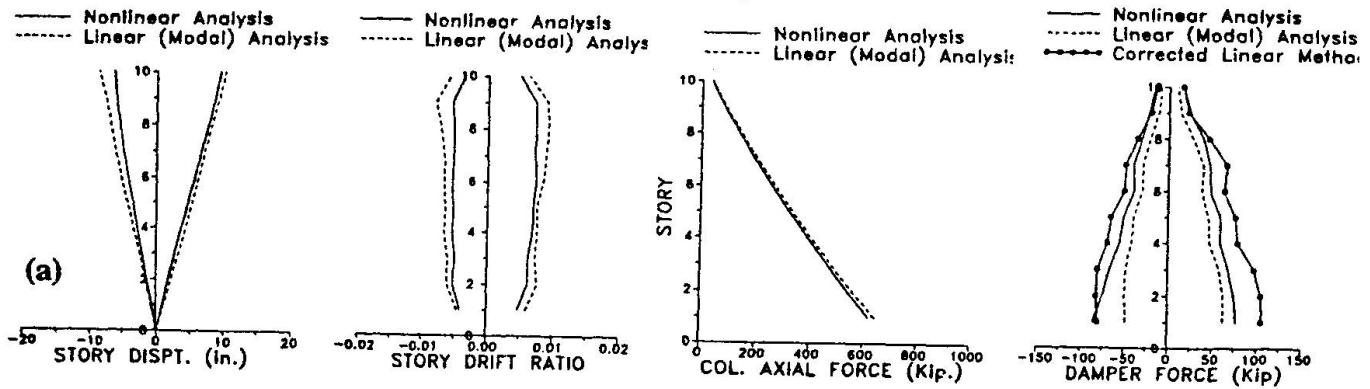
Fig. 7 Linear Response Simulation for El Centro earthquake (24°C).

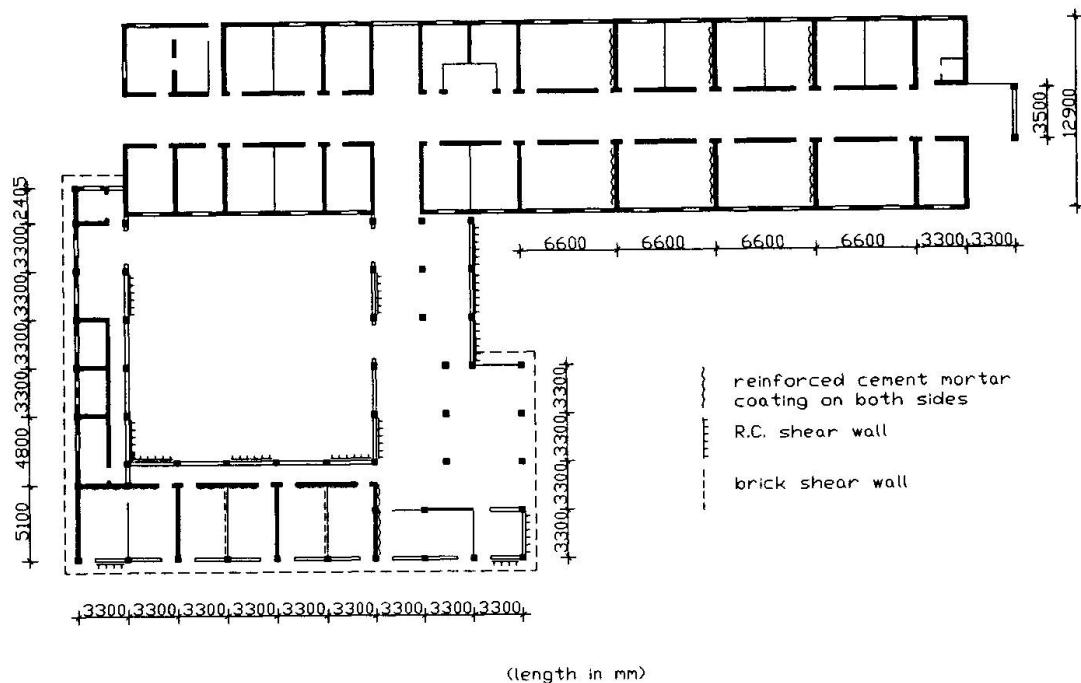
**Fig.1 Strengthening of brick masonry building**

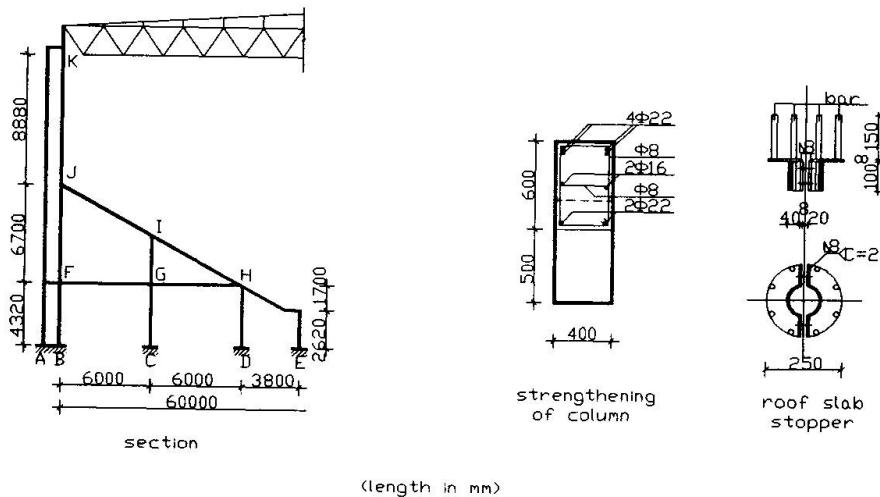
Fig.2 Strengthening of reinforced concrete structures

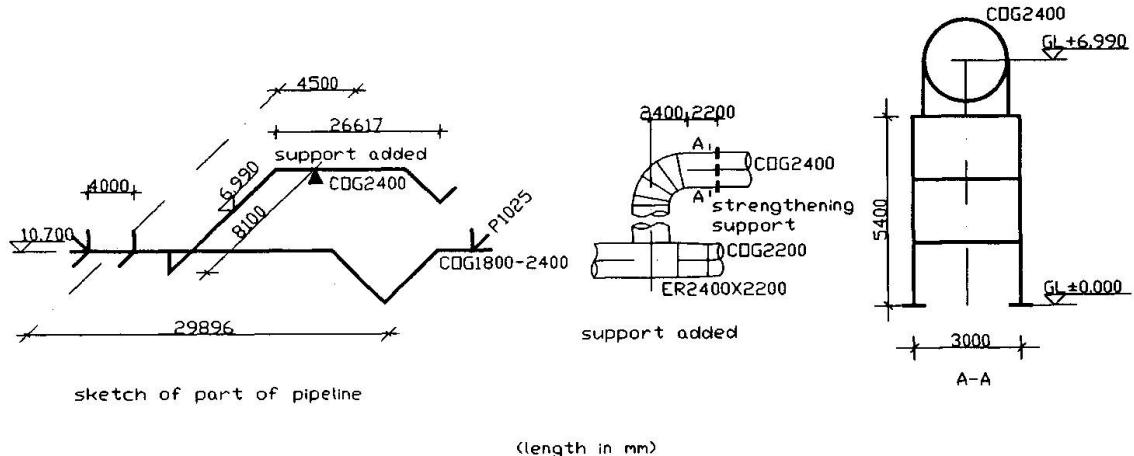
Fig.3 Strengthening of steel pipeline

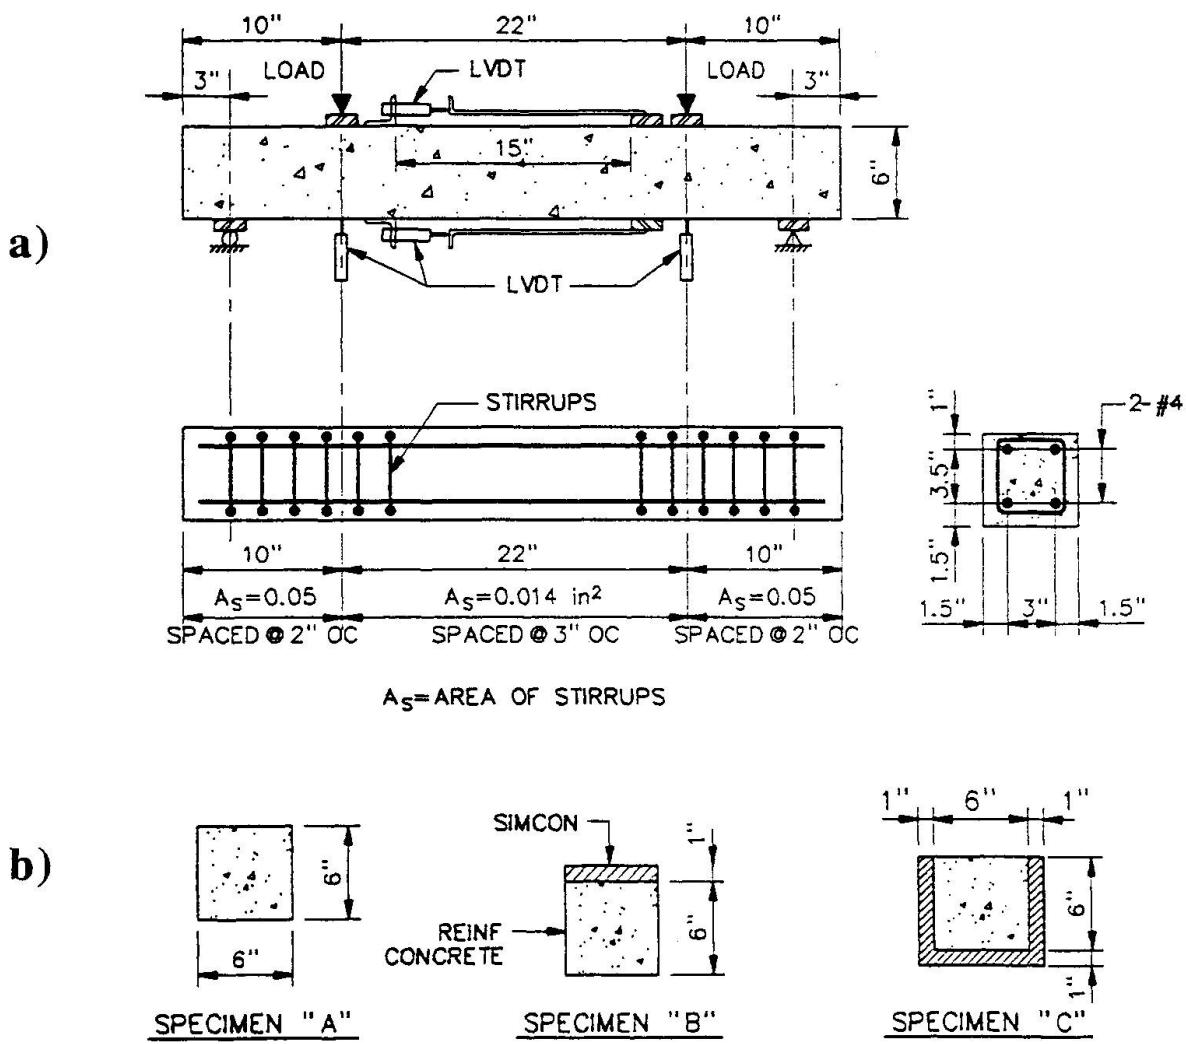
Figure 1: (a) Layout of the reinforced beam tested in this investigation. (b) SIMCON retrofit layouts.

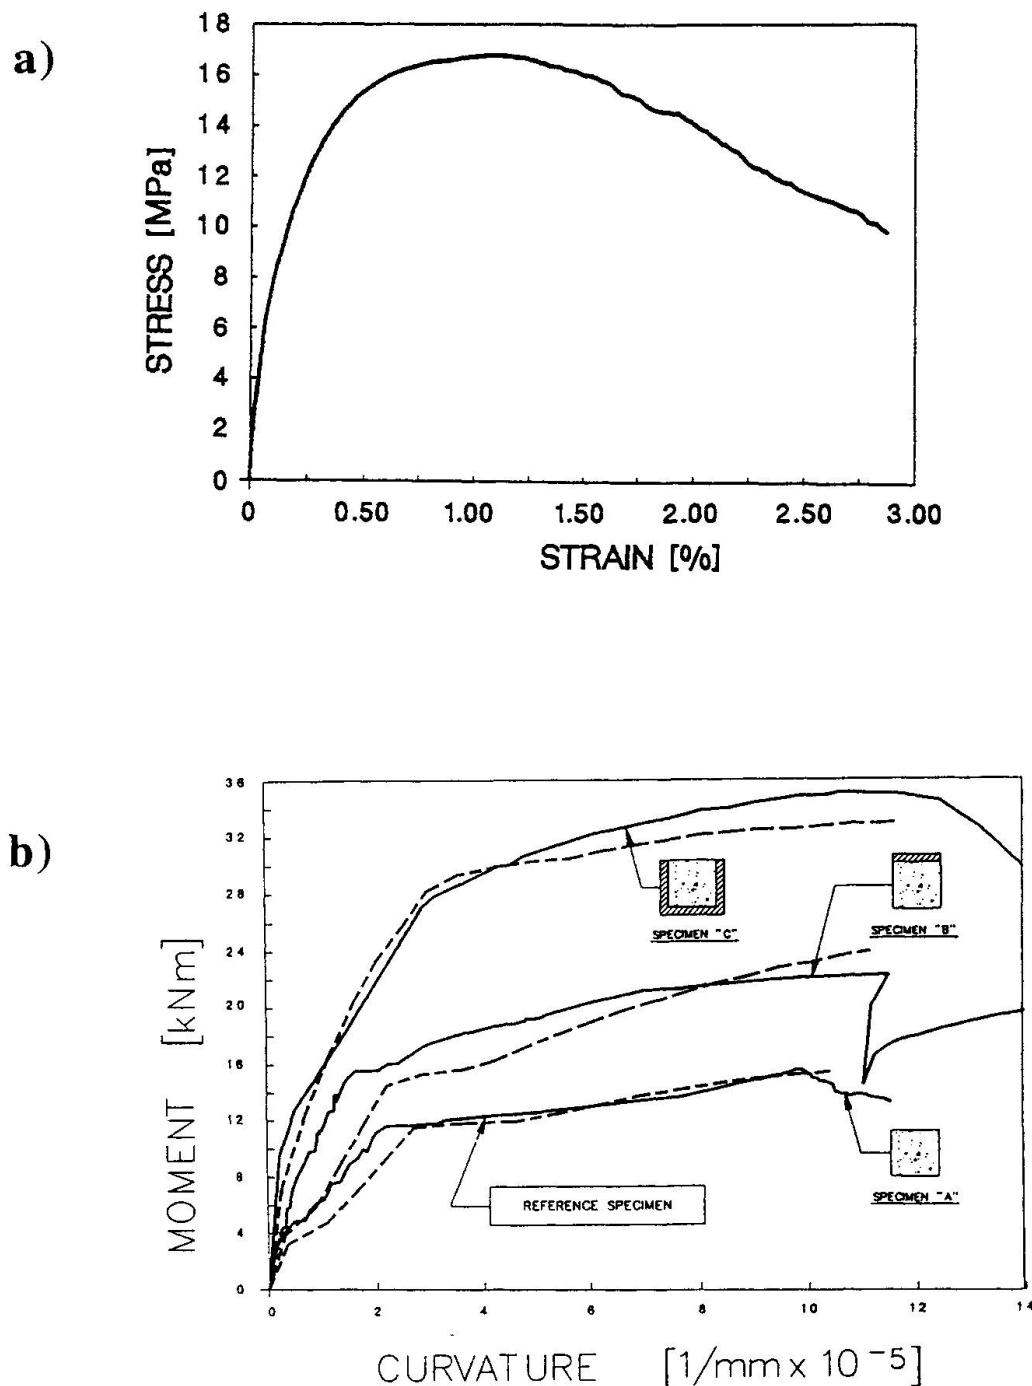
**Figure 2:** (a) Response of SIMCON in tension. (b) Experimentally (solid line) and analytically (dashed line) obtained moment - curvature behavior of reinforced concrete beams. Letters "A," "B," and "C" denote specimen types defined in Figure 1b.
