Artikel: Strengthening of the wooden covering of the Archaeological Museum in Naples
Autor: Augenti, Nicola
DOI: <https://doi.org/10.5169/seals-55363>

Strengthening of the Wooden Covering of the Archaeological Museum in Naples

SUMMARY

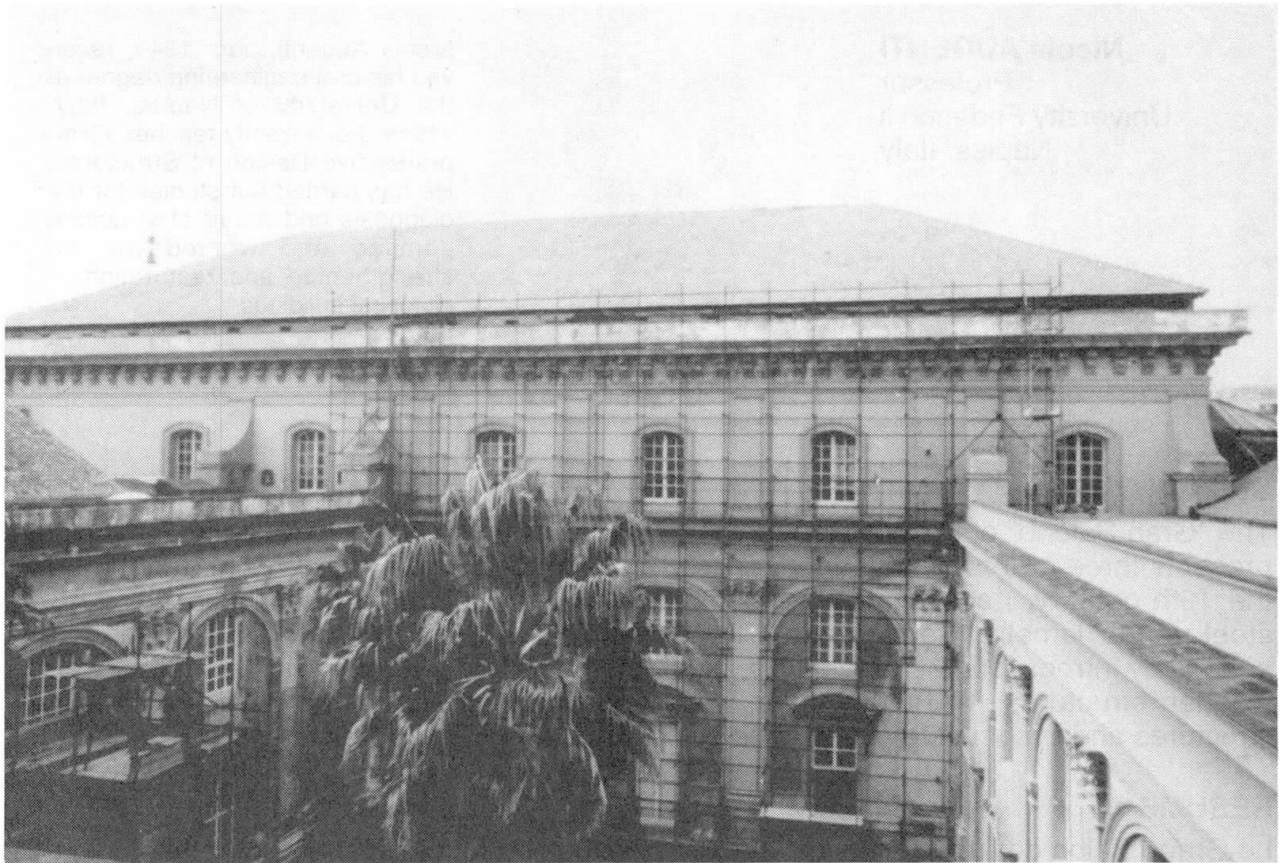
Fig. 1 Outside view of "Gran Salone" covering.

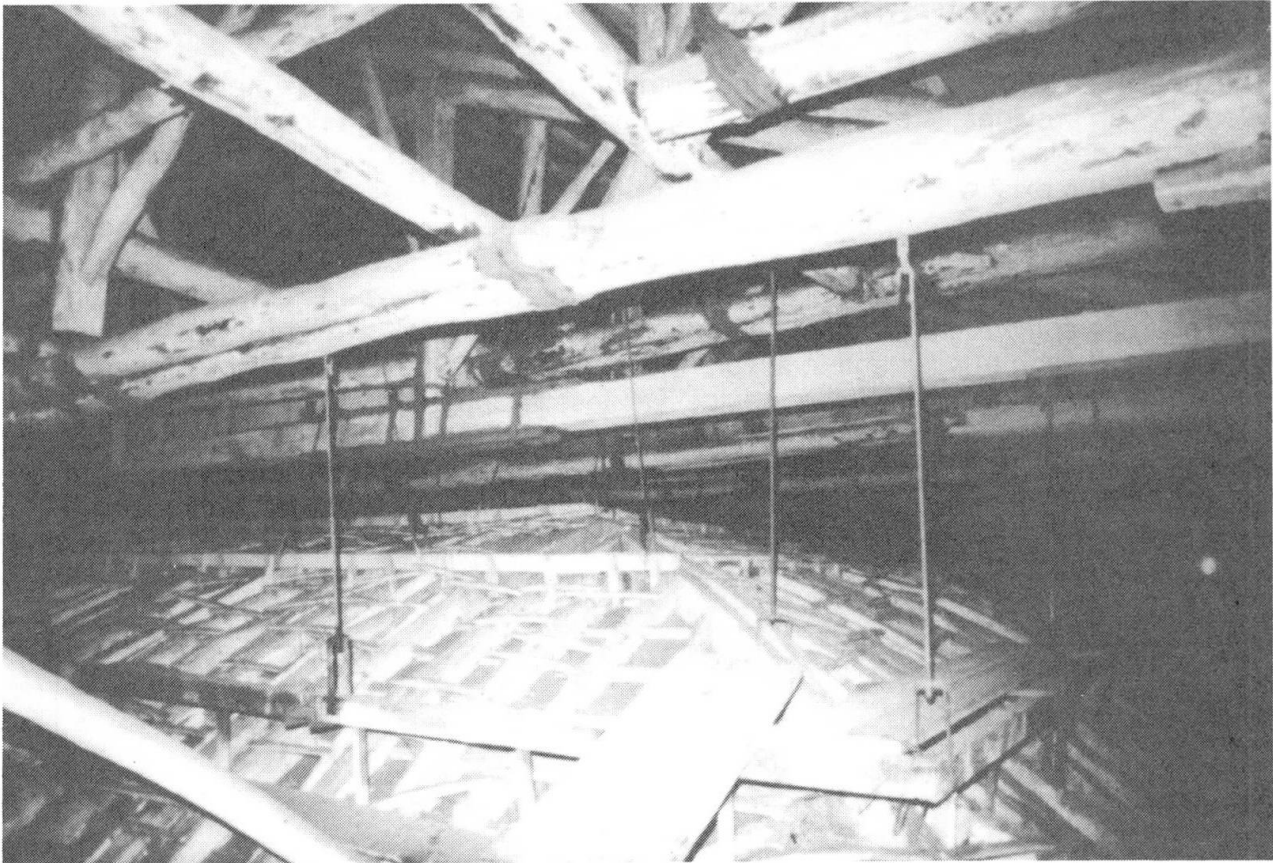
The first upper order, represented by a roof realized through Palladian chestnut trusses with spans of about 23 m. The second intermediate one is formed by another roof of similar wooden trusses, alternate to the first ones, having impost height and pitches inclination smaller than that ones sustaining the upper roof. The third lower one is formed of a depressed wooden vault with stiffening ribs hanged to the trusses, whose intrados is painted with valuable frescoes (Fig. 2) .

Fig. 2 Inner structure of wooden covering: lower trusses and depressed wooden vault with stiffening ribs before intervention.

The difficult choice between preserving existing structures and their replacement engaged many engineers since the end of the last century. For the roof of the "Gran Salone" a long research allowed to identify the most important diseases: great deformations in the vault, an elongation of 15 cm in the tie beams, partly disjointed knots and greatly deformed elements in the trusses, significant settlements of the bearing walls. A finite element analysis of the structures demonstrated that the above damages are partly due to the seismic events occurred during the past two centuries and half, and partly to some inadequate past interventions. Particularly, studying the original covering system and the next transformations, the author came to the conclusion that the horizontal differential movement, happened during the seismic oscillations between the main walls where trusses lean, caused most of the slidings between the wooden tie beams (which were already subject to the dead load strains and to relaxation of the joints); these slidings caused a lot of the observed damages.

In 1911, then, the vault was overhanged to the upper trusses to replace some of the lower tie beams. In this way, both the upper trusses and the lower ones were damaged.

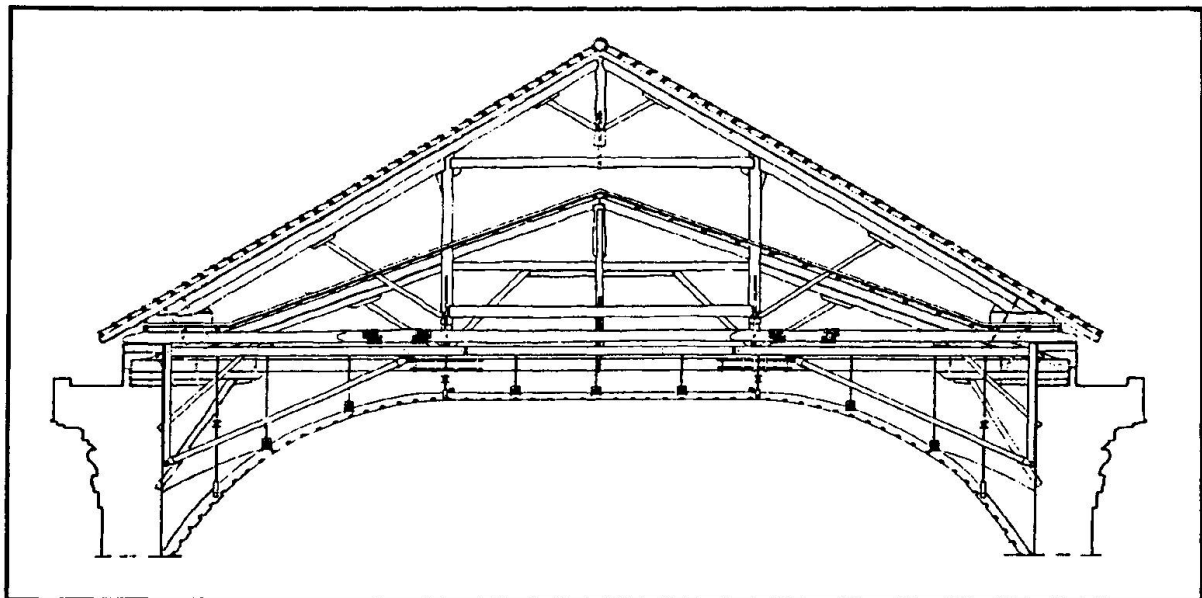
Fig. 3 Covering section after intervention: in evidence (down from above) upper trusses, lower trusses, steel prosthesis and the wooden vault now suspended to them.

The intervention philosophy consists in making the three structures statically independent. Through the proposed strengthening interventions, the two trusses orders could separately support their own weight and the overloads strictly pertinent to them. On the contrary the vault structure was not even able to sustain itself. Neither it was possible to retrofit the existing trusses and to secure the vault load to them, since it would have upset their original organism. To integrate the vault self-supporting capacity, a spatial steel structure (prosthesis) endowed of adequate resistance and stiffness, but little visible in the structural contest, has been introduced (Fig. 3). It was designed so as to be assemblable on site and compatible with the existing wooden structures. This avoided the demolition of the existing structures which would have disturbed the equilibrium and depreciated the historical value of the covering.

Eighteen space beams, realized with elements compatible for weight and dimension with the existing wooden structures, made up the new supporting structures of the vault.

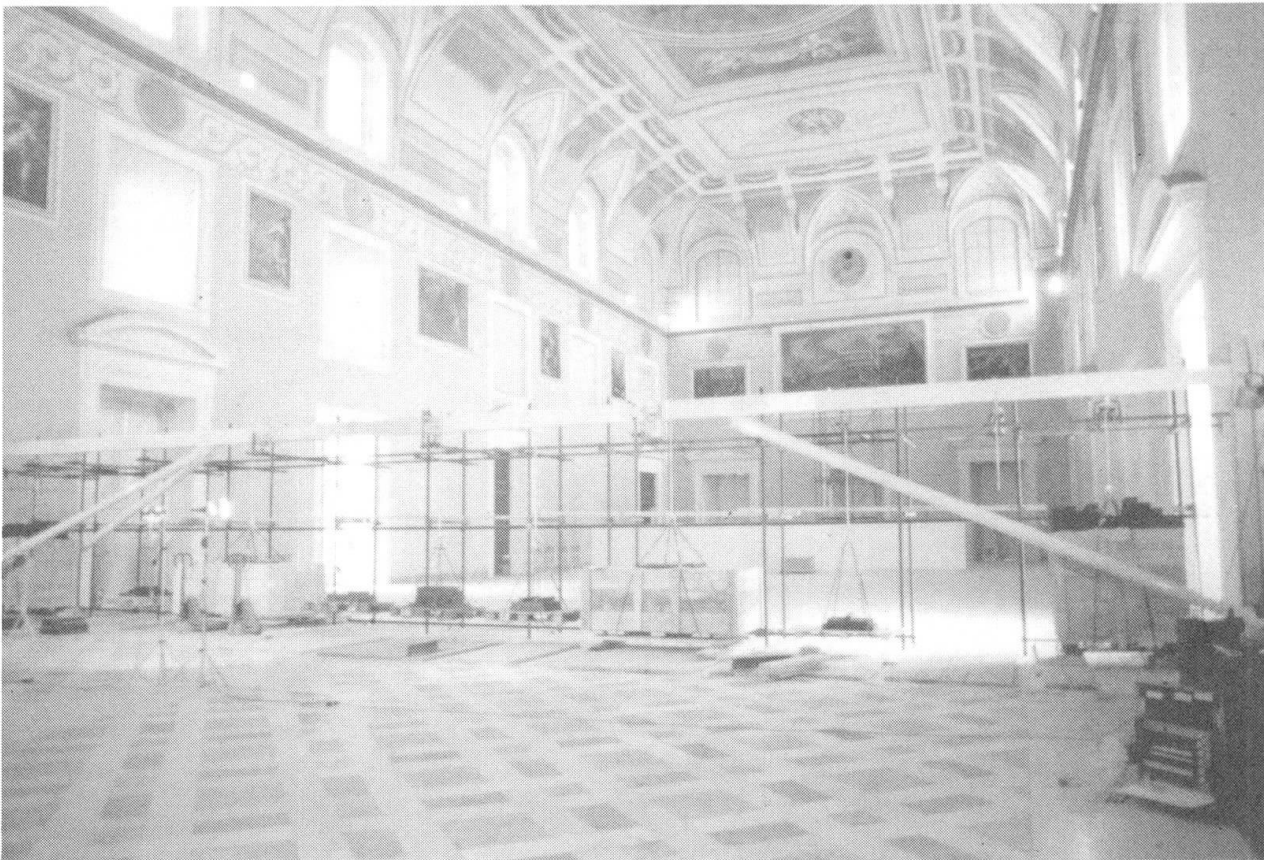
Fig. 4 Inside view of "Gran Salone" where a prosthesis prototype has been subjected to a load test.

Every prosthesis is made up by two lateral beams (composed with 2 NPU240 and 2 Ø 159/4) and a central one (composed with 2 NPU240). At first, they were calculated in exercise and breaking conditions under the action of permanent loads, thermic variations and seismic actions. Afterwards, a prosthesis prototype, assembled in the "Gran Salone" temporarily, was subject to a load test.

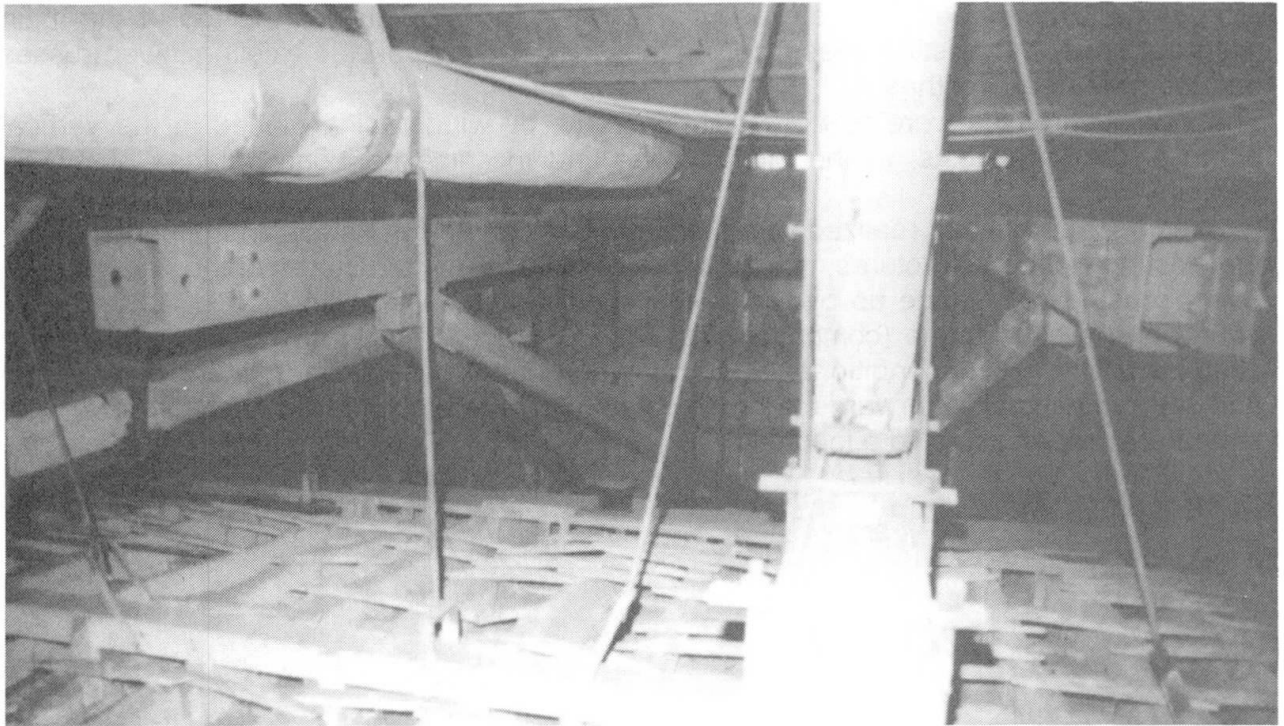
Fig. 5 Assemblage stages of prosthesis lateral beams.

These structures were assembled joining the constraint systems (realized with stainless steel) to the new reinforced concrete beam and to the existing masonry and, subsequently, assembling every prosthesis with pieces lifted and transported one by one. After the assemblage of all the prosthesis, the new suspensions were put under tension checking the painted vault movements by monitoring its strains. In this way, it was possible to eliminate the old joints between wooden trusses and vault. The reinforcement of the existing wooden structures has been obtained by completely restoring the disjointed connections in the trusses, replacing the broken elements, adding braces in the horizontal, vertical and pitch planes, disinfecting all the trusses by wooden parasites.

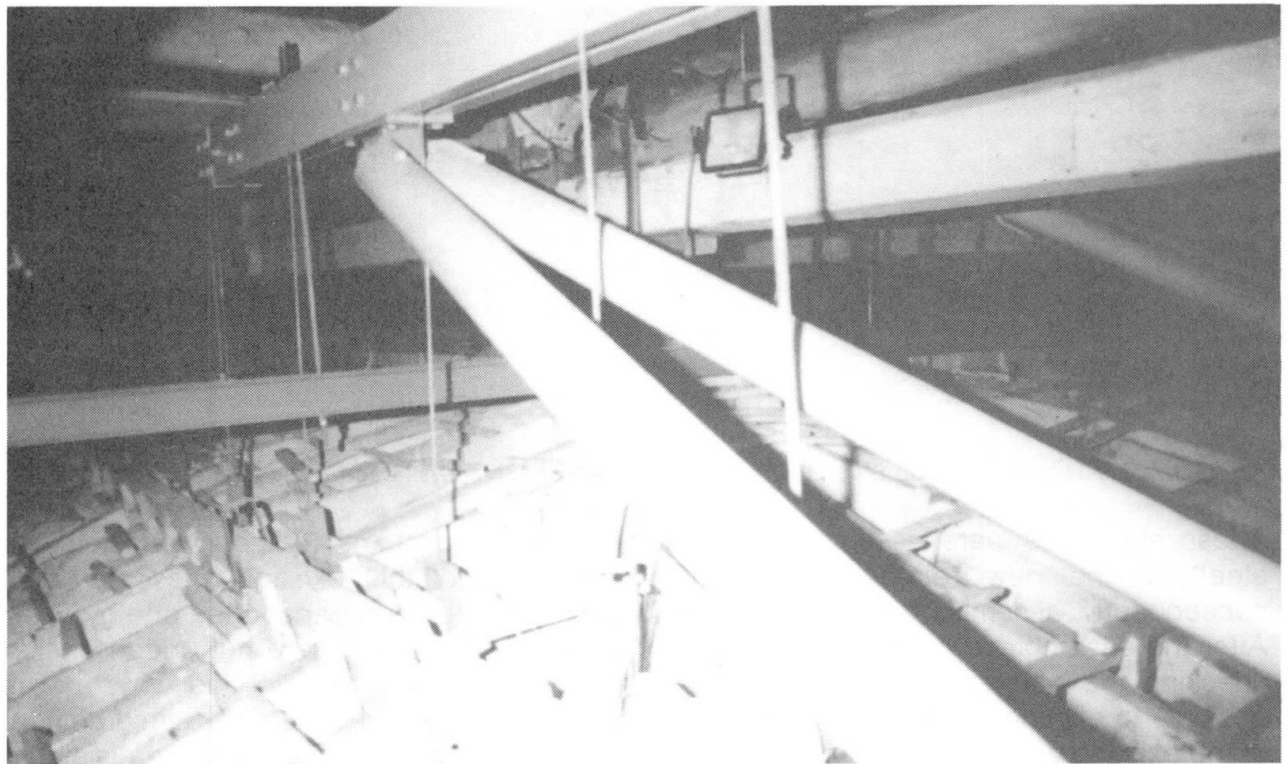
Fig. 6 New suspensions to steel prosthesis of the wooden vault after intervention.
