Rebuilding of the Bridge Over the River Damuji in Cuba

José H. DIAS FERRER

This paper deals with the reconstruction of a prestressed concrete Gerber bridge, partially collapsed due to the collision of a bus and a truck-mounted crane and the corrosion of the vertical anchoring cables of the deck in one of its abutments. Different studied alternatives are described here and a technical-economical comparison between them is also made, enumerating the difficulties of the most economical one, showing the adopted solutions in each case.

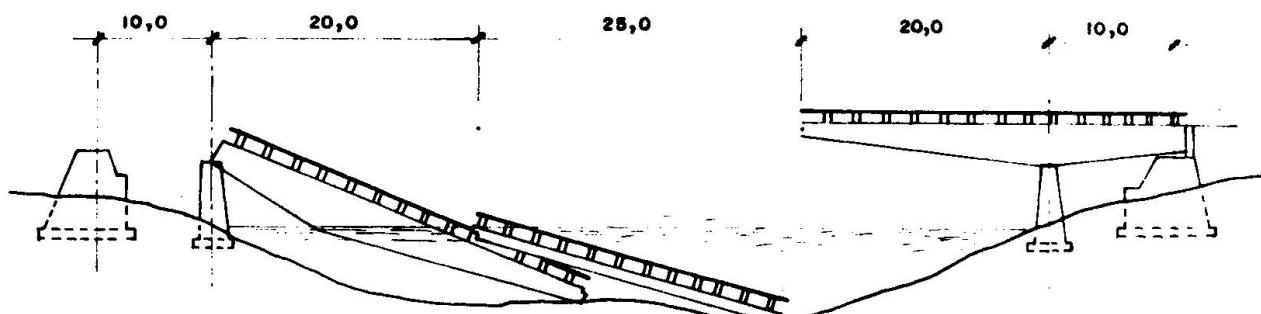
FIG. 1

ELEVATION

After collapsing, only one Gerber beam remained in place while the other sank in

an inclined position with its main part inside the river water. The single central simply supported 25.00 m. beam remained totally submerged in bent position too (see fig. 1).

This prestressed concrete bridge (12 ϕ 7mm. Freyssinet cables) with a (10.00 m. + 65.00 m. + 10.00 m.) sketch has a principal structure or deck composed by two extreme Gerber 30.00 m. longs and a simply supported 25.00 m. beam. The 30.00 m. Gerber beams are distributed in 10.00 m. extreme spans and 20.00 m. cantilevers close to the central bay. Deck cross section (1.50 m. + 6.00 m. + 1.50 m.) has been achieved with box girders for the extreme 10.00 m. spans and for the first 5.00 m. cantilevers; for the 15.00 m. extreme cantilevers and the central simply supported beam, "T" sections have been used. Longitudinally, the height of the deck section varies between 1.25 and 3.00 m.

As can be appreciated, extreme 10.00 m. spans are not able, by themselves, to compensate or balance the central bay; consequently, these spans are anchored, in their extremes, to their respective massive abutments, by vertical cables pressing the deck against the top of the above mentioned abutments and guaranteeing the deck stability under dead and live loads. These anchoring cables were designed with a working force of 6 400 kN and a breaking force of 10 000 kN.

Due to a deficiency in design, vertical cables to anchor the deck to the abutments had not enough anticorrosive protection; due to this fact, those cables were submitted to corrosion in the contact zone between the abutment and the deck in the side next to Abreus town, since there was penetration of moisture, in that zone, through the cavities due to the non coincidence of the different contact surfaces and due to the separation between those surfaces provoked by the crossing of great loads; this corrosion was weakening the cables' cross sections until the appearance of live loads (a truck-mounted crane and a bus) making these corroded cables reach to breaking stresses. When the cables were broken, occurred excessive surcharge to the adjacent cables, making them break as a chain action and reaction.

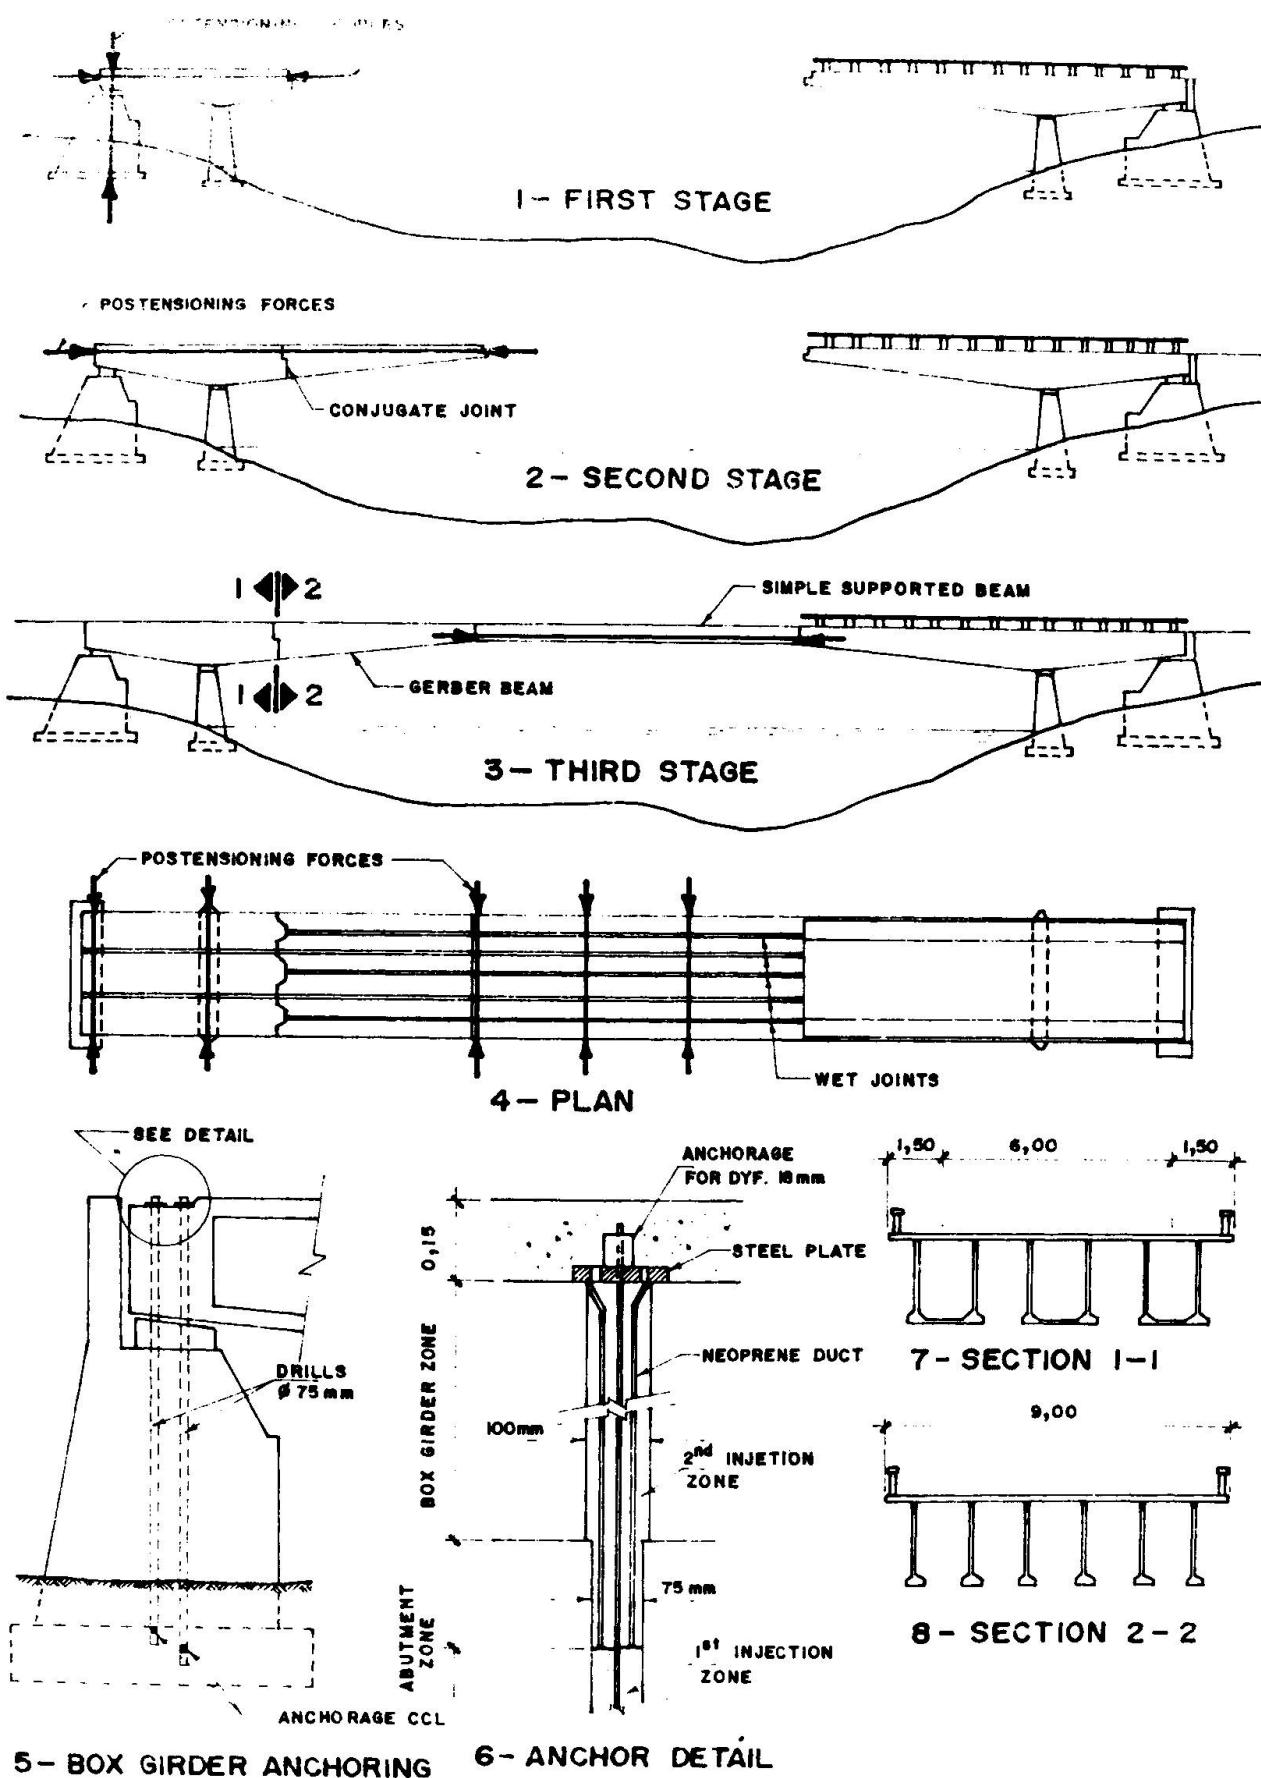
FIG. 2

For the transition from box sections to "T"-shaped beams, a conjugate joint was designed, able to constraint the three degrees of freedom of the dowels when assembled in an appendix form or as longitudinally preconstraint bosses (see fig 2).

At the time of the analysis of this topic, it was thought that deck concreting should be made directly on the site ("in situ") in order to solve the problem of conjugate joints in the transition section from box to precast "T"-shaped girders (see fig 2.7 and 2.8). At that time, there was no available wood for formwork, and precasting of the box-sectioned length would result in a huge member for which there was no joisting equipment.

The first step was to check whether the non collapsed zone fulfilled the requirements of the Codes in force in Cuba (about critical sections); this turned out be satisfactory. The following was to undertake the solution of all the different problems (see fig 2.5).

As this case is a postensioned structure, in the initial case cables were kept embedded in the mass of the abutment and anchored in the lower zone, reserving an upper zone for elongations; this was solved practicing vertical holes in the mass of the abutment and putting one cable in each one with fixed anchorage grips in their lower extremes. Later, cement gel was grouted, forming an embedding column for cables and of frictional force transference between the column and the drilled hole; the upper zone of the drills remained as elongation, anticorrosive or neoprene sheath zone, and final grouting (see fig 2.5 and 2.6).

The first 15.00 m. of the Gerber beam length were fractioned in three boxes with a weight of 800kN, and wet longitudinal joints. Transverse stiffness was achieved posttensioning the supporting diaphragms (see fig. 2.1 and 2.4).

The extreme 15.00 m. cantilever in Gerber beam were achieved with precast "T"-shaped dowels weighing 200 kN (two per eachbox), because they are the extension of the vertical box walls. The longitudinal assembly was made with wet joints and the transverse stiffness was achieved with transverse posttensioning of the slab and the extreme diaphragm (see fig 2.2 and 2.4).

Six precast "T"-shaped beams were placed, longitudinally assembled by wet joints and the transverse stiffness was achieved by transverse posttensioning of the slab and diaphragms (see fig 2.3 and 2.4).
