Evaluation and Analysis of a Masonry Structure for Seismic Loading

T.V. MOSUR

Murugs MURUGANANDAN

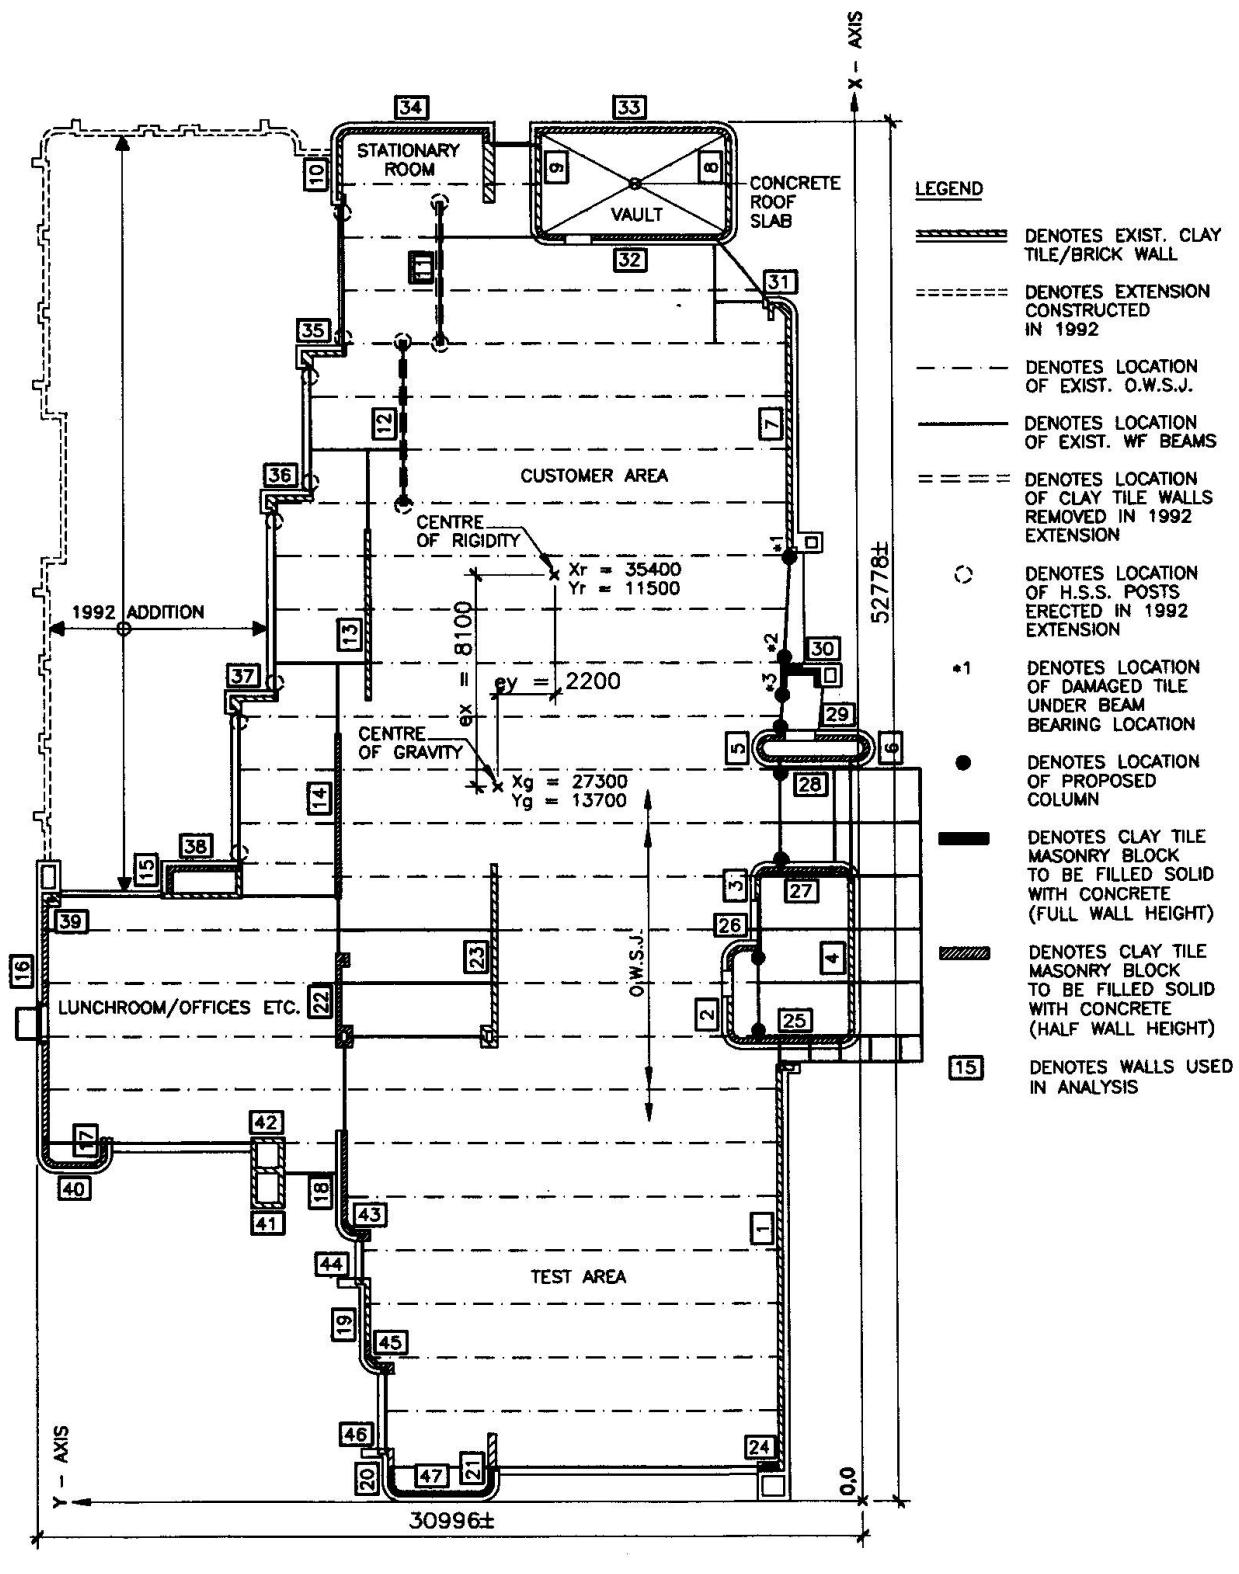
Fig. 1 Building Layout

The layout of the building is shown on Figure 1. The walls are built with clay tile block and face clay brick as shown on Figure 3. Typical clay tile block used in the building is shown in Figure 2.

The wall system which resist gravity and earthquake loads is shown on Figure 1. The load resisting system consists of 45 individual walls. The exterior masonry cavity walls have been assumed to act integrally in resisting lateral forces. The clay tile block wall and brick wall are tied together with ladder type reinforcement. Gravity loads, however are supported by the loaded wythe of clay tile block masonry only.

The analysis is based on a relative wall stiffness method. Torsional effects due to horizontal forces are adequately dealt with by a stiffness matrix of the composite walls at various locations, as shown on Figure 1. Calculations indicated that seismic force controlled the analysis.

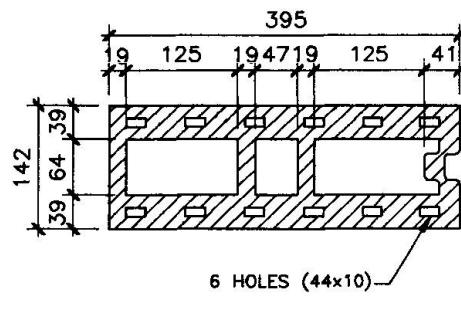
Fig. 2 Clay Tile Block

1. HEIGHT OF CLAY TILE 200mm.
2. ALL DIMENSIONS OF CLAY TILE BLOCK ARE APPROXIMATE AND FIELD MEASURED.

TYPICAL 142mm
CLAY TILE BLOCK SECTION
