Zeitschrift: IABSE reports = Rapports AIPC = IVBH Berichte
Band: 73/1/73/2 (1995)

Rubrik: Session A4: Concrete durability I

Session A4

Application of Super-Workable Concrete to an Arch Bridge

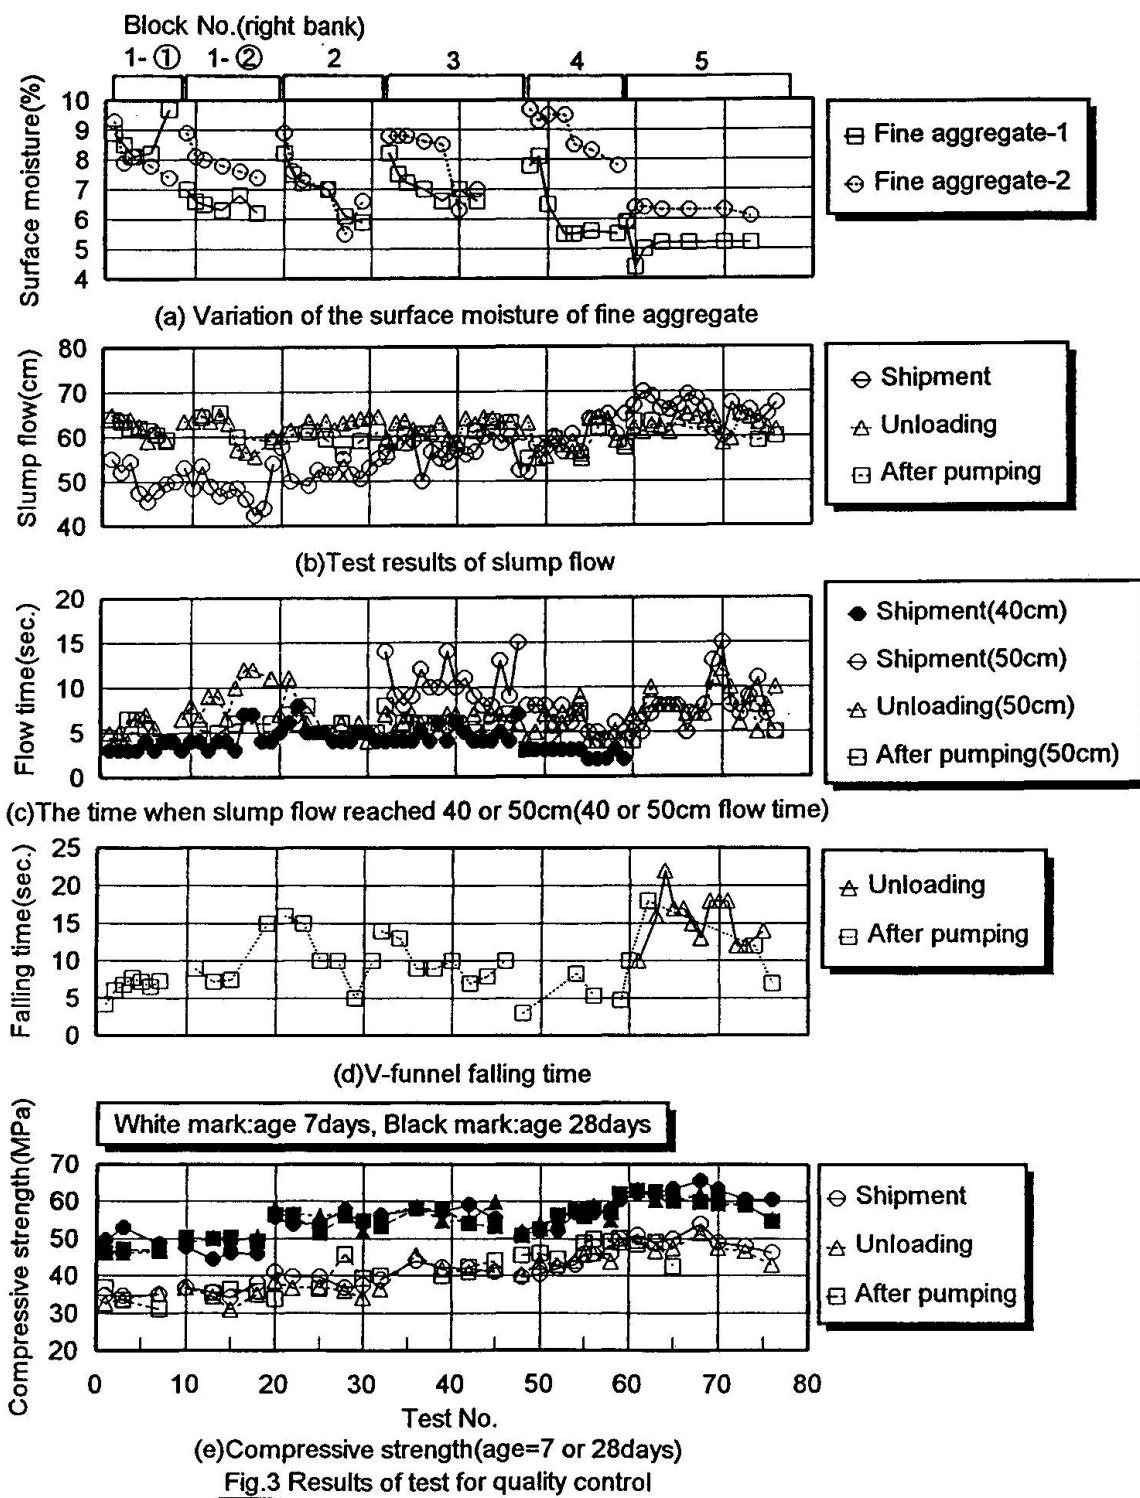
Fig.3 Results of test for quality control

(e) Compressive strength(age=7 or 28days)

As can be seen from Figure 3(a), the fine aggregate is a combination of two systems, one of which is used in the making of regular concrete, and the surface moisture is affected considerably by the amount and rate of shipment and results in considerable fluctuations. However, in the case of number 5 placement block (crown portion), the concrete was placed at night as countermeasure of hot weather concrete, and as a result the amount of surface moisture was relatively stable.

The results of slump flow tests are shown in Figure 3(b). At the time of commencement of the concrete placement in March it was found that there was a tendency for the slump flow to increase by 10cm from the time of shipment to the time of unloading, which was the same as in the case of the preliminary placing experiment carried out in February. From this result, to achieve a slump flow of 60 ± 5 cm at unloading or after pumping, it was decided to make the slump flow value at shipment 50 ± 5 cm. However, due to the rise in environment temperatures (temperature when the concrete is mixed up) the increase in slump flow and the time taken to reach a peak value of slump flow became short, so to increase the value of slump flow, the amount of superplasticizer was increased. At the time of final placing (crown portion : July 30), there was virtually no difference between the slump flow value at shipment and the slump flow value at unloading or after pumping.

The V-funnel falling time measured at after pumping fluctuates considerably even when there is little variation in slump flow, this is seen as the effect of different viscosities of the placed concrete (see Figure 3(d)). Also, the V-funnel falling time value showed the same relative trend as the 50cm flow time after pumping, but the V-funnel falling time showed the differences most clearly. The main reason for the variations in V-funnel falling time, even though the super workable concrete is of fixed mix proportion and same slump flow, is believed to lie in the surface moisture content of fine aggregate. In such a case, it is necessary to measure the surface moisture and make fine adjustments to the set value.

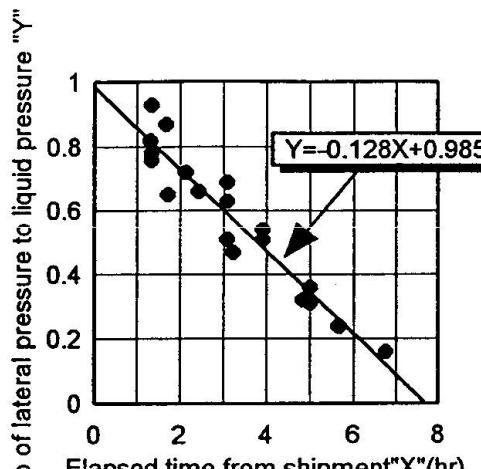
Fig.4 Ratio of lateral pressure to liquid pressure with elapsed time

In Figure 4 is shown the relationship between the time elapsed since shipment and the ratio of lateral pressure and liquid pressure on the preliminary placing experiments. It was found that the measured values showed a good correlation with the straight line of the regression equation. By setting the rate of placing in the regression equation, the maximum lateral pressure on the formwork can be obtained. Substitution of the respective values in equation (1) yields the quadratic equation (2).

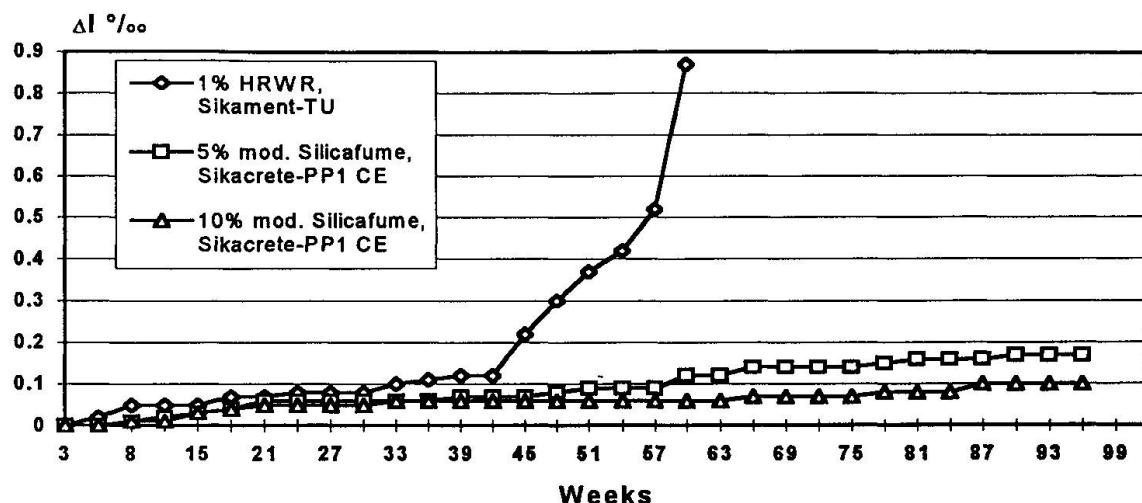
Fig.1 SBB Sulfate Resistance Test (modified ASTM C 1012-89)

Concrete produced with **Portland Cement** and high-range water-reducing admixture have only a very modest sulfate resistance, even with very low w/c ratio (< 0.43). Top sulfate resistance results have been obtained only when specially designed Sikacrete additives were used. (Fig.1) The measured Length Changes (without swelling caused by storage of the specimens in water) remain very modest and the standard deviation of the compressive strength is small. The cracking on the test specimens after 2 years exposure to sulfates is minimal.

Concrete mixed with the so-called "**Sulfate Resistant Cements**" gain only high sulfate resistance together with silica fume and the appropriate amount of high-range water-reducers. New accelerator technologies (aluminium-free) permit nowadays to compensate for insufficient early-strength development.

Water-reduction by means of appropriate admixtures has a beneficial effect on concretes produced with **Blast-Furnace Cements**. Addition of silica fume increases the sulfate resistance insignificantly only. Although many test specimens showed very little inner deterioration (little length change) their outer surfaces had been eroded by sulfate attack in such a way that the tests could not be carried on.

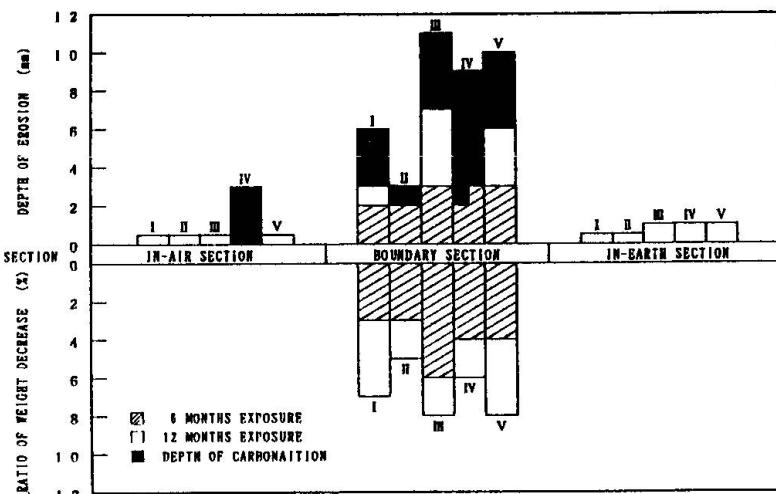
Fig. 3 Depth of erosion and ratio of weight decrease at soaked specimens

5 kinds of concrete specimens were soaked and exposed in 3 hot springs each with a different pH chosen from among the Beppu hot-spring group, after which weight changes and erosion depths were determined, the result of which is as shown in Fig. 3. The result has revealed that the deterioration of concrete is dictated more heavily by the kind of soaked hot-spring water rather than the kind of cement and its mixture used for the concrete used.

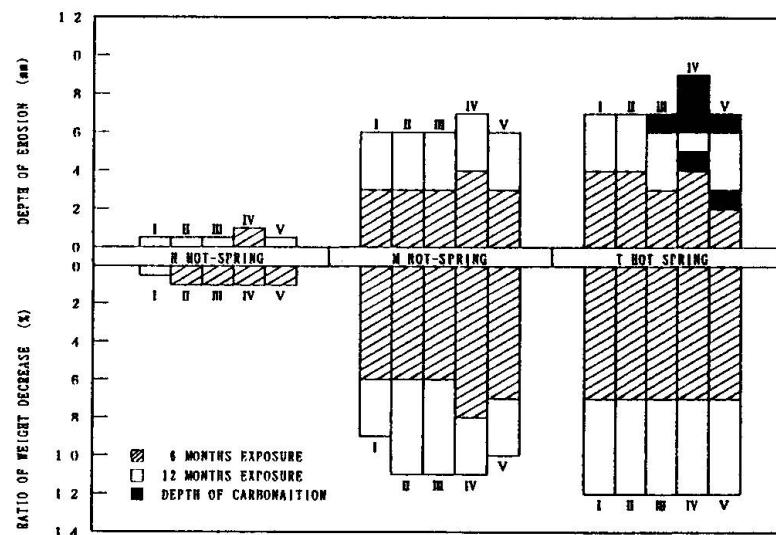
Fig. 4 Depth of erosion and ratio of weight decrease at soil exposure test specimens

terioration in the boundary section is the most conspicuous and the degree of deterioration is just about the same as the specimen soaked in the M hot-spring water. The depth of erosion in the in-earth section is about 1/7 that of the boundary section, and the deterioration in the in-air section is almost negligible. From above, the pH of the soil, the period of exposure, and the depth of erosion have been estimated as shown in Formula below:

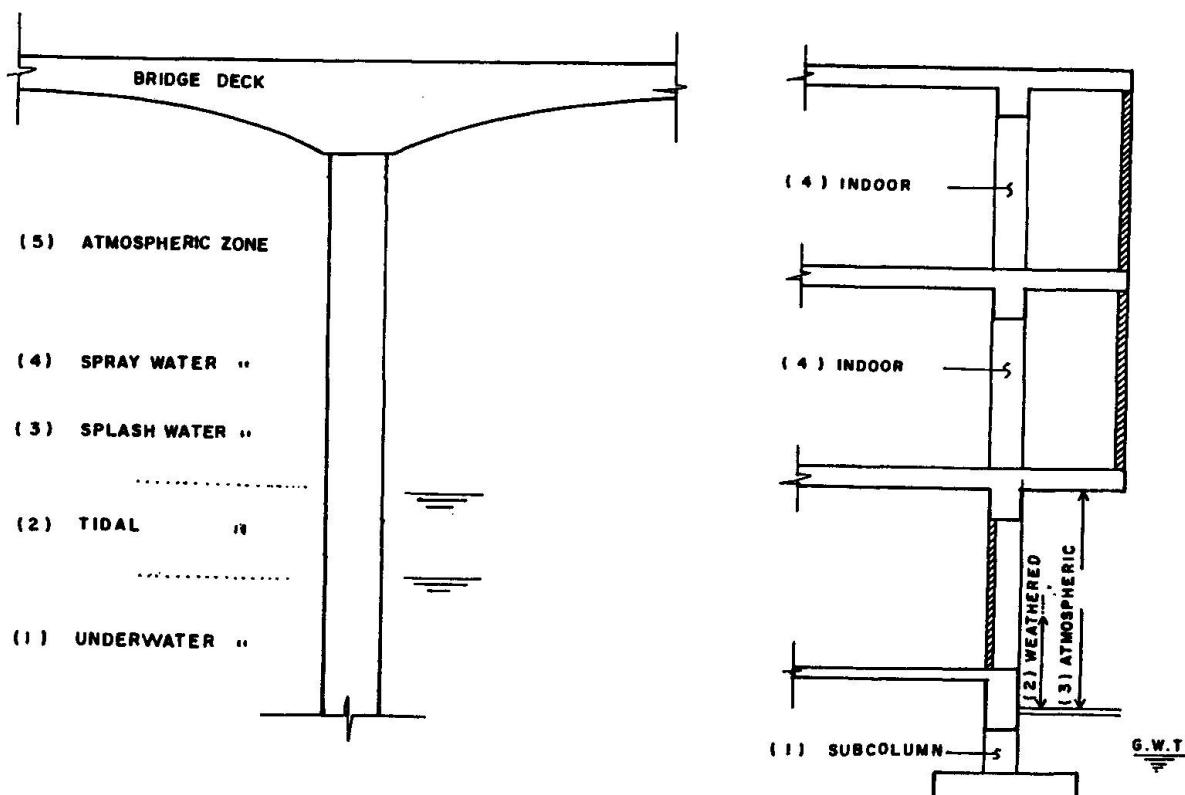
(2.a) Pier of a Causeway

(2.b) A column in a building

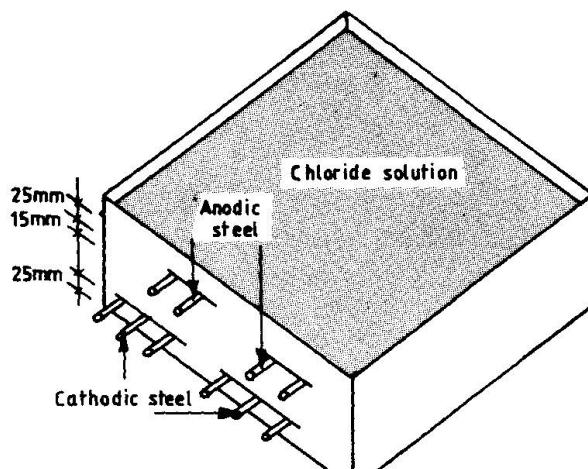
Figure 1. Details of specimens used
for the chloride ponding test

Specimen size -300x300x150 mm
Details of bars -10mm diameter. M.S.
Cover -25mm & 40 mm

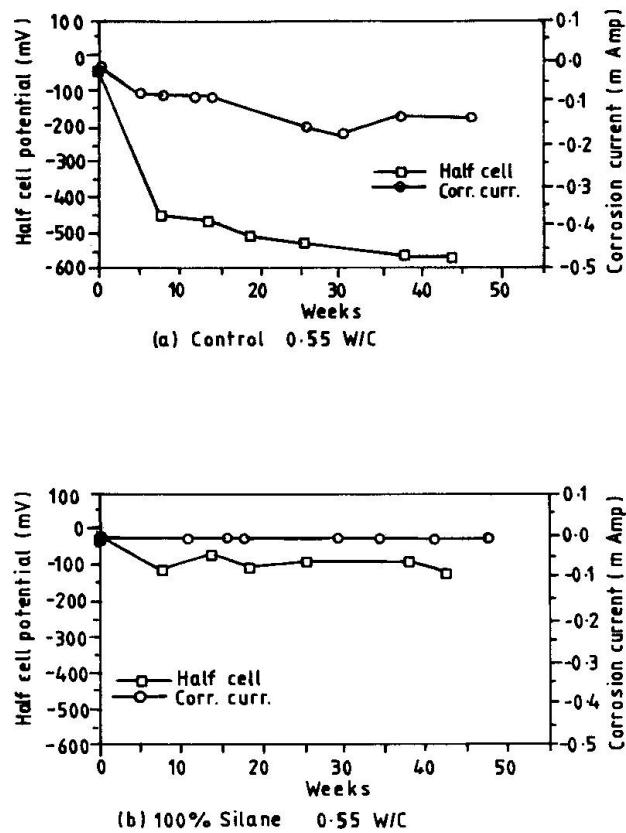
Figure 3. Corrosion at 25 mm cover in cyclic ponding test

For the control slabs, there was evidence of corrosion activity within the first 10 weeks. Figure 3(a) shows the half-cell and corrosion current readings for 0.55 water/cement ratio concrete. At the end of the test period, half-cell potentials were between -450mV and -600mV for all three concretes. The corresponding corrosion currents were -0.02mA to 0.20mA. At the end of the test, the samples

were broken and the bars inspected for rusting. This confirmed the above result with rusting evident on all the bars at 25mm cover in the untreated specimens. In fact, except in the case of the 0.45 water-cement ratio concrete, the bars at 40mm cover had some rust on the top surface; also confirming the potential and corrosion current readings.

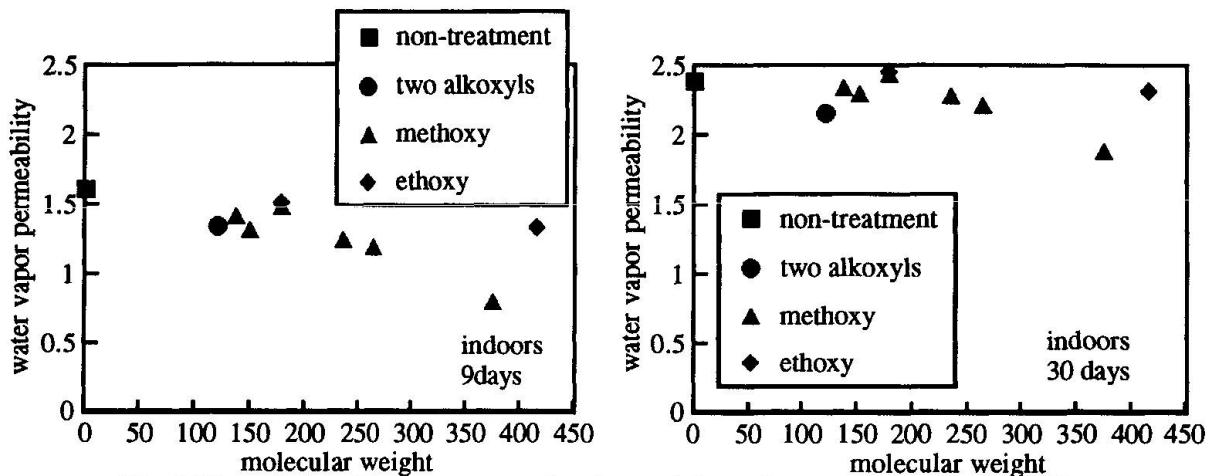
Fig.1 The relationship between molecular weight and water vapor permeability

Fig.1 shows the relationship between molecular weight and water vapor permeability. After 9 days of exposure, the silanes of smaller molecular weight in methoxy series had the larger water vapor permeability. The same tendency was observed in ethoxy series as well. The tendency was still observed after 30 days of exposure, although the influence of molecular weight on the water vapor permeability was reduced to some extent. These results indicate that the water vapor permeability of the silanes of smaller molecular weight was generally larger than that of larger ones during the above period.

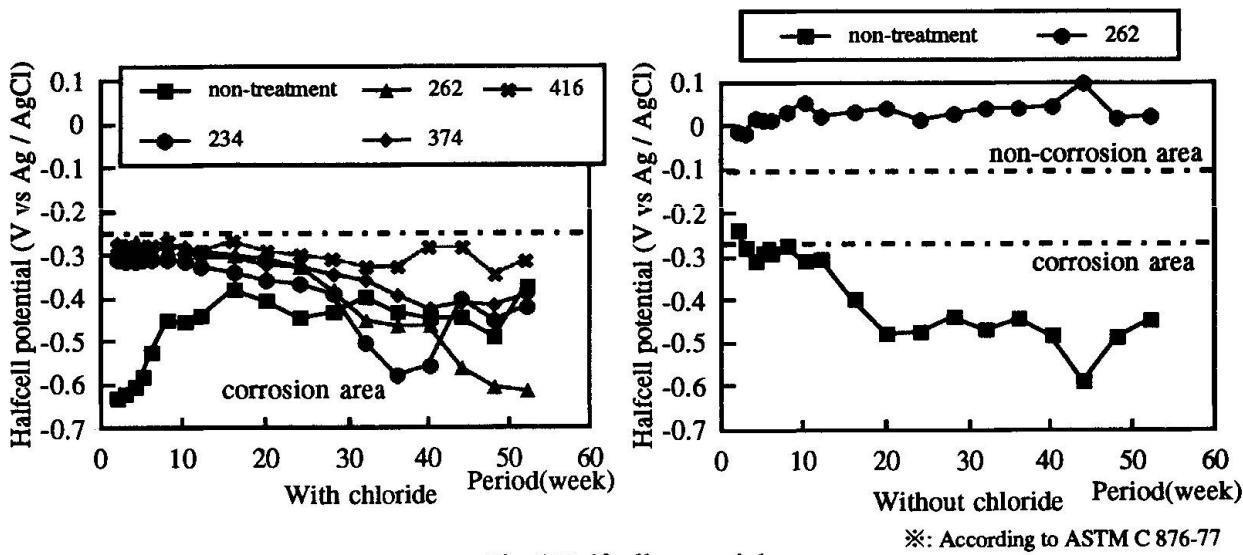
Fig.5 Halfcell potential

Fig.5 shows some results of the halfcell potential obtained from the non-reactive specimens in the condition of partially immersing in chloride solution. While the

halfcell potential of the non-treated specimen without chloride was in the corrosion area, that of the specimen impregnated with 262 was still in the non-corrosion area. This indicates that the silane worked effectively also against corrosion of reinforcement caused by the chloride solution. However, when concrete included much chloride, although the halfcell potential of the impregnated specimens were less negative than that of non-treated specimens in a short term, they gradually became negative with the time passing until some of them were more negative than that of non-treated specimens.

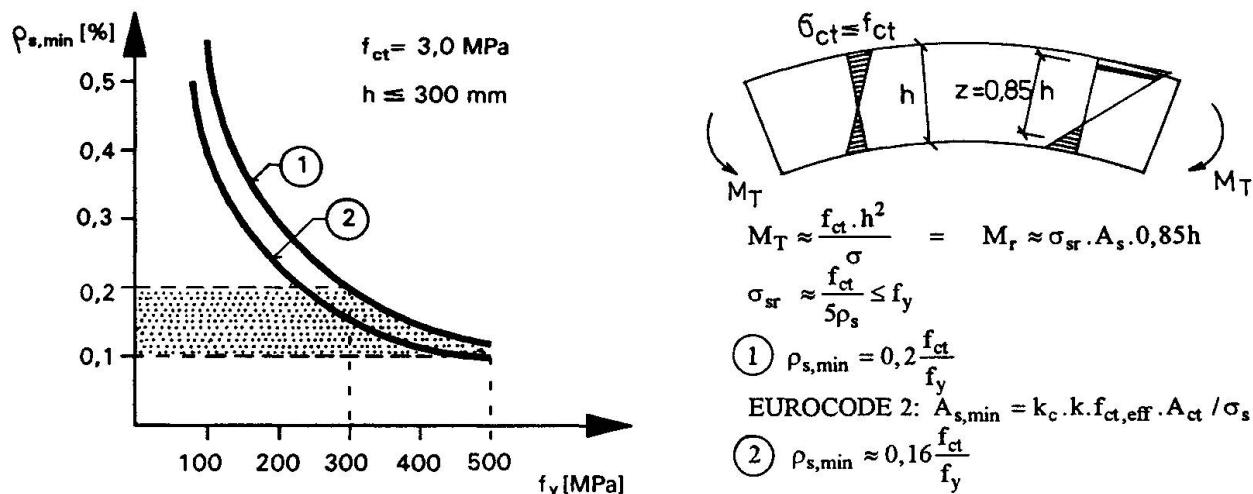
Fig.1 The min. degree of reinforcement ρ_{\min} versus yield point f_y of steel

Older cylindrical concrete structures, were designed and built frequently with insufficient hoops and that is the reason why, relatively often, vertical separation cracks with the yielding of the reinforcement can be observed. As shown in Figure 1, the minimal degree of reinforcement ρ_{\min} depends on the relation of the tensile strength f_{ct} of concrete to the yield point f_y of steel.

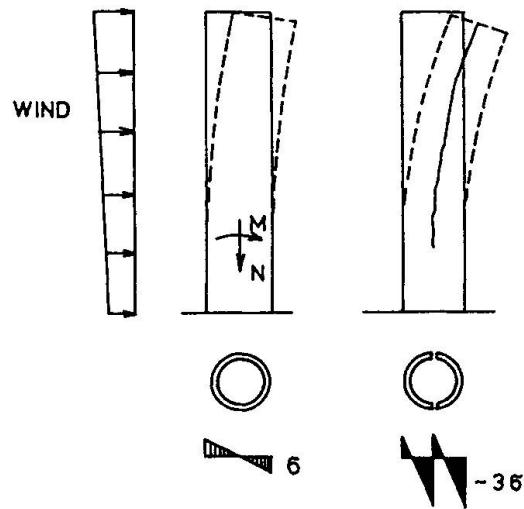
As shown in Fig.2, the cylindrical wall divided by separation cracks behaves with regard to its stresses and deflection much more unfavourably than a monolith structure.

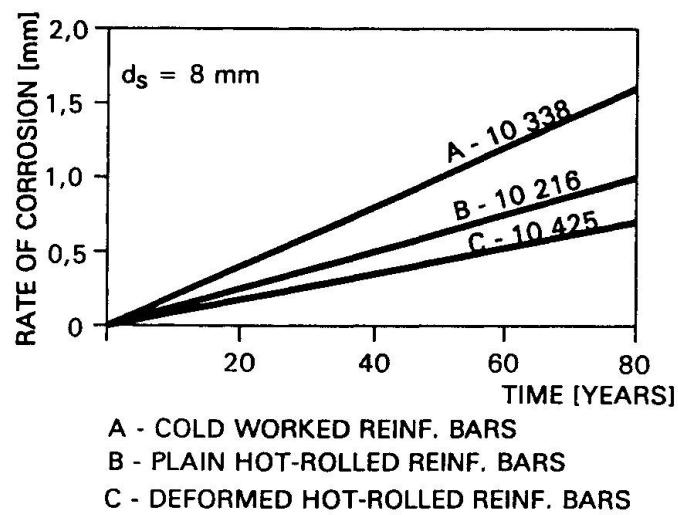
Fig.3 Mean atmospherical corrosion rate as a function of time [7]

Once the concrete cover has been cracked and spalled of, corrosion of the exposed steel will freely proceed like atmospherical corrosion. The mean values for the atmospherical corrosion rate are presented in Fig.3.

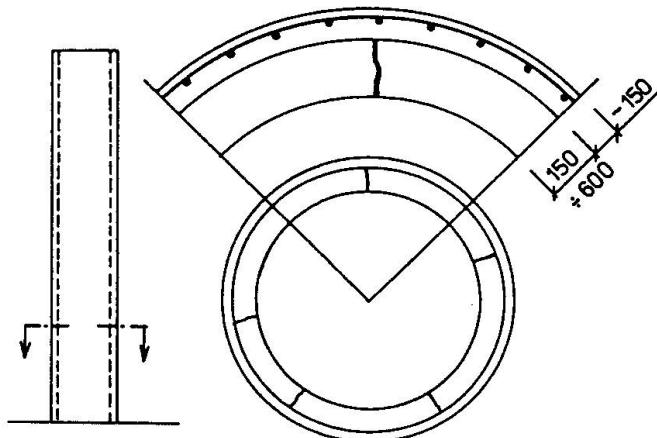
Fig.4 Shaft modification by means of reinforced concrete-jacketing

However, unless the cracks are dormant (or the cause of cracking is removed), they will probably recur. In order to restrict the crack width at the outer shell, high amount of reinforcement must be inserted. In view of the increase in dead weight the foundation pressure must be verified.

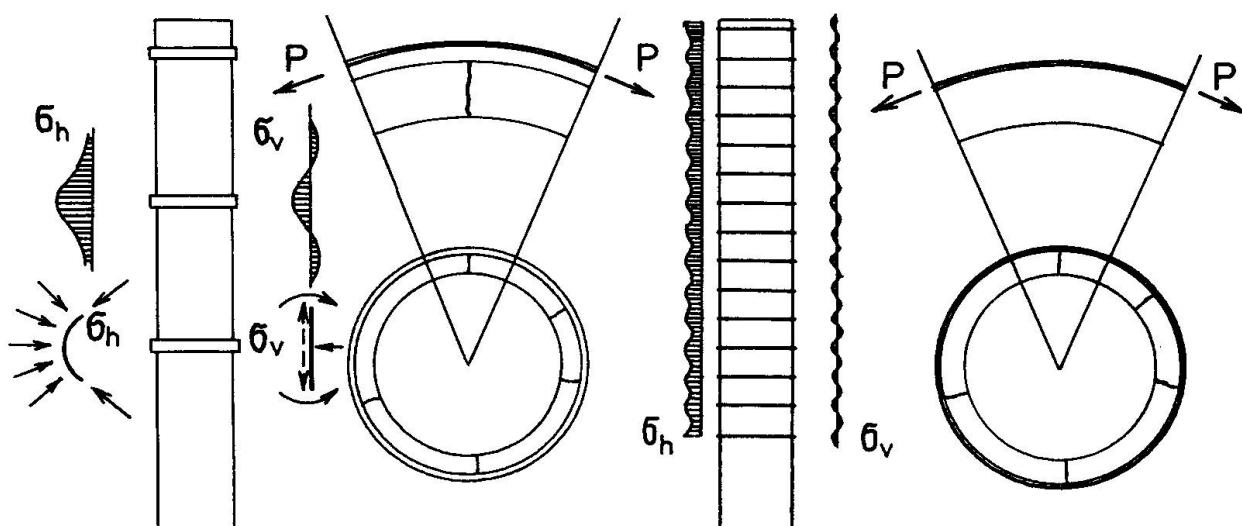
Fig.5 Shaft modification by means of prestressed concrete-rings

Post-tensioning is often the desirable solution when the cracks that have formed must be closed. This technique uses prestressed concrete rings at intervals of about 10 m (Fig.5). They are post-tensioned by means of single unbonded tendons [9]. The local transverse prestressing must be restricted in view of additional vertical and tangential stresses which can lead to a additional crack formation. More uniform circumferential precompression can be achieved with external prestressing tendons at intervals about 2 m (Fig.6). This stressing technique is particularly beneficial when the wall is insufficiently reinforced at the inner surface.
