**Zeitschrift:** IABSE reports = Rapports AIPC = IVBH Berichte  
**Band:** 73/1/73/2 (1995)  
**Rubrik:** Opening session

**Opening Session**  
**Séance d'ouverture**  
**Eröffnungssitzung**

## New Approaches to Monitoring and Repair of Concrete Structures

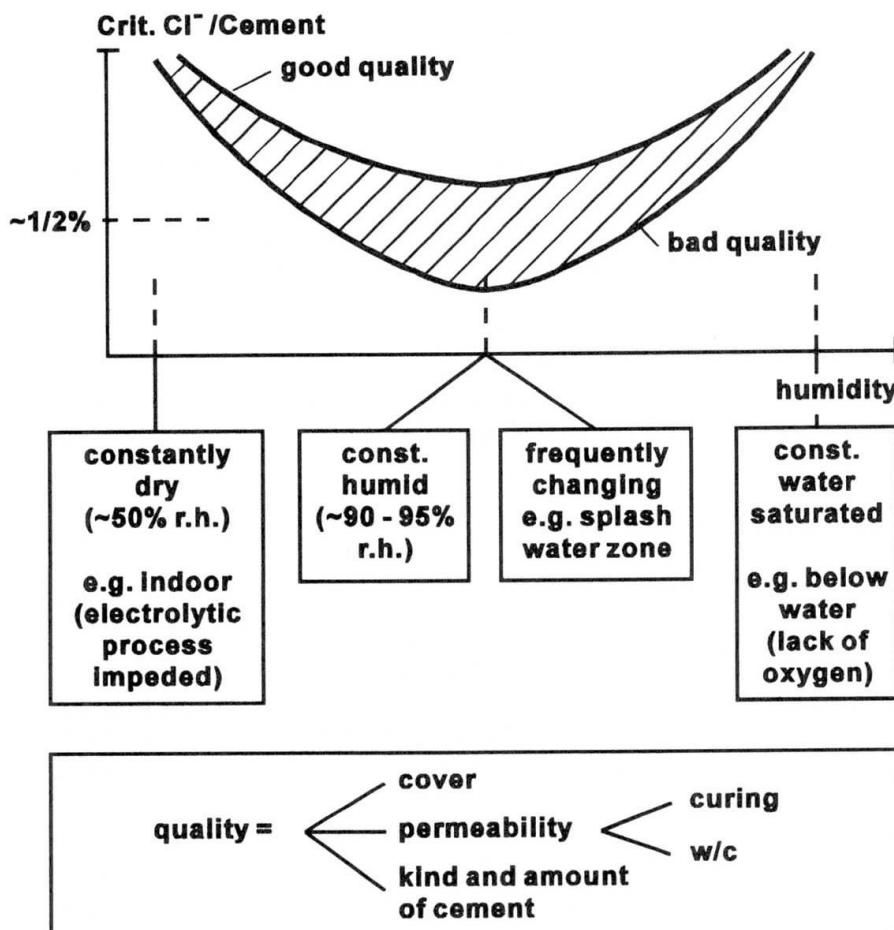
Fig. 1 Influence of concrete cover and environmental conditions on critical chloride content

It is evident from current knowledge that the critical chloride content is not a fixed value but is dependent both on the quality of the concrete cover (type of cement, w/c-ratio, curing, thickness) and on environmental conditions. Fig. 1 presents this relationship in qualitative terms [2].

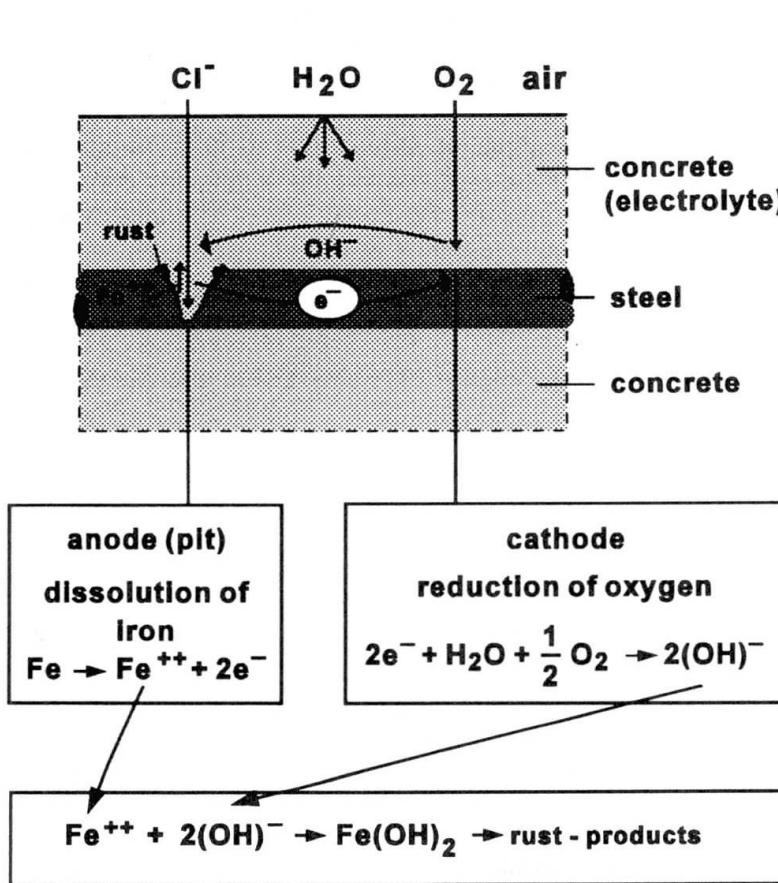
Fig. 2 Diagram showing chloride-induced corrosion of steel in concrete schematically

The corrosion process takes place in two sub-processes, as outlined in Fig. 2:

- At the anode, iron ions pass into solution, separating from the electrons. They are converted into rust products in further reactions.
- At the cathode, electrons, water and oxygen are converted into hydroxyl ions. The cathodic process doesn't cause any deterioration of the steel.

These hydroxyl ions transport the negative charge in the electrolyte through the electrical field created between the anode and the cathode, towards the direction of the anode. Near the anode, they react with the steel ions in solution. Depending on moisture and aeration conditions, this intermediate product may continue to react, producing the final corrosion products.

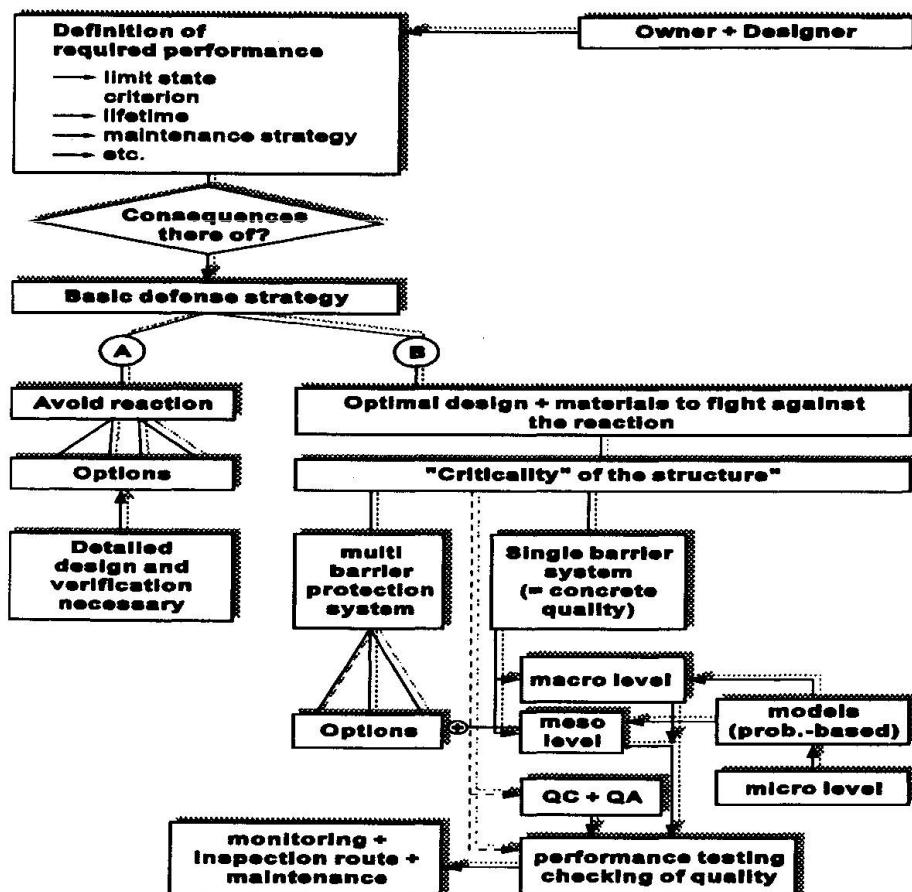
**Fig. 3** Format for Durability Design

Strategy A can be subdivided into three possibilities:

- A1 Change the environment, e.g. by tanking, membranes, coatings etc.
- A2 Select non-reactive materials, e.g. stainless steel, coated steel.
- A3 Inhibit the reaction, e.g. cathodic protection or cathodic prevention.

Coming back to Fig. 3, the amount of quality control to check the real quality gained in the structure depends on the criticality of the structure, i.e. the consequences of durability failures and/or the possibilities to repair them.

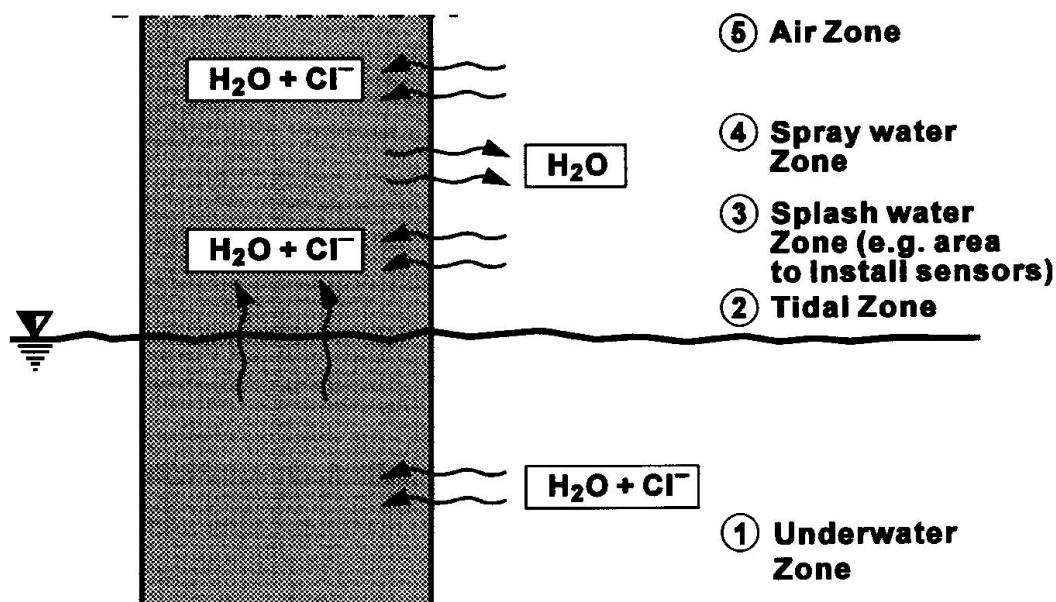
**Fig. 4** Extremely varying micro-environmental conditions  
Example: Marine Structure

For structures as sketched in Fig. 4 the meso-level (see Fig. 3) approach is appropriate. The time dependant penetration of chlorides can be calculated using simplified penetration laws modelling the prevailing penetration mechanisms. Within such a model the effective diffusion coefficient could be the relevant material parameter, e.g. in a very simplified way

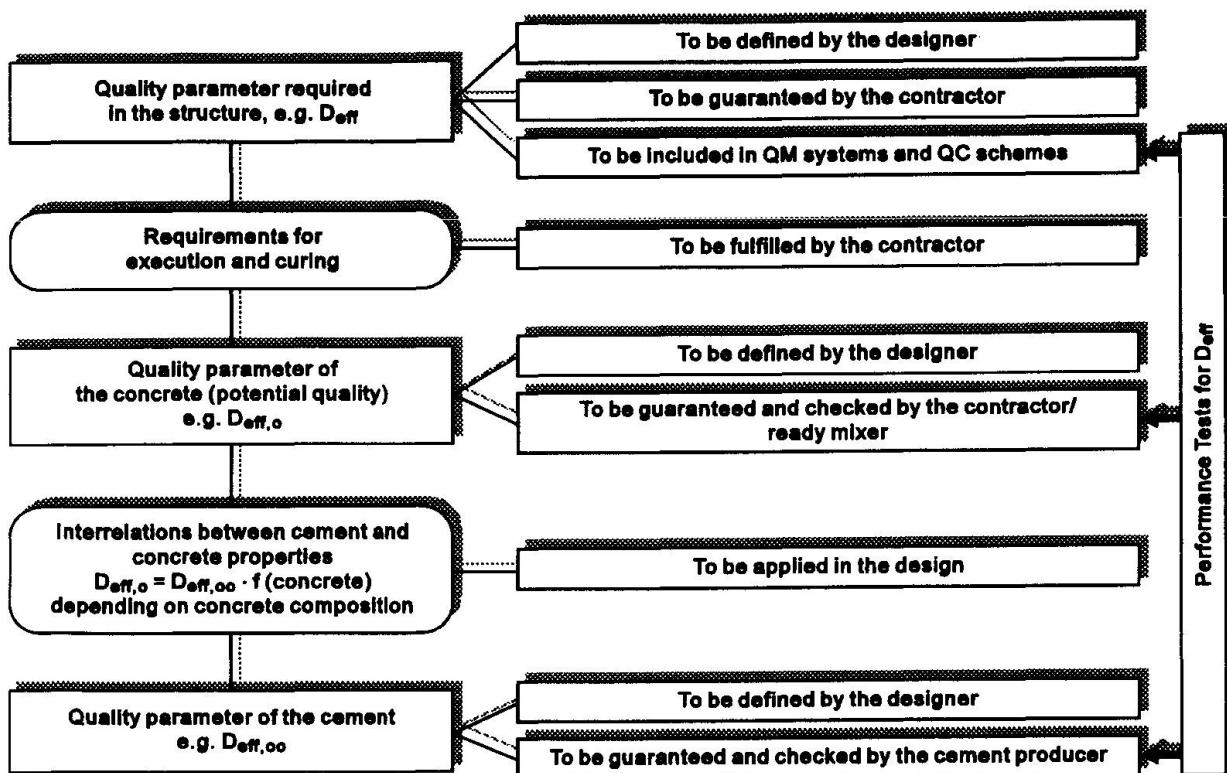
Fig. 5 Performance based durability design at the meso-level

As the effective diffusion coefficient is the performance parameter of concrete governing the resistance of the structure it needs to be incorporated in the material characterisation, starting from the production of the binders to the execution of the structure. The overall system is sketched in Fig. 5. If we replace  $D_{eff}$  in Fig. 5 by strength we realise exactly the system we are using for load design since ever.

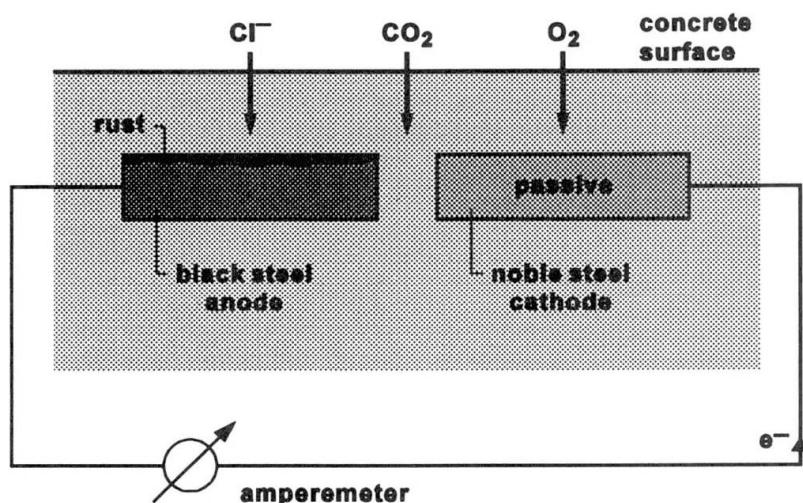
Fig. 6 Macrocell consisting of a black steel anode and noble metal cathode

The operation of a macrocell consisting of a piece of black steel (anode) and a noble metal (cathode) is shown in Fig. 6. In chloride free and non-carbonated concrete, both electrodes are protected against corrosion due to the alkalinity of the pore solution of the concrete (passive state). The electrical current between both electrodes is negligibly low under such conditions. If, however, a critical chloride content is reached, or if the pH-value of the concrete decreases due to carbonation, the steel surface of the anode is no longer protected

against corrosion. Provided that the cathode material is corrosion resistant in chloride contaminated or carbonated concrete (e.g. stainless steel, platinum), and sufficient moisture and oxygen are available, oxygen reduction takes place at the surface of the cathode. The local separation of anodically and cathodically acting areas leads to an electron flow between the black steel and the cathode, which can easily be measured at the external cable connection.

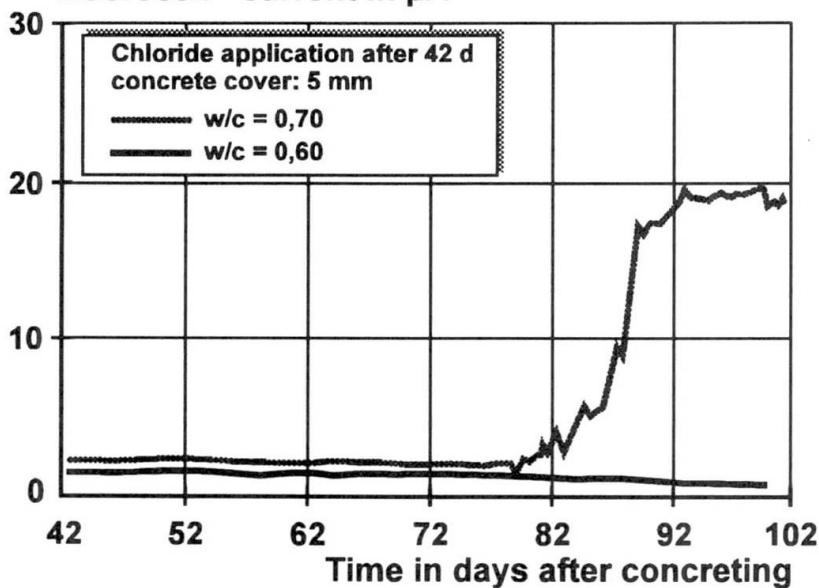
Fig. 7 Time-dependent behaviour of the electrical currents between anode and cathode

Fig. 7 shows the result of electrical current measurements (demonstration test in the laboratory) between a black steel anode and a stainless steel cathode in two concretes with different water-cement ratios. The macrocells were embedded with a concrete cover of only 5 mm (0.20 in.) to initiate corrosion by applying a chloride solution on the concrete surface within a short period of time. The results of the macrocell current measurements showed that the critical chloride content reached a depth of 5 mm (0.20 in.) at the specimen with  $w/c = 0.7$  about 80 days after concrete placement. This caused a significant increase of the macrocell current while the specimen with a lower  $w/c$  and a higher resistance against chloride diffusion remained passive.

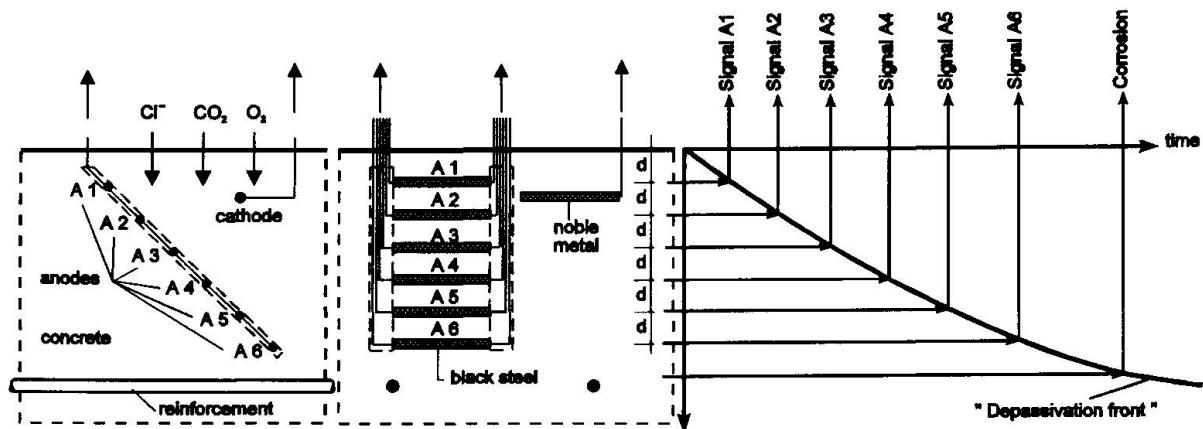
**Fig. 8** Arrangement of the anodes and cathodes to monitor the corrosion risk for the reinforcement

Fig. 8 shows exemplarily a possible arrangement of anodes and a locally separated cathode.

Normally all the electrodes are disconnected from each other to prevent electrochemical interactions between them. Only during the electrical current measurements the anodes are coupled with the cathode one after the other.

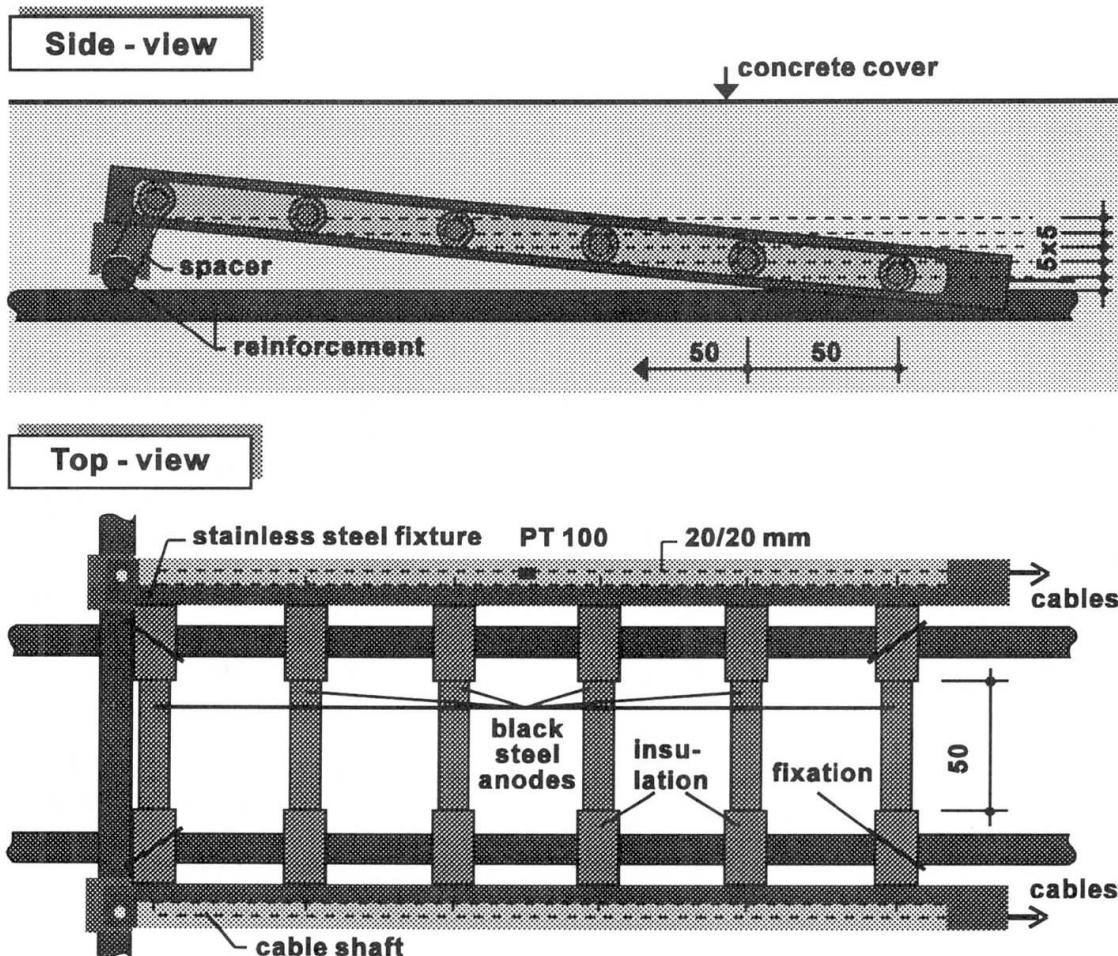
Fig. 9 Design of a set of 6 anodes

A typical layout and arrangement of a corrosion sensor consisting of 6 single anodes is shown in Fig. 9. Each of the 6 black steel anodes is positioned 50 mm (2 in) from the next one to prevent interactions between the anodes.

Fig. 9 also shows that the cables are lead through a stainless steel fixture to the measuring device. The cable shaft is filled with epoxy resin that acts as mechanical protection for the wires and a PT 100 temperature sensor that can be additionally installed. Two wires are connected with each single anode to get a redundant system. This allows the cables and cable connections to be checked after installation by resistance measurements.

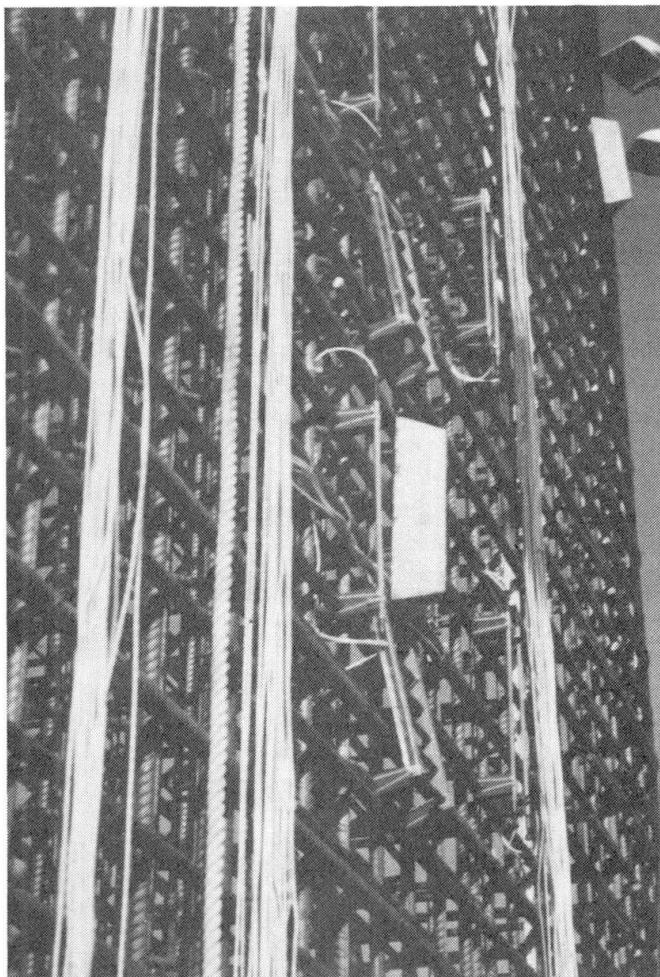
Fig. 10 Installed sensors (6 sets of anodes and 1 cathode - Pier shaft of the Western Bridge, Great Belt Link

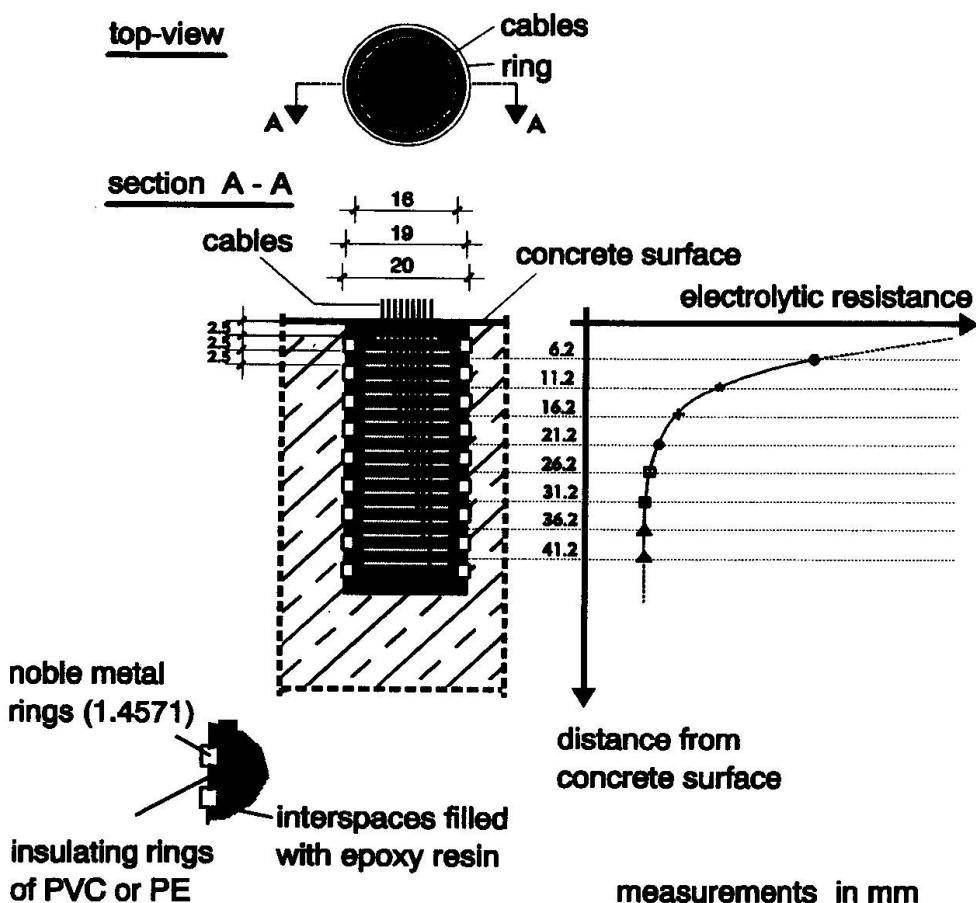
Fig. 11 Schematic representation of the multi-ring-electrode and a qualitative diagram of measured values

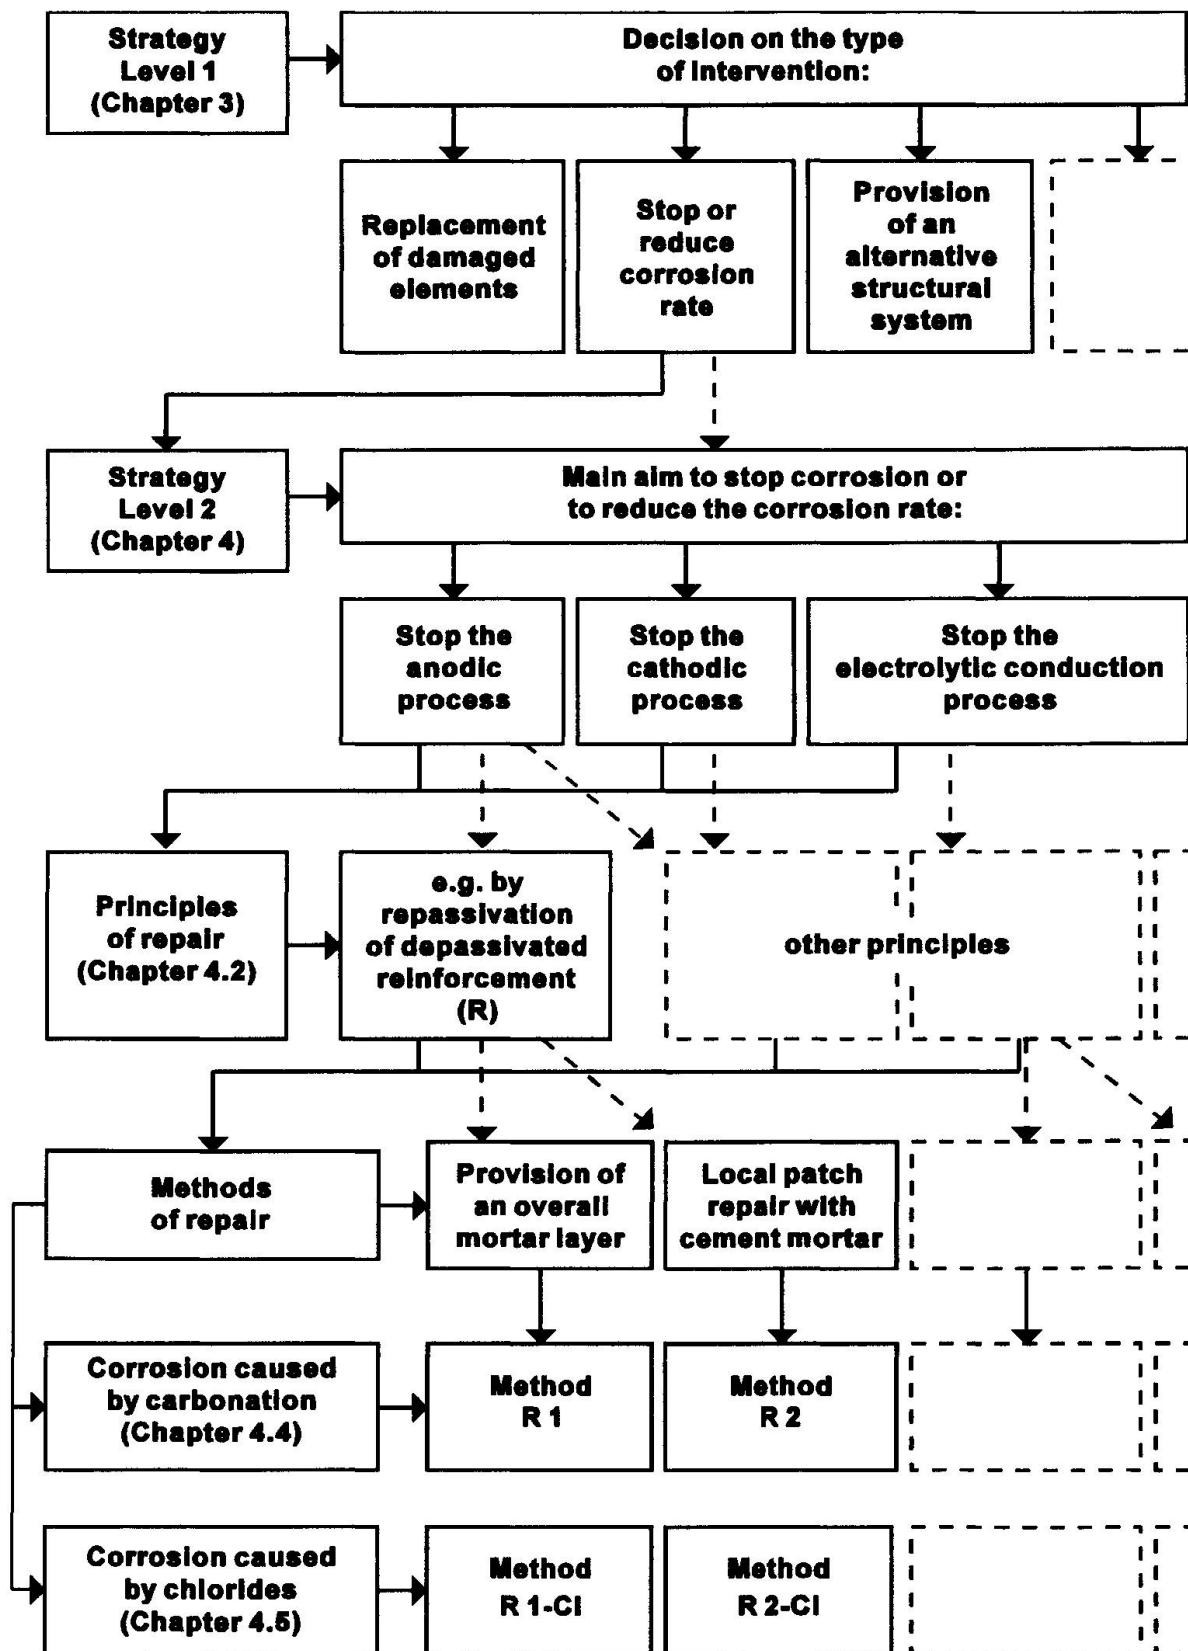
Fig. 12 Format of the Technical Recommendation

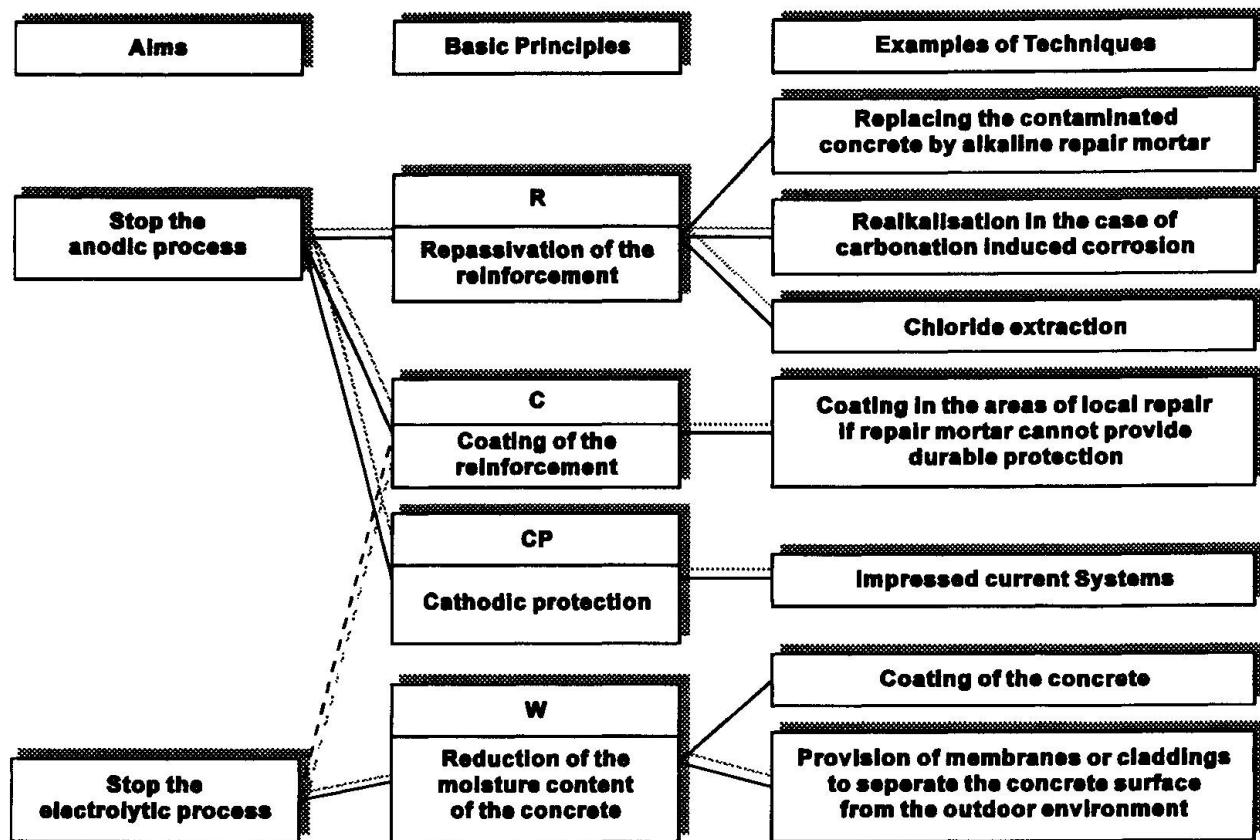
**Fig. 13** Principles of repair to stop corrosion

Fig. 13 presents basic principles and examples of techniques based on these principles. There are no generally proven repair procedures to stop the cathodic process, e.g., by the total block of oxygen access to the surface of the reinforcement. Although theoretically possible, the concept of stopping the cathodic process therefore is not included in Fig. 13.

For the different basic principles sketched in Fig. 13 different methods for repair must be elaborated, depending on the cause of depassivation (i.e., carbonation or chlorides).

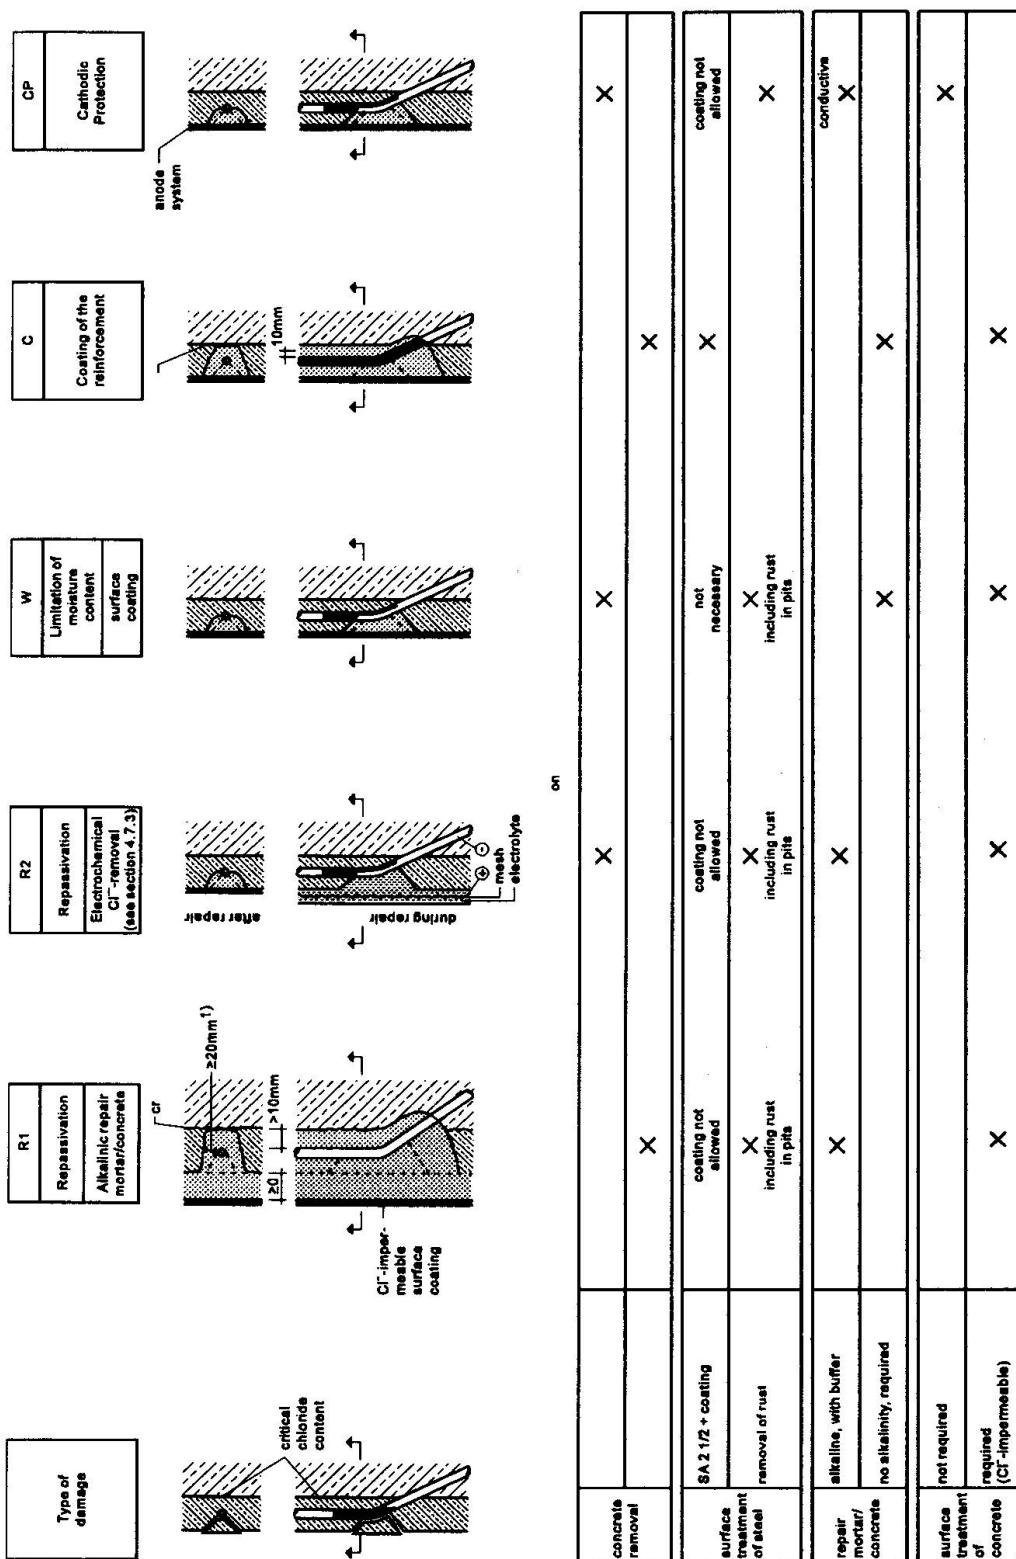
**Fig. 14** Basic methods for the repair of chloride induced corrosion

As an example the basic methods for the repair of chloride induced corrosion, as presented in [10] are shown in Fig. 14.

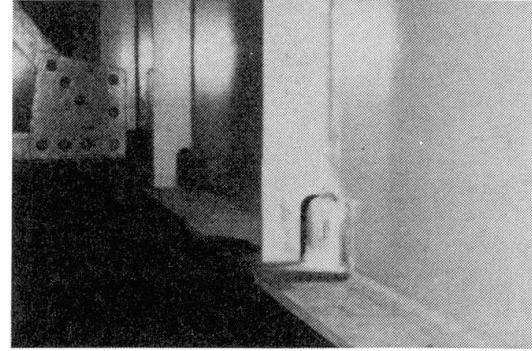
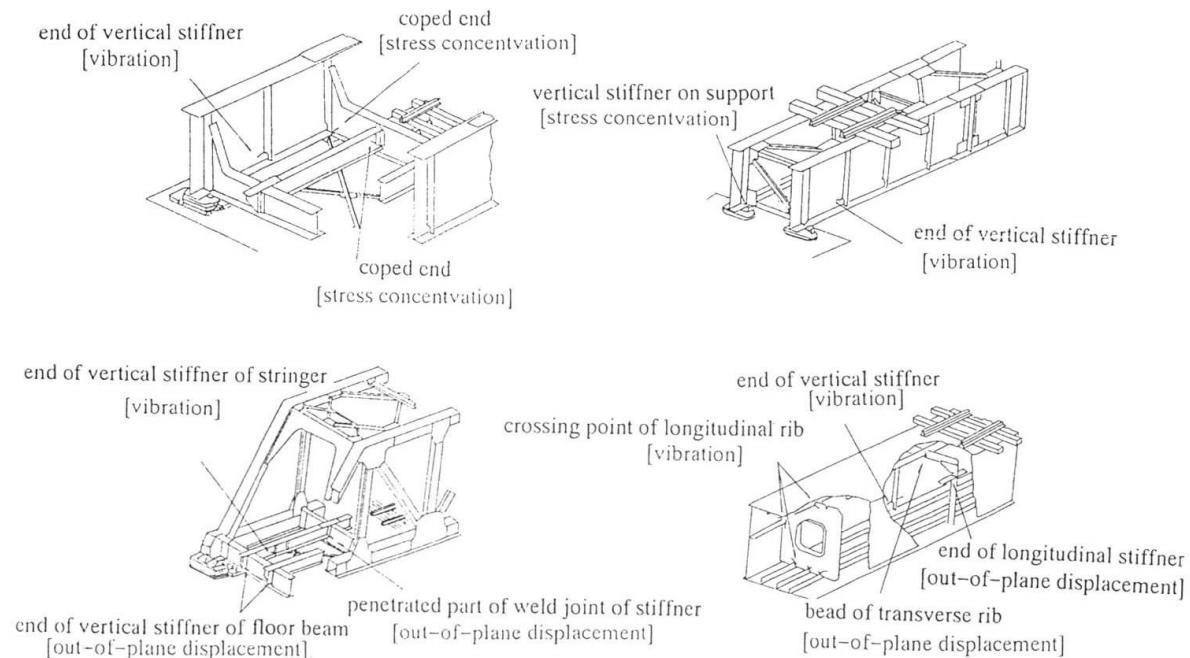
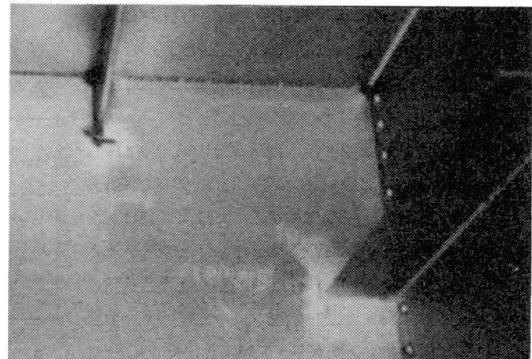
Fig.2 Fatigue damage in steel bridges of Tokaido Shinkansen

Occurrences of fatigue damage began to be reported concerning bridges of the Tokaido Shinkansen from around 10 years after having been put into service. An outline is given in Fig. 2, with cases of damage being those resulting from stress concentrations due to structural details of members, those due to out of plane displacements occurring between perpendicularly crossing members such as main girders and cross beams or cross beams and stringers, and those due to vibration induced distortion by high-speed operation of trains peculiar to Shinkansen[1].

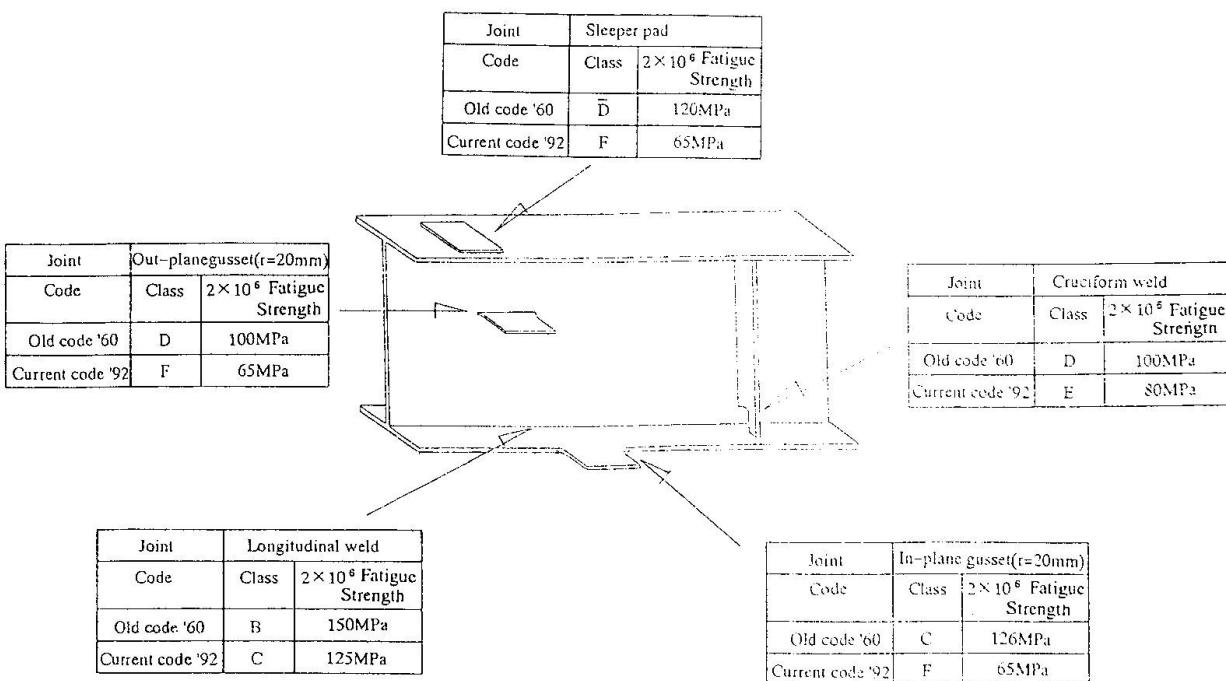
Fig.3 Changes of allowable fatigue stress from '60 code to '92 code

When what had been assumed at the time of designing and the subsequent condition of use are considered, certain parts in bridge structures are approaching the ends of their design service lives. Therefore, a number of preventive and protective set-ups against fatigue damage have been established. What have great differences in allowable fatigue strengths between the time when Shinkansen was designed and the current design standards are longitudinal weld between flanges and webs, and ends of gusset plates welded to webs (Fig.3). They are the points in damage prevention work.

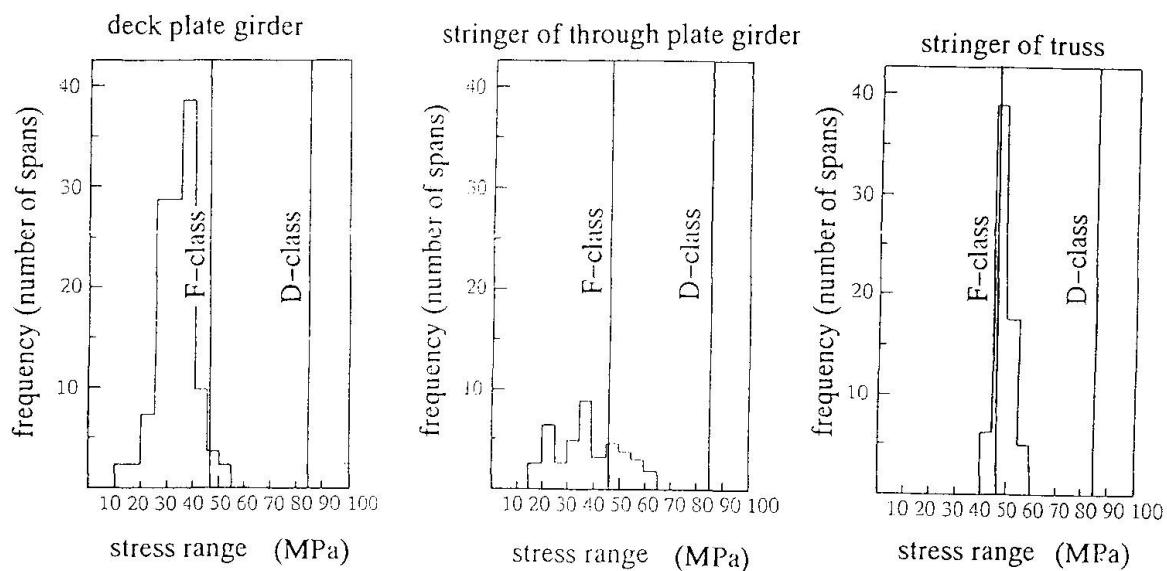
longitudinal joint	: C
vertical stiffener end	: E
flange gusset detail	: F

Fig.4 Variation of measured maximum stress range and fatigue assessments

One of damage prevention works is measurement of actual stresses. This is done regarding plate girders and the stringers of truss girders. To elaborate, since stresses in bridge members actually occurring are normally low compared with those in design calculations, it is thought to consider maintenance based on stresses actually occurring. Stress measurements for this purpose consist of grasping the bending stress on average occurring in the bottom flange and the location of the neutral axis. The reason for actual stresses being low compared with calculated stress in case of railway bridges, lies in the load distribution due to rails and secondary members. The results of stress measurements are illustrated in Fig. 4, in which it is clearly shown that the possibility of fatigue damage in a fairly large number of members is high on the basis of design calculated stress, however, there is hardly any cause for concern when actual stress is observed. Regarding longitudinal welds joining flanges and web (categorized into C class), it was learned that there was ample allowance from measurements of actual stresses, but the degrees of allowance at the ends of gussets attached to flanges (categorized into F class) were slightly small. Hence, remedial measures regarding fatigue strength are presently under study for this gusset detail. Methods being considered are to increase the radius of the fillet at the end of the gusset and, further, to add residual compressive stress by peening, and the effectivenesses are being examined through fatigue tests (Fig.5).

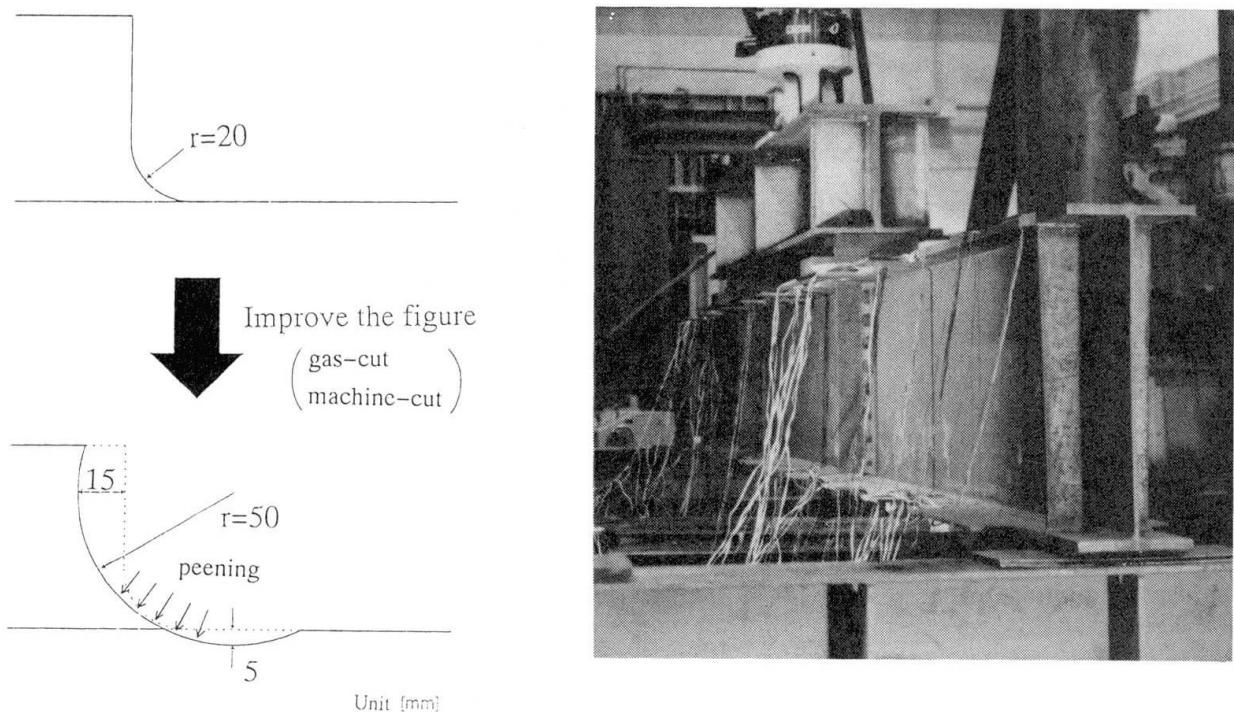
Fig.5 Improving work of flange gusset detail and fatigue test

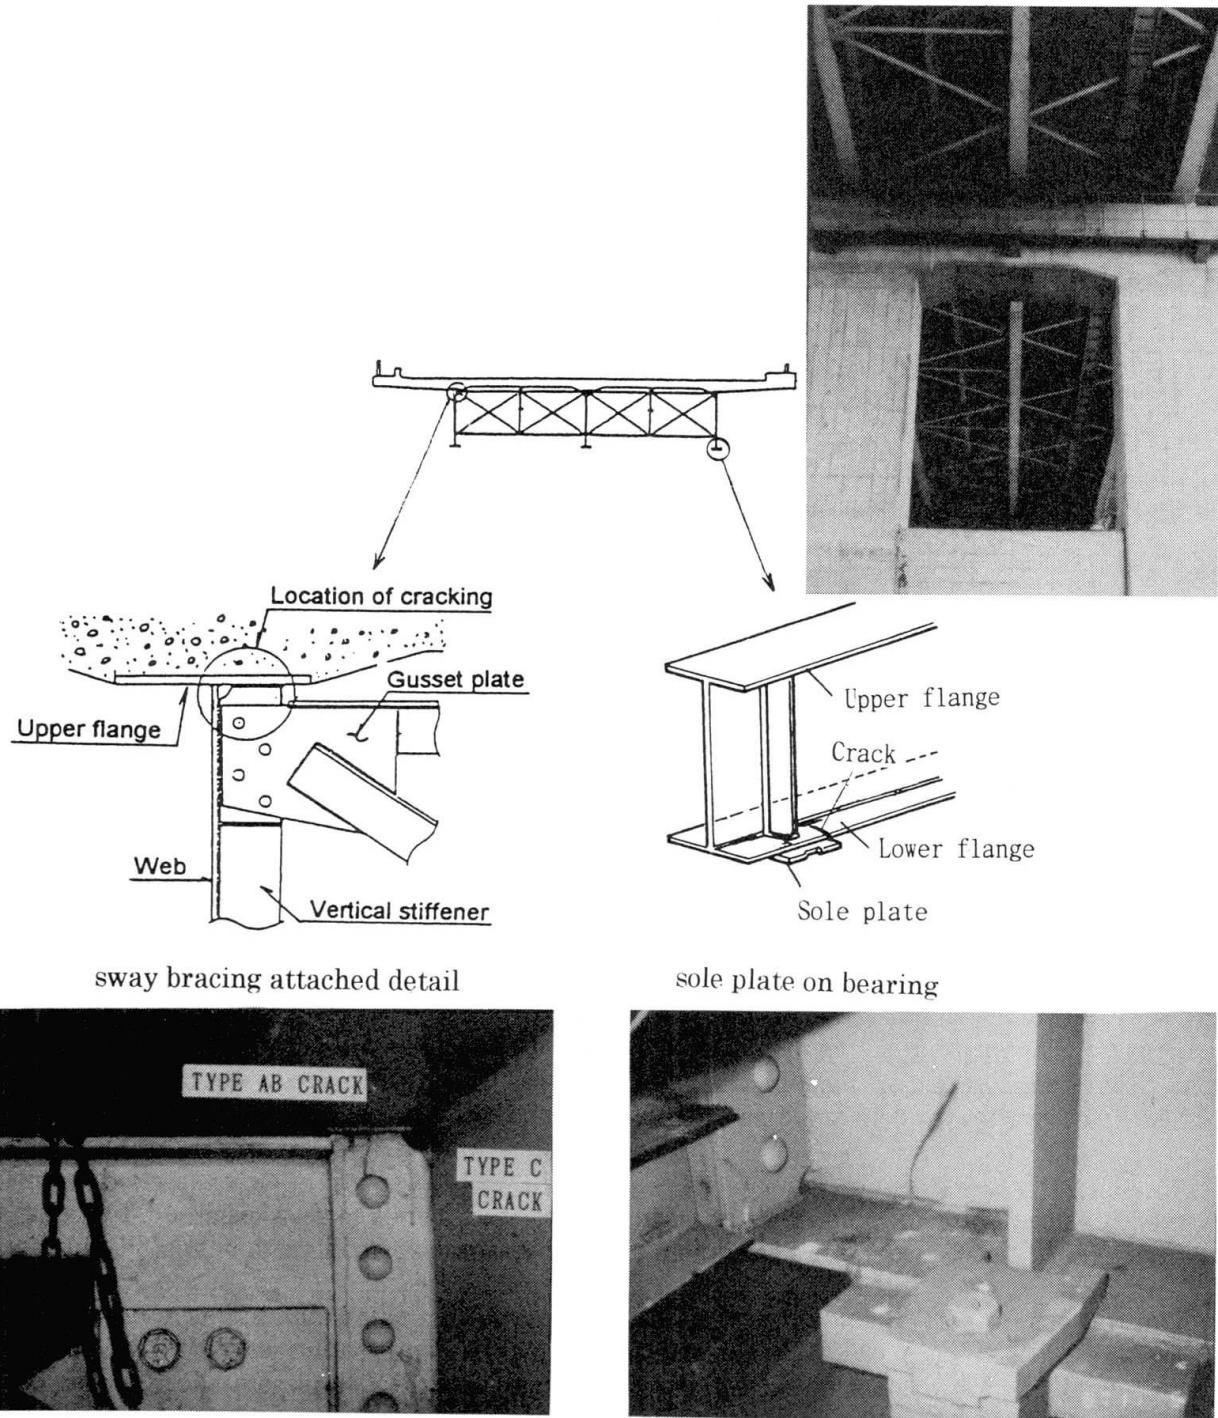
Fig.9 Typical fatigue damage in plate girder bridge

The types of fatigue damage in steel plate girder bridges of the Tomei Expressway are shown in Fig. 9 [2]. Various types of fatigue damage have been observed. The percentage of occurrence is highest for fatigue cracks at the ends of vertical stiffeners with sway bracing attached, and detailed studies have been made on this fatigue. It has been found to be due to force acting so that displacement will occur orthogonally to the web from differences in deflections between girders and deformations of deck slabs.

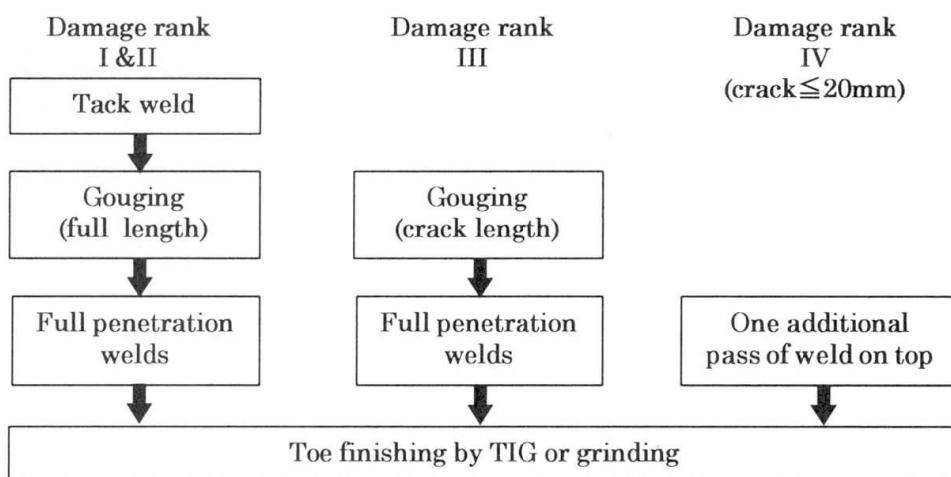
Fig.10 Retrofit methods depend on damage ranks

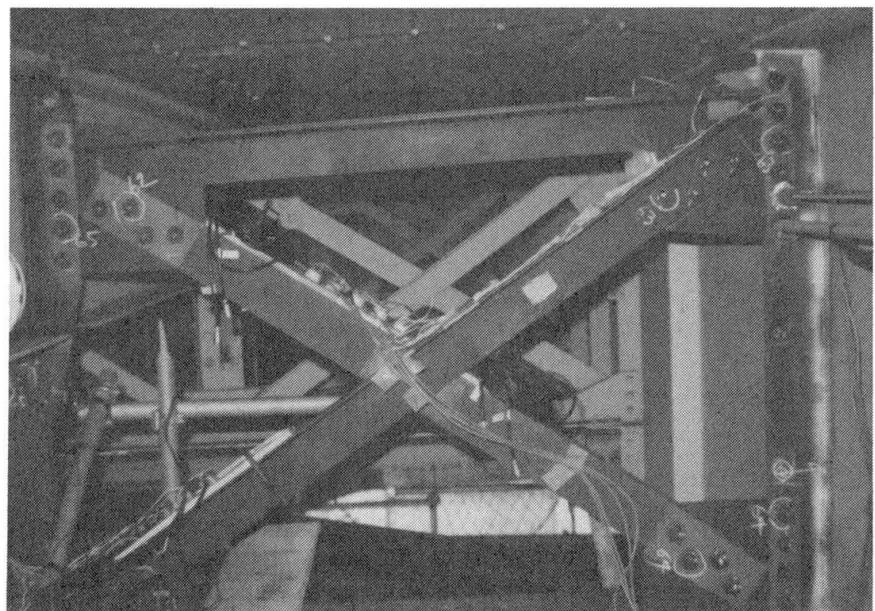
Fig.12 Adding work of sway bracing

At bridges with prominent damage, the load applied in the lateral direction by existing sway bracing is to be alleviated by adding sway bracing in improved joint details (Fig.12). The joint details between the sway bracing and main girder at this time was proven by fatigue tests to have been improved. The stresses at fatigue crack occurrence points were reduced approximately 20 percent by providing this measure, while further, stresses were reduced approximately 30 percent by detaching the horizontal members of existing sway bracing.

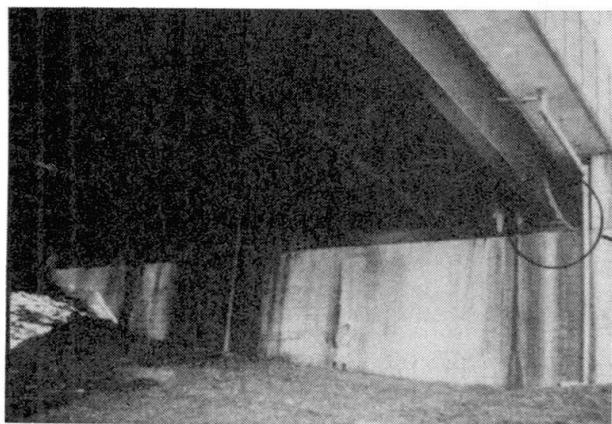
Fig.13 Fatigue crack around sole plate

What have become conspicuous recently are cracks around sole plates of bearing points of main girders (Fig.13). Fatigue cracks have occurred in fillet welds for attaching sole plates to main girders and fillet welds between main girders and webs. The feature of this damage is that it occurs in a girder which has impairment of the rotating function of its support. The bearing point is the point where loading concentration is the severest in a bridge, while structurally, since this location is at a distance from the neutral axis, the stress is different from that according to the beam theory, and the deterioration of the support function causes such a condition to come about. Regarding this damage, the sole plate is exchanged for a larger one, attaching it with high-strength bolts, while further, structural improvements such as to add vertical stiffeners are provided (Fig.14).
