**Zeitschrift:** IABSE reports = Rapports AIPC = IVBH Berichte  
**Band:** 73/1/73/2 (1995)  
**Rubrik:** Opening session

**Opening Session**  
**Séance d'ouverture**  
**Eröffnungssitzung**

## New Approaches to Monitoring and Repair of Concrete Structures

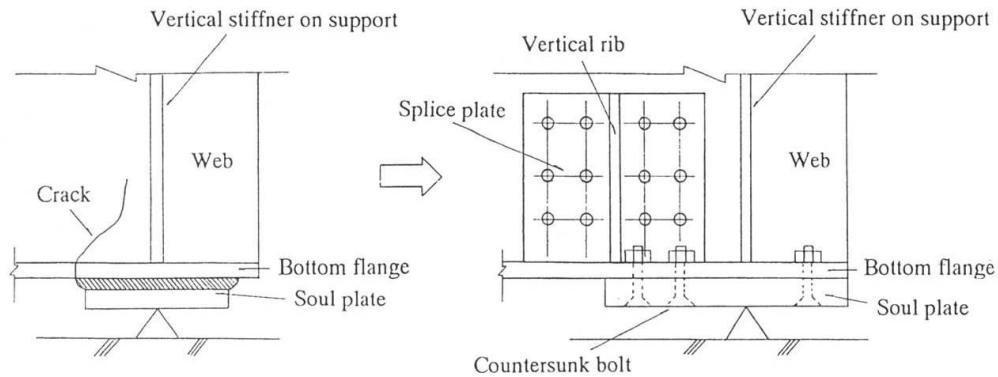
Fig.14 Retrofit detail for cracks at sole plate

What have become conspicuous recently are cracks around sole plates of bearing points of main girders (Fig.13). Fatigue cracks have occurred in fillet welds for attaching sole plates to main girders and fillet welds between main girders and webs. The feature of this damage is that it occurs in a girder which has impairment of the rotating function of its support. The bearing point is the point where loading concentration is the severest in a bridge, while structurally, since this location is at a distance from the neutral axis, the stress is different from that according to the beam theory, and the deterioration of the support function causes such a condition to come about. Regarding this damage, the sole plate is exchanged for a larger one, attaching it with high-strength bolts, while further, structural improvements such as to add vertical stiffeners are provided (Fig.14).

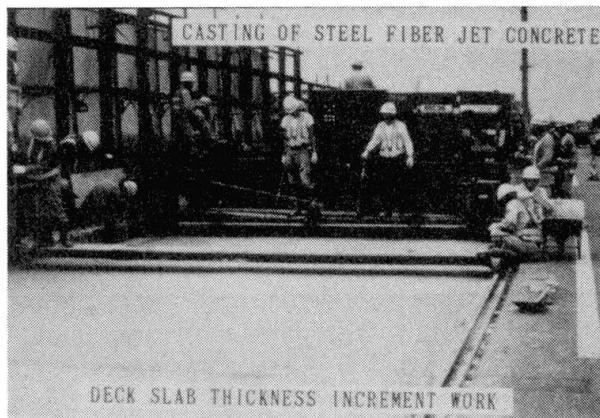
Fig.15 RC deck slab thickness increment work

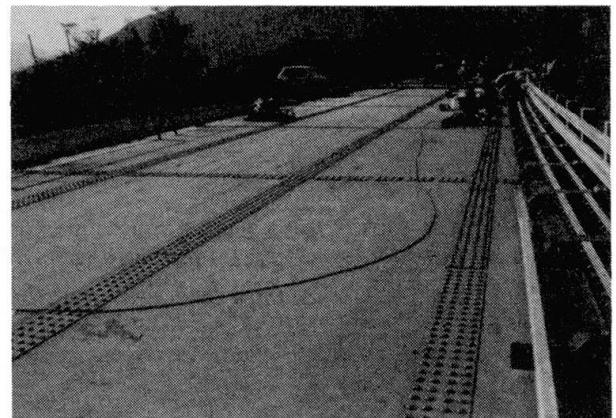
Fig.16 Replacement works of damaged RC decks to prefabricated steel bridge deck

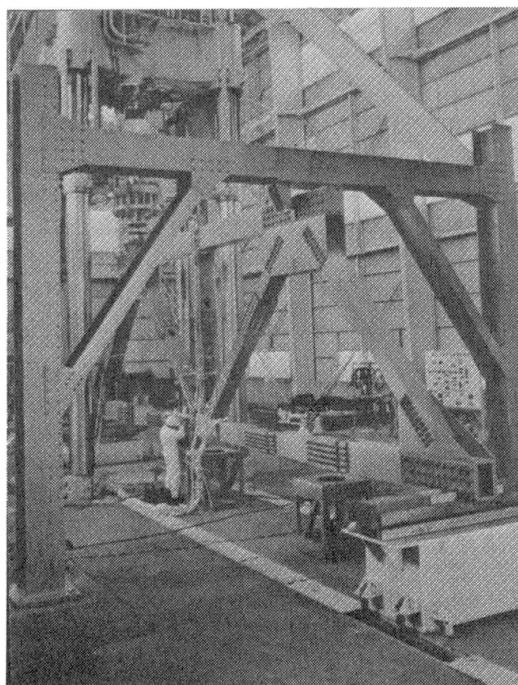
Fig.18 Large scale fatigue test  
(truss panel joint)

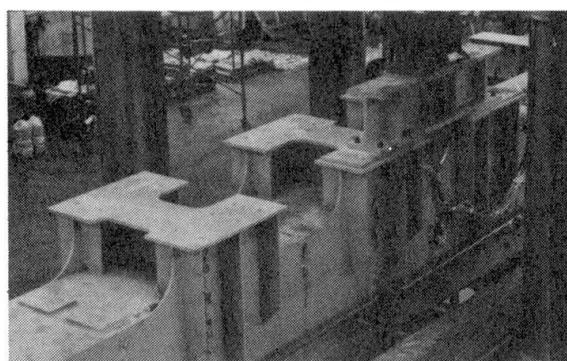
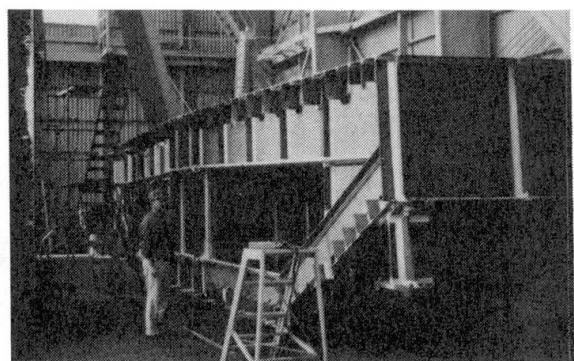
(a) floor beam of stiffening truss

(b) box section stiffening girder

Fig.19 Examples of fatigue test

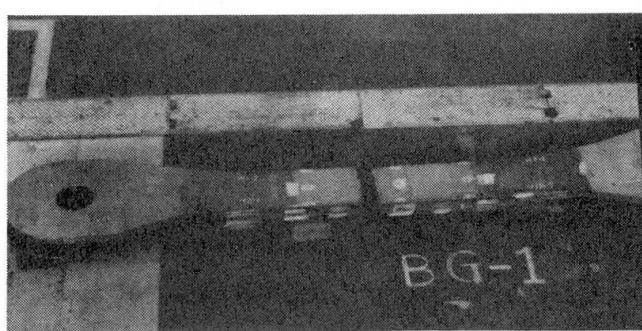
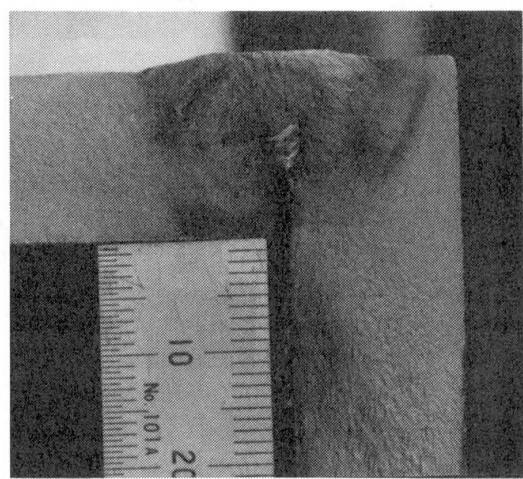
crack initiated from blowhole

Fig.20 Box section members

Various new and useful things have been learned from these fatigue tests, typical of which may be cited fatigue of longitudinal-bead welds of box section members (Fig.20). Such joints play almost no role in transmitting load, and simply are for assembly of members, but if defects such as blowholes exist at root portions, fatigue strength will be extremely reduced. The relationship between defect size and fatigue strength has been ascertained from the results of experiments on many large-sized models and from fracture mechanics models (Fig.21), based on which design allowable fatigue stress and corresponding allowable defect size have been determined (Fig.22). Fabrication methods have been improved so that all truss members will have defects not more than the allowable limits. Joint portions are inspected using a newly developed automatic ultrasonic flaw detection system, and defects exceeding allowable values are repaired. These nondestructive inspection results have been organized as a data base, and play an important role in the maintenance plan.

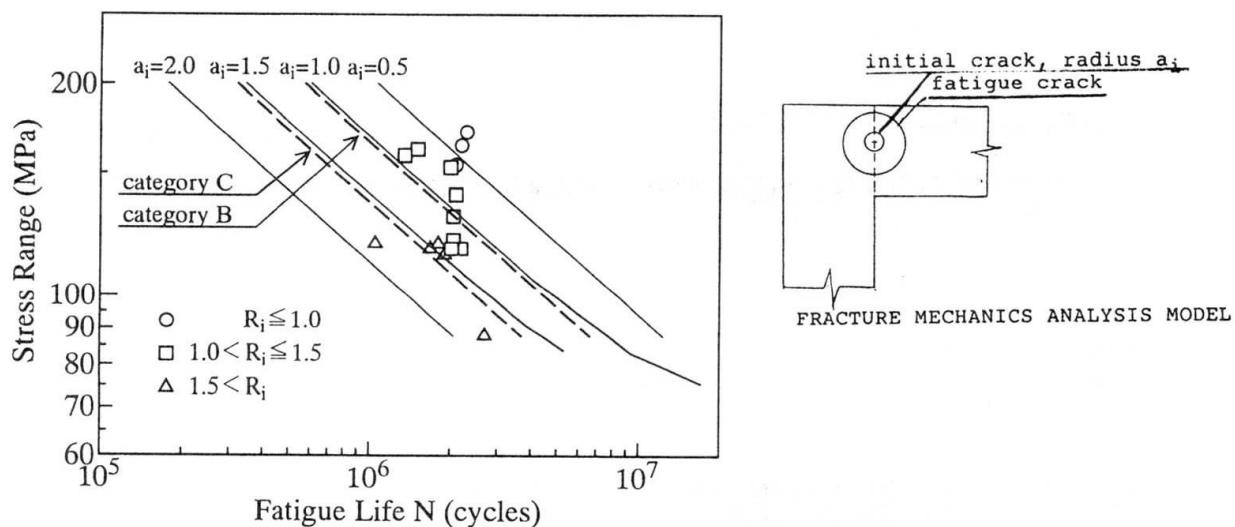
Fig.21 Results of fatigue test and fracture mechanics analysis

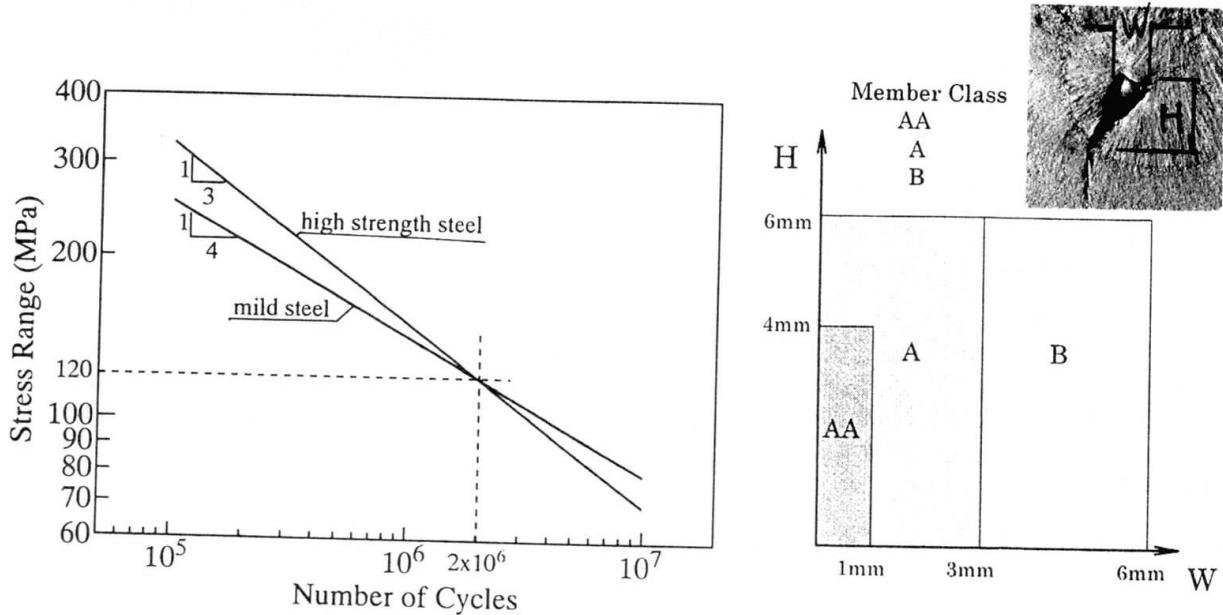
Fig.22 Allowable stress for corner joint and permissible size of blowhole in corner joint

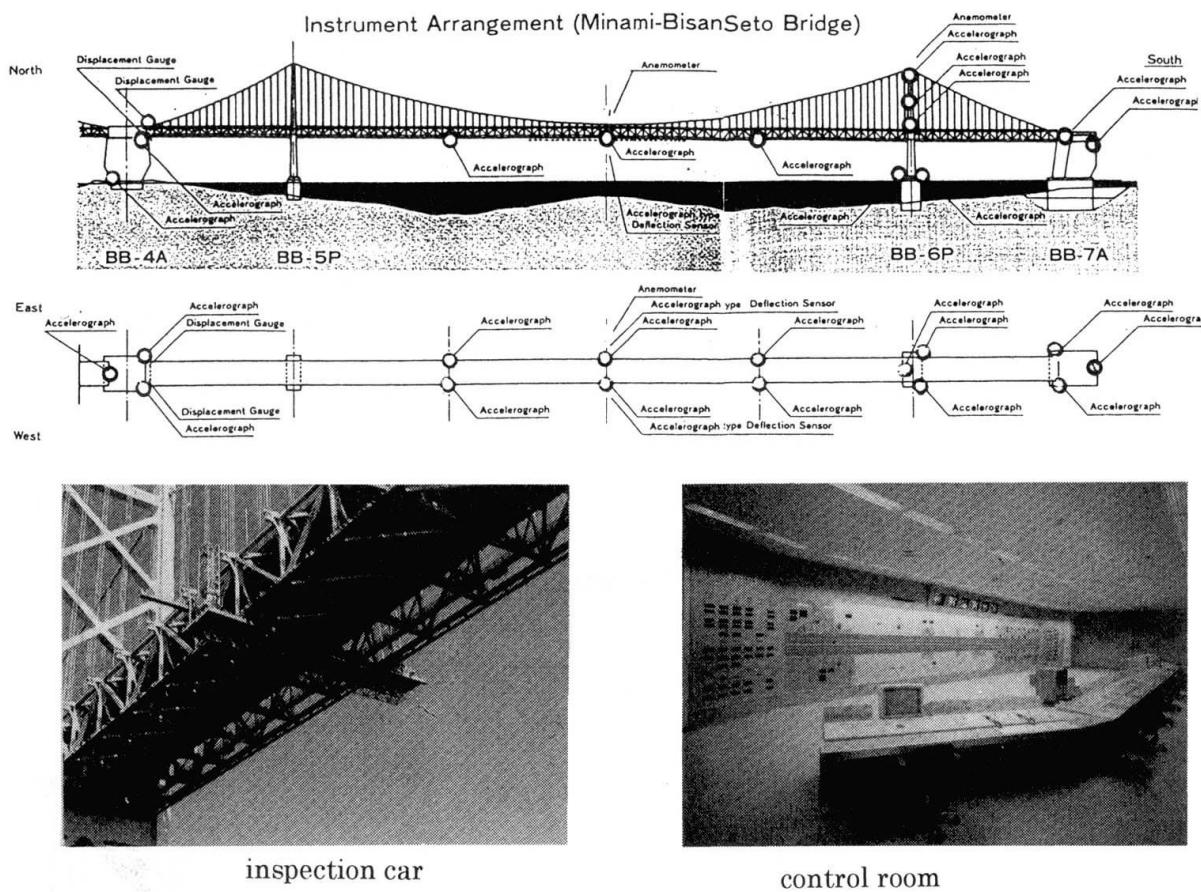
Fig.23 Instruments for monitoring of bridge behavior

Various new technologies have been applied in maintenance also. Honshu-Shikoku bridges are equipped with inspection cars making it possible for on-hand inspections to be made of all members. And as shown in Fig. 23, various types of sensors such as accelerometers and displacement meters are installed and the behaviors of bridges are monitored at all times at a central control room. Besides these data being used for operations, the records comprise a base for formulating maintenance plans.
