Zeitschrift: IABSE reports = Rapports AIPC = IVBH Berichte
Band: 73/1/73/2 (1995)
Rubrik: Opening session

New Approaches to Monitoring and Repair of Concrete Structures

Peter SCHIESSL
Professor
University of Aachen
Aachen, Germany

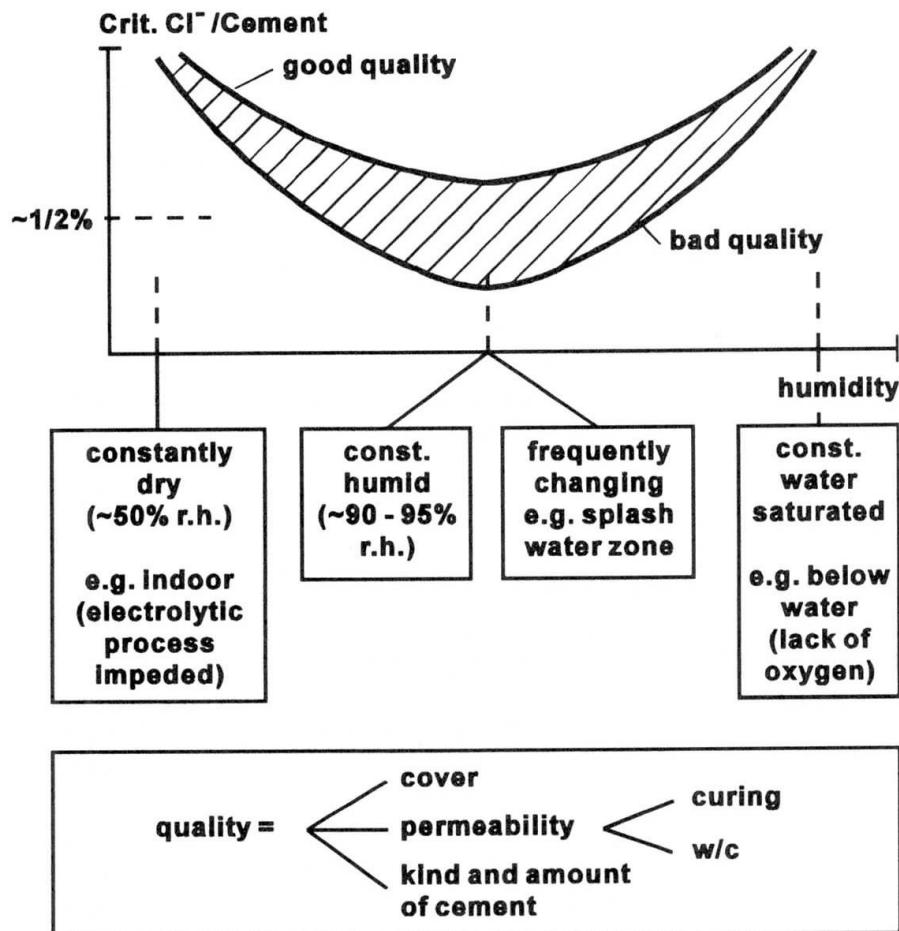
Fig. 1 Influence of concrete cover and environmental conditions on critical chloride content

It is evident from current knowledge that the critical chloride content is not a fixed value but is dependent both on the quality of the concrete cover (type of cement, w/c-ratio, curing, thickness) and on environmental conditions. Fig. 1 presents this relationship in qualitative terms [2].

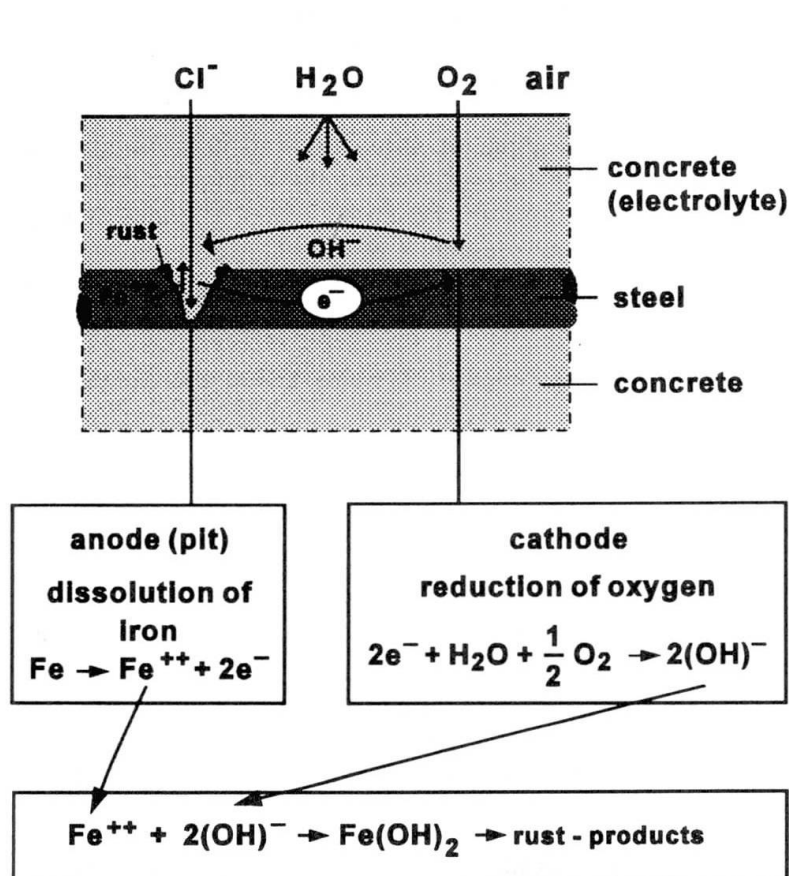
Fig. 2 Diagram showing chloride-induced corrosion of steel in concrete schematically

The corrosion process takes place in two sub-processes, as outlined in Fig. 2:

- At the anode, iron ions pass into solution, separating from the electrons. They are converted into rust products in further reactions.
- At the cathode, electrons, water and oxygen are converted into hydroxyl ions. The cathodic process doesn't cause any deterioration of the steel.

These hydroxyl ions transport the negative charge in the electrolyte through the electrical field created between the anode and the cathode, towards the direction of the anode. Near the anode, they react with the steel ions in solution. Depending on moisture and aeration conditions, this intermediate product may continue to react, producing the final corrosion products.

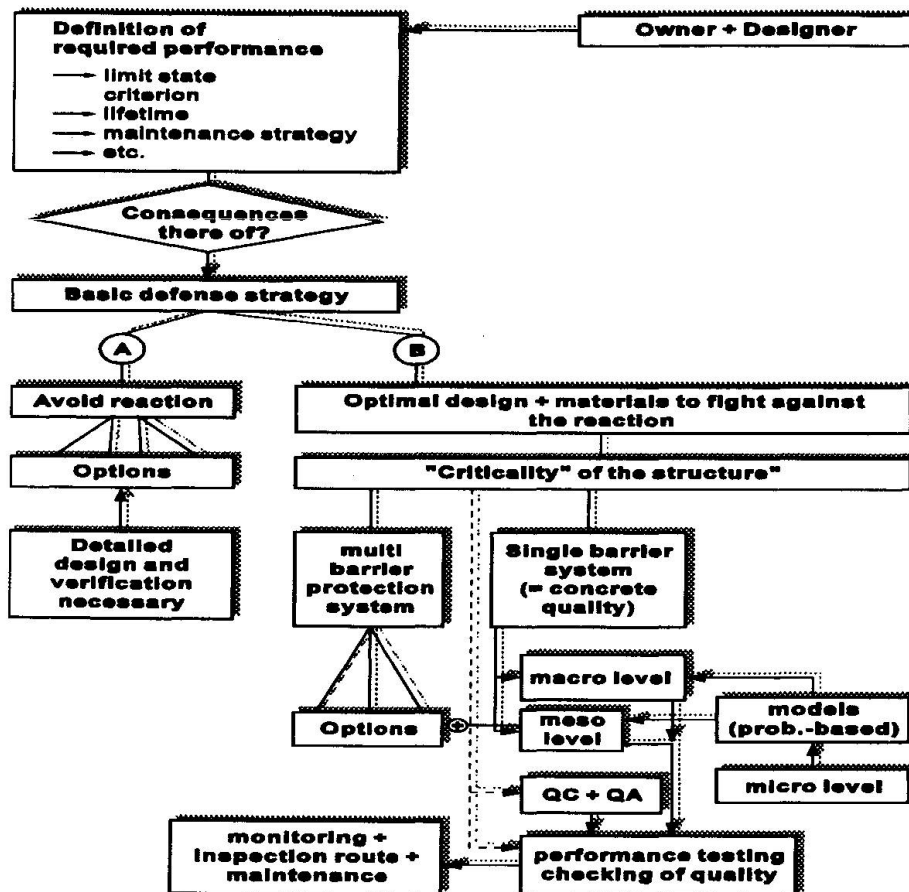
Fig. 3 Format for Durability Design

Strategy A can be subdivided into three possibilities:

- A1 Change the environment, e.g. by tanking, membranes, coatings etc.
- A2 Select non-reactive materials, e.g. stainless steel, coated steel.
- A3 Inhibit the reaction, e.g. cathodic protection or cathodic prevention.

Strategy B is to fight against deterioration by optimal design and choice of materials. The choice of the protection strategy very much depends on the micro-environmental aggressivity. For structures or parts of a structure exposed to very aggressive environmental conditions or/and long target service lives (100 years or more) multi barrier protection strategies are advisable. Such a strategy could be the provision of

For structures as sketched in Fig. 4 the meso-level (see Fig. 3) approach is appropriate. The time dependant penetration of chlorides can be calculated using simplified penetration laws modelling the prevailing penetration mechanisms. Within such a model the effective diffusion coefficient could be the relevant material parameter, e.g. in a very simplified way

Coming back to Fig. 3, the amount of quality control to check the real quality gained in the structure depends on the criticality of the structure, i.e. the consequences of durability failures and/or the possibilities to repair them.

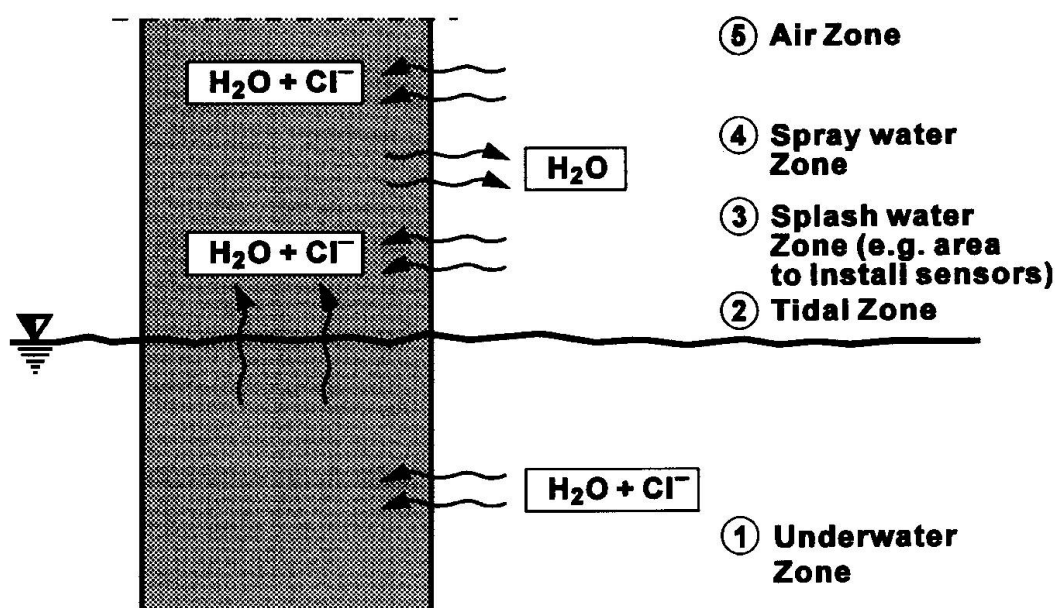
Fig. 4 Extremely varying micro-environmental conditions
Example: Marine Structure

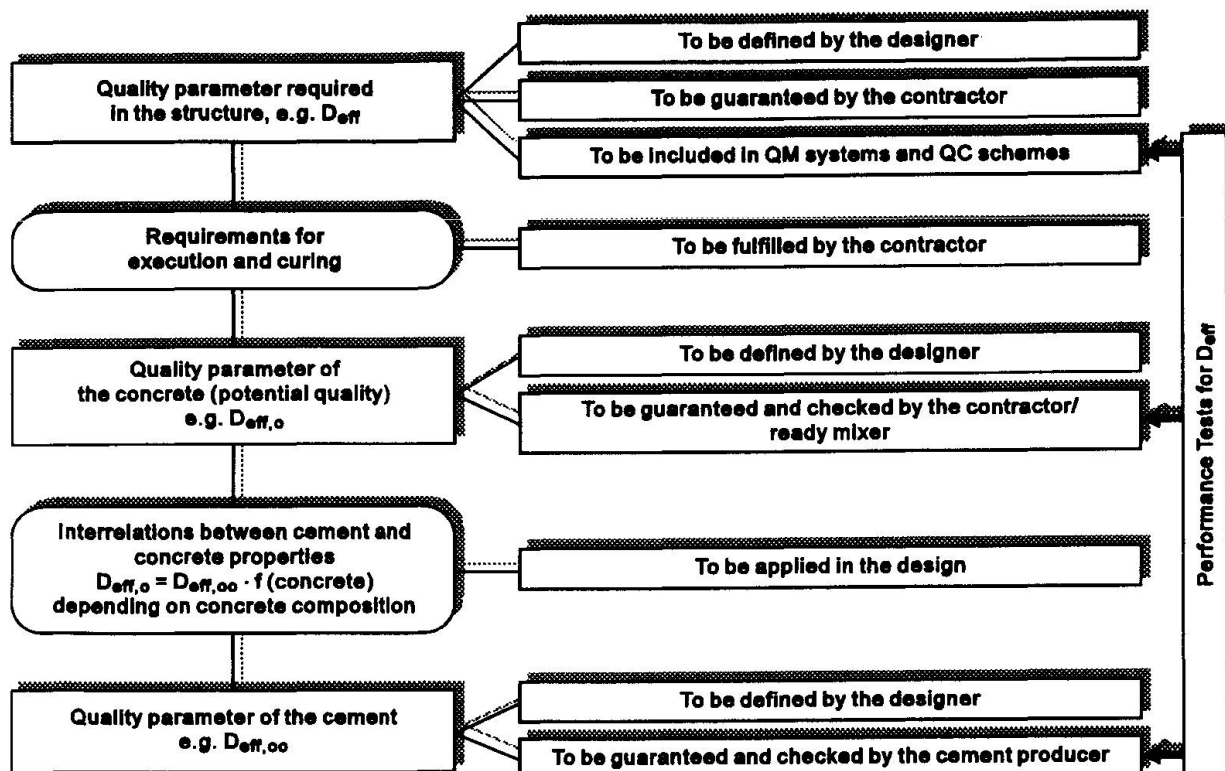
Fig. 5 Performance based durability design at the meso-level

As the effective diffusion coefficient is the performance parameter of concrete governing the resistance of the structure it needs to be incorporated in the material characterisation, starting from the production of the binders to the execution of the structure. The overall system is sketched in Fig. 5. If we replace D_{eff} in Fig. 5 by strength we realise exactly the system we are using for load design since ever.

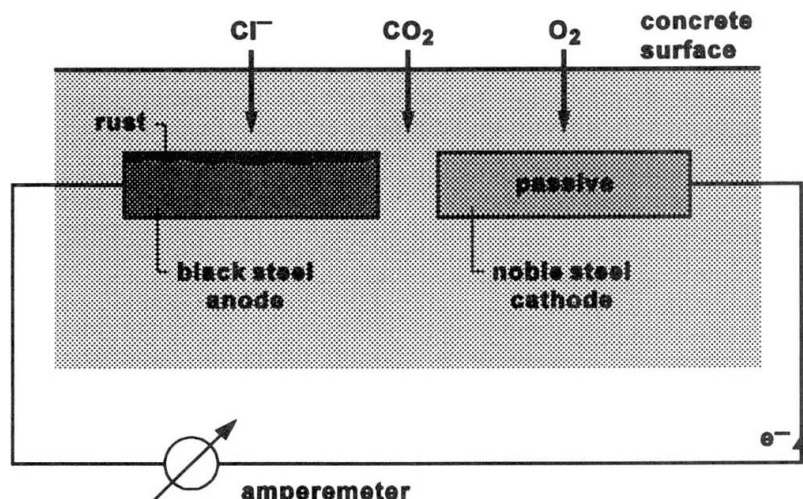
Fig. 6 Macrocell consisting of a black steel anode and noble metal cathode

The operation of a macrocell consisting of a piece of black steel (anode) and a noble metal (cathode) is shown in Fig. 6. In chloride free and non-carbonated concrete, both electrodes are protected against corrosion due to the alkalinity of the pore solution of the concrete (passive state). The electrical current between both electrodes is negligibly low under such conditions. If, however, a critical chloride content is reached, or if the pH-value of the concrete decreases due to carbonation, the steel surface of the anode is no longer protected

against corrosion. Provided that the cathode material is corrosion resistant in chloride contaminated or carbonated concrete (e.g. stainless steel, platinum), and sufficient moisture and oxygen are available, oxygen reduction takes place at the surface of the cathode. The local separation of anodically and cathodically acting areas leads to an electron flow between the black steel and the cathode, which can easily be measured at the external cable connection.

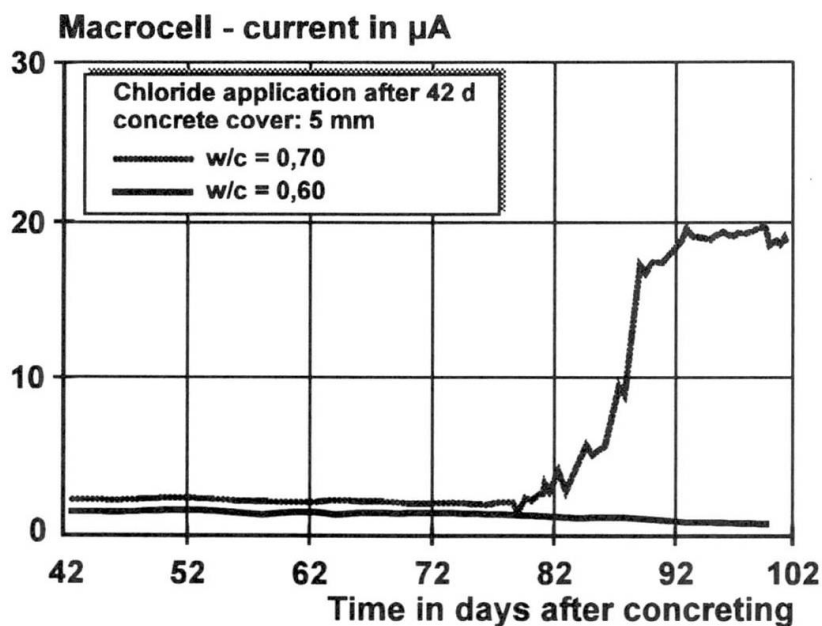
Fig. 7 Time-dependent behaviour of the electrical currents between anode and cathode

Fig. 7 shows the result of electrical current measurements (demonstration test in the laboratory) between a black steel anode and a stainless steel cathode in two concretes with different water-cement ratios. The macrocells were embedded with a concrete cover of only 5 mm (0.20 in.) to initiate corrosion by applying a chloride solution on the concrete surface within a short period of time. The results of the macrocell current measurements showed that the critical chloride content reached a depth of 5 mm (0.20 in.) at the specimen with w/c = 0.7 about 80 days after concrete placement. This caused a significant increase of the macrocell current while the specimen with a lower w/c and a higher resistance against chloride diffusion remained passive.

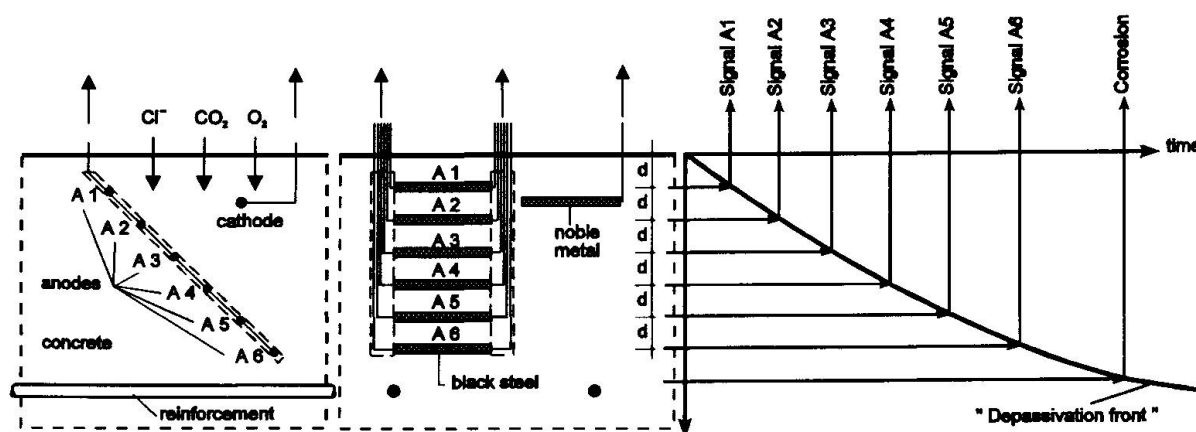
Fig. 8 Arrangement of the anodes and cathodes to monitor the corrosion risk for the reinforcement

Fig. 8 shows exemplarily a possible arrangement of anodes and a locally separated cathode.

Normally all the electrodes are disconnected from each other to prevent electrochemical interactions between them. Only during the electrical current measurements the anodes are coupled with the cathode one after the other.

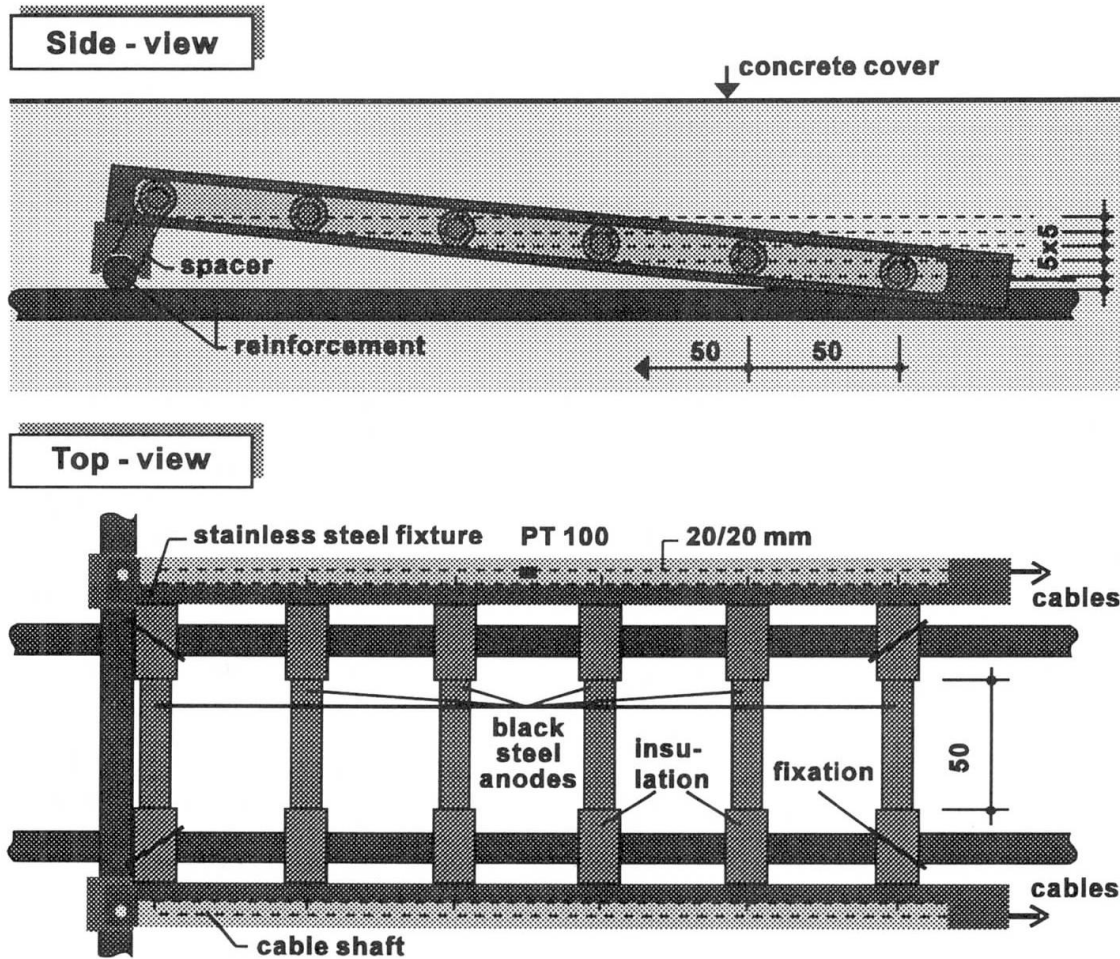
Fig. 9 Design of a set of 6 anodes

A typical layout and arrangement of a corrosion sensor consisting of 6 single anodes is shown in Fig. 9. Each of the 6 black steel anodes is positioned 50 mm (2 in) from the next one to prevent interactions between the anodes.

Fig. 9 also shows that the cables are lead through a stainless steel fixture to the measuring device. The cable shaft is filled with epoxy resin that acts as mechanical protection for the wires and a PT 100 temperature sensor that can be additionally installed. Two wires are connected with each single anode to get a redundant system. This allows the cables and cable connections to be checked after installation by resistance measurements.

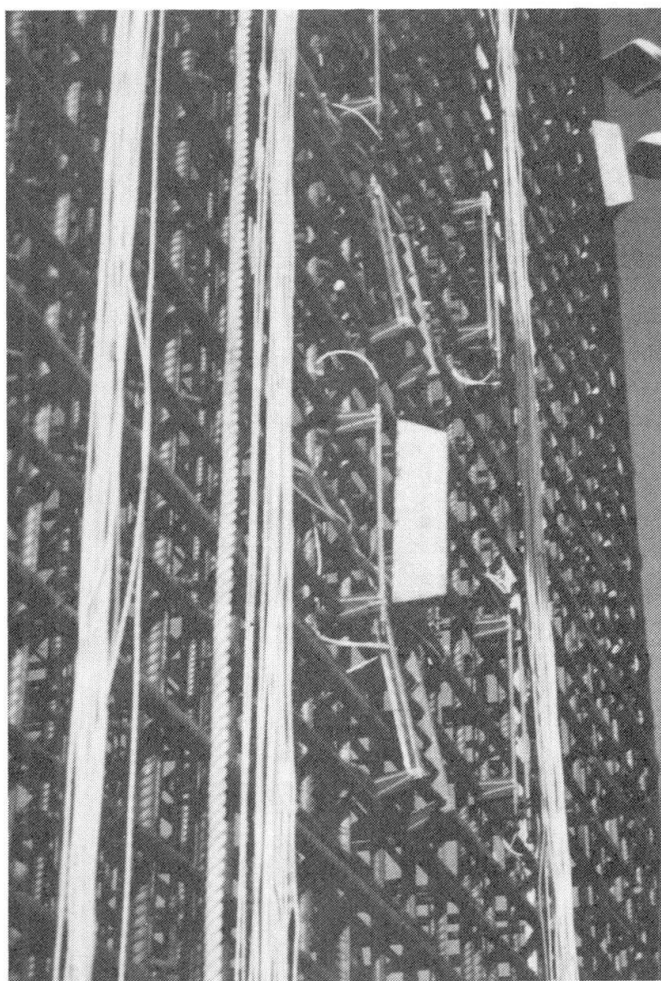
Fig. 10 Installed sensors (6 sets of anodes and 1 cathode - Pier shaft of the Western Bridge, Great Belt Link

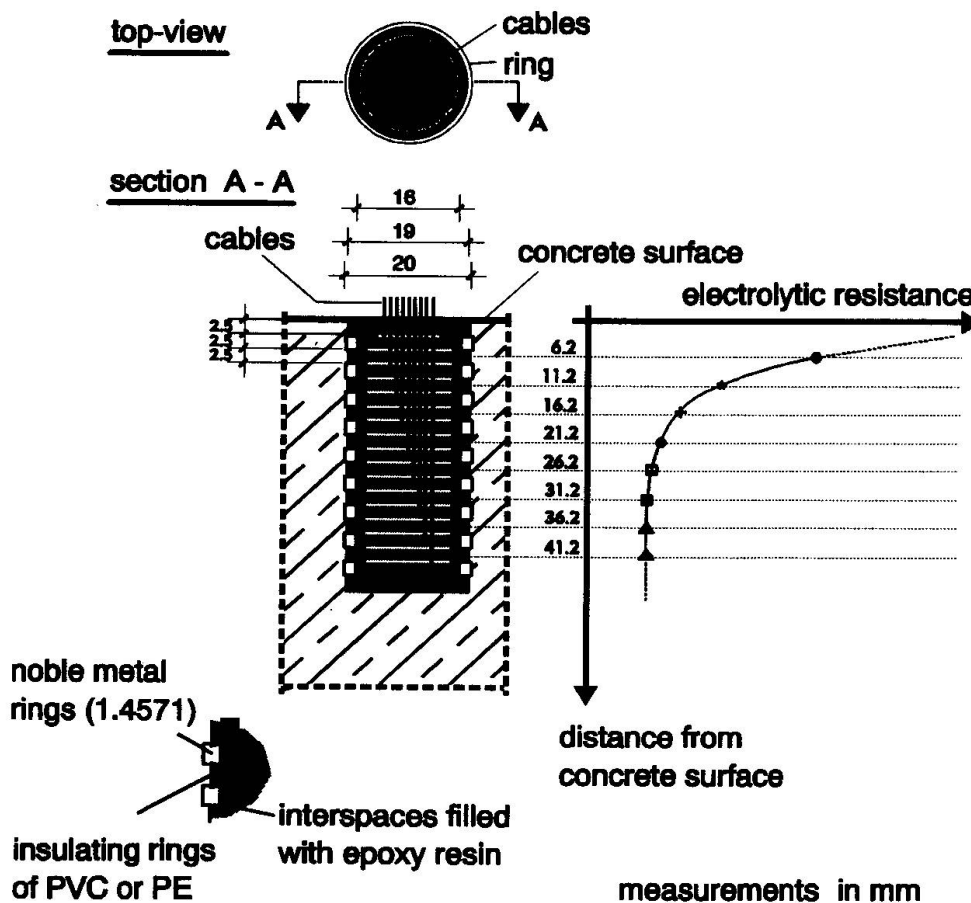
Fig. 11 Schematic representation of the multi-ring-electrode and a qualitative diagram of measured values

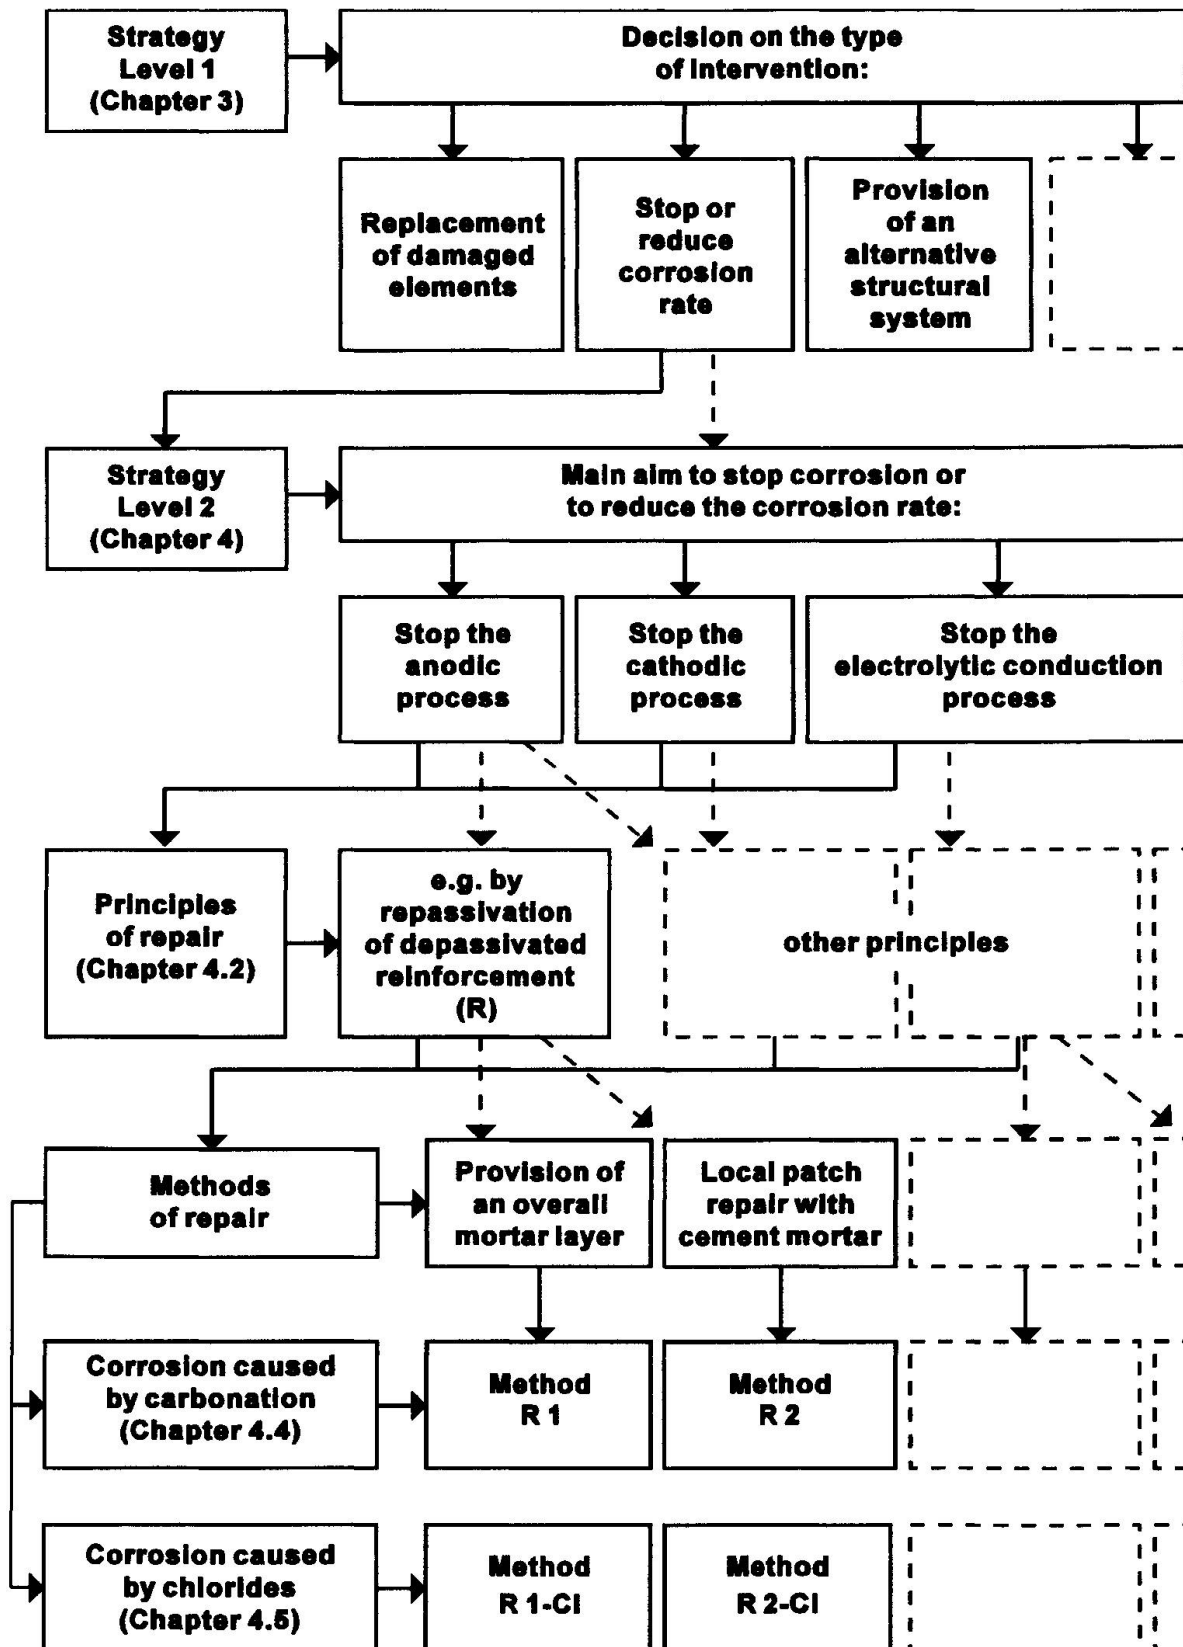
Fig. 12 Format of the Technical Recommendation

The format of this RILEM Technical Recommendation is sketched in Fig. 12. Strategy Level 1 deals with various possibilities of interventions, one of them being an intervention into the corrosion process. This strategy is treated in detail within Strategy Level 2 (chapter 4 of [10]). Based on the aim to avoid further corrosion after repair, different Principles of Repair are defined. Based on these principles possible Methods of Corrosion Protection are elaborated including the basic requirements needing to be fulfilled to ensure a successful repair. The presented options for repair are based on the existing knowledge at the time of drafting the document and are related to the possible deterioration processes prior to and after repair works.

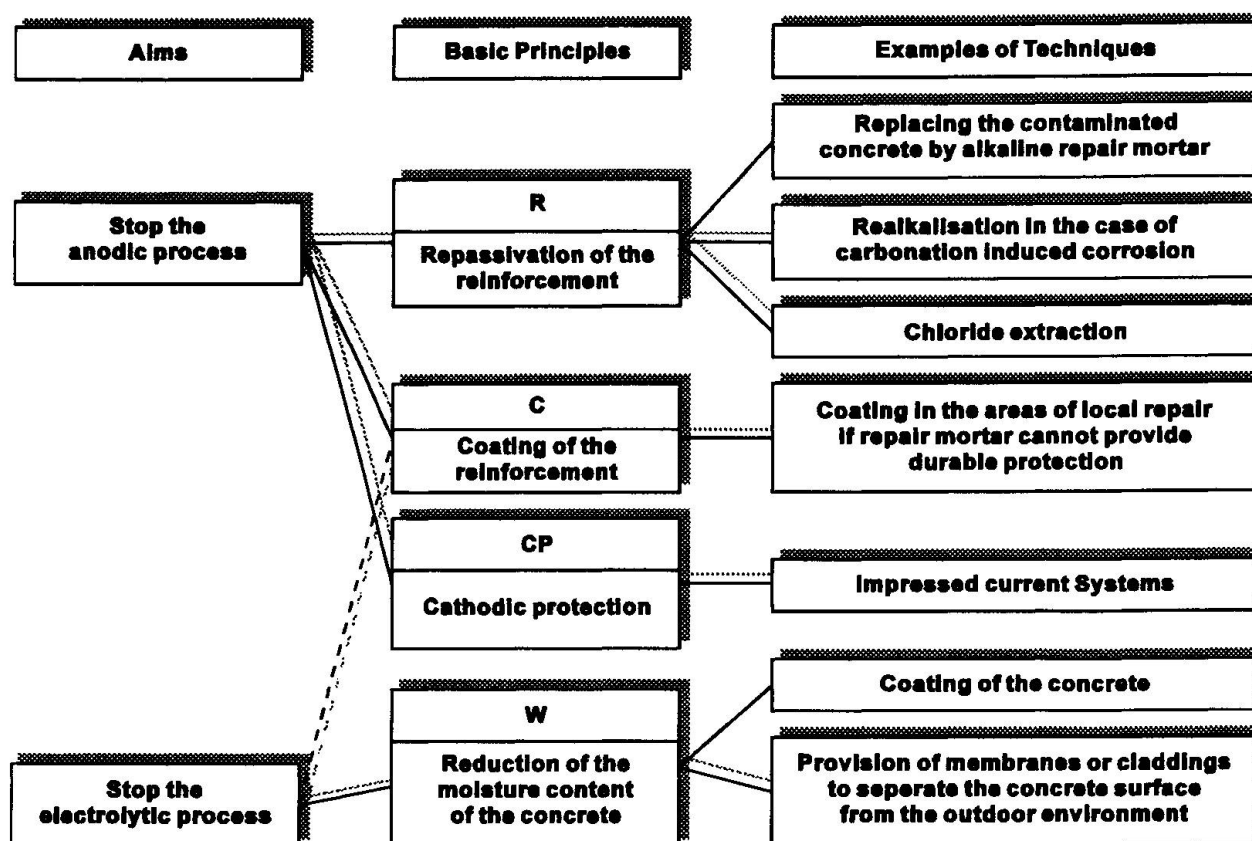
Fig. 13 Principles of repair to stop corrosion

In order to achieve one of these effects, different repair principles, presented schematically in Fig. 13, are possible. The repair principles to restore corrosion protection need to be designed on the basis of the electrochemical corrosion processes at the steel surface and the chemical and physical processes within the surrounding concrete.

Fig. 13 presents basic principles and examples of techniques based on these principles. There are no generally proven repair procedures to stop the cathodic process, e.g., by the total block of oxygen access to the surface of the reinforcement. Although theoretically possible, the concept of stopping the cathodic process therefore is not included in Fig. 13.

For the different basic principles sketched in Fig. 13 different methods for repair must be elaborated, depending on the cause of depassivation (i.e., carbonation or chlorides).

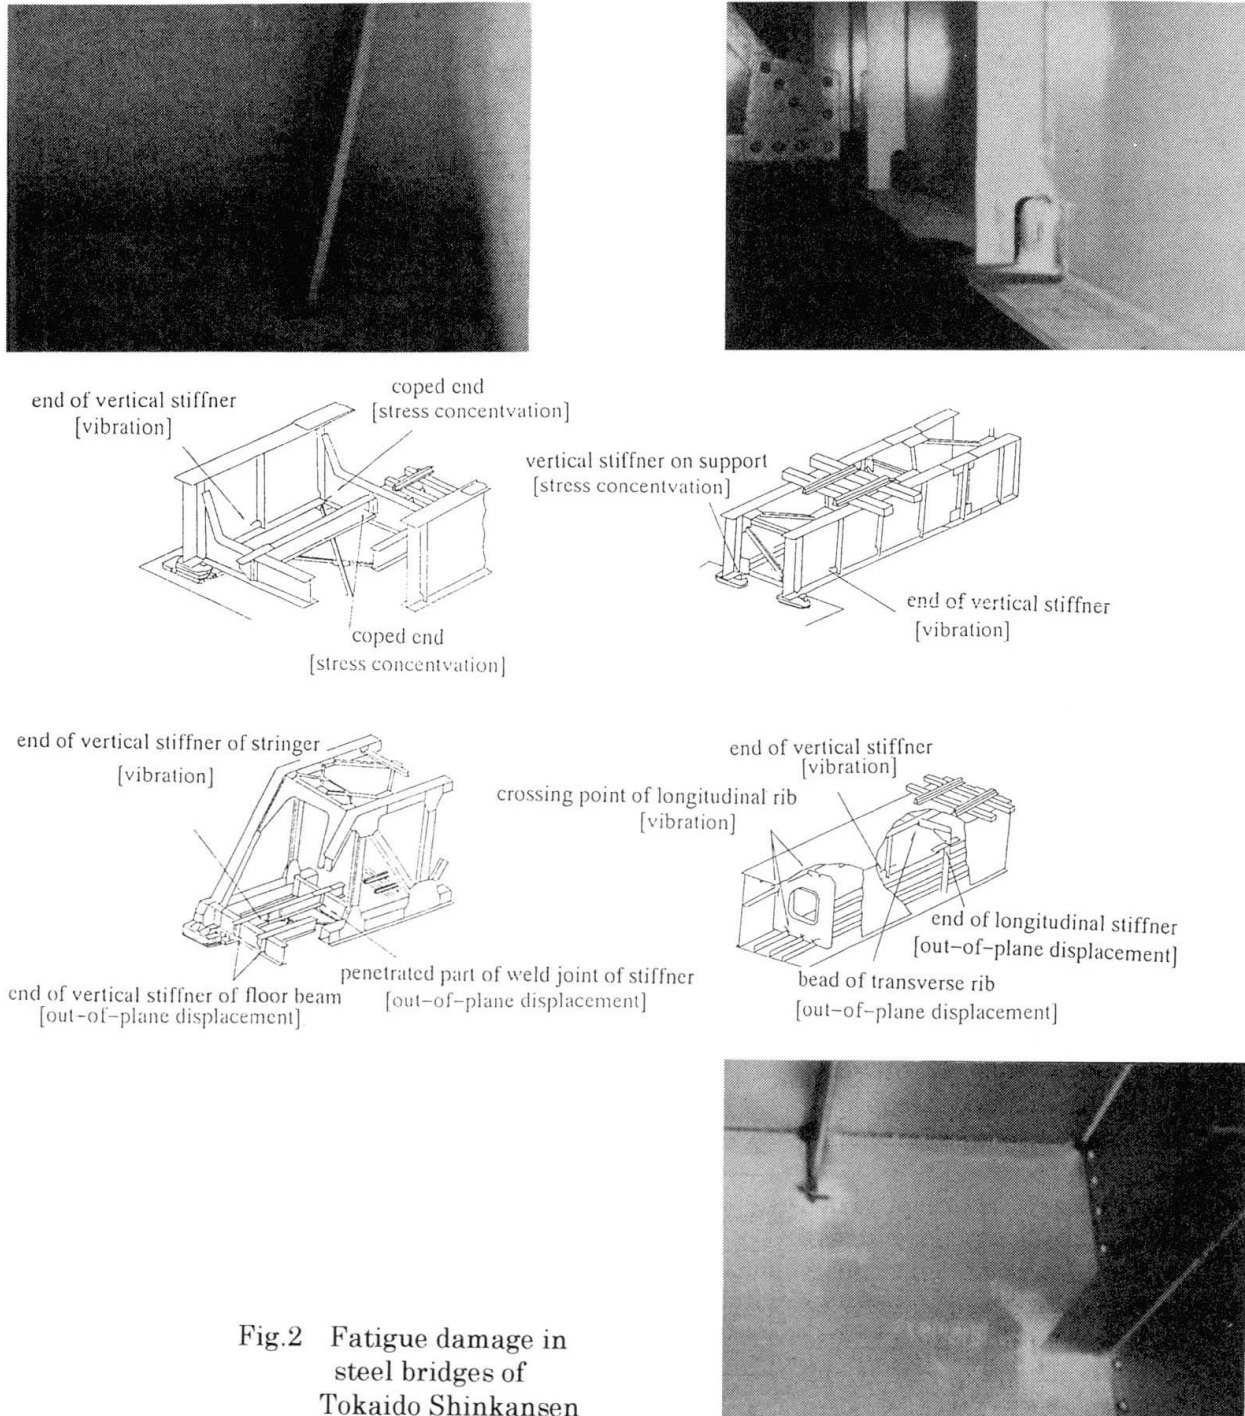
Fig.2 Fatigue damage in steel bridges of Tokaido Shinkansen

Occurrences of fatigue damage began to be reported concerning bridges of the Tokaido Shinkansen from around 10 years after having been put into service. An outline is given in Fig. 2, with cases of damage being those resulting from stress concentrations due to structural details of members, those due to out of plane displacements occurring between perpendicularly crossing members such as main girders and cross beams or cross beams and stringers, and those due to vibration induced distortion by high-speed operation of trains peculiar to Shinkansen[1].

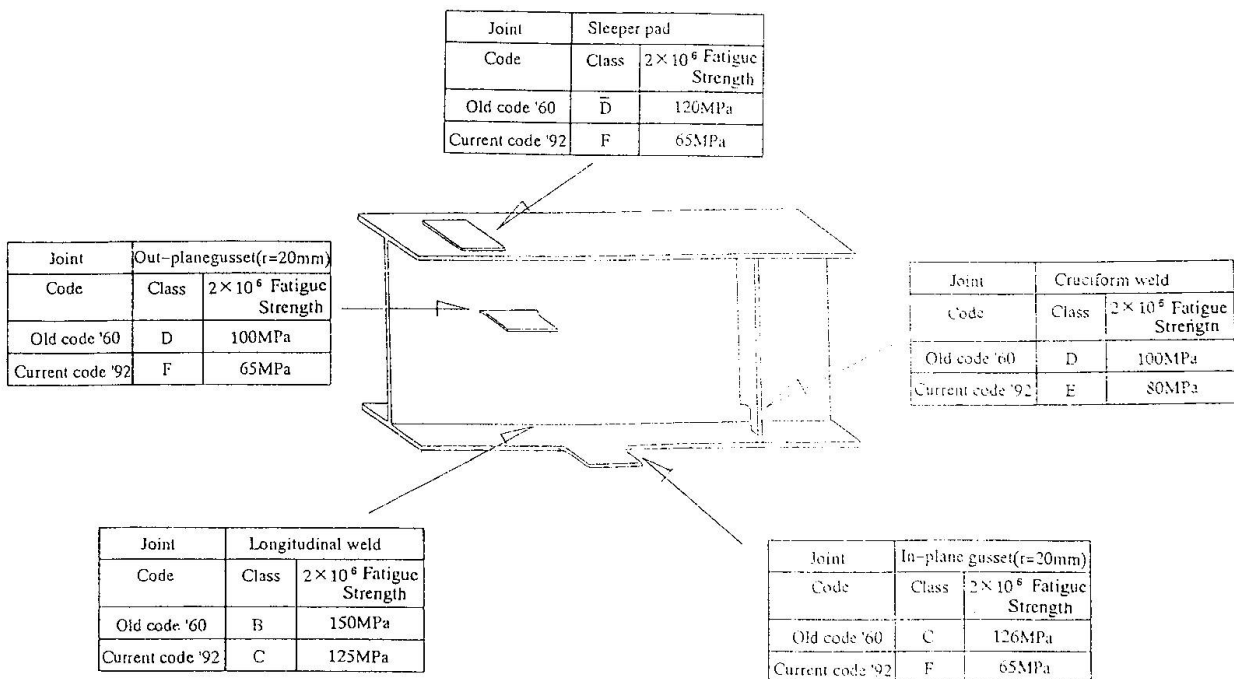
Fig.3 Changes of allowable fatigue stress from '60 code to '92 code

When what had been assumed at the time of designing and the subsequent condition of use are considered, certain parts in bridge structures are approaching the ends of their design service lives. Therefore, a number of preventive and protective set-ups against fatigue damage have been established. What have great differences in allowable fatigue strengths between the time when Shinkansen was designed and the current design standards are longitudinal weld between flanges and webs, and ends of gusset plates welded to webs (Fig.3). They are the points in damage prevention work.

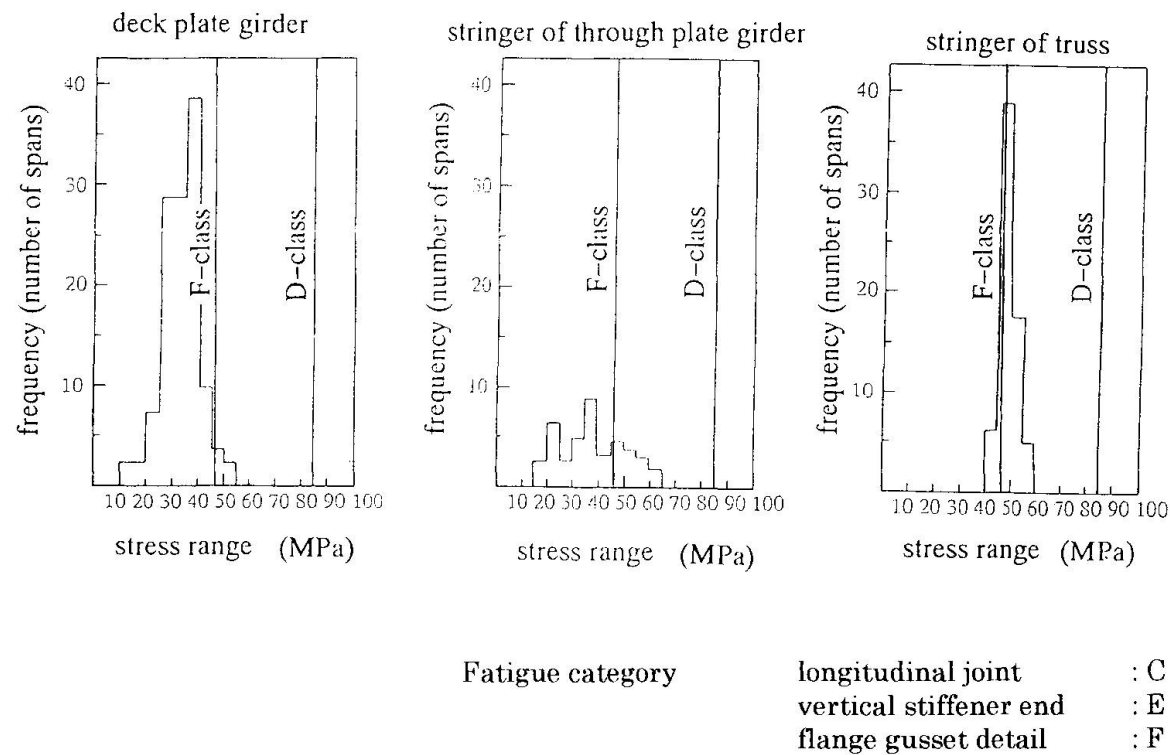
Fig.4 Variation of measured maximum stress range and fatigue assessments

One of damage prevention works is measurement of actual stresses. This is done regarding plate girders and the stringers of truss girders. To elaborate, since stresses in bridge members actually occurring are normally low compared with those in design calculations, it is thought to consider maintenance based on stresses actually occurring. Stress measurements for this purpose consist of grasping the bending stress on average occurring in the bottom flange and the location of the neutral axis. The reason for actual stresses being low compared with calculated stress in case of railway bridges, lies in the load distribution due to rails and secondary members. The results of stress measurements are illustrated in Fig. 4, in which it is clearly shown that the possibility of fatigue damage in a fairly large number of members is high on the basis of design calculated stress, however, there is hardly any cause for concern when actual stress is observed. Regarding longitudinal welds joining flanges and web (categorized into C class), it was learned that there was ample allowance from measurements of actual stresses, but the degrees of allowance at the ends of gussets attached to flanges (categorized into F class) were slightly small. Hence, remedial measures regarding fatigue strength are presently under study for this gusset detail. Methods being considered are to increase the radius of the fillet at the end of the gusset and, further, to add residual compressive stress by peening, and the effectivenesses are being examined through fatigue tests (Fig.5).

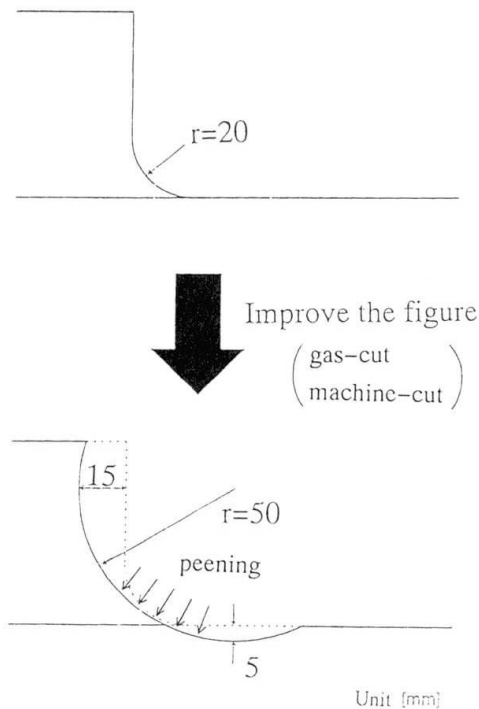
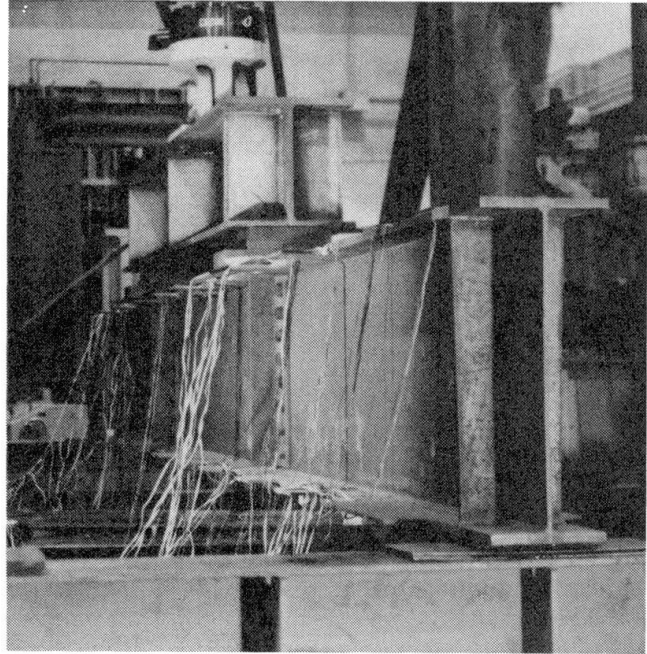
Fig.5 Improving work of flange gusset detail and fatigue test

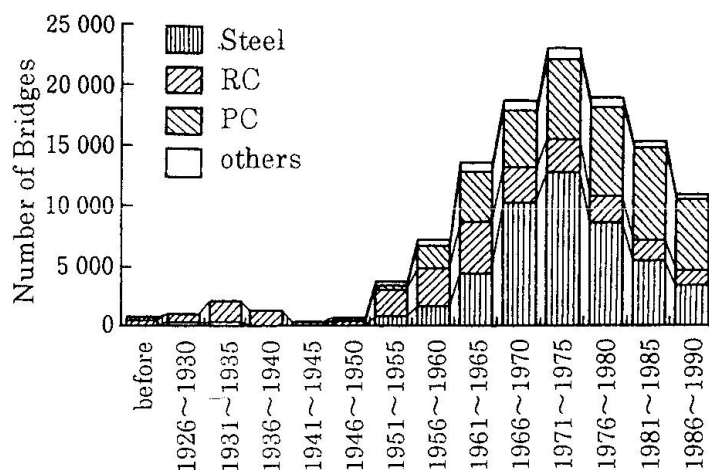
Fig.6 History of bridge construction

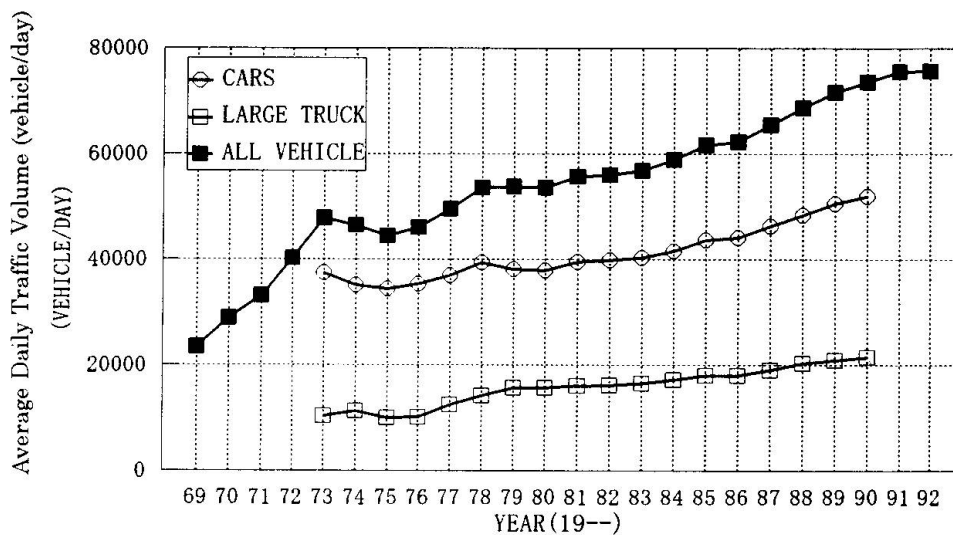
Fig.7 Change of daily traffic volume

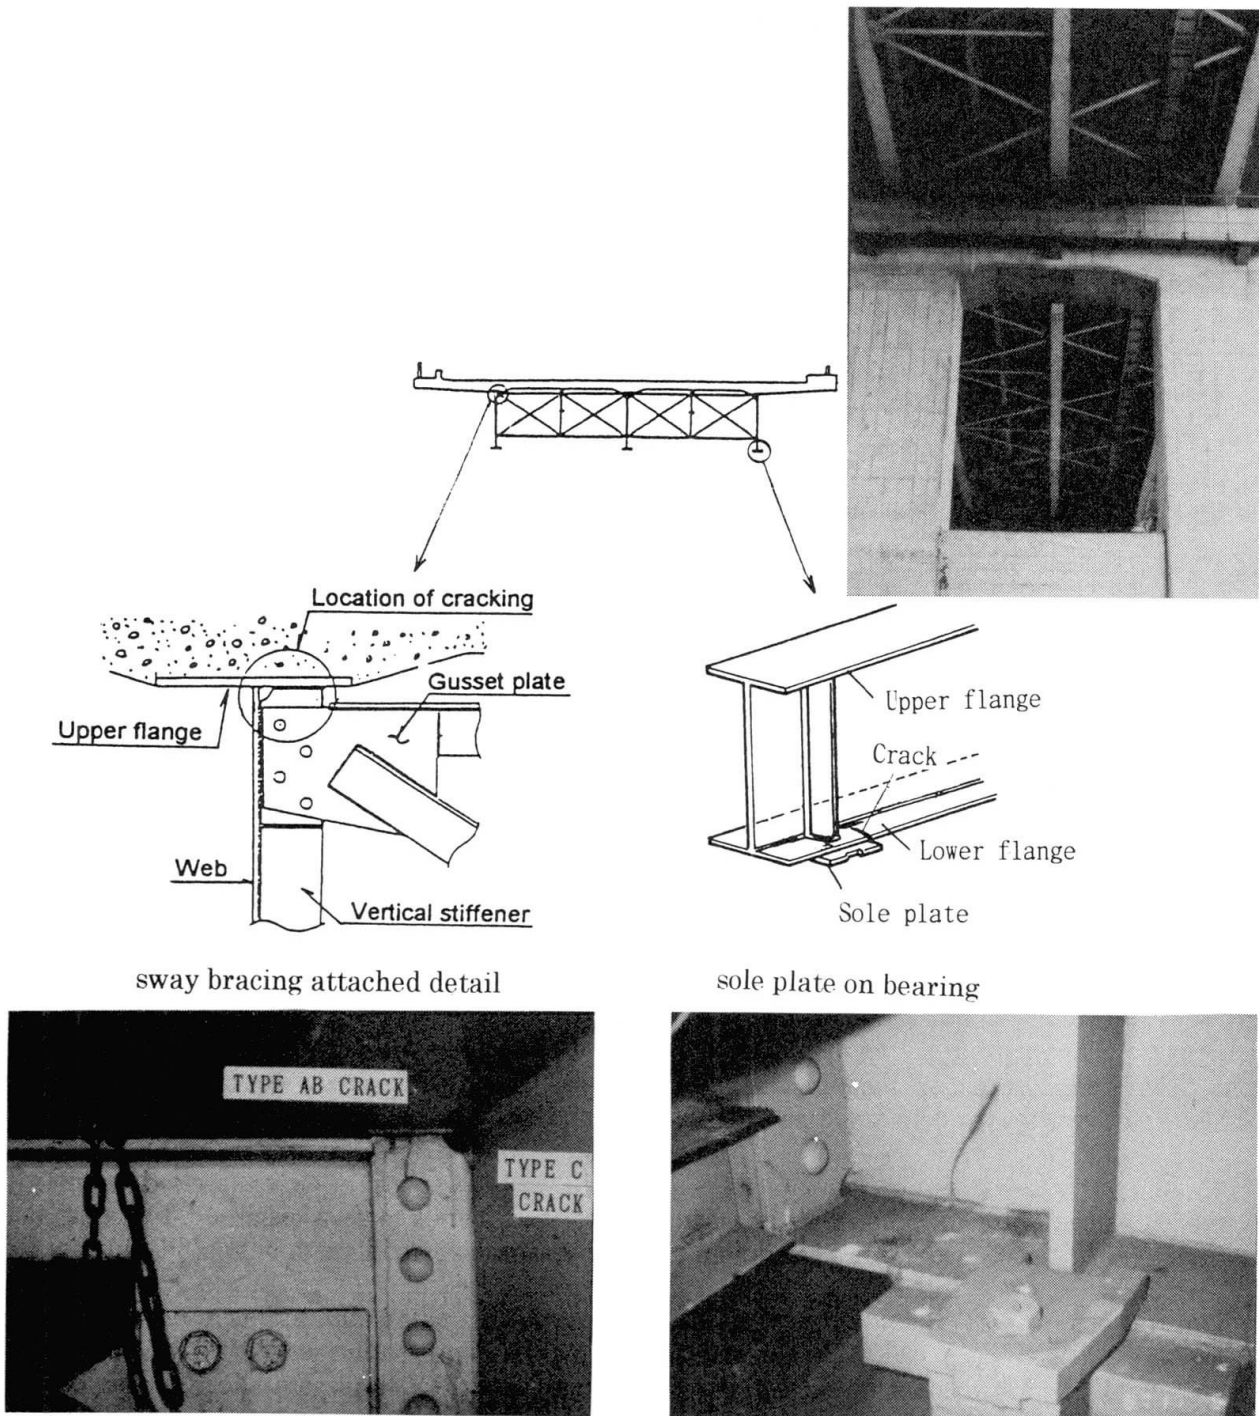
Fig.9 Typical fatigue damage in plate girder bridge

The types of fatigue damage in steel plate girder bridges of the Tomei Expressway are shown in Fig. 9 [2]. Various types of fatigue damage have been observed. The percentage of occurrence is highest for fatigue cracks at the ends of vertical stiffeners with sway bracing attached, and detailed studies have been made on this fatigue. It has been found to be due to force acting so that displacement will occur orthogonally to the web from differences in deflections between girders and deformations of deck slabs.

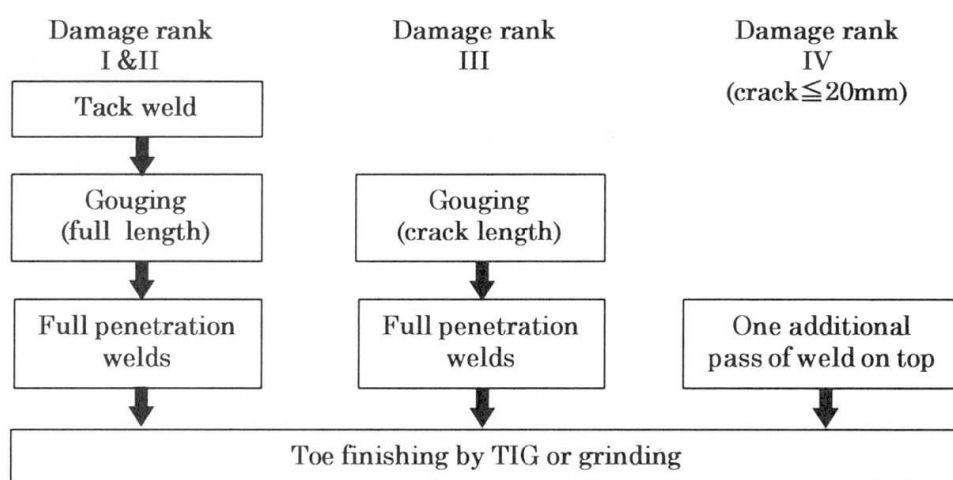
Fig.10 Retrofit methods depend on damage ranks

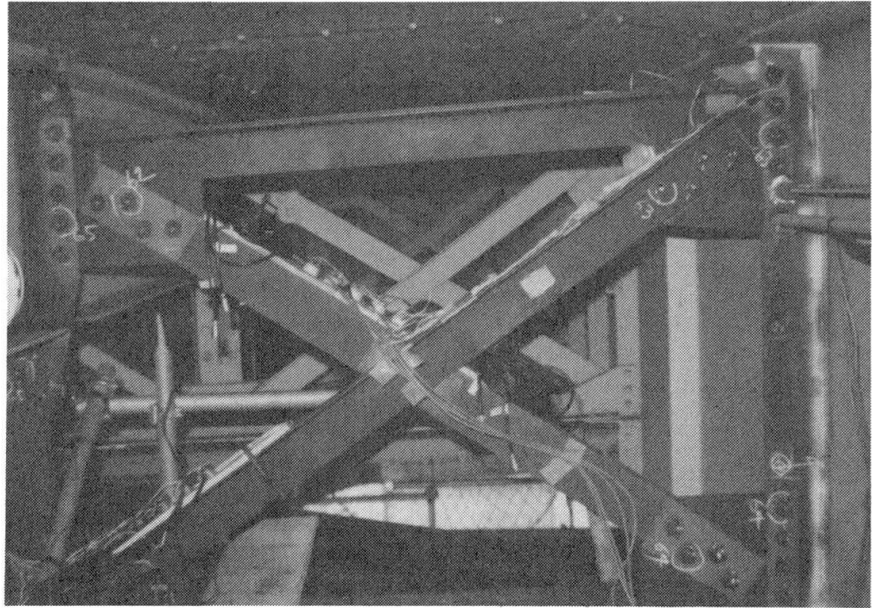
Fig.12 Adding work of sway bracing

At bridges with prominent damage, the load applied in the lateral direction by existing sway bracing is to be alleviated by adding sway bracing in improved joint details (Fig.12). The joint details between the sway bracing and main girder at this time was proven by fatigue tests to have been improved. The stresses at fatigue crack occurrence points were reduced approximately 20 percent by providing this measure, while further, stresses were reduced approximately 30 percent by detaching the horizontal members of existing sway bracing.

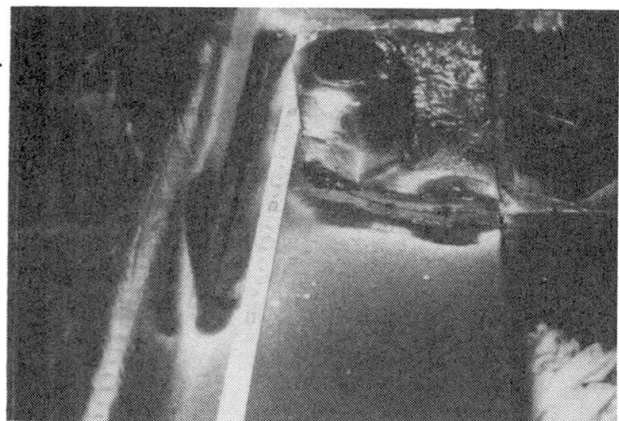
Fig.13 Fatigue crack around sole plate

What have become conspicuous recently are cracks around sole plates of bearing points of main girders (Fig.13). Fatigue cracks have occurred in fillet welds for attaching sole plates to main girders and fillet welds between main girders and webs. The feature of this damage is that it occurs in a girder which has impairment of the rotating function of its support. The bearing point is the point where loading concentration is the severest in a bridge, while structurally, since this location is at a distance from the neutral axis, the stress is different from that according to the beam theory, and the deterioration of the support function causes such a condition to come about. Regarding this damage, the sole plate is exchanged for a larger one, attaching it with high-strength bolts, while further, structural improvements such as to add vertical stiffeners are provided (Fig.14).
