Zeitschrift: IABSE reports = Rapports AIPC = IVBH Berichte
Band: 73/1/73/2 (1995)
Rubrik: Opening session

New Approaches to Monitoring and Repair of Concrete Structures

Peter SCHIESSL
Professor
University of Aachen
Aachen, Germany

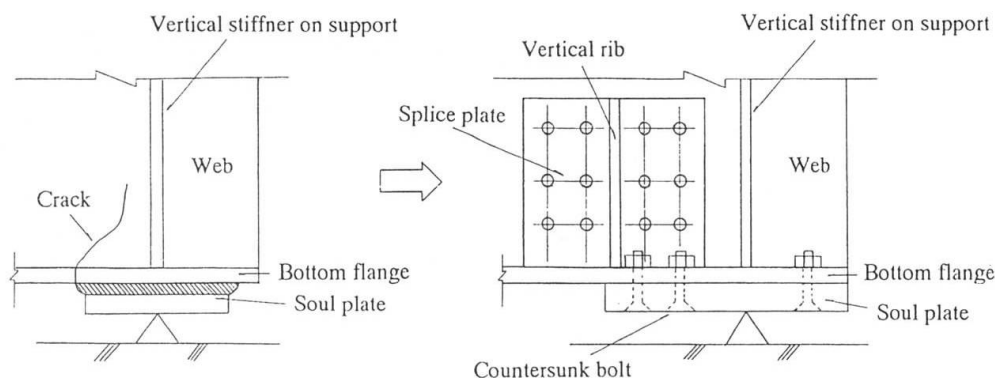
Fig.14 Retrofit detail for cracks at sole plate

What have become conspicuous recently are cracks around sole plates of bearing points of main girders (Fig.13). Fatigue cracks have occurred in fillet welds for attaching sole plates to main girders and fillet welds between main girders and webs. The feature of this damage is that it occurs in a girder which has impairment of the rotating function of its support. The bearing point is the point where loading concentration is the severest in a bridge, while structurally, since this location is at a distance from the neutral axis, the stress is different from that according to the beam theory, and the deterioration of the support function causes such a condition to come about. Regarding this damage, the sole plate is exchanged for a larger one, attaching it with high-strength bolts, while further, structural improvements such as to add vertical stiffeners are provided (Fig.14).

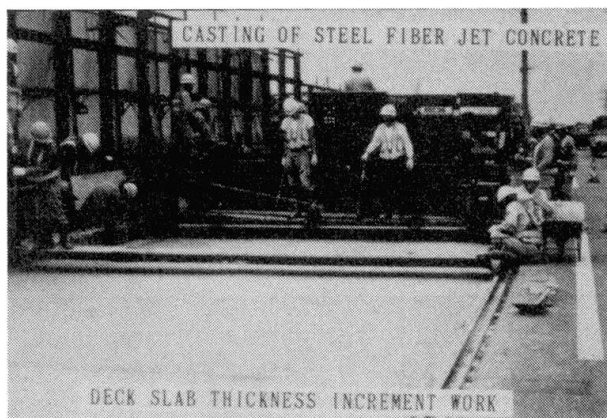
Fig.15 RC deck slab thickness increment work

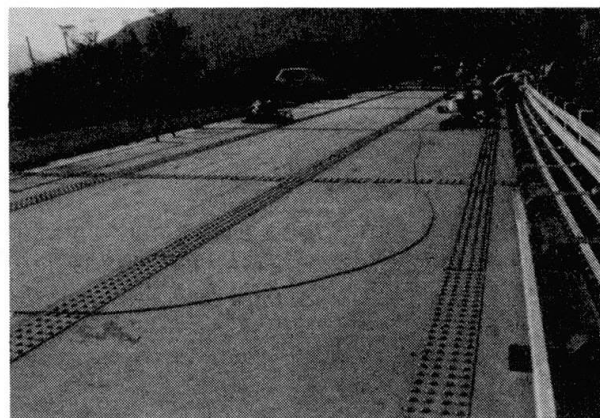
Fig.16 Replacement works of damaged RC decks to prefabricated steel bridge deck

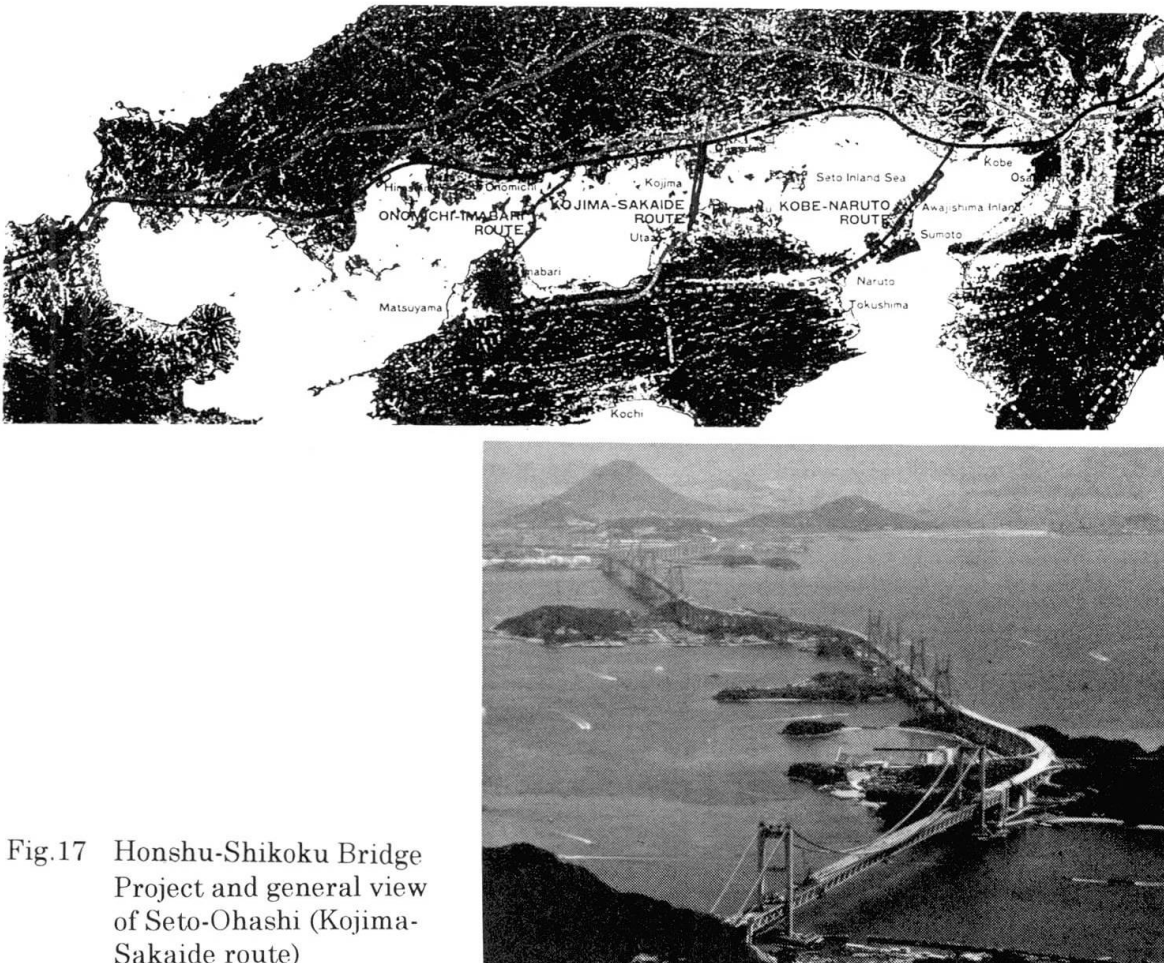
Fig.17 Honshu-Shikoku Bridge Project and general view of Seto-Ohashi (Kojima-Sakaide route)

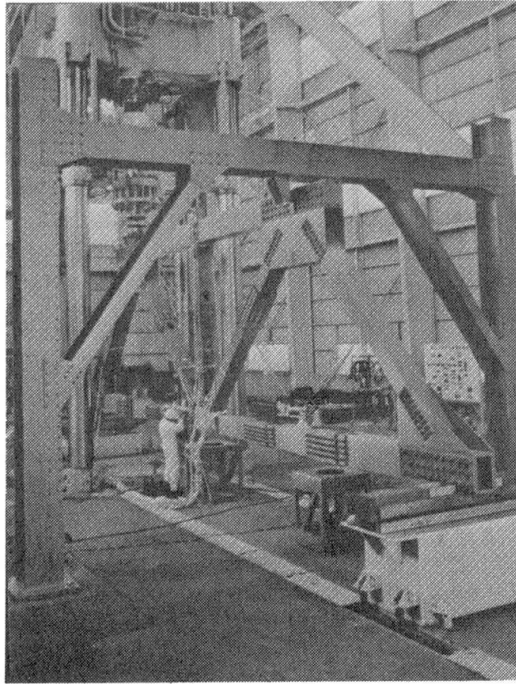
Fig.18 Large scale fatigue test
(truss panel joint)

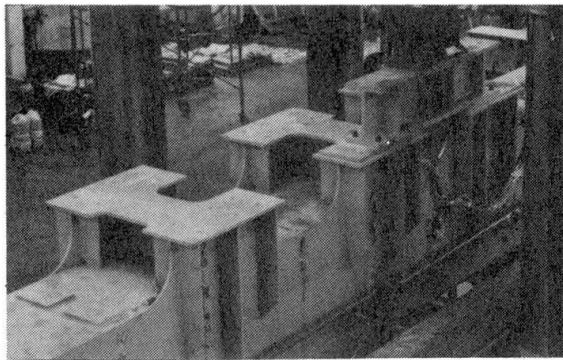
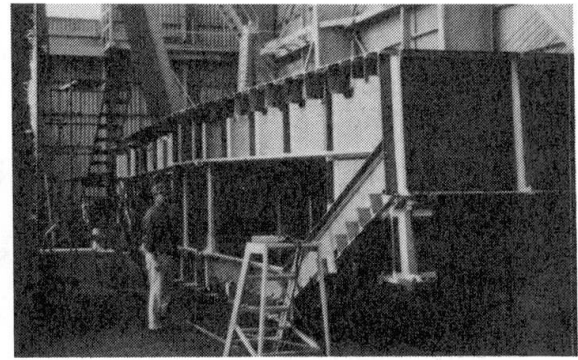
(a) floor beam of stiffening truss

(b) box section stiffening girder

Fig.19 Examples of fatigue test

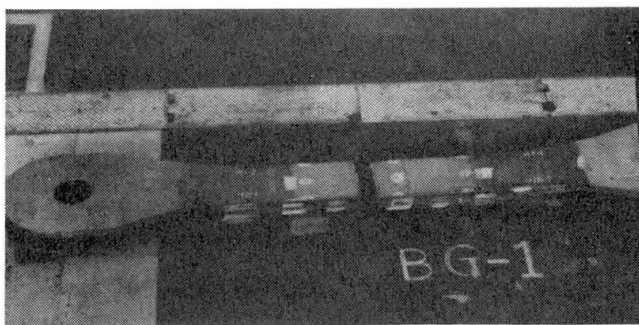
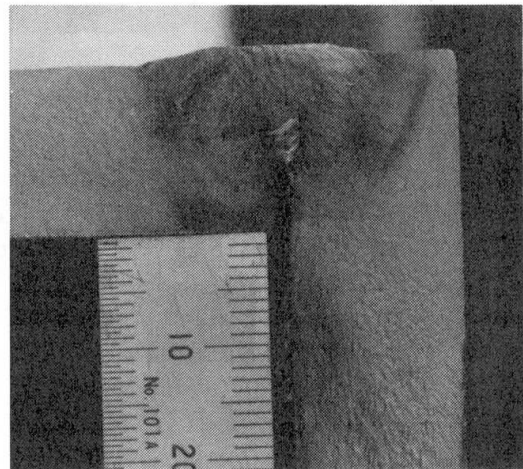
crack initiated from blowhole

Fig.20 Box section members

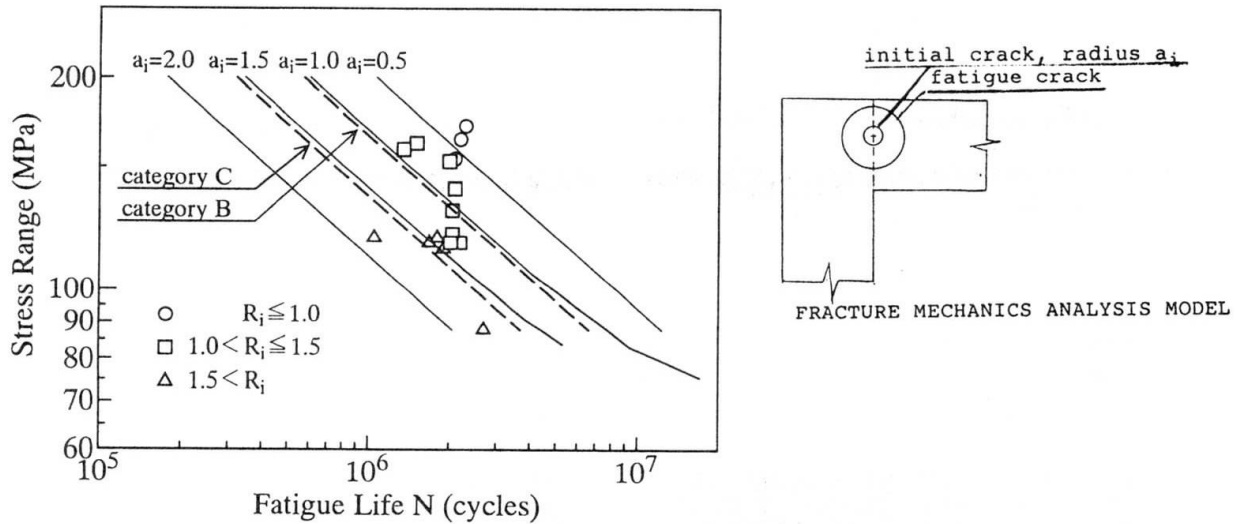
Fig.21 Results of fatigue test and fracture mechanics analysis

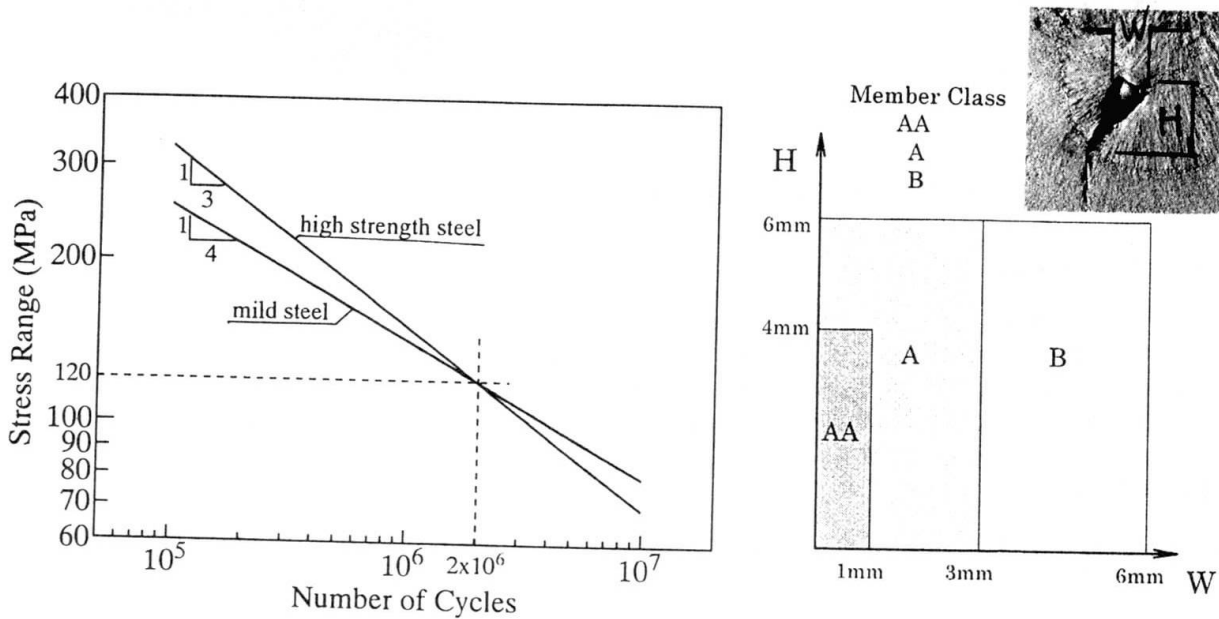
Fig.22 Allowable stress for corner joint and permissible size of blowhole in corner joint

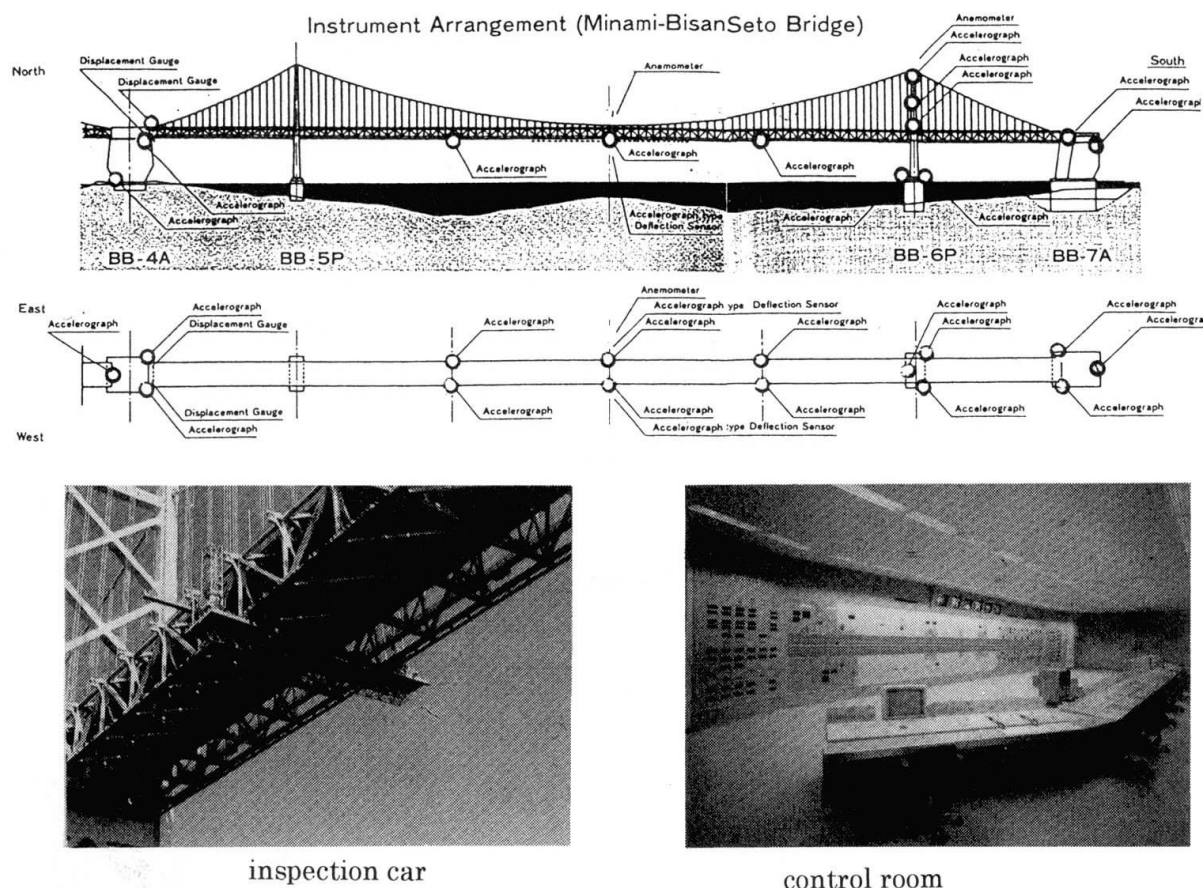
Fig.23 Instruments for monitoring of bridge behavior

Various new technologies have been applied in maintenance also. Honshu-Shikoku bridges are equipped with inspection cars making it possible for on-hand inspections to be made of all members. And as shown in Fig. 23, various types of sensors such as accelerometers and displacement meters are installed and the behaviors of bridges are monitored at all times at a central control room. Besides these data being used for operations, the records comprise a base for formulating maintenance plans.
