Zeitschrift: IABSE reports = Rapports AIPC = IVBH Berichte
Band: 73/1/73/2 (1995)

Session B2

Seismic Strengthening: Laboratory Studies
Renforcement parasismique: études de laboratoire
Seismische Verstärkung: Laborstudien

Seismic Strengthening of Reinforced Concrete Columns with Inadequate Lap Splices

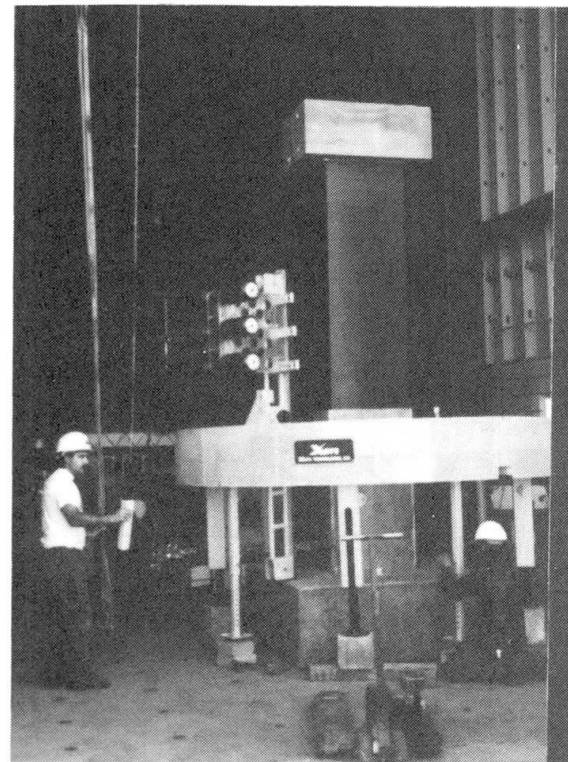
Fig. 1 Automated Carbon Jacket System

All of the above deficiencies can be removed by jacketing of the existing concrete column preferably with a circular or oval jacket providing distributed confining forces which result from the jacket curvature once membrane action in the jacket is activated by column dilation. For shear, which is not so much a confinement but rather a strength issue, also jackets of rectangular
