Rubrik: Session B2: Seismic strengthening: laboratory studies

Seismic Strengthening: Laboratory Studies
Renforcement parasismique: études de laboratoire
Seismische Verstärkung: Laborstudien

Seismic Strengthening of Reinforced Concrete Columns with Inadequate Lap Splices

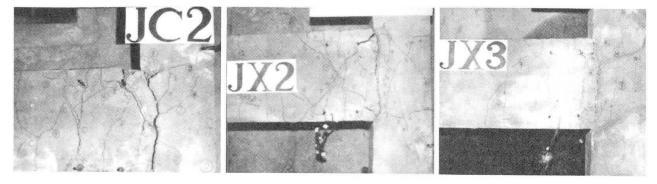
Fig 5 Cracking in the joint region for three specimens at the end of the test

minor cracking occurred in joint region for specimens JC1, JX1, JC3, and JX3, while in specimens JC2 and JX2, which had the largest joint shear stress, there were many more and larger cracks as shown in Fig. 5. In order to compare the performance of X-Specimens and C-Specimens a plot of percent yield strength versus the displacement ductility is shown in Fig. 6. The yield load and displacement for each specimen were measured from the strain gauge data of the beam longitudinal reinforcement at the face of the column. The presence of inclined crossed bars within the joint core of X-Specimens enhanced its load carrying capacity by more than 10% compared with that of C-Specimens. Specimen JX2 with 4D12 inclined bars had less load carrying capacity than JC2 with 4D10 inclined bars. This showed that increasing the amount of inclined bars had a significant improvement when the joint shear stress was low.

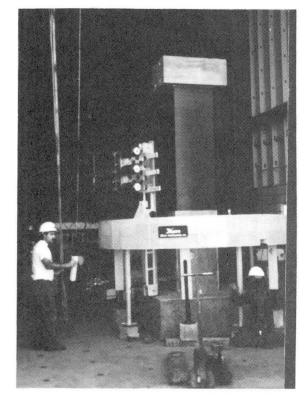
Fig. 1 Automated Carbon Jacket System

All of the above deficiencies can be removed by jacketing of the existing concrete column preferably with a circular or oval jacket providing distributed confining forces which result from the jacket curvature once membrane action in the jacket is activated by column dilation. For shear, which is not so much a confinement but rather a strength issue, also jackets of rectangular
