**Zeitschrift:** IABSE reports = Rapports AIPC = IVBH Berichte  
**Band:** 73/1/73/2 (1995)

**Artikel:** Reinforced concrete sheath for repair of damaged masonry walls  
**Autor:** Benjamin, Bezaleel  
**DOI:** <https://doi.org/10.5169/seals-55210>

## Reinforced Concrete Sheath for Repair of Damaged Masonry Walls

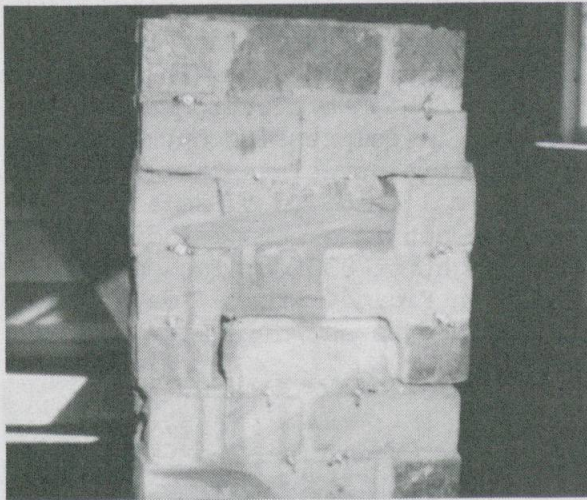
Fig. 6 Cracked wall with sheath

A cracked wall was first built as described in 3.2, with, however, 34 ties embedded into the mortar. The ties were screws, 5 mm dia. and 64 mm long. Wing nuts were used when the mortar had set. Fine wire mesh reinforcement was tied to the bolt heads and the cracked wall assembled against a sheet steel form covered with plastic wrap. To prevent leakage, the wall was taped to the form; nevertheless, some leakage did occur. The wall was still a cracked wall, as seen in Fig. 6. A flowable mix was used, yet the walls still required some patching with the same grout. The thickness of the sheath varied from 6 mm, at sections where failure occurred, to a maximum of 12 mm. These walls were tested with end conditions of fixed at the base and free at the top, to stay within the load capacity of the actuator. The results are shown in Table 3.

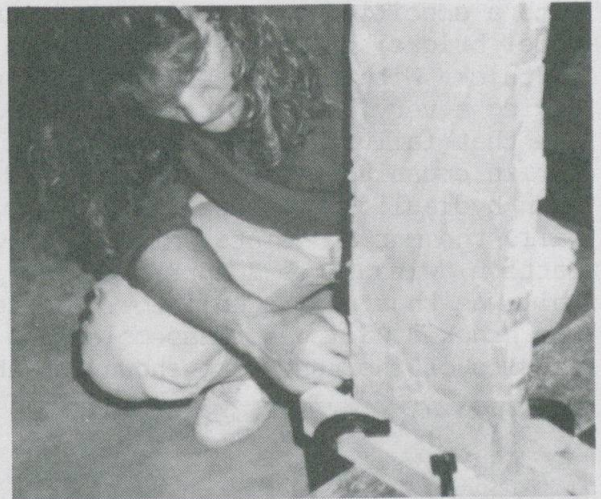
Fig. 7 Sheath at collapse

This research shows that even severely damaged masonry walls can provide lateral support to the thin, reinforced concrete sheath to prevent buckling. The cracked wall has about 30% of the strength of the uncracked wall, and the provision of the sheath returns the structure to 107% of its original strength. Furthermore, whereas both uncracked and cracked walls showed explosive failure in the mortar joints, the cracked wall with the sheath showed a non-explosive failure along a single line of weakness, as shown in Fig. 7.
