Zeitschrift: IABSE reports = Rapports AIPC = IVBH Berichte
Band: 73/1/73/2 (1995)

Rubrik: Session B3: Maintenance of structures

Maintenance of Structures
Maintenance des structures
Instandhaltung der Tragwerke

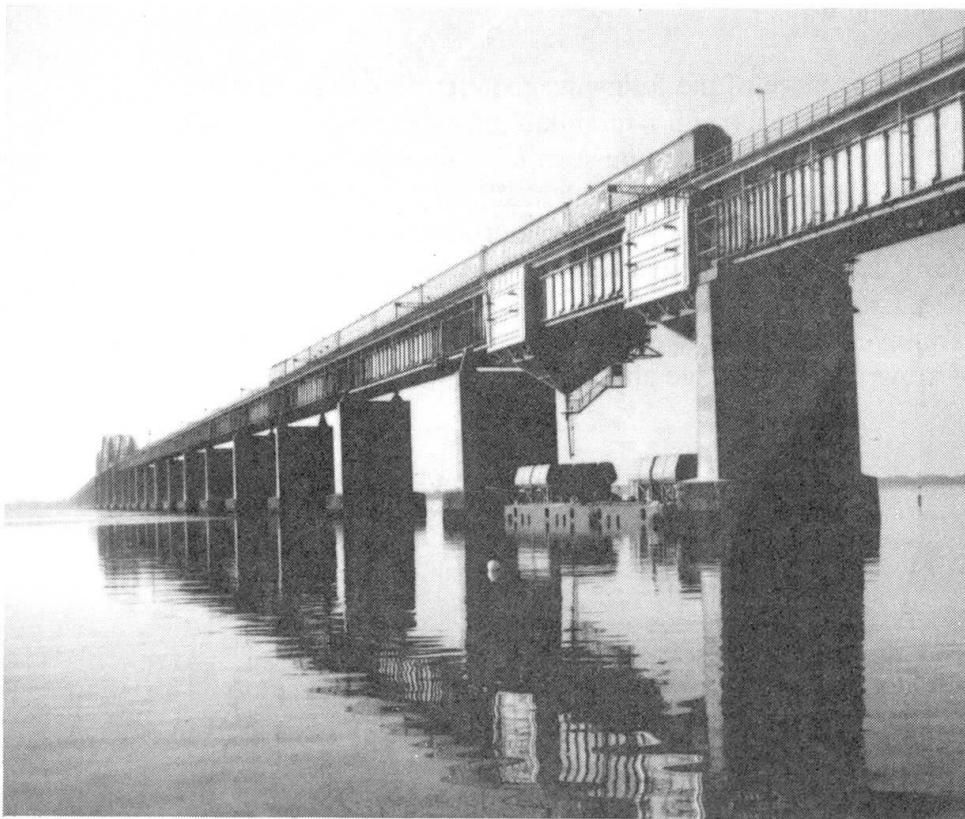
Photo 2 shows the mounting of the mobile platforms under the Storstrøm Bridge.

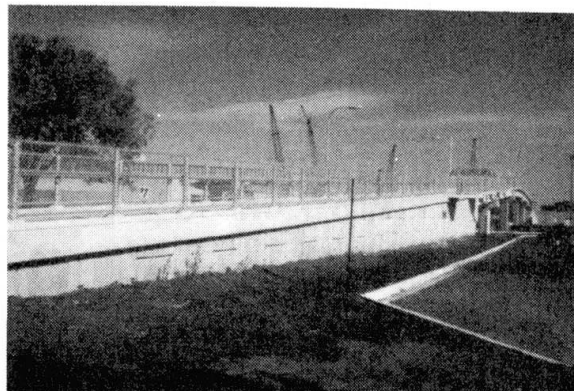
Fig. 1 New 10th Street Pedestrian Viaduct

The structure is a 5-span, 169.8-m-long precast-prestressed-post-tensioned concrete superstructure with an 165-mm-thick by 3.7-m-wide cast-in-place deck. The approaches, supported on mechanically stabilized earth (MSE), are 70.7-m- and 126.5-m-long and have 5 percent grade. The total top surface areas of the south approach, elevated structure, and north approach are 289 m², 696 m², and 614 m², respectively. The highest deck is 8.8 m above the boiler.
