**Zeitschrift:** IABSE reports = Rapports AIPC = IVBH Berichte  
**Band:** 73/1/73/2 (1995)

**Rubrik:** Session B3: Maintenance of structures

**Maintenance of Structures**  
**Maintenance des structures**  
**Instandhaltung der Tragwerke**

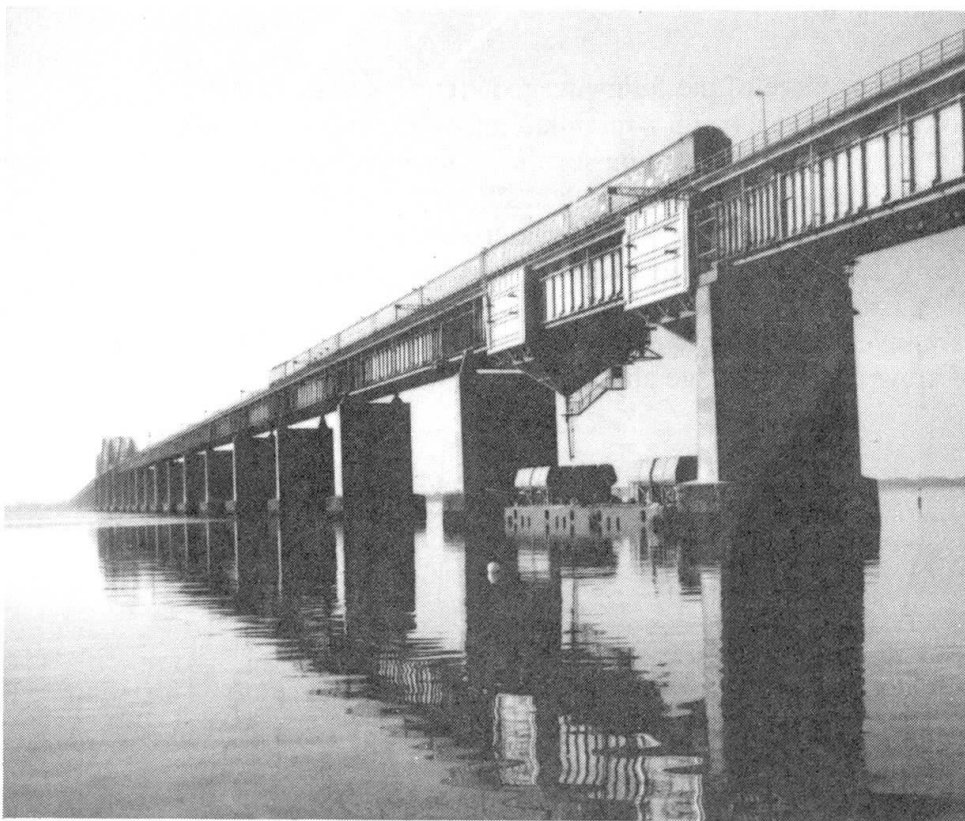
Photo 2 shows the mounting of the mobile platforms under the Storstrøm Bridge.
