Zeitschrift: IABSE reports = Rapports AIPC = IVBH Berichte
Band: 73/1/73/2 (1995)

Rubrik: Session B3: Maintenance of structures

Maintenance of Structures
Maintenance des structures
Instandhaltung der Tragwerke

Guidelines for a Handbook on the Service Life of Buildings

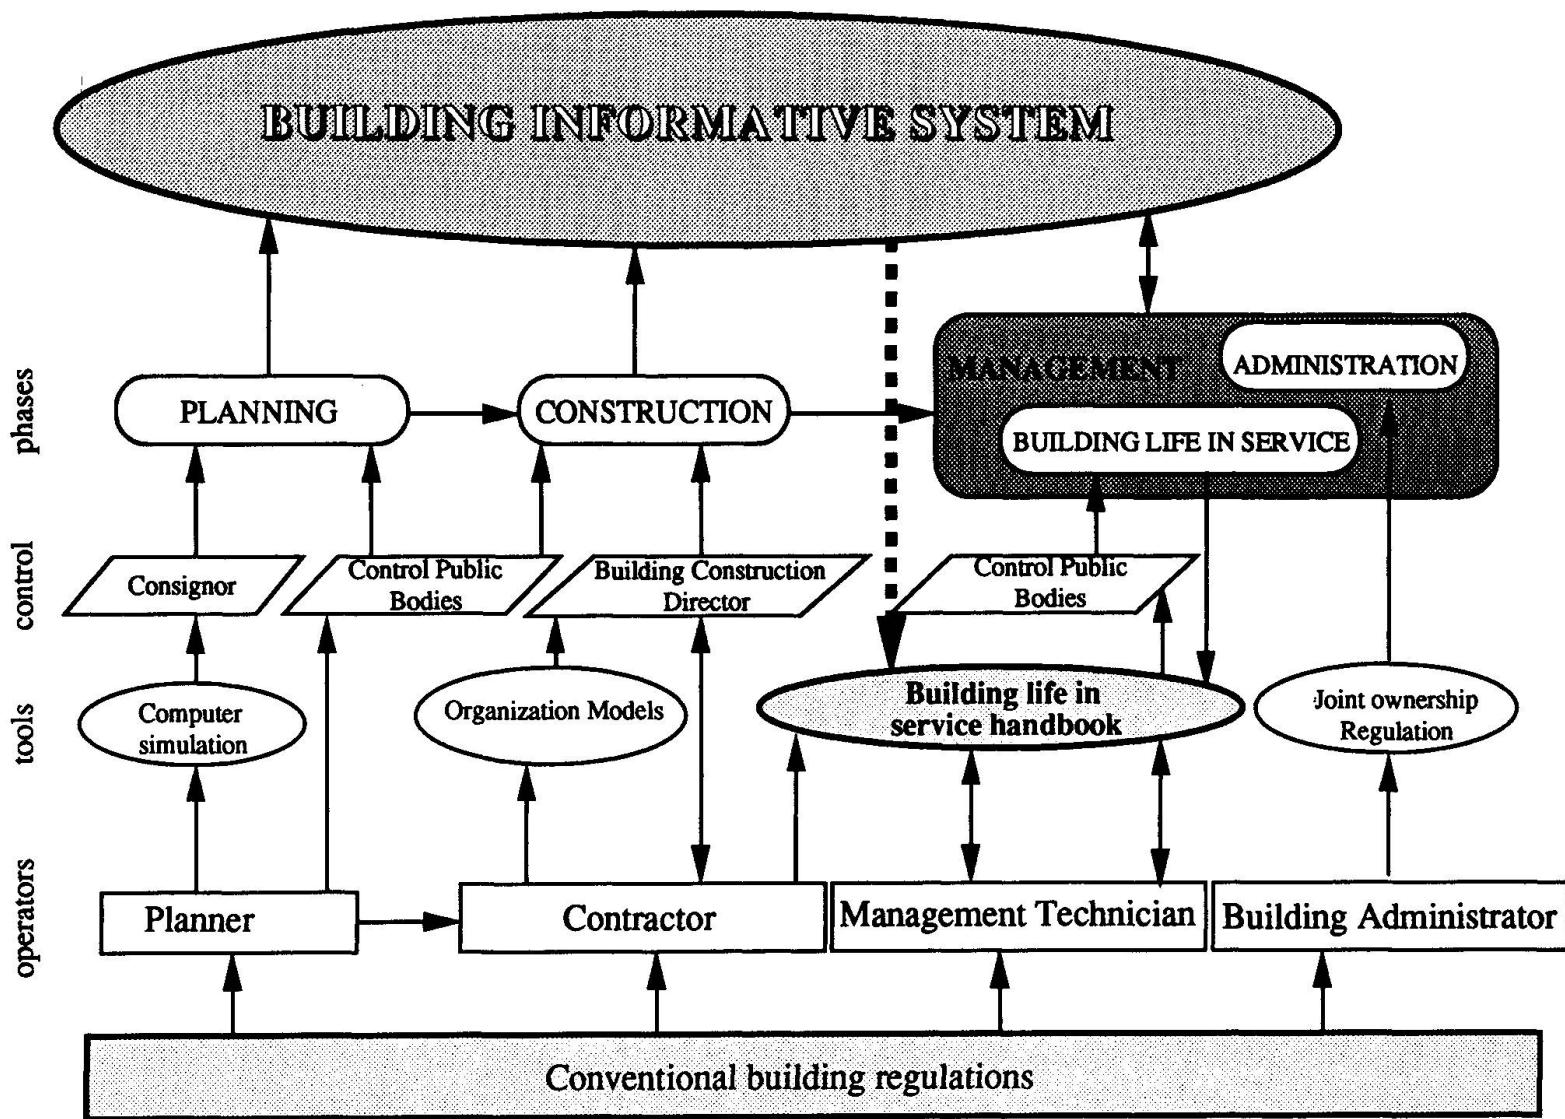
Fig. 1 The Management phase within the Building Process

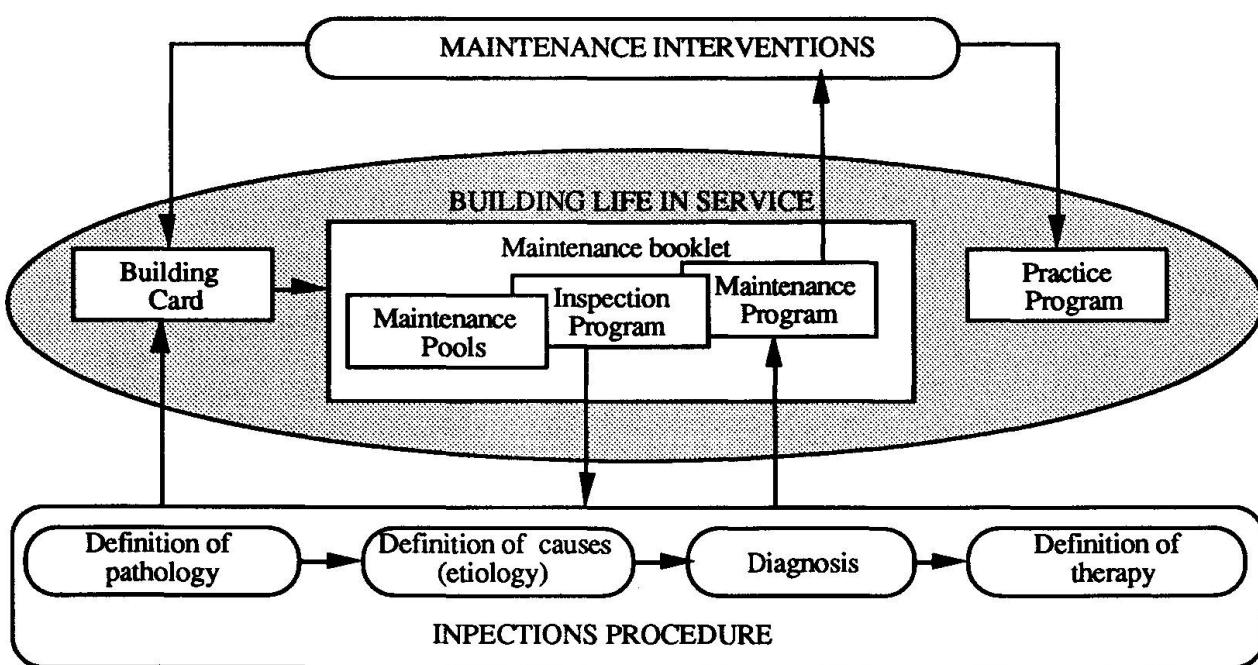
Fig. 2 Relationships between constituent parts of buildings life in service handbook, inspections procedures and execution of maintenance interventions

Such a program should be useful for the final user and the building administrator, in order to avoid requests which are either unexpected and/or contrary to established planning criteria (Fig. 2).

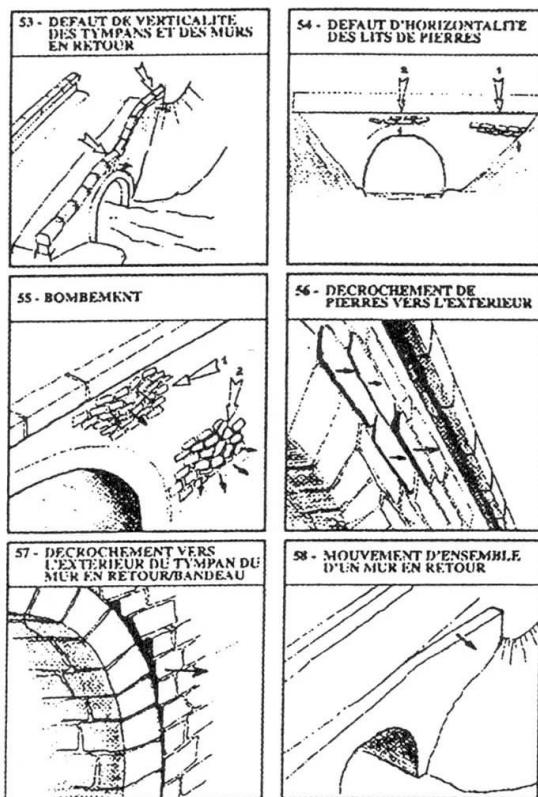
Figure 3 : Example of visit report of disorders (for masonry bridge)

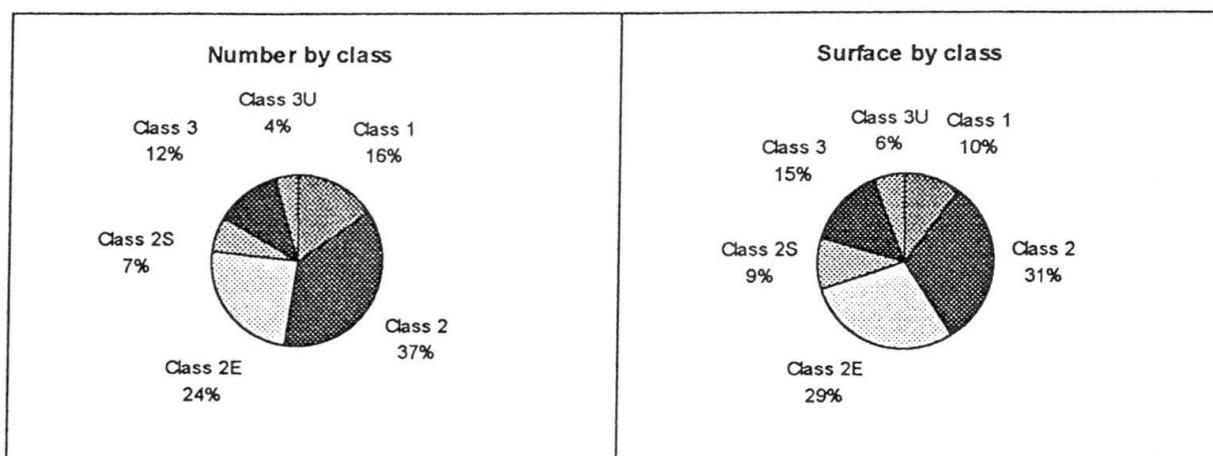
Figure 4 : Overall distribution by class of bridges and culverts

The following graph charts give the main results of the first campain of evaluation : the distribution by class (in number and in surface) and the analysis according to the type of bridge.

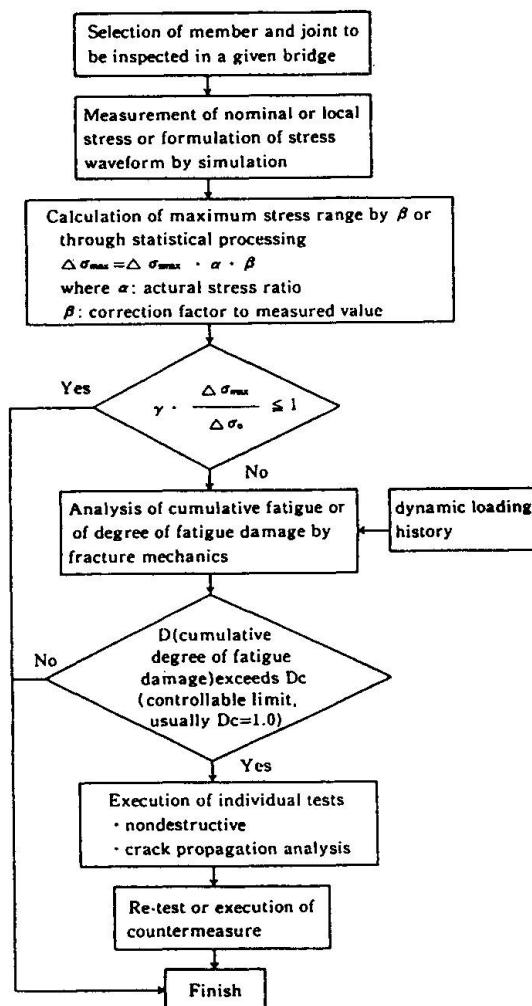
Fig.1 Flow of fatigue damage evaluation

Fig. 1 shows the flow chart of standard evaluation of fatigue damage.

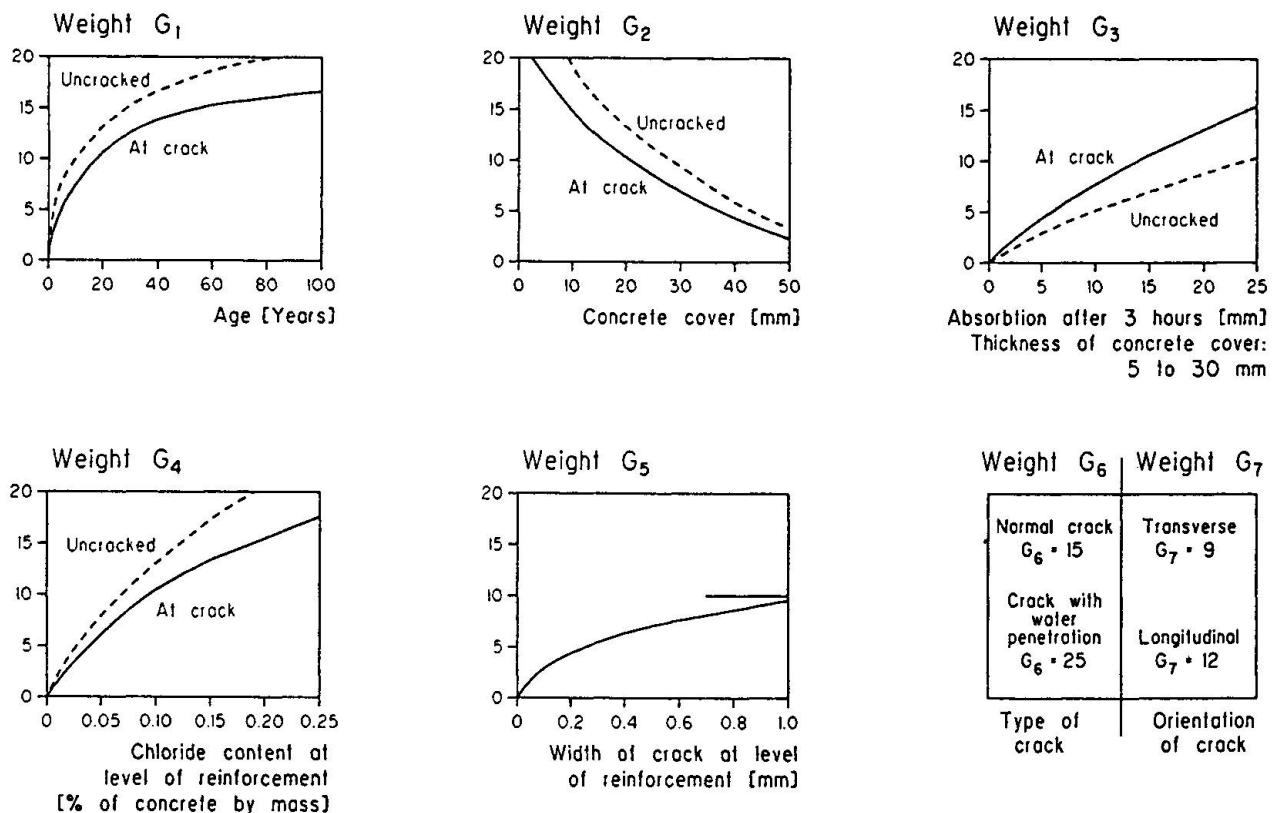
Fig. 1 Weighting functions

Based on these results, threshold values were defined for S in homogeneous regions and at cracks, beyond which corrosion of reinforcement could be deemed to begin. These threshold values are $S=40$ for uncracked homogeneous regions and $S_R=65$ at cracks.

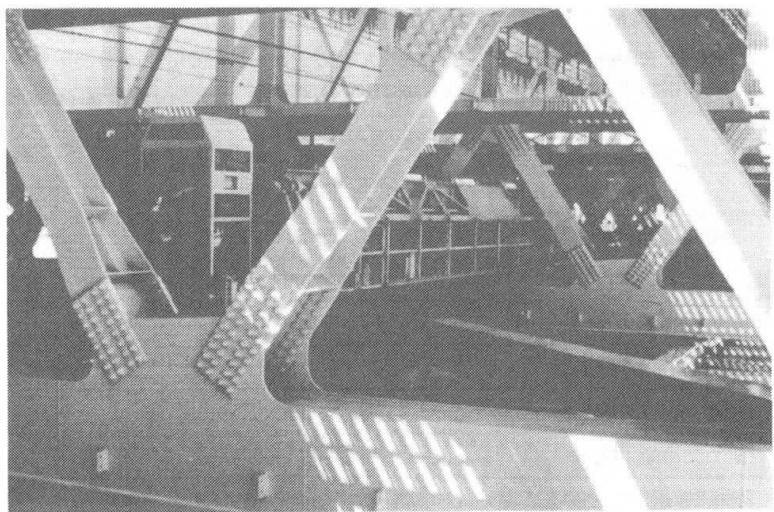
Photo 2 Work vehicle for inspecting girder interiors

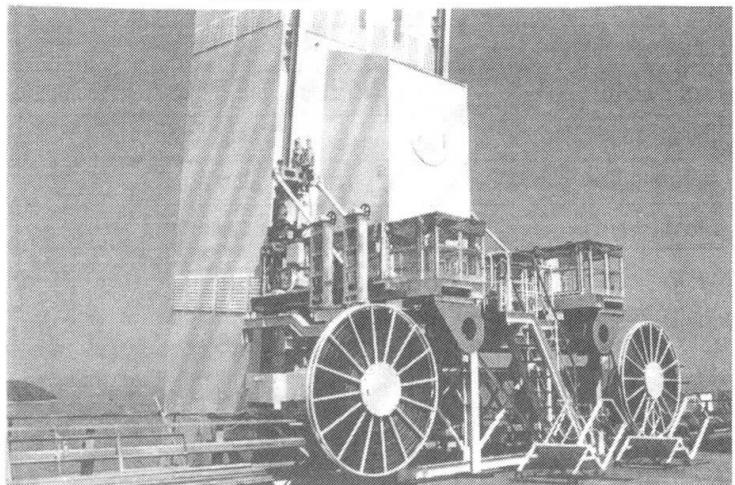
Photo 3 Work vehicle for inspecting roadside walls of the tower

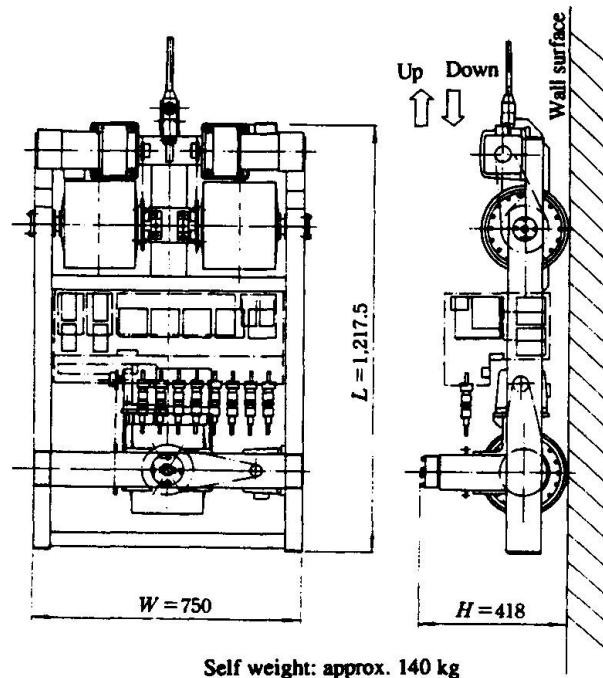
Fig. 1 Outline of the concept of the mechanical facilities for repair painting

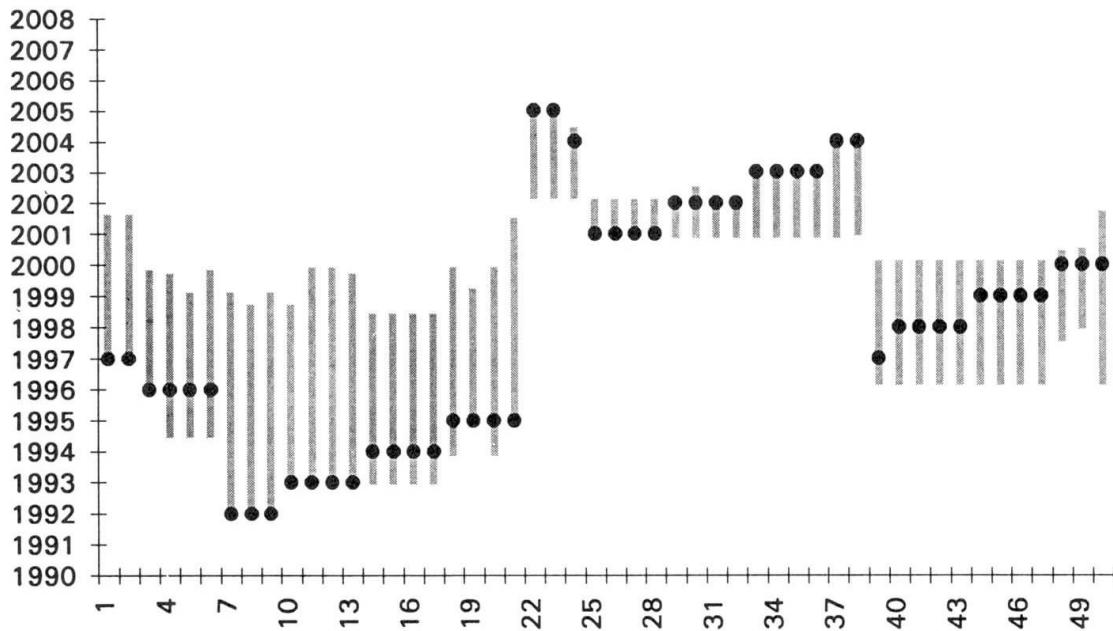
Figure 1 shows one of the results from the database. On the abscissa is shown the bridge span number from 1 to 50, on the ordinate is shown the weighted lifetime of the steel members in the spans. There are three different types of information: *Minimum* which shows the minimum lifetime of the existing surface treatment on the members, *Maximum* which shows the maximum lifetime, and *Dots* showing the planned maintenance. In an optimal case the dots should be somewhere between the Minimum and the Maximum points.

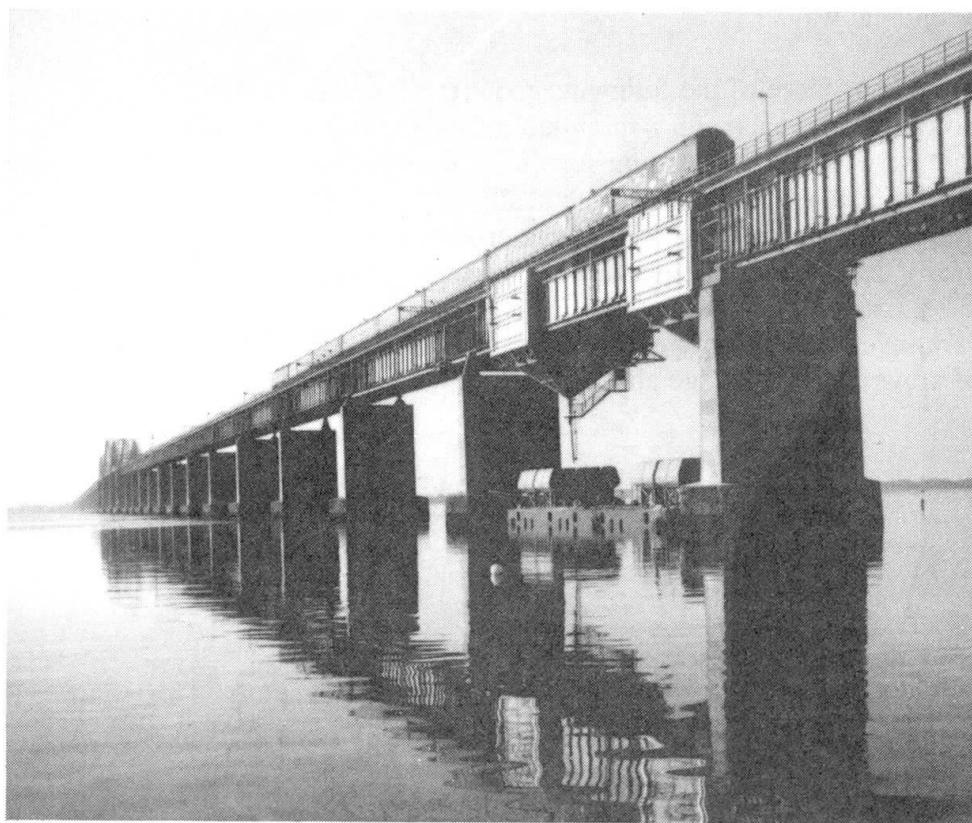
Photo 2 shows the mounting of the mobile platforms under the Storstrøm Bridge.

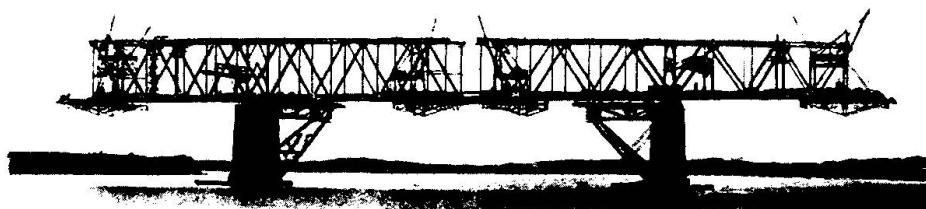
Fig. 3

The Situation from the construction where the cantilevered ends were just reaching each other between pier 3 and 4.

The riveted steel superstructure was assembled without use of falsework. On one side of each pier an erection bracket was placed and from there, the superstructure was cantilevered out to both sides.

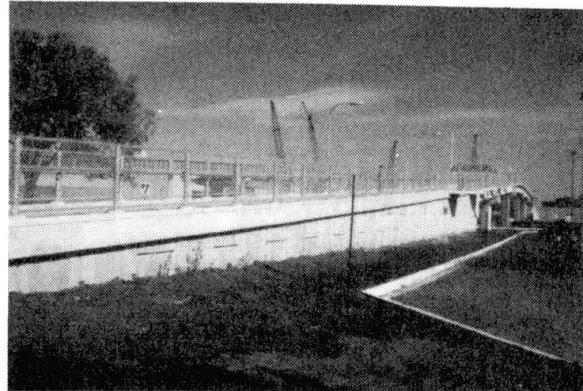
Fig. 1 New 10th Street Pedestrian Viaduct

The structure is a 5-span, 169.8-m-long precast-prestressed-post-tensioned concrete superstructure with an 165-mm-thick by 3.7-m-wide cast-in-place deck. The approaches, supported on mechanically stabilized earth (MSE), are 70.7-m- and 126.5-m-long and have 5 percent grade. The total top surface areas of the south approach, elevated structure, and north approach are 289 m², 696 m², and 614 m², respectively. The highest deck is 8.8 m above the boiler.

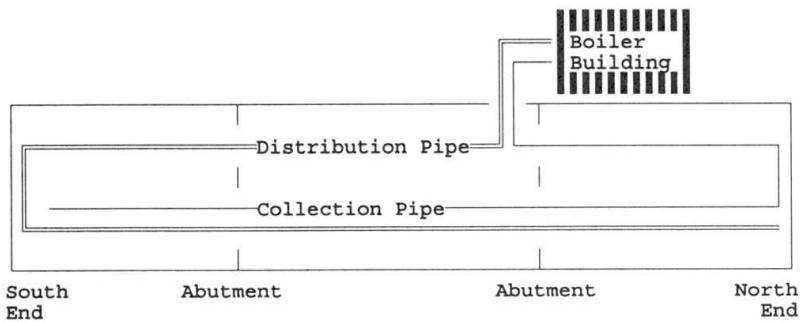
Fig. 2 Distribution/collection Network Schematic

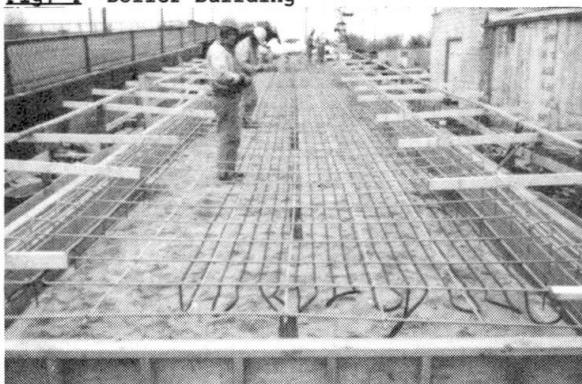
Fig. 6 Hydronic Hoses

and back to the collection manifold (Fig. 6), which is located adjacent to the distribution manifold (Fig. 5). The solution is then transported from the collection manifold to the PVC collection line in a 25-mm-diameter flexible plastic hose. Finally, the solution is returned to the boiler, where it is reheated and recycled (Fig. 7).

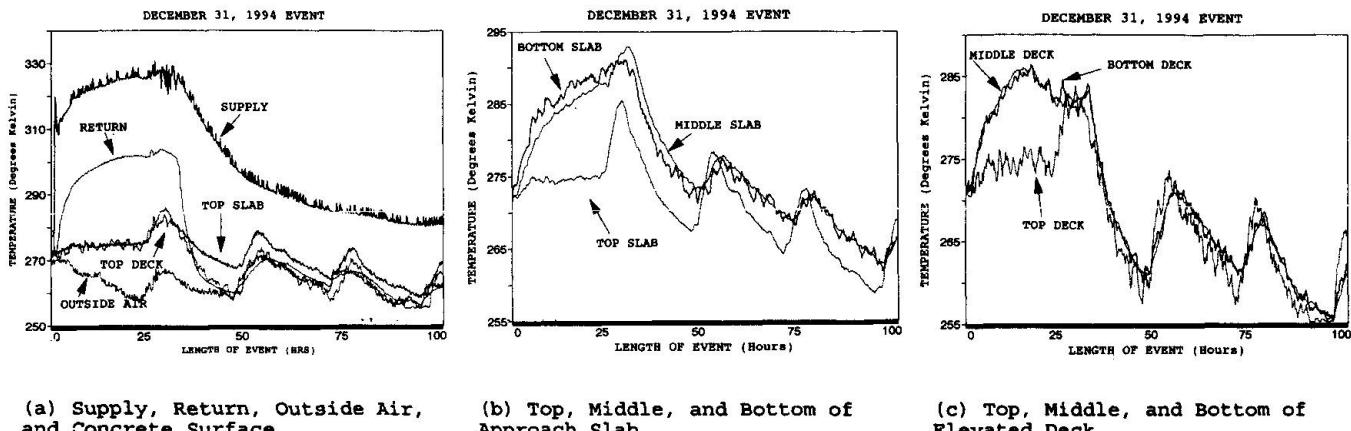
(a) Supply, Return, Outside Air, and Concrete Surface

(b) Top, Middle, and Bottom of Approach Slab
