Maintenance of the Structures of the Existing Severn Crossing

K. SRISKANDAN
Consultant
Mott MacDonald Ltd
Croydon, UK

SUMMARY

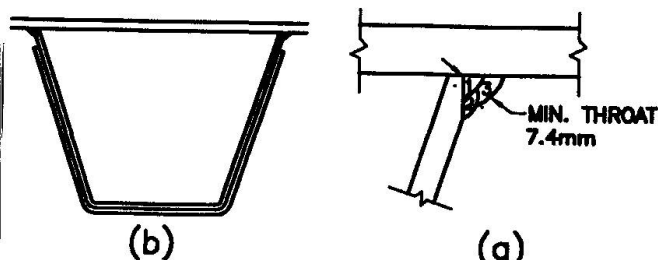
Fig. 1

5.1.1 Most of the work has been in reinstating/repairing fillet welds in the orthotropic deck, joining trough stiffeners to deck or to the diaphragms. Standard repair methods have been devised. For the first, Fig 1(a), the existing 6mm weld is cut out over a certain length and replaced by a larger fillet weld which includes some preparation of the stiffener web. In the Second, Fig1(b), a shaped strap is fillet welded to the trough and also the diaphragm. Table 1 gives the numbers of these repairs on each structure from concession date to the present time.
