**Zeitschrift:** IABSE reports = Rapports AIPC = IVBH Berichte  
**Band:** 73/1/73/2 (1995)

**Rubrik:** Session B4: Concrete durability II

## Global Strategy to Enhance Service Life of Deteriorating Structures

## Forecasting the Condition of a Reinforced Concrete Structure under Corrosion

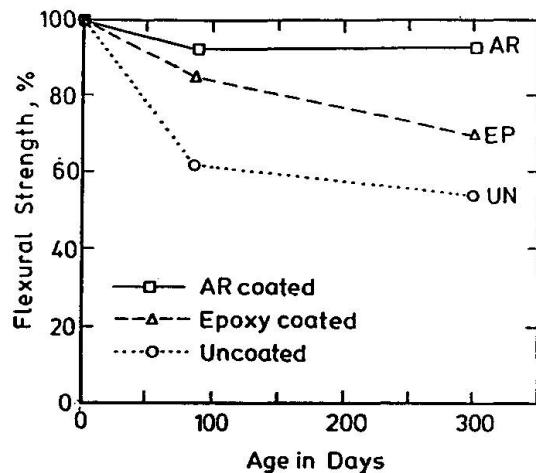
**Fig. 2 Loss of flexural strength due to ASR expansion**

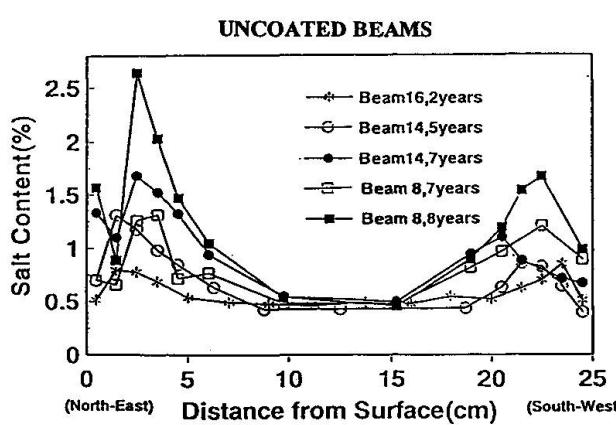
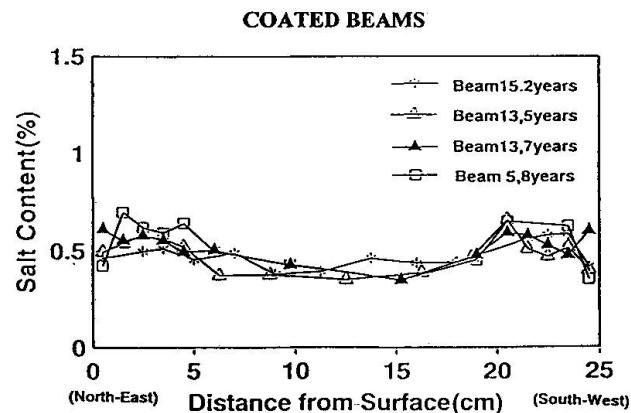
**Fig. 3 Chloride distribution in beams with 0.5% salt**

The total ability of the AR coating in controlling chloride penetration into concrete is illustrated in Fig. 3 which shows chloride distribution in uncoated and coated reinforced concrete beams made with 0.5% salt added during mixing and built in an aggressive marine environment with sub-tropical weather conditions of high temperature, humidity and wind, and exposed to salt-laden breeze and sea water splash. The performance data over 8 years is ample proof of the role and effectiveness of the coating and its ability to maintain its continuity and integrity.

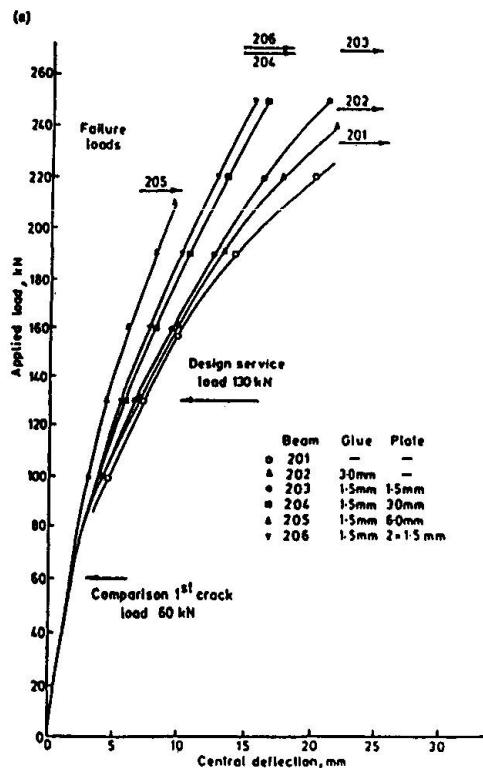
**Fig. 4** Effect of bonded plates on mid-span deflection

The provision of a steel plate at the tension face of a beam significantly reduces both deflections and crack widths, more than what would be achieved by additional internal reinforcement equivalent to that of the external plate, (Figs 4 and 5). The stiffening and crack controlling action of the plates can lead to substantial increases in serviceability loads for various serviceability conditions as shown in Table 2. Plating structurally damaged beams can also lead to substantial reductions in deformations and increases in serviceability loads, as shown in Table 3.

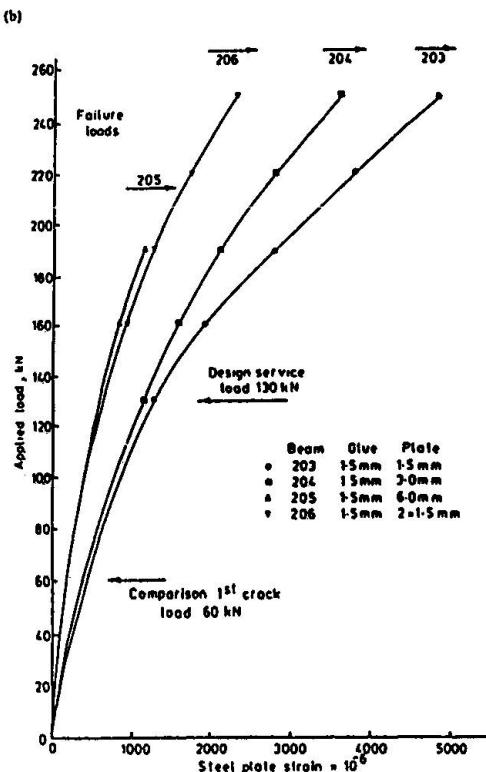
**Fig. 5** Effect of bonded plates on steel plate strain

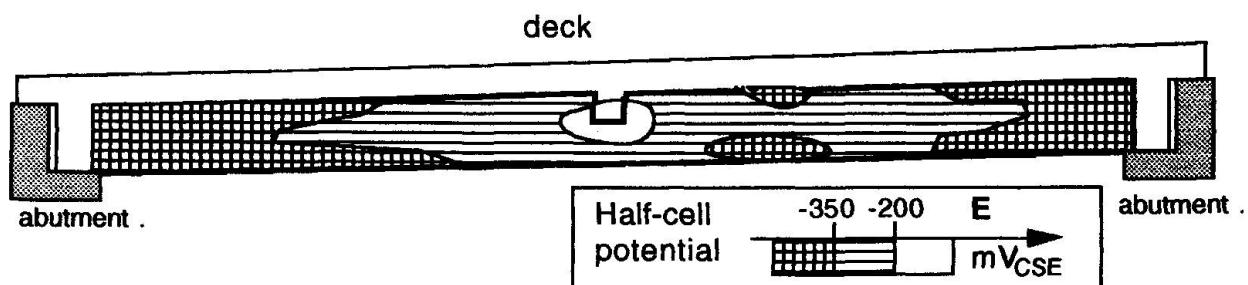
Fig. 1 : Example of potential map of a bridge member, about 7 m long and 0.5 m high.

Figure 1 gives an example of potential mapping. It deals with a bridge, in mountain area, on which deicing salts have been applied. This map shows that the corroding rebars are also in the lower part of the members, near their ends. The reason of this deterioration was that the waterproof membrane (on the bridge deck) was not effective at its ends.

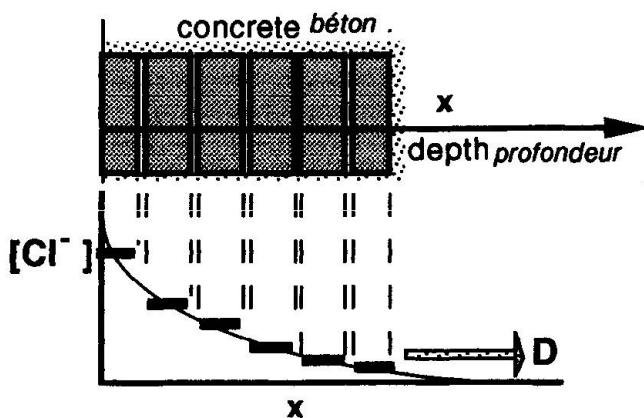
These slices are parts of cores drilled from the concrete cover. They are about 4mm thick

So, soluble chloride content is determined at various depths in concrete. Results are plotted in a curve (chloride profile) giving the chloride content against the concrete depth (Fig. 2). If some assumptions are met, chloride profiles can be interpreted in terms of a diffusion process. One of these assumption is that the concrete humidity shall be almost constant. But some theoretical studies [2] [3] [4] have also shown that chloride penetration into concrete can be assumed to be a diffusion process only if the concrete cover is not deteriorated during the chloride penetration.

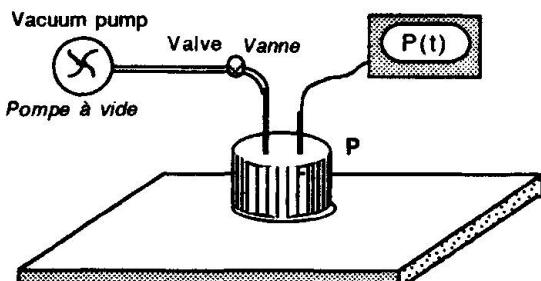
Fig. 3 :  
Principle of the equipment for measuring the air permeability of a concrete surface.

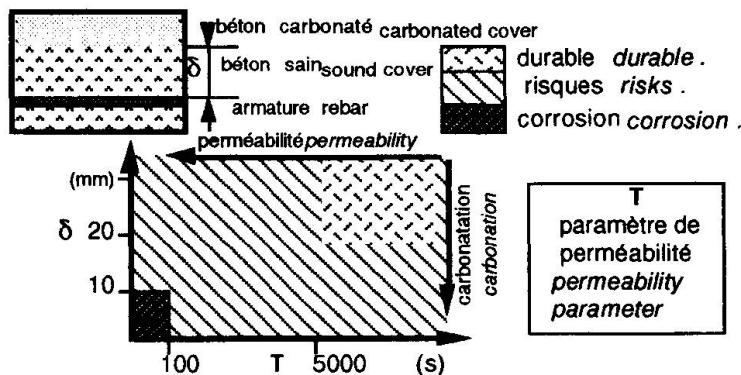
Procedure for predicting the corrosion of rebar by using results of carbonation depth and air permeability measurements.

Here it is assumed that no chloride is involved in the corrosion process.

As mentioned here above, results of carbonation depth and air permeability measurements can predict if rebar, in the investigated area, will likely corrode [8]. Fig. 4 shows that, when the carbonation depth is thin and the air permeability low, rebar corrosion will not occur in short term. On the contrary, if the concrete cover is carbonated and if it is permeable to fluids, rebar are likely corroding.

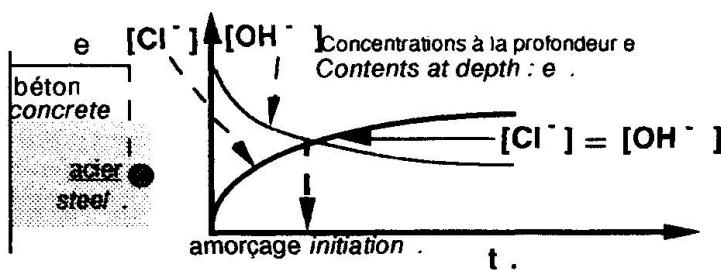
Prediction of the chloride and  $OH^-$  contents which make it possible to determine when rebar will corrode in a given part of a structure

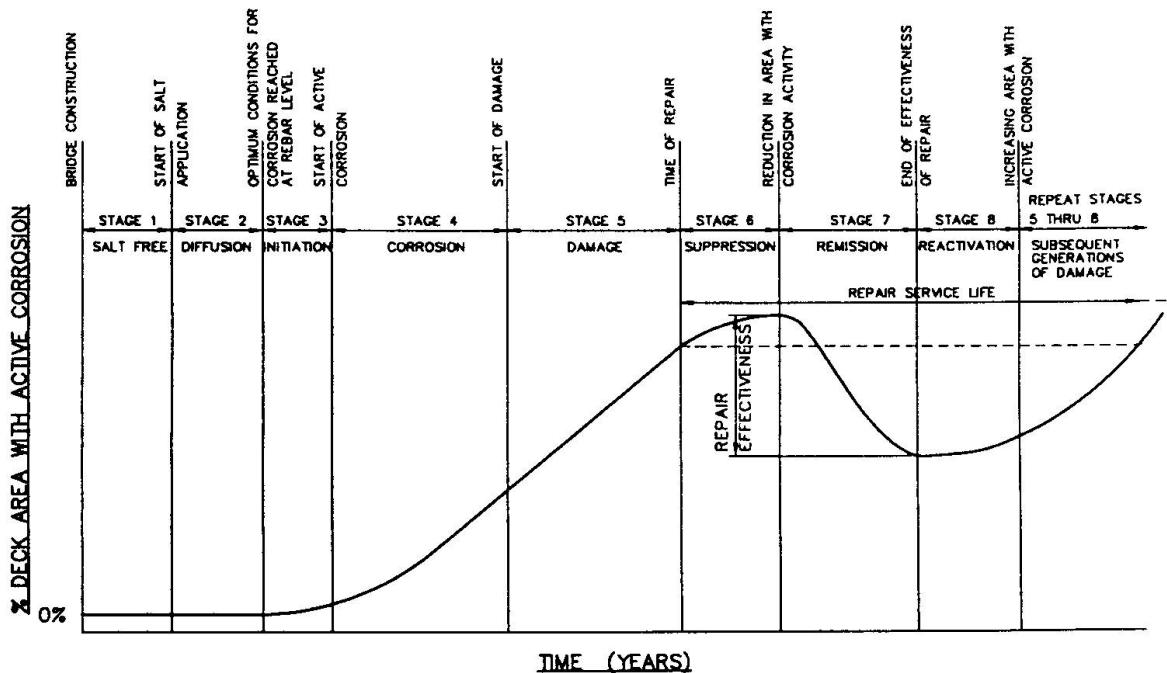
Figure 2 Bridge Deck Corrosion Life Cycle

Damage levels generally build up over time and it is considered that there is a threshold level of damage above which a deck system is considered completely failed. Complete failure is either due to the deck becoming unsafe structurally or due to it developing an unacceptably poor ridability resulting from damage levels that are too great to permit selective repairs. Levels of damage which preceed the threshold level sometimes manifest in the form of minor spalling and/or potholes and some limited amount of associated poor ridability. However, levels of damage that have proven economical to repair are often limited to internal delamination, cracking and debonding that are invisible, but which can be detected by non-destructive diagnostic methods such as chain drag delamination surveys and/or electrical potential corrosion surveys. Figure 2 depicts a generic life cycle for a bridge deck subjected to a corrosive environment and a repair application. It presents characteristic stages which are considered pertinent to this subject matter.

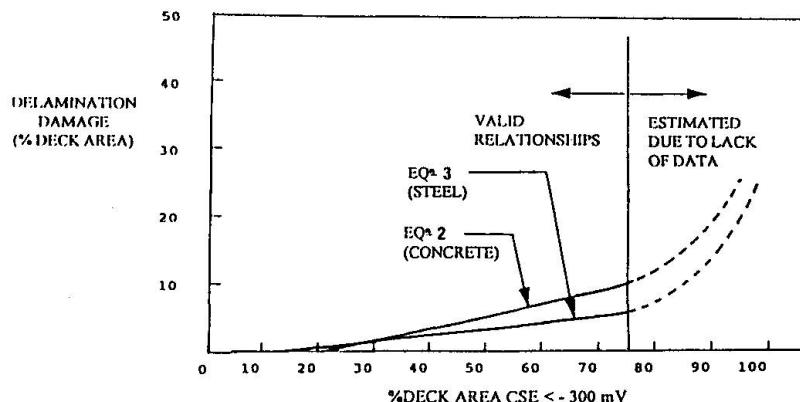
Figure 3 Damage vs.CSE , -300 mV

The data was separated and relationships developed for the two categories of girder types because of the perception, based upon observations of experienced field personnel, that the two types of bridges tend to perform differently, probably due to the inherent differences in flexibility and thermal sensitivity. Figure 3 shows equations (2) and (3) plotted, and it appears from this derivation that corrosion-induced damage begins to develop when CSE readings are more negative than -300 mV over about 10% to 25% of the deck area. Figure 3 also shows that on average less damage occurs in steel girder bridge decks than for concrete girder decks at a given level of CSE measured corrosion activity. It is hypothesized that the presence of the steel girder tends to increase the corrosion activity measured within the deck, but that this additional activity associated with the steel girder is not likely causing any additional damage to the deck. However, it is important to note that the variability of damage observed on steel girder decks, as represented by the reliability index,  $R^2$ , is significantly greater.

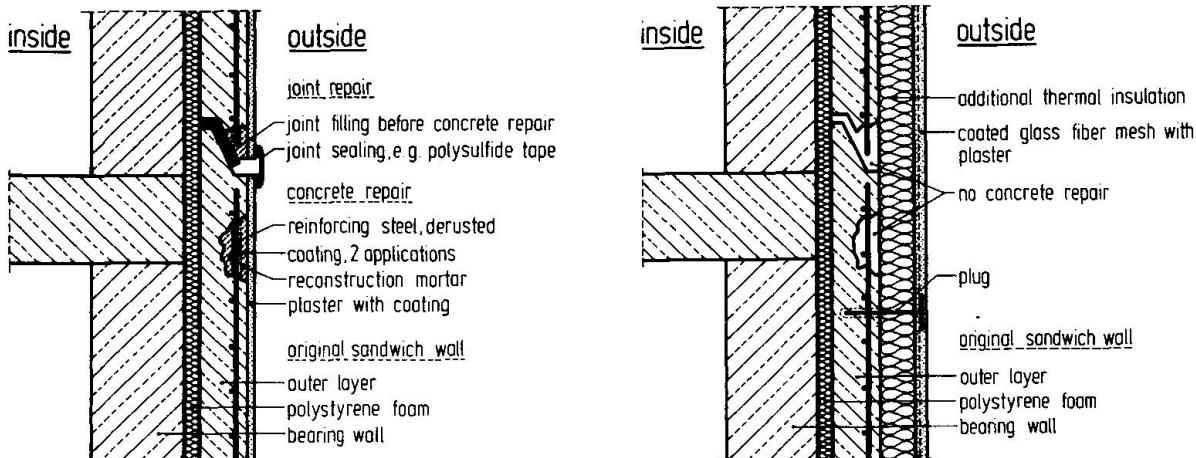
**Fig. 1** Common method of concrete repair to the exterior of a sandwich wall (left), alternative repair using an external thermal insulation composite system (ETICS, right)

It can be demonstrated by diffusion calculations that it is possible to dry the exterior walls of concrete buildings in Central European or similar climates by attaching an additional thermal insulation to the outside of these walls. Preliminary results were reported at the IABSE symposium in Lisbon, 1989 [1]. By the undermentioned tests it will be verified that it is possible to arrest rebar corrosion by means of additional thermal insulation (fig. 1 right).

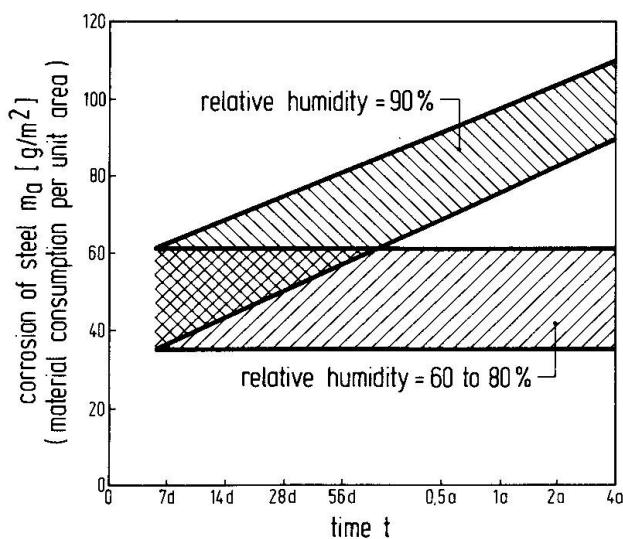
**Fig. 2** Mass losses of rebars in carbonated concrete specimens stored at different r.h.

These experiments show that steel corrosion in reinforced concrete can be arrested if the concrete moisture level is in equilibrium to not more than 80 % relative humidity to the surrounding atmosphere, a result which does not depend on the reinforcing steel type.

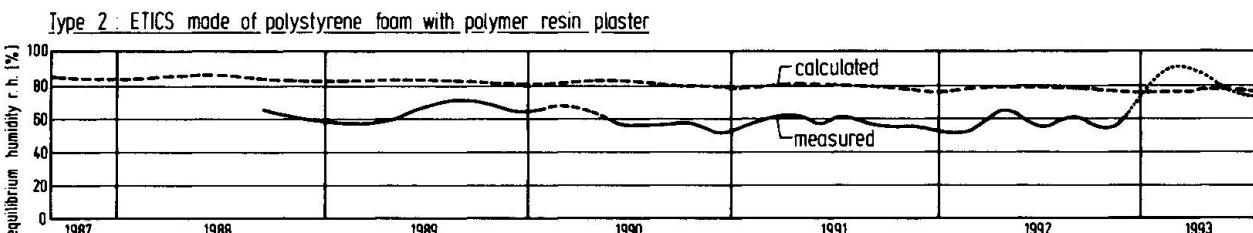
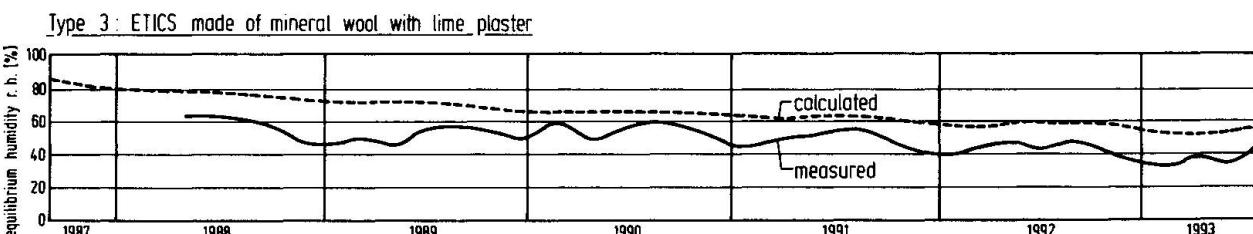
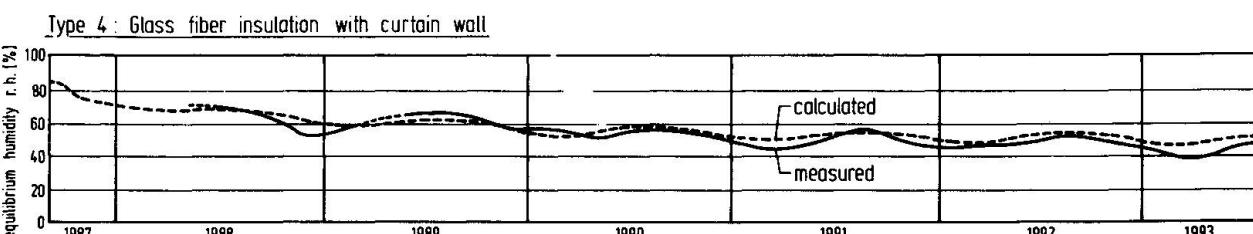
**Fig. 3** Measured and calculated equilibrium humidities in the outer layers of concrete sandwich exterior walls with additional thermal insulation

- the outer layers of the sandwich walls were drying behind the additional thermal insulation significantly, and after a few years the concrete moisture level was in an equilibrium at the measured relative humidity of 40 to 70 % (fig. 3),
- the bearing walls were drying, too, and after a few years the concrete moisture level was in an equilibrium at the measured relative humidity of 30 to 60 %.

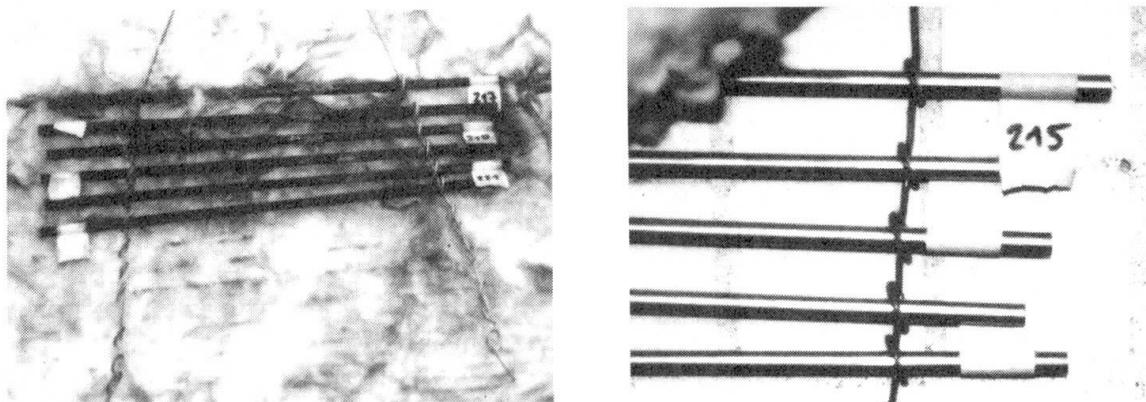
**Fig. 4** Unprotected steel bars after one year of in-situ storage between a curtain wall and the fiberglass insulation behind it (left) and between the fiberglass insulation and the outer layer of the sandwich exterior wall (right)

- steel bars were placed in the airspace between the curtain wall and the additional fiberglass insulation (type 4, cp. table 1),
- steel bars were mounted between the different additional thermal insulations (type 2, 3 and 4, cp. table 1) and the outer layer of the original sandwich wall, too.

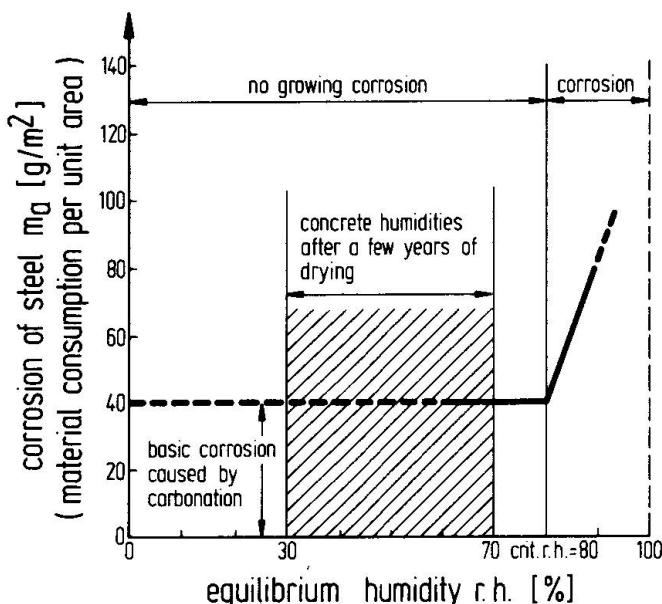
**Fig. 5** Scheme of arresting rebar corrosion in concrete exterior walls using additional thermal insulation

- steel in carbonated concrete specimens needs more than 80 % relative humidity for corrosion (fig. 5).

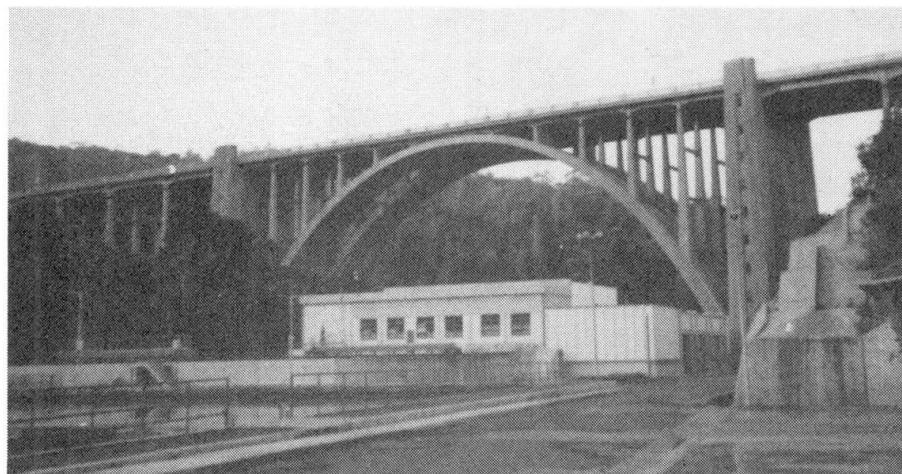
Fig. 1 General view of the bridge

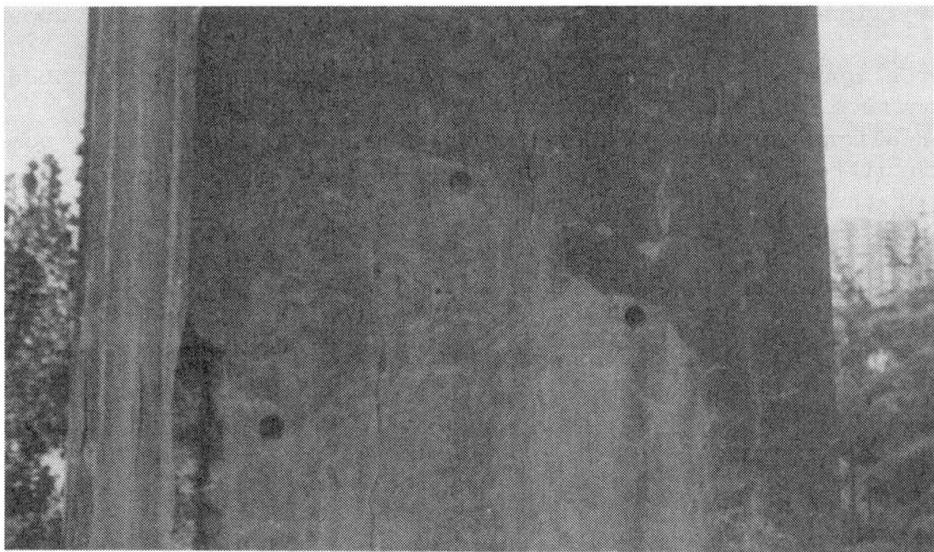
**Fig. 3** Column of the Central Arch, facing the south. Cracking aligned with the main reinforcing bars

The areas of greater deterioration were located in the central arch, below which the road traffic is more intense, in places more exposed to rain and sunshine. Figs. 2 and 3 show typical examples of cracking observed in concrete.

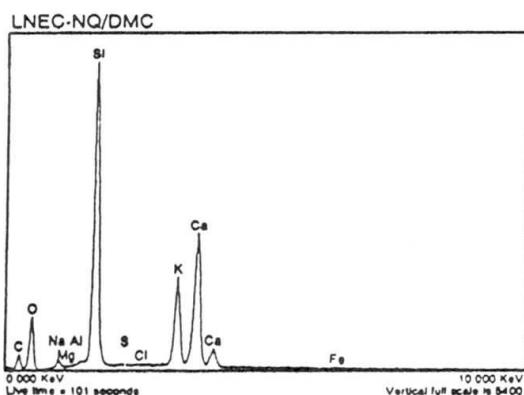
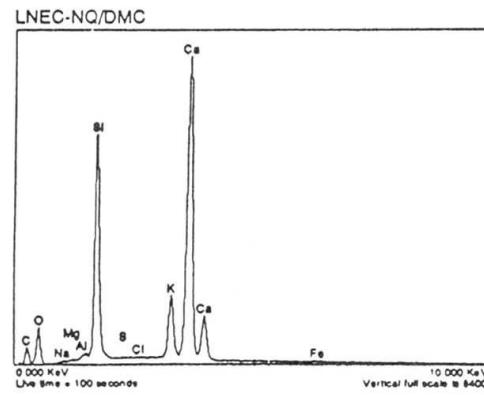
**Fig. 4** Products of alkali-silica reaction (calcium and potassium silicates) in a limestone/paste interface.

Observations were also carried out on other samples taken from more cracked areas of the Central Arch. These observations showed in limestone/paste interfaces the presence of typical compounds of alkali-silica reaction (Fig. 4), such as hydrated calcium and potassium silicates (crystalline and amorphous), as well as ettringite, either in the characteristic form of acicular crystals, or in a massive form. Other authors [6] have observed similar morphologies in the presence of alkali-silica reactions.

The X-ray microanalysis of the alkali-silica reaction products showed that the crystalline products are less rich in calcium (Ca) than the amorphous ones. The occurrence of ettringite in cracks, pores and slightly disperse in the paste was also observed.

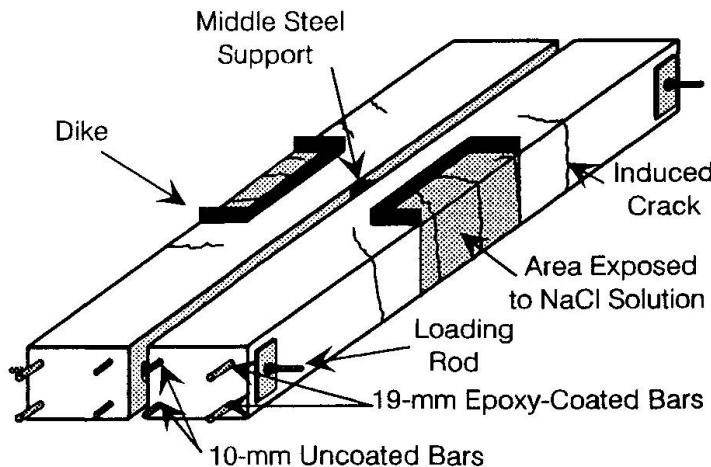
Fig. 1 Model of Beam Test Specimen

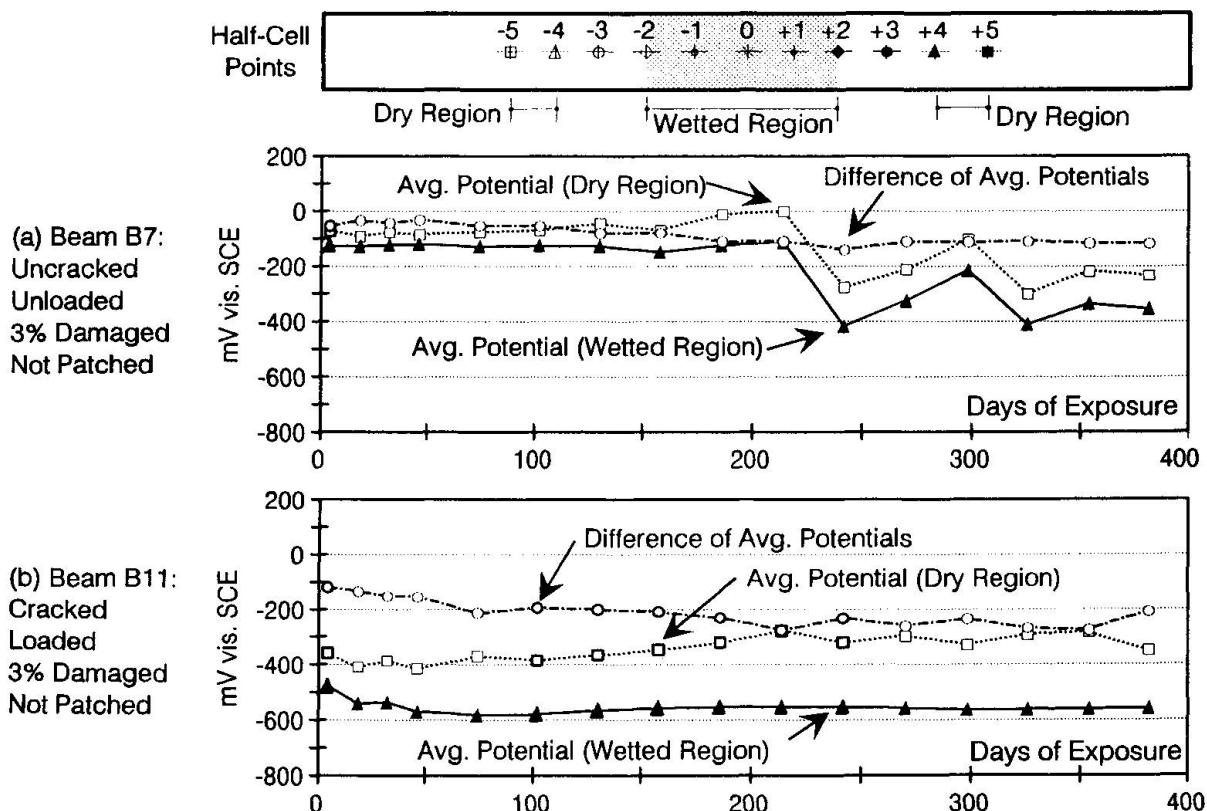
Fig. 2 Average Potentials of "Dry" and "Wet" Regions

Due to hydrolysis, the localized lower pH of solution within an active pit encourages further corrosion at the available potential level. This phenomenon explains why corrosion progression and pitting continued on some bars at a stable half-cell potential between -400 and -600 mV SCE.

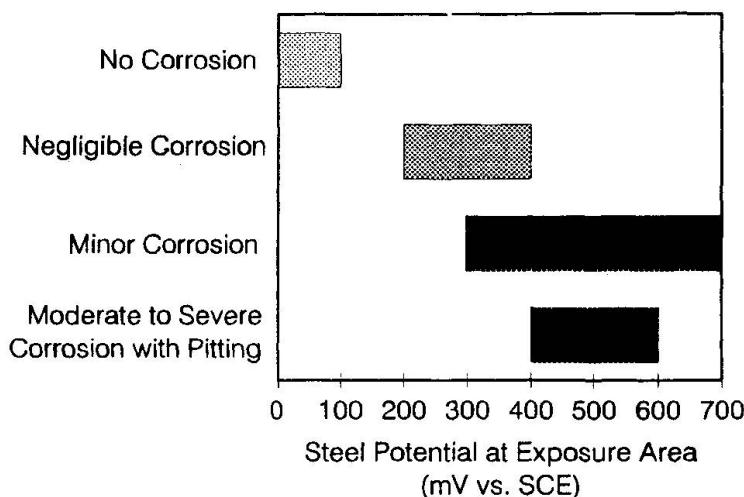
Fig. 3 Relation Between Corrosion Activity and Steel Potential

- No corrosion was associated with potential gradients  $< 150$  mV.
- General corrosion (negligible-moderate) was associated with potential gradients  $> 150$  mV.
- Pitting corrosion in presence of chlorides was associated with potential gradients  $> 200$  mV.

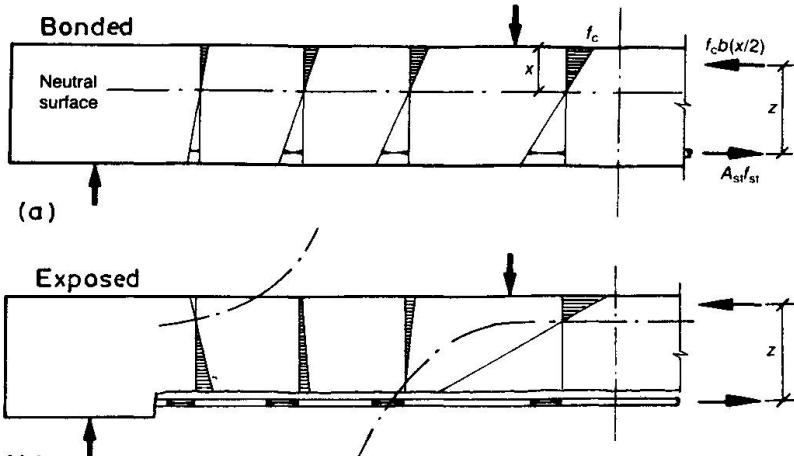
Figure 1 Pattern of strains in reinforced concrete beams

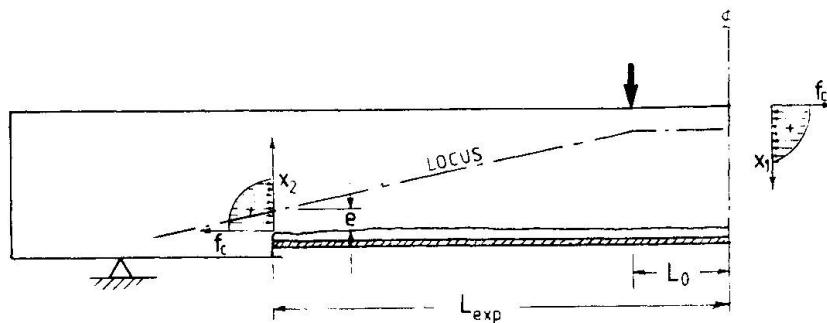
Figure 3 Pattern of stress at critical sections.

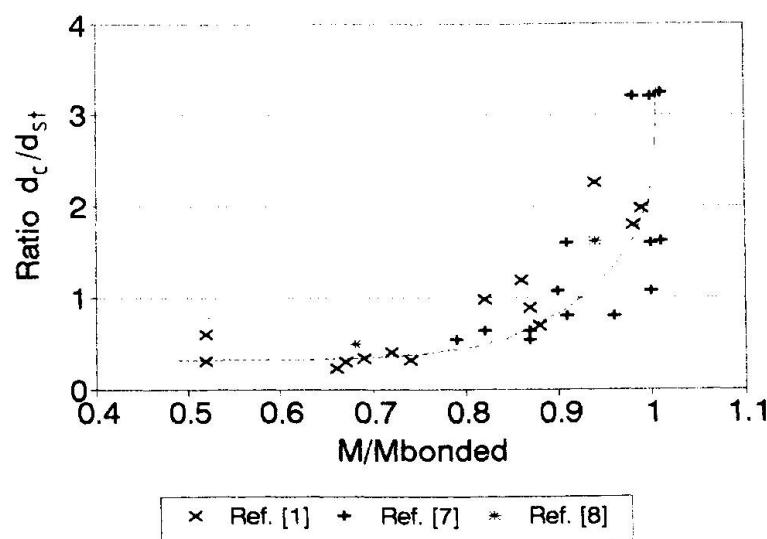
Figure 4 Comparison with test data.

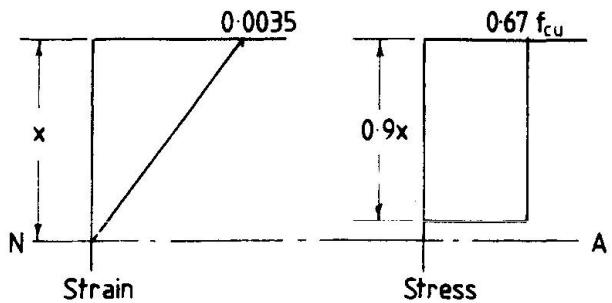
Figure 5 Simplified stress block for concrete at ultimate limit state.

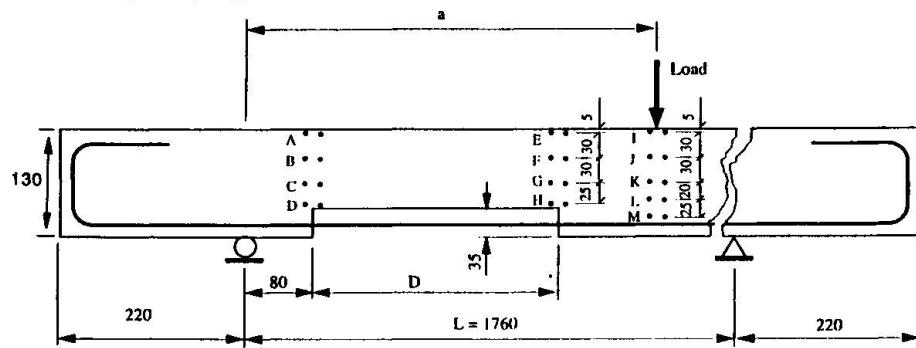
**Fig. 1**  
Details of the small scale beams

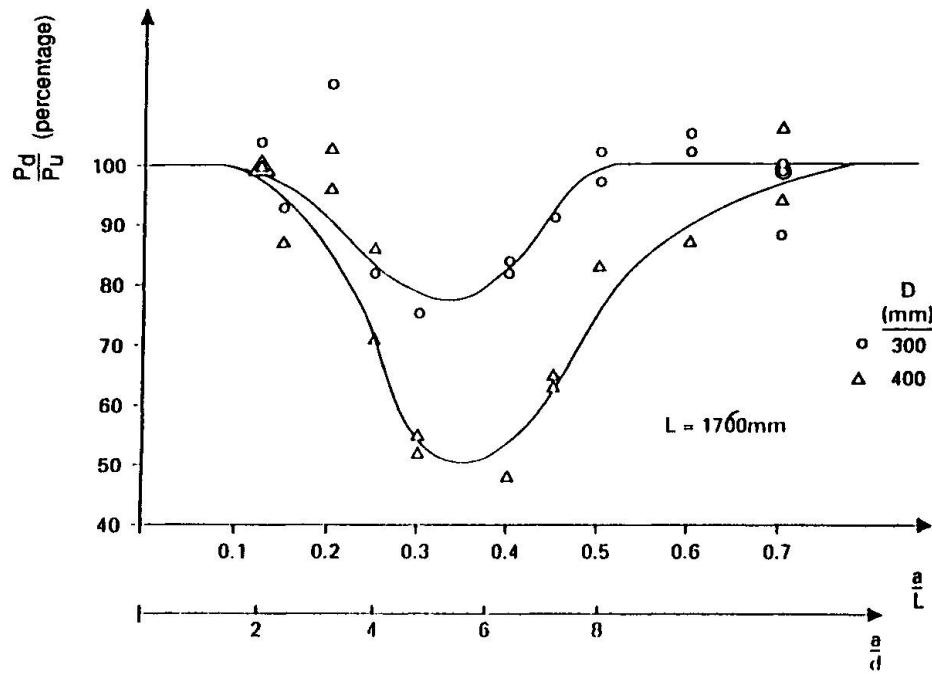
**Fig. 2**  
Variation of the loss of strength with changes in the position of the single point load for two values of  $D = 300$  and  $400\text{mm}$  - small scale tests.

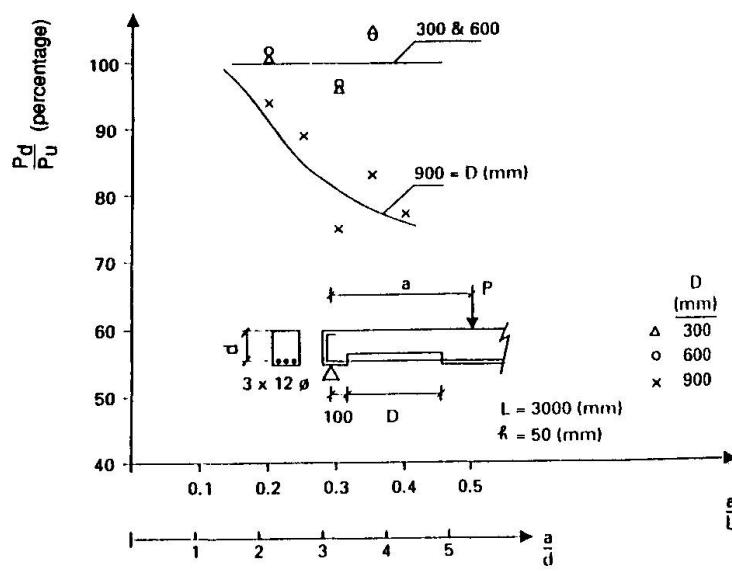
Fig. 3  
Variation of the loss of strength with changes in the position of the single point load for three values of  $D$  = 300, 600 and 900mm - large scale tests.

In the next phase of the experimental programme, a total number of eighty-eight large scale beams were tested following a similar testing procedure to that adopted for the small scale beams, but covering a much wider number of potentially important parameters: these included variations in the loading position,  $a/L$ , percentage of tensile steel reinforcements,  $A_s/bd$ , extent of loss of cover and bond,  $D$ , relative position of the damaged section from the support,  $x$ , depth of removal of concrete,  $h$ , effect of including nominal top steel (in the absence of stirrups), loading arrangement, and finally the effects of including shear reinforcement in the form of stirrups. The large scale beams had overall dimensions of 150 x 300mm with an overall length of 3500mm. They were all tested as simply supported beams with a clear span of 3000mm under single (or two) point loading whose position(s) varied from beam to beam. In most cases, each batch of large scale beams consisted of one undamaged (control) beam and three beams in which the cover and bond to main steel reinforcement was removed over a variable length,  $D$ . Three levels of  $D$ , namely, 300, 600 and 900mm were investigated.

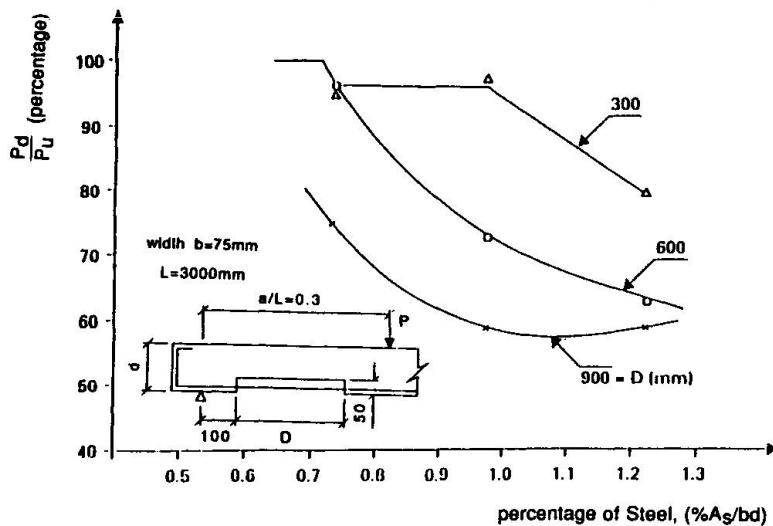
**Fig. 4**  
Variation of the loss of strength with changes in the percentage of tensile steel for  $D = 300$ ,  $600$  and  $900\text{mm}$  - large scale tests.

the percentage of tensile reinforcement can lead to substantial increases in the percentage loss of strength. Noting that the percentage of tensile reinforcement in small-scale beams of Fig. 2, and large scale beams of Fig. 3, were  $A_s/bd = 1.61\%$  and  $0.75\%$ , respectively, it is concluded that the much larger values of loss of strength in small scale beams (c.f. larger ones) has been mainly due to their significantly higher percentage of tensile reinforcement, with the relative values of  $h = 35$  and  $50\text{mm}$  in small and large scale beams, respectively, playing a role.

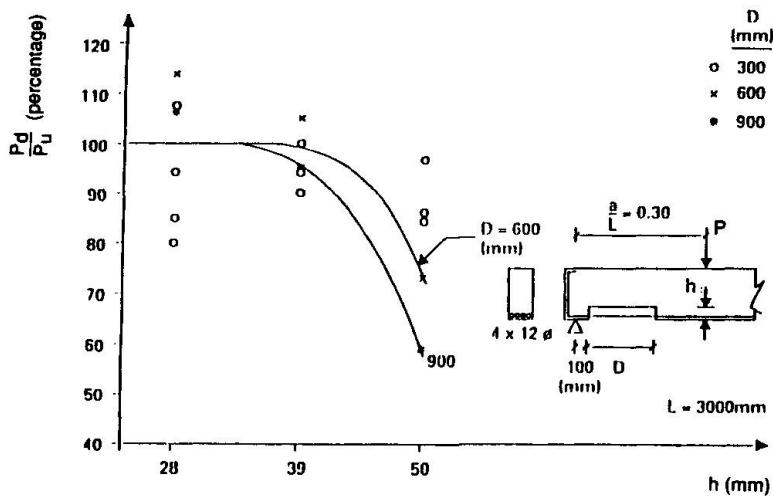
**Fig. 5**  
Effect of varying the depth of removal of concrete cover,  $h$ , on the percentage loss of strength in large scale tests for  $D = 300$ ,  $600$  and  $900\text{mm}$ .

The effect of varying the depth of removal of concrete cover,  $h$ , on the percentage loss of strength,  $P_d/P_u$ , is shown in Fig. 5. All the data in Fig. 5 were obtained for beams with  $x = 100\text{mm}$ ,  $a/d = 3.23$  (or  $a/L = 0.3$ ) and  $A_s/bd = 1\%$ . From data in Fig. 5 it is concluded that for the beams tested, the parameter  $P_d/P_u$  is only mildly sensitive to changes of  $h$  below  $40\text{mm}$ . Values of  $h$  greater than  $40\text{mm}$  are found to lead to sudden reductions in the measured values of residual strength with the reductions being more severe for increasing levels of the extent of damage,  $D$ . As mentioned previously, from plots in Fig. 5, there appears to be a threshold value of  $h$  above which (depending on concrete strength) substantial reductions in strength can occur. The value of  $h = 28\text{mm}$  in Fig. 5 corresponds to a nominal  $1\text{mm}$  gap between the steel and concrete simulating total loss of bond. In, for example, spalling conditions, it appears that even in extreme cases of total loss of bond there may be no significant adverse effect on ultimate strength. This observation may prove of value to those interested in the assessment of corrosion damaged structures where partial bond may still exist.

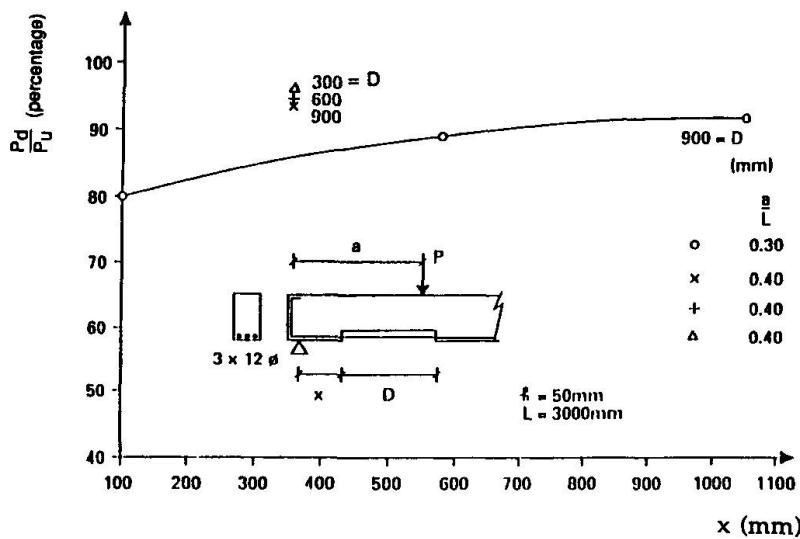
Fig. 6 shows the variation of  $P_d/P_u$  with the parameter,  $x$ , which defines the location of the region of exposed reinforcement (recess) from the simply supported end. Results in Fig. 6 suggest that, keeping other parameters constant, the closer the region of exposed reinforcement is to the support, the higher will be the magnitude of the loss of strength.

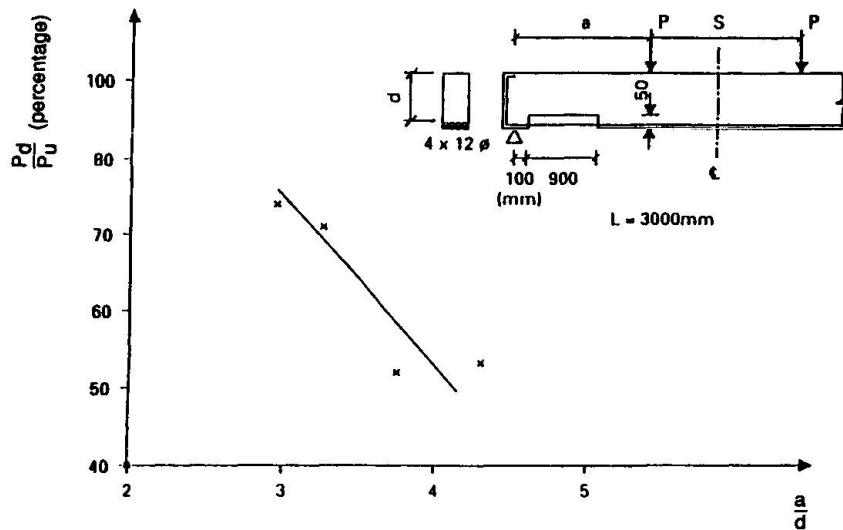
**Fig. 7**  
Variation of the loss of strength with changes in the position of two-point loadings - large scale tests.

steel) for the three beams which had nominal top steel. It should, however, be noted that none of the beams exhibited a ductile mode of failure.
