Zeitschrift: IABSE reports = Rapports AIPC = IVBH Berichte
Band: 73/1/73/2 (1995)

Rubrik: Session B4: Concrete durability II

Global Strategy to Enhance Service Life of Deteriorating Structures

Forecasting the Condition of a Reinforced Concrete Structure under Corrosion

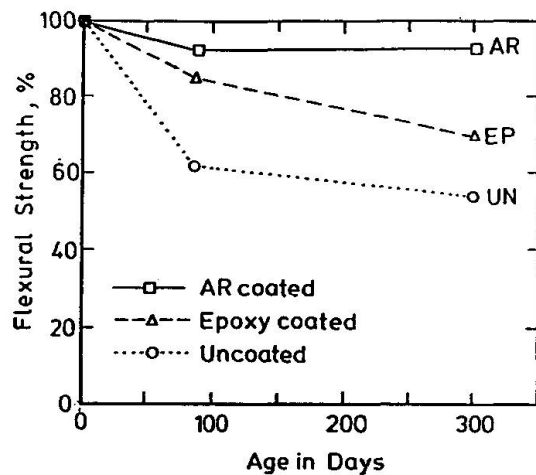
Fig. 2 Loss of flexural strength due to ASR expansion

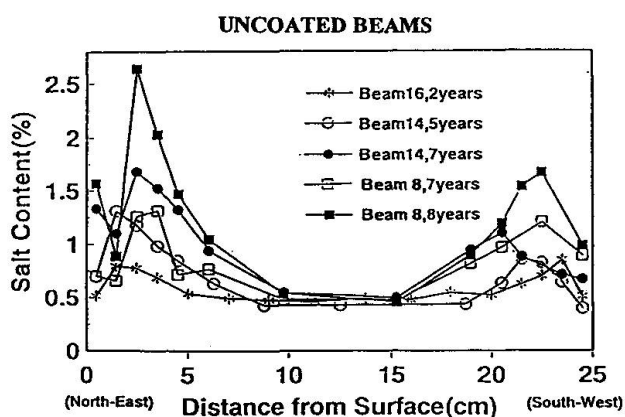
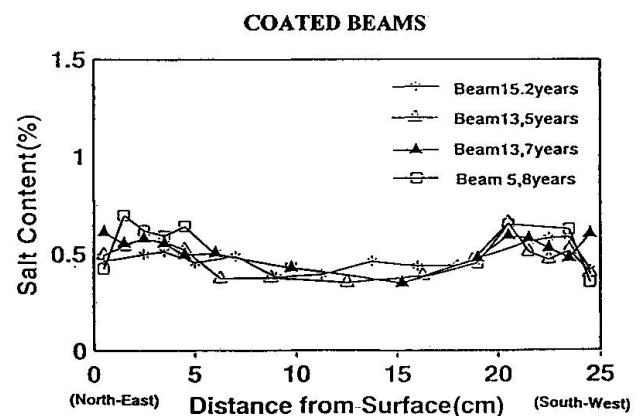
Fig. 3 Chloride distribution in beams with 0.5% salt

The total ability of the AR coating in controlling chloride penetration into concrete is illustrated in Fig. 3 which shows chloride distribution in uncoated and coated reinforced concrete beams made with 0.5% salt added during mixing and built in an aggressive marine environment with sub-tropical weather conditions of high temperature, humidity and wind, and exposed to salt-laden breeze and sea water splash. The performance data over 8 years is ample proof of the role and effectiveness of the coating and its ability to maintain its continuity and integrity.

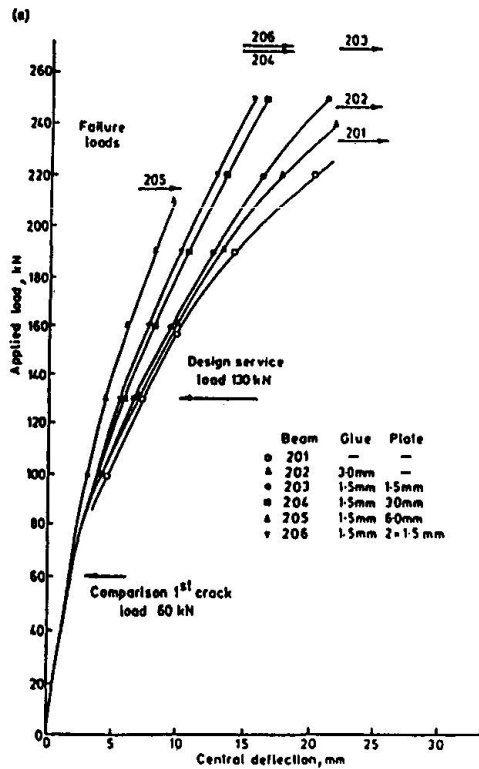
Fig. 4 Effect of bonded plates on mid-span deflection

The provision of a steel plate at the tension face of a beam significantly reduces both deflections and crack widths, more than what would be achieved by additional internal reinforcement equivalent to that of the external plate, (Figs 4 and 5). The stiffening and crack controlling action of the plates can lead to substantial increases in serviceability loads for various serviceability conditions as shown in Table 2. Plating structurally damaged beams can also lead to substantial reductions in deformations and increases in serviceability loads, as shown in Table 3.

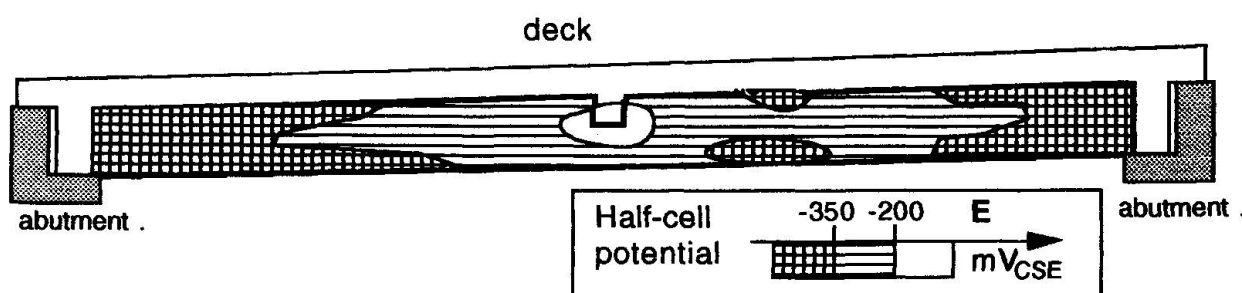
Fig. 1 : Example of potential map of a bridge member, about 7 m long and 0.5 m high.

Figure 1 gives an example of potential mapping. It deals with a bridge, in mountain area, on which deicing salts have been applied. This map shows that the corroding rebars are also in the lower part of the members, near their ends. The reason of this deterioration was that the waterproof membrane (on the bridge deck) was not effective at its ends.

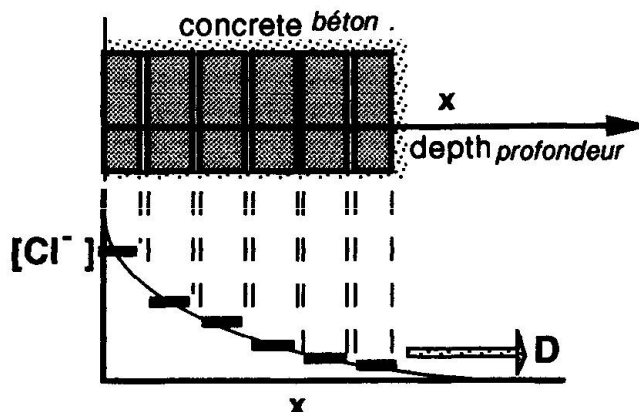
So, soluble chloride content is determined at various depths in concrete. Results are plotted in a curve (chloride profile) giving the chloride content against the concrete depth (Fig. 2). If some assumptions are met, chloride profiles can be interpreted in terms of a diffusion process. One of these assumption is that the concrete humidity shall be almost constant. But some theoretical studies [2] [3] [4] have also shown that chloride penetration into concrete can be assumed to be a diffusion process only if the concrete cover is not deteriorated during the chloride penetration.

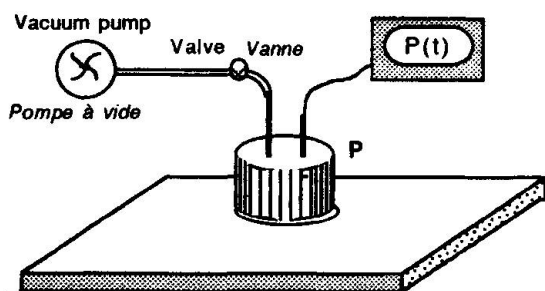
Fig. 3 :

Principle of the equipment for measuring the air permeability of a concrete surface.

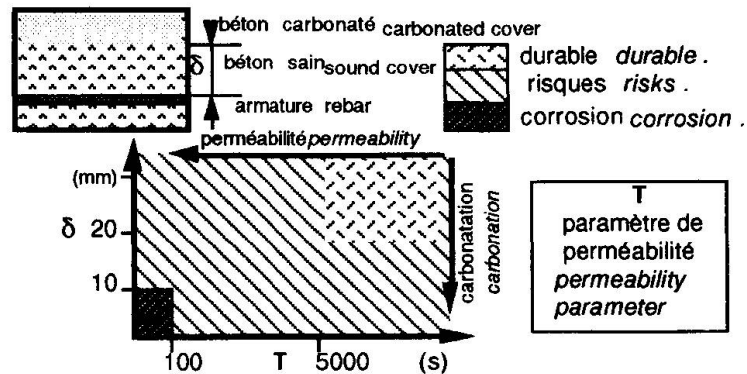
As mentioned here above, results of carbonation depth and air permeability measurements can predict if rebar, in the investigated area, will likely corrode [8]. Fig. 4 shows that, when the carbonation depth is thin and the air permeability low, rebar corrosion will not occur in short term. On the contrary, if the concrete cover is carbonated and if it is permeable to fluids, rebar are likely corroding.

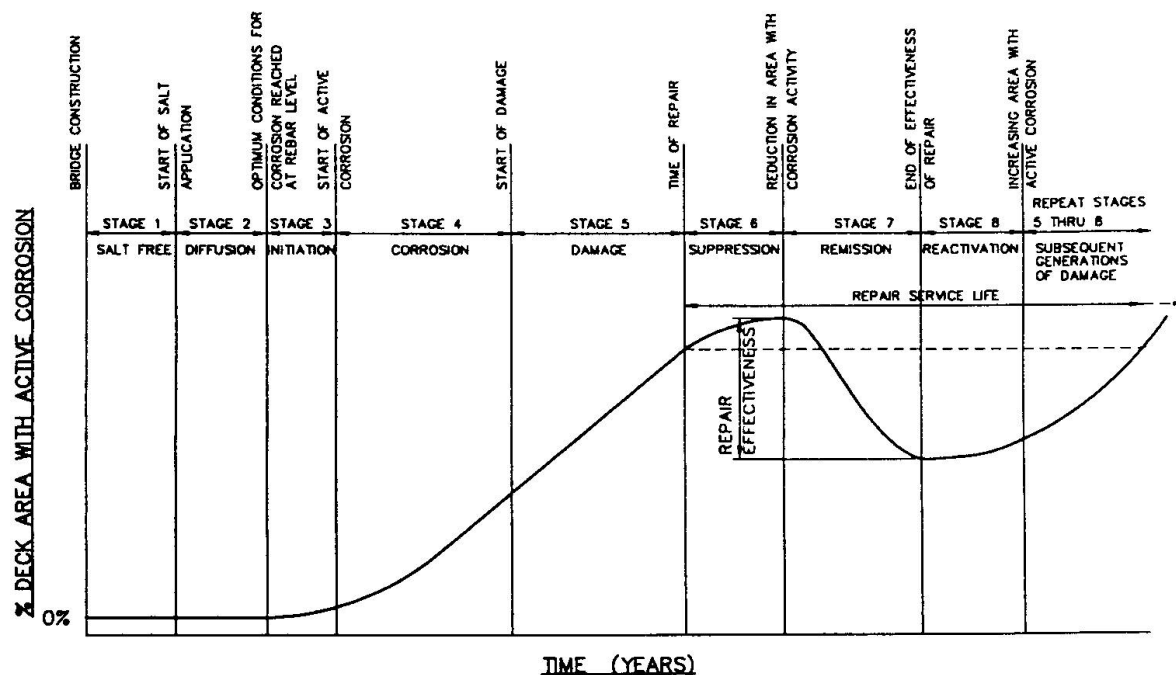
Figure 2 Bridge Deck Corrosion Life Cycle

Damage levels generally build up over time and it is considered that there is a threshold level of damage above which a deck system is considered completely failed. Complete failure is either due to the deck becoming unsafe structurally or due to it developing an unacceptably poor rideability resulting from damage levels that are too great to permit selective repairs. Levels of damage which precede the threshold level sometimes manifest in the form of minor spalling and/or potholes and some limited amount of associated poor rideability. However, levels of damage that have proven economical to repair are often limited to internal delamination, cracking and debonding that are invisible, but which can be detected by non-destructive diagnostic methods such as chain drag delamination surveys and/or electrical potential corrosion surveys. Figure 2 depicts a generic life cycle for a bridge deck subjected to a corrosive environment and a repair application. It presents characteristic stages which are considered pertinent to this subject matter.

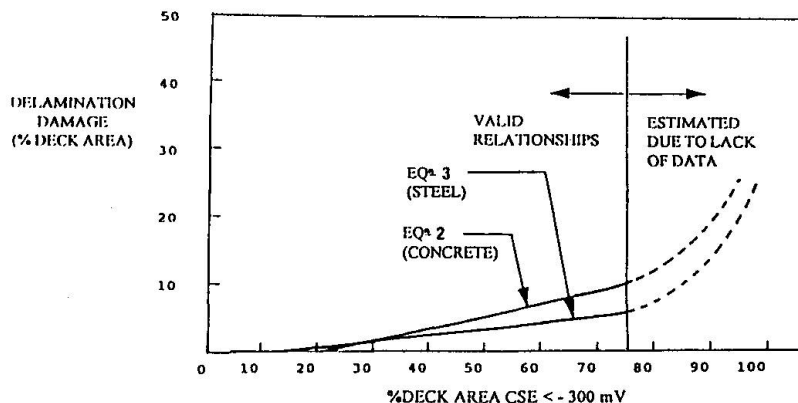
Figure 3 Damage vs. CSE, -300 mV

The data was separated and relationships developed for the two categories of girder types because of the perception, based upon observations of experienced field personnel, that the two types of bridges tend to perform differently, probably due to the inherent differences in flexibility and thermal sensitivity. Figure 3 shows equations (2) and (3) plotted, and it appears from this derivation that corrosion-induced damage begins to develop when CSE readings are more negative than -300 mV over about 10% to 25% of the deck area. Figure 3 also shows that on average less damage occurs in steel girder bridge decks than for concrete girder decks at a given level of CSE measured corrosion activity. It is hypothesized that the presence of the steel girder tends to increase the corrosion activity measured within the deck, but that this additional activity associated with the steel girder is not likely causing any additional damage to the deck. However, it is important to note that the variability of damage observed on steel girder decks, as represented by the reliability index, R^2 , is significantly greater.

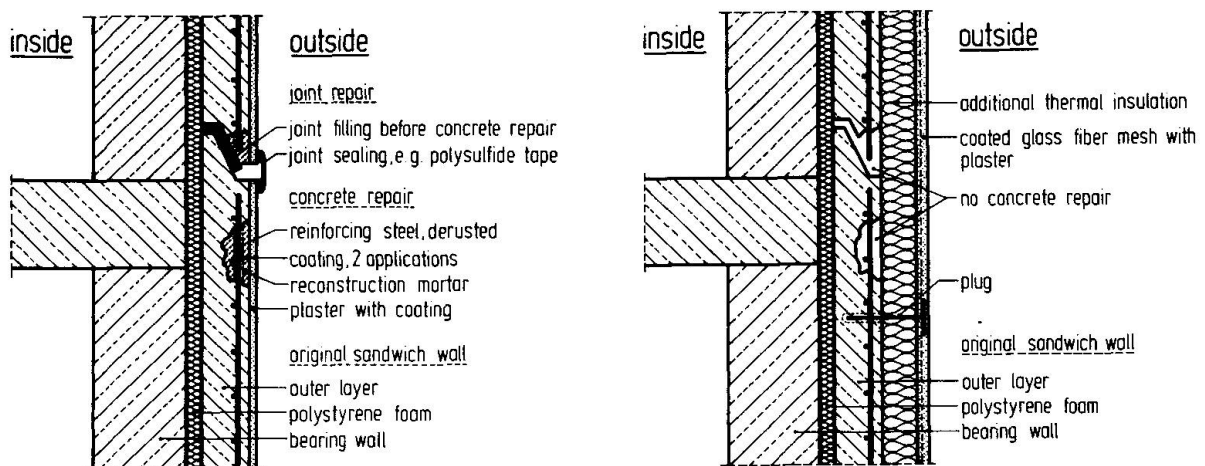
Fig. 1 Common method of concrete repair to the exterior of a sandwich wall (left), alternative repair using an external thermal insulation composite system (ETICS, right)

It can be demonstrated by diffusion calculations that it is possible to dry the exterior walls of concrete buildings in Central European or similar climates by attaching an additional thermal insulation to the outside of these walls. Preliminary results were reported at the IABSE symposium in Lisbon, 1989 [1]. By the undermentioned tests it will be verified that it is possible to arrest rebar corrosion by means of additional thermal insulation (fig. 1 right).

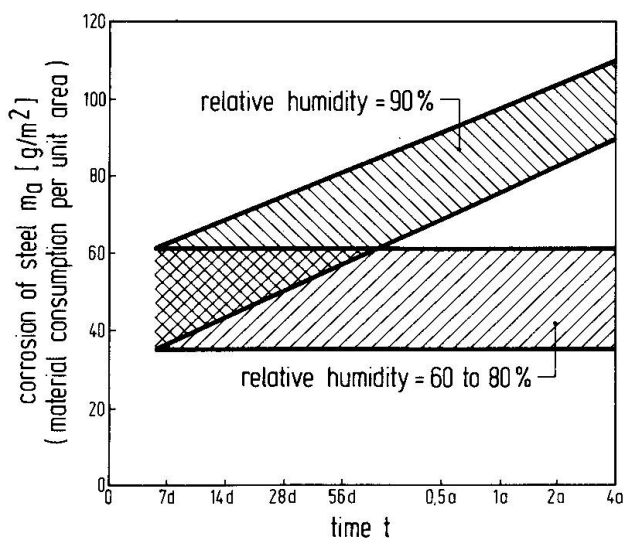
Fig. 2 Mass losses of rebars in carbonated concrete specimens stored at different r.h.

These experiments show that steel corrosion in reinforced concrete can be arrested if the concrete moisture level is in equilibrium to not more than 80 % relative humidity to the surrounding atmosphere, a result which does not depend on the reinforcing steel type.

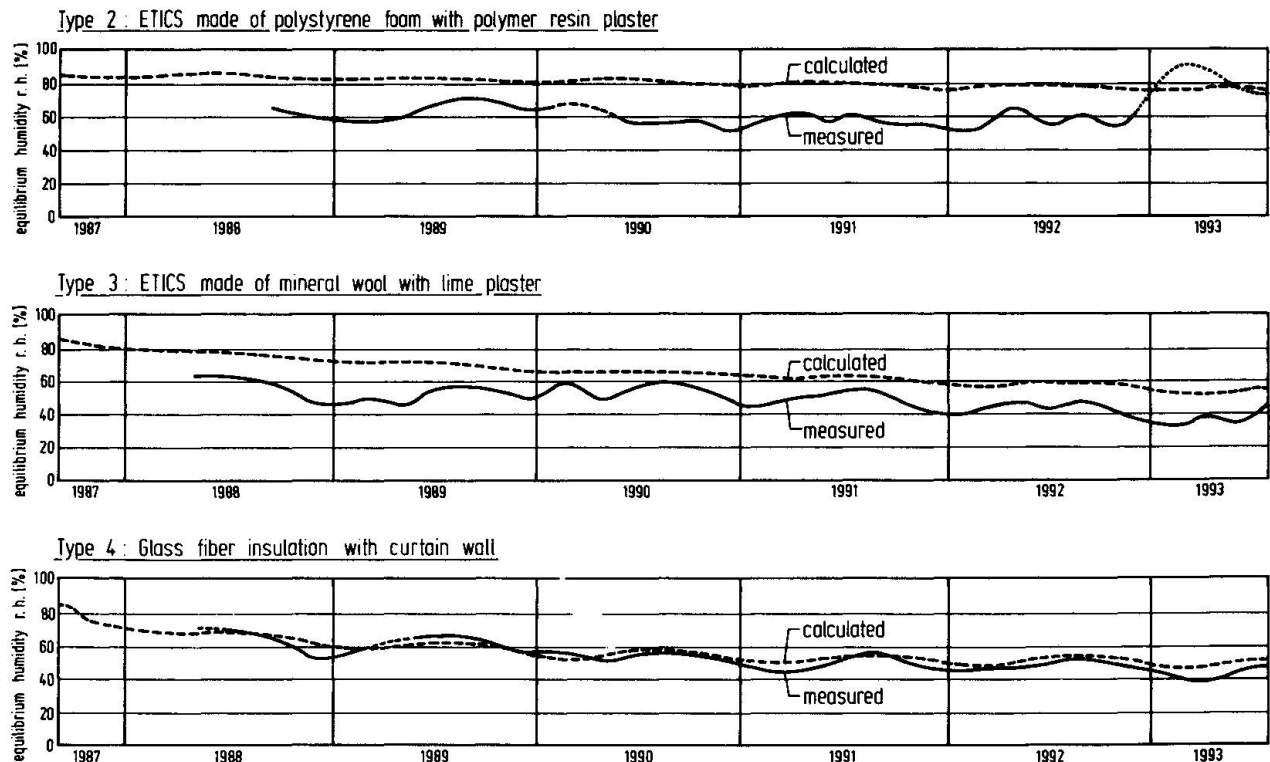
Fig. 3 Measured and calculated equilibrium humidities in the outer layers of concrete sandwich exterior walls with additional thermal insulation

- the outer layers of the sandwich walls were drying behind the additional thermal insulation significantly, and after a few years the concrete moisture level was in an equilibrium at the measured relative humidity of 40 to 70 % (fig. 3),
- the bearing walls were drying, too, and after a few years the concrete moisture level was in an equilibrium at the measured relative humidity of 30 to 60 %.

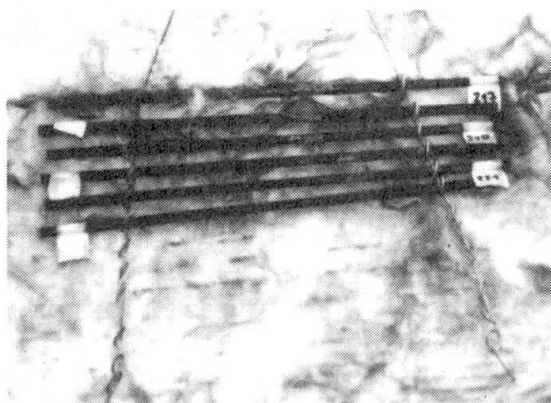
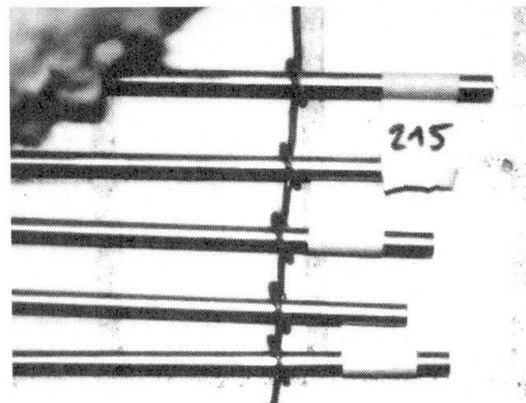
Fig. 4 Unprotected steel bars after one year of in-situ storage between a curtain wall and the fiberglass insulation behind it (left) and between the fiberglass insulation and the outer layer of the sandwich exterior wall (right)

- steel bars were placed in the airspace between the curtain wall and the additional fiberglass insulation (type 4, cp. table 1),
- steel bars were mounted between the different additional thermal insulations (type 2, 3 and 4, cp. table 1) and the outer layer of the original sandwich wall, too.

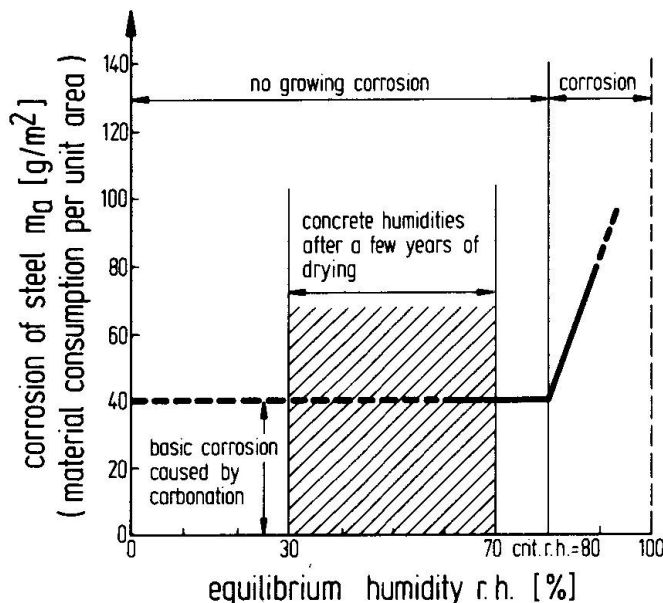
Fig. 5 Scheme of arresting rebar corrosion in concrete exterior walls using additional thermal insulation

- the concrete layers of sandwich exterior walls with additional thermal insulation will get moistures in equilibrium to relative humidities of 30 to 70 % after a few years of drying,
- steel in carbonated concrete specimens needs more than 80 % relative humidity for corrosion (fig. 5).

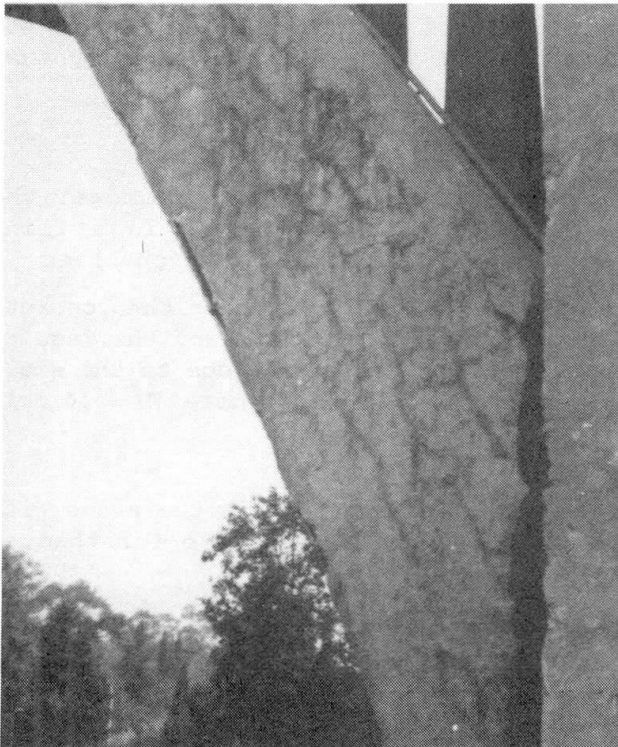
Fig. 2 Central Arch, southern view. Map cracking

The areas of greater deterioration were located in the central arch, below which the road traffic is more intense, in places more exposed to rain and sunshine. Figs. 2 and 3 show typical examples of cracking observed in concrete.

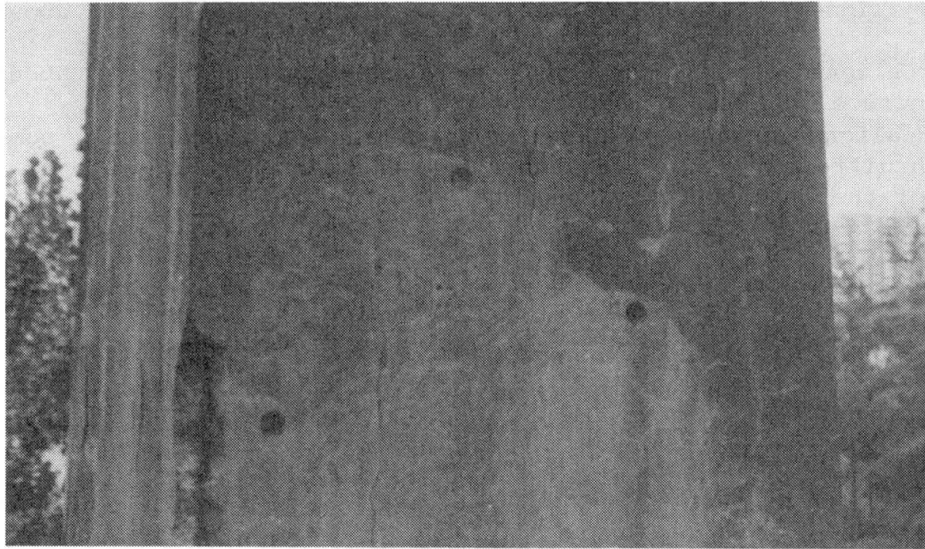
Fig. 3 Column of the Central Arch, facing the south. Cracking aligned with the main reinforcing bars

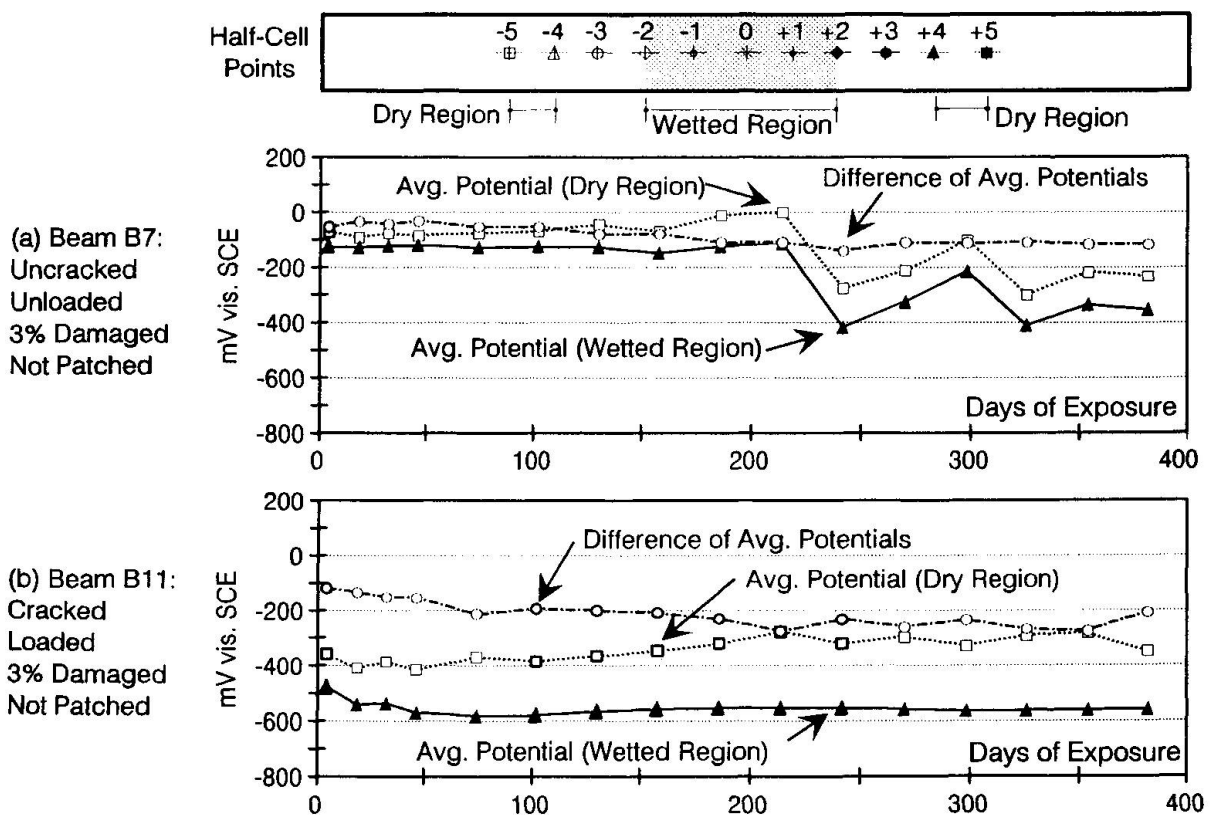
Fig. 2 Average Potentials of "Dry" and "Wet" Regions

Due to hydrolysis, the localized lower pH of solution within an active pit encourages further corrosion at the available potential level. This phenomenon explains why corrosion progression and pitting continued on some bars at a stable half-cell potential between -400 and -600 mV SCE.

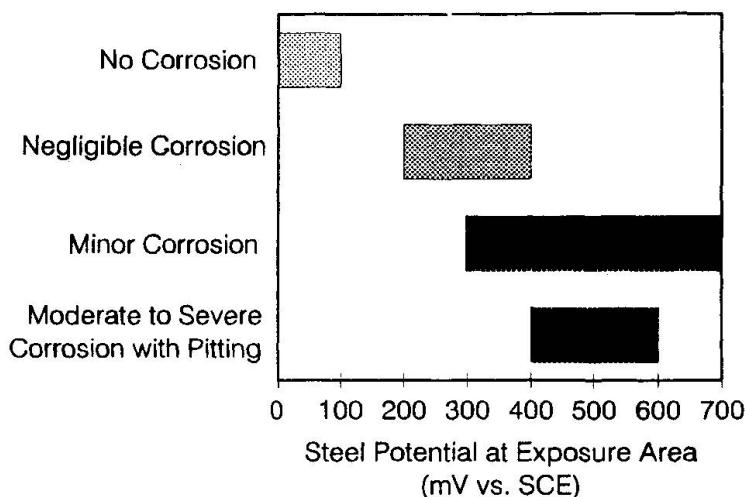
Fig. 3 Relation Between Corrosion Activity and Steel Potential

Previous studies have indicated that the electrical potential of an anode cannot be used to indicate rate of corrosion. Elsener and Bohni[4] found that the local potential gradient was a better way to identify the type of corrosion and to locate corroding sites. Large differences of potentials along a concrete member may be used as indicators of macrocell formations. The closely-spaced potential measurement points along the beam surfaces allowed the identification of predominantly anodic and cathodic sites. Potential differences were studied between adjacent and far points (about 0.6 m apart). The state of corrosion was consistently related to these differences as follows:

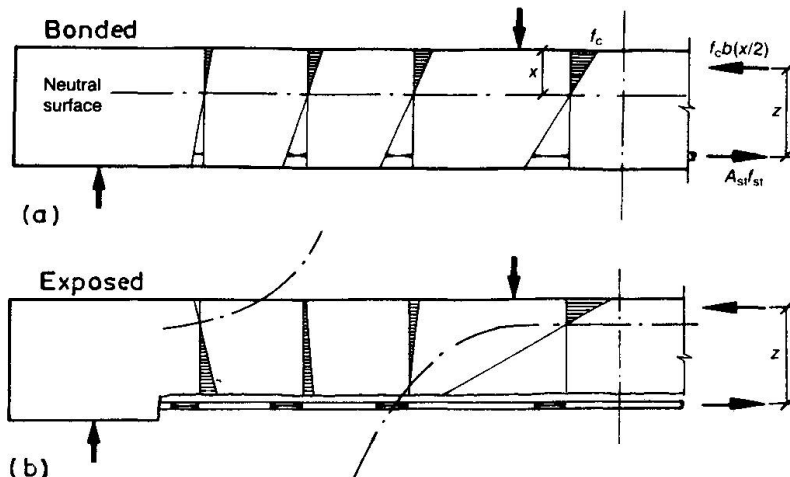
Figure 1 Pattern of strains in reinforced concrete beams

that of an equivalent bonded bar under a given load. To satisfy compatibility, there must also be an increase in elongation of the concrete between anchorages. The necessary increase in elongation of the concrete is achieved through an increase in curvature of the concrete section near midspan. This will in turn increase the maximum compressive strain in the concrete at midspan. As failure of reinforced concrete is deemed to occur at a limiting compressive strain, it is clear that bending strength may be affected by loss of bond.

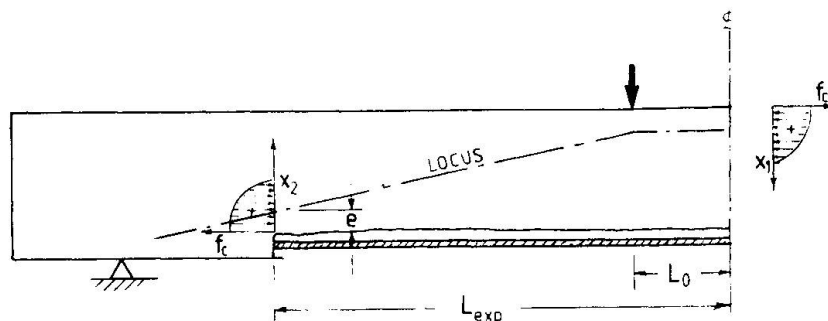
Figure 3 Pattern of stress at critical sections.

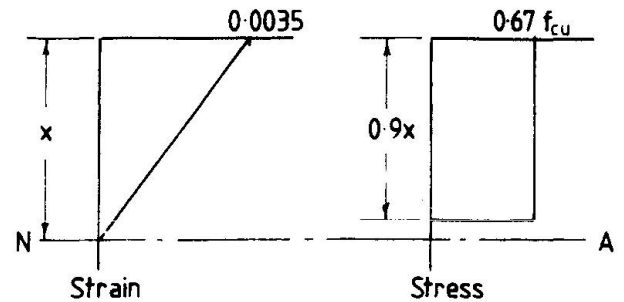
Figure 5 Simplified stress block for concrete at ultimate limit state.

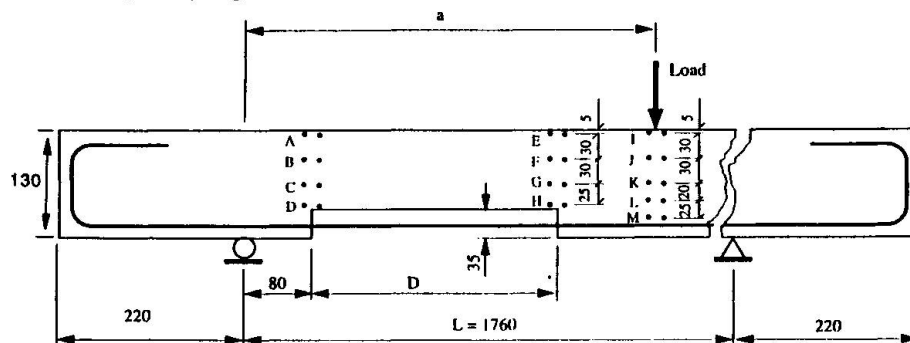
Fig. 1
Details of the small scale beams

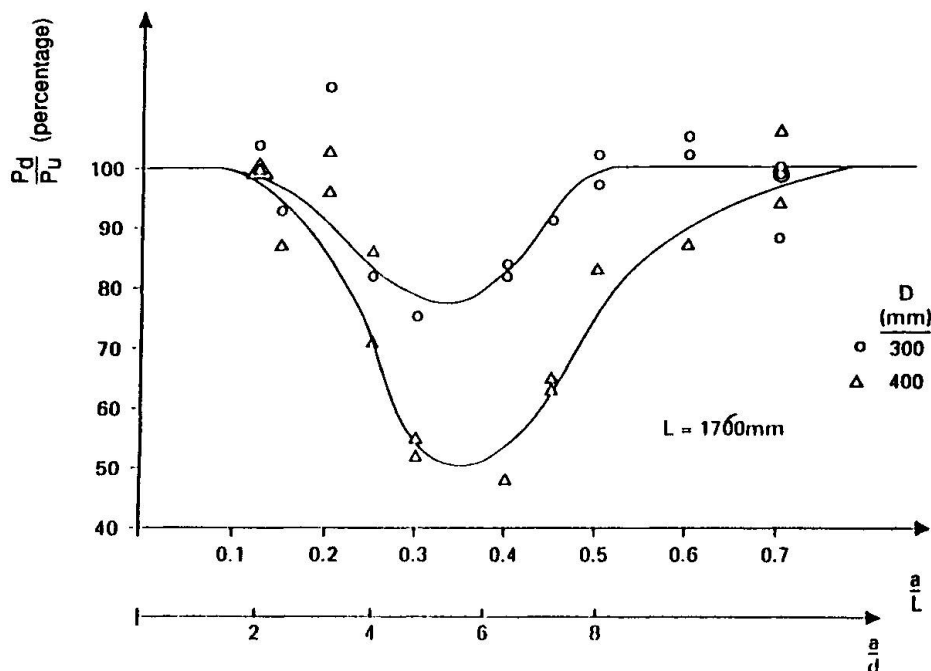
Fig. 2
Variation of the loss of strength with changes in the position of the single point load for two values of $D = 300$ and 400 mm - small scale tests.

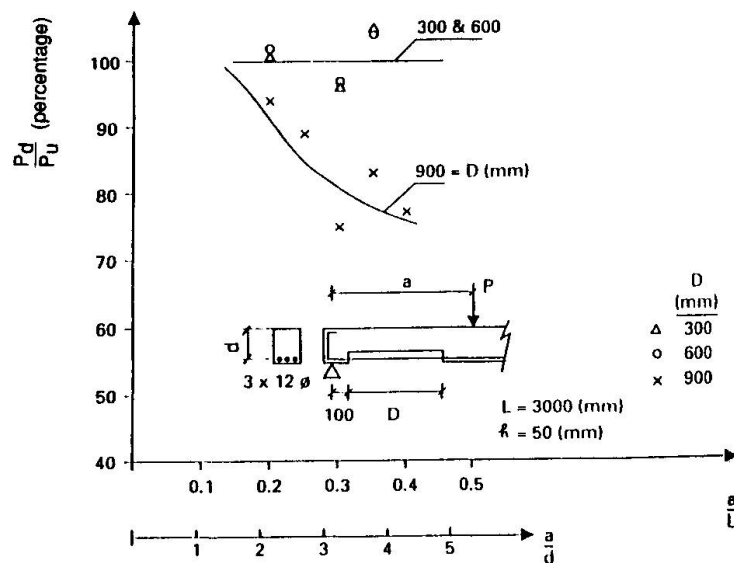
Fig. 3
Variation of the loss of strength with changes in the position of the single point load for three values of $D = 300$, 600 and 900 mm - large scale tests.

In the next phase of the experimental programme, a total number of eighty-eight large scale beams were tested following a similar testing procedure to that adopted for the small scale beams, but covering a much wider number of potentially important parameters: these included variations in the loading position, a/L , percentage of tensile steel reinforcements, A_s/bd , extent of loss of cover and bond, D , relative position of the damaged section from the support, x , depth of removal of concrete, h , effect of including nominal top steel (in the absence of stirrups), loading arrangement, and finally the effects of including shear reinforcement in the form of stirrups. The large scale beams had overall dimensions of 150×300 mm with an overall length of 3500 mm. They were all tested as simply supported beams with a clear span of 3000 mm under single (or two) point loading whose position(s) varied from beam to beam. In most cases, each batch of large scale beams consisted of one undamaged (control) beam and three beams in which the cover and bond to main steel reinforcement was removed over a variable length, D . Three levels of D , namely, 300 , 600 and 900 mm were investigated.

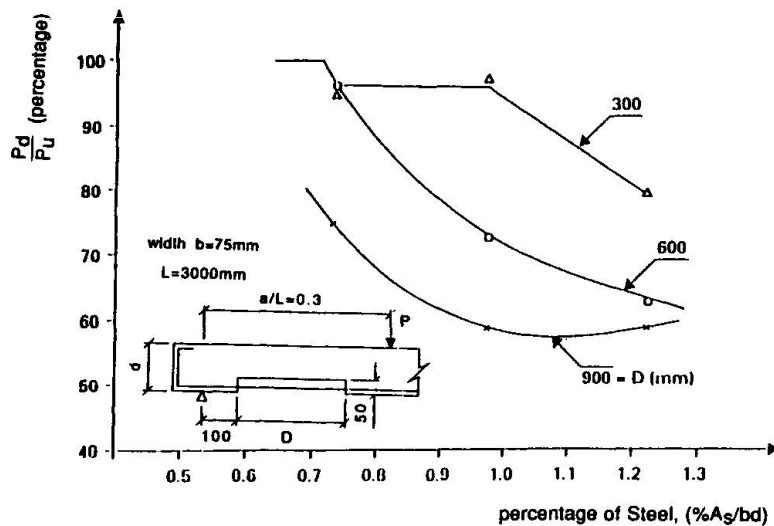
Fig. 4
Variation of the loss of strength with changes in the percentage of tensile steel for $D = 300, 600$ and 900mm - large scale tests.

the percentage of tensile reinforcement can lead to substantial increases in the percentage loss of strength. Noting that the percentage of tensile reinforcement in small-scale beams of Fig. 2, and large scale beams of Fig. 3, were $A_s/bd = 1.61\%$ and 0.75% , respectively, it is concluded that the much larger values of loss of strength in small scale beams (c.f. larger ones) has been mainly due to their significantly higher percentage of tensile reinforcement, with the relative values of $h = 35$ and 50mm in small and large scale beams, respectively, playing a role.

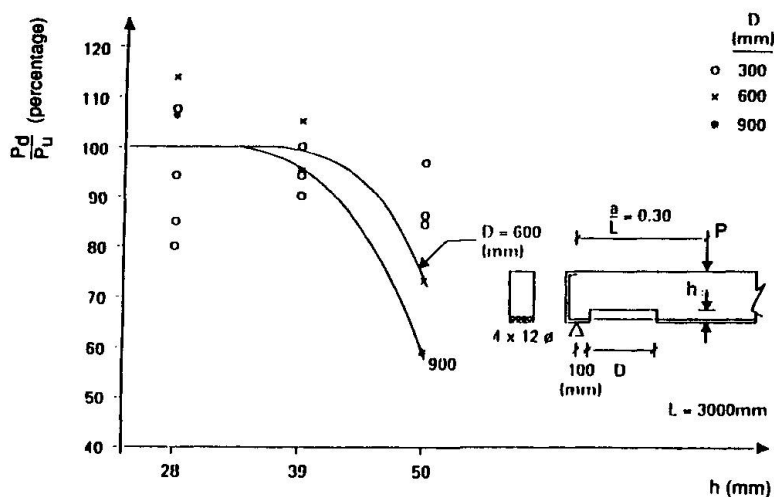
Fig. 5
Effect of varying the depth of removal of concrete cover, h , on the percentage loss of strength in large scale tests for $D = 300, 600$ and 900mm .

The effect of varying the depth of removal of concrete cover, h , on the percentage loss of strength, P_d/P_u , is shown in Fig. 5. All the data in Fig. 5 were obtained for beams with $x = 100\text{mm}$, $a/d = 3.23$ (or $a/L = 0.3$) and $A_s/bd = 1\%$. From data in Fig. 5 it is concluded that for the beams tested, the parameter P_d/P_u is only mildly sensitive to changes of h below 40mm . Values of h greater than 40mm are found to lead to sudden reductions in the measured values of residual strength with the reductions being more severe for increasing levels of the extent of damage, D . As mentioned previously, from plots in Fig. 5, there appears to be a threshold value of h above which (depending on concrete strength) substantial reductions in strength can occur. The value of $h = 28\text{mm}$ in Fig. 5 corresponds to a nominal 1mm gap between the steel and concrete simulating total loss of bond. In, for example, spalling conditions, it appears that even in extreme cases of total loss of bond there may be no significant adverse effect on ultimate strength. This observation may prove of value to those interested in the assessment of corrosion damaged structures where partial bond may still exist.

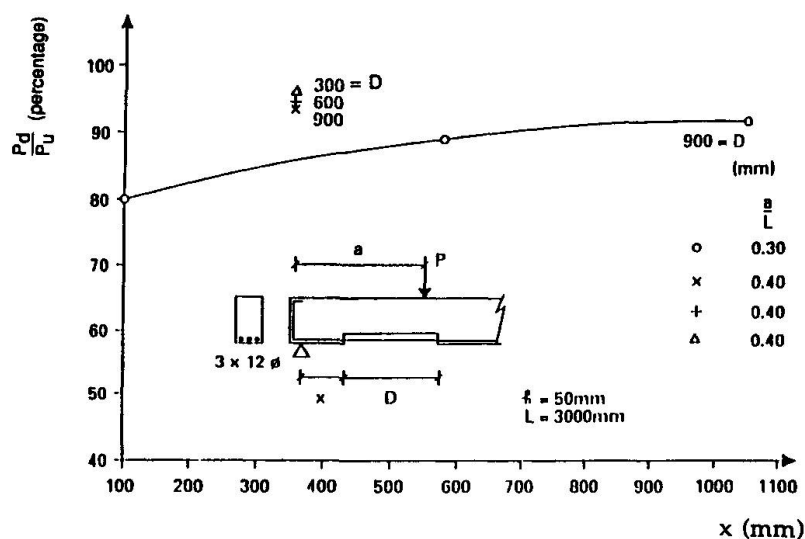
Fig. 6
Variation of the percentage loss of strength with the location of the simulated damage area (recess) with respect to the simply supported end, x , for $D = 900\text{mm}$ - large scale tests.

Fig. 6 shows the variation of P_d/P_u with the parameter, x , which defines the location of the region of exposed reinforcement (recess) from the simply supported end. Results in Fig. 6 suggest that, keeping other parameters constant, the closer the region of exposed reinforcement is to the support, the higher will be the magnitude of the loss of strength.

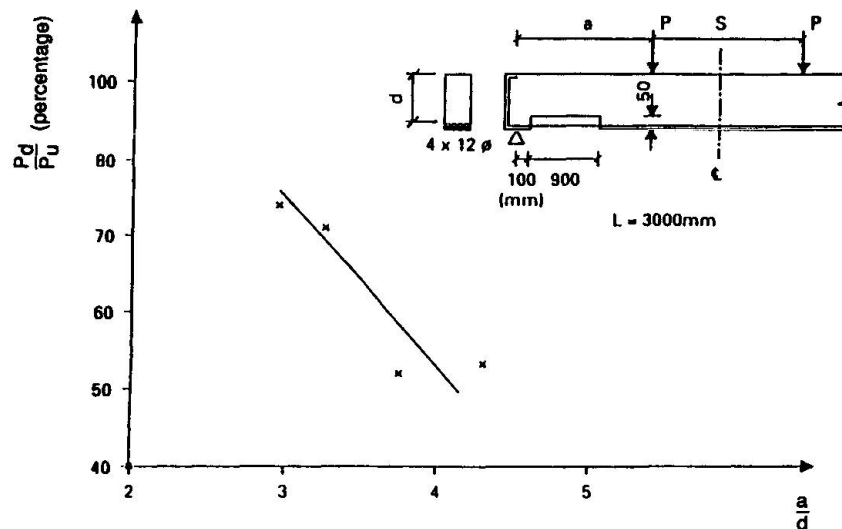
Fig. 7
Variation of the loss of strength with changes in the position of two-point loadings - large scale tests.

steel) for the three beams which had nominal top steel. It should, however, be noted that none of the beams exhibited a ductile mode of failure.
