Zeitschrift: IABSE reports = Rapports AIPC = IVBH Berichte
Band: 73/1/73/2 (1995)

Rubrik: Session C1: General repair of bridges II

General Repair of Bridges II

Cable Anchorage Repairs on New York City Suspension Bridges

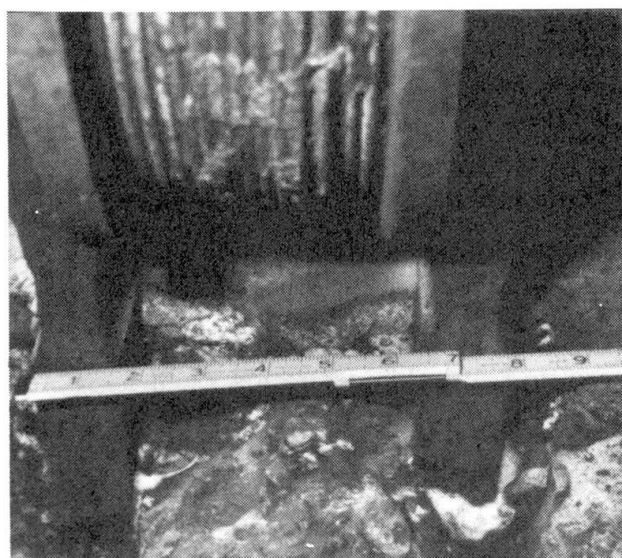
When chipping off the layers of loose rust, it was seen that a hard dark gray layer of corrosion product was firmly attached to the steel. Wire brushing only polished this material, and chipping with chisels and hammers was necessary to remove it. In both bridges, it quickly became obvious that the dark corrosion product concealed considerable section loss, and removal by grit blasting was required to clean the bars to white metal. During this process, it was found that the steel bars are indeed protected from corrosion inside their concrete embedment. In both cases, corrosion loss stopped abruptly at the concrete surface. Above the concrete surface, varying degrees of corrosion were found, with losses exceeding 40 percent in some eyebars (Figure 1, in inches).

Figure 1. Corroded Eyebars on Manhattan Bridge

In both cases, drainage from the roadway is the major culprit in causing the corrosion. In the Manhattan Bridge, this chloride laden water entered through cracks and porosity in the unreinforced concrete vaults, exacerbated by the presence of an abandoned, but not sealed, system of clay tile drains in the concrete.

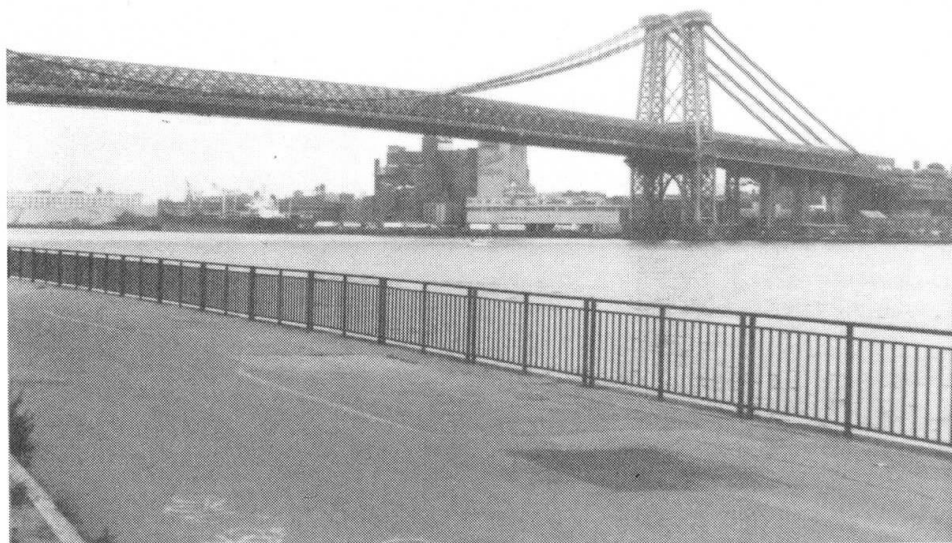
Figure 6
Partial View of Williamsburg Bridge during the Cable Rehabilitation Work

Work started in September 1992 and is scheduled to be completed at the end of September 1995. The first stage was the construction of 2.4 m wide footwalks under each cable (Figure 6), except at the center of the main span, where the proximity of the cable to the roadway allowed the Contractor to work from scaffolding installed on the roadway. The work proceeded according to the Contract Plans, and as described here, except for some minor modifications. Work remaining to be done consists primarily of the cable enclosures and the remainder of the new roof at the anchorages. In addition to the work included in the Rehabilitation Contract Plans, the cable condition encountered after removal of the splay casting of Cable A at the Manhattan anchorage forced the decision to replace seven strands [Ref. 6].
