## **Cable Anchorage Repairs on New York City Suspension Bridges**

**Ronald M. MAYRBAURL**

Weidlinger Associates

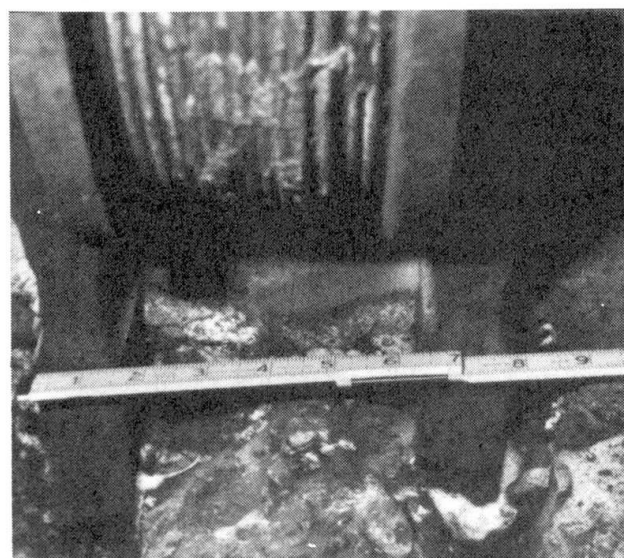
When chipping off the layers of loose rust, it was seen that a hard dark gray layer of corrosion product was firmly attached to the steel. Wire brushing only polished this material, and chipping with chisels and hammers was necessary to remove it. In both bridges, it quickly became obvious that the dark corrosion product concealed considerable section loss, and removal by grit blasting was required to clean the bars to white metal. During this process, it was found that the steel bars are indeed protected from corrosion inside their concrete embedment. In both cases, corrosion loss stopped abruptly at the concrete surface. Above the concrete surface, varying degrees of corrosion were found, with losses exceeding 40 percent in some eyebars (Figure 1, in inches).

Figure 1. Corroded Eyebars on Manhattan Bridge

On the Manhattan Bridge, the average loss in section in one of the cable anchorages was over 27 percent, with losses in some eyebars up to 44 percent. An analysis of the remaining eyebar strength, showed that the cable could not safely carry the transit or highway loads on this side of the bridge supported by this cable (there are four subway tracks on the bridge). Fortunately, this side of the bridge was closed for rehabilitation work, and the closure was extended for 18 months so the cable anchorage could be reinforced.

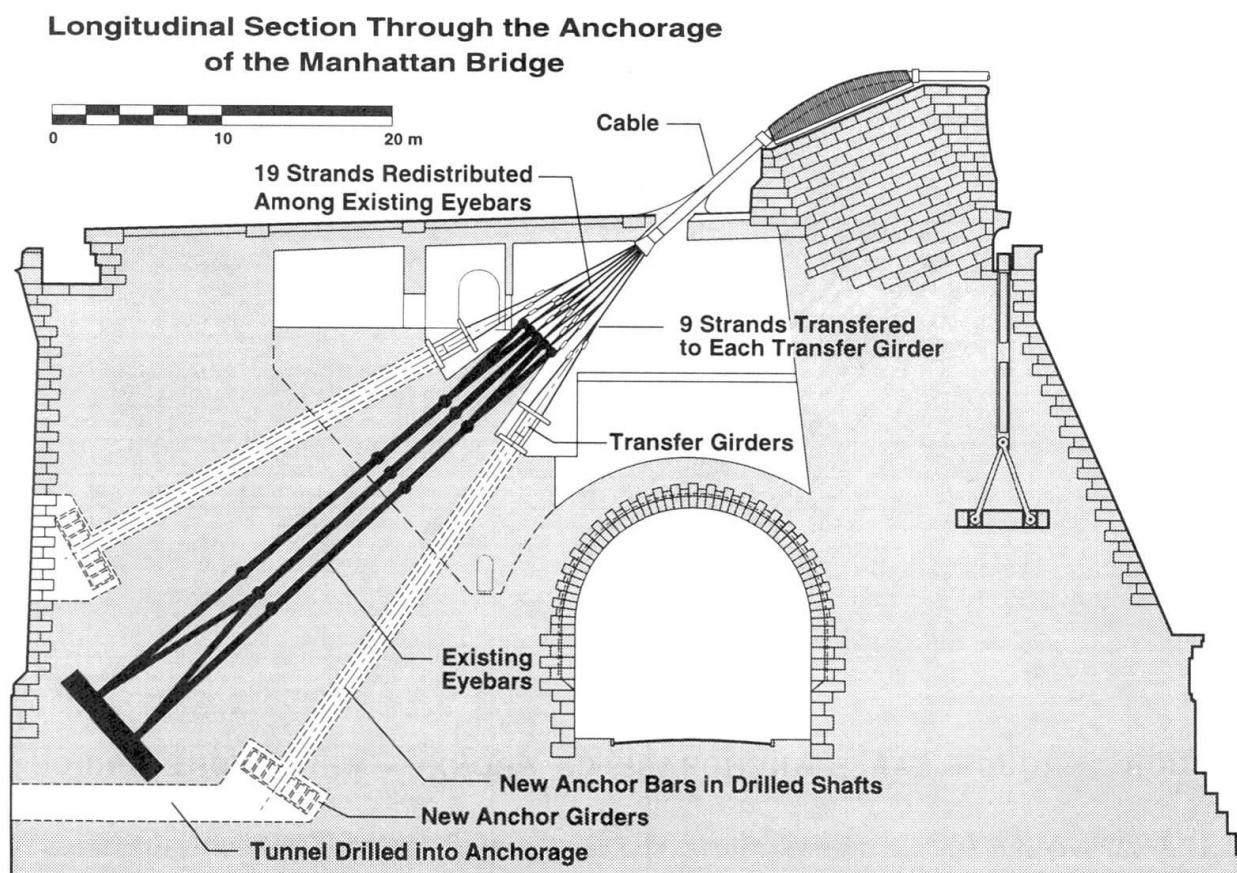
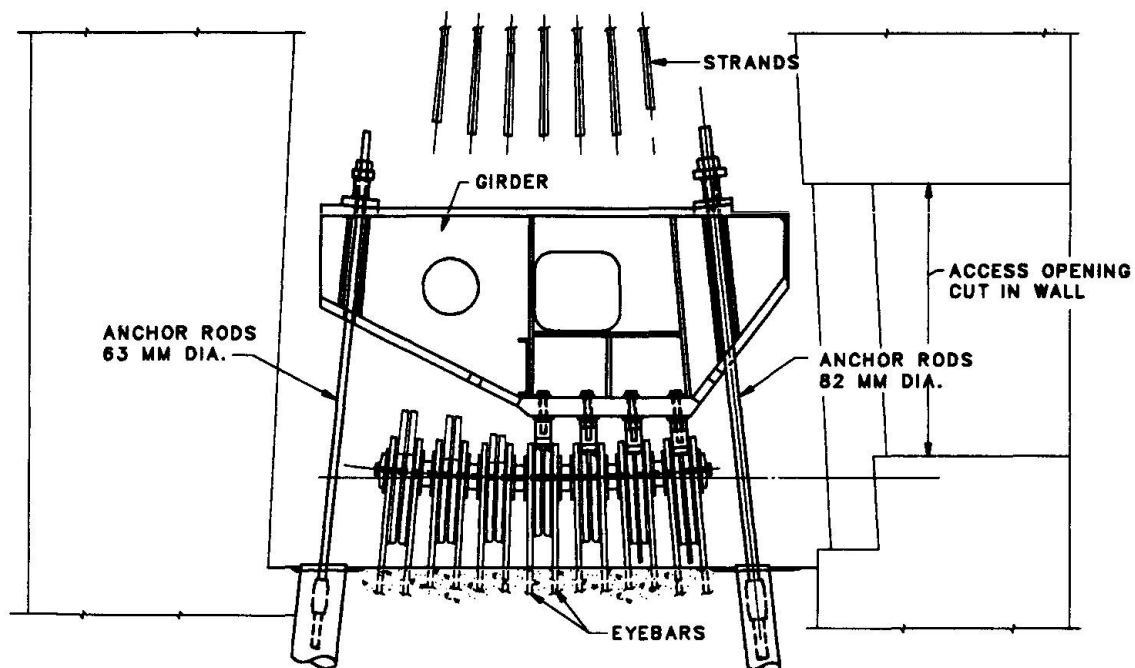
SECTION A-A

Because of the lack of access to the eyebars, a new anchorage system for half the cable was designed (Figure 2). The anchorage has longitudinal vaults 2.5 to 6 m wide, separated by 1.5 m thick concrete walls. The 2.4 m deep steel transfer girders were installed above and below the eyebar array, extending into adjacent chambers through openings cut through the concrete walls. These girders are anchored into the massive gravity anchor block by means of seven high strength steel rods at each end, installed in 860 mm diameter inclined shafts drilled 20 m into the concrete. The lower end of the shafts was accessed by means of tunnels driven into the back face of the anchorage, through which steel anchor girders were installed to receive the bottom end of these anchor rods.

Figure 2. Reanchoring Scheme for Main Cable on Manhattan Bridge

The cable had many corroded wires; 10 percent of the wires had ferrous rust and 34 wires were already broken because of section loss. Five hundred wires had badly rusted sections removed and new wires spliced in. It was necessary to cut and reconnect 18 of the 37 strands of the cable to the new transfer girders, just to provide enough space to access inner strands. Half of these were then cut and reanchored to the vacated eyebars.

The procedure of reanchoring the strands to the new girders consisted of cutting one strand, using clamps and jacks to gradually relieve the force in the strand. The wires in each half strand were cleaned, fluxed and fastened to sockets using molten zinc. These sockets were connected to the transfer girders by high strength rods and had a force equal to the calculated load on the bridge jacked into them by means of Biach jacks. The force in each strand due to dead load is 1,550 kN with live load the total strand force to 2,100 kN. During jacking, a force of 2,760 kN was applied to set and test the sockets, and to be certain that the strand was pulled back out of the cable, into which it had slipped by about 15 mm. The force was then lowered to 1,600 kN and the nuts turned into bearing.

In order to prevent stretching of the anchor rods or flexure of the girders as load was transferred to them, the anchor rods were prestressed to hold the transfer girders firmly against the concrete of the anchorage. Because of the great force involved, this prestress was applied in steps as the cable strands were attached to the girders. During all operations, forces in the strands were monitored by means of strain gages attached to wires, as well as to the rods between the sockets and the transfer girders.

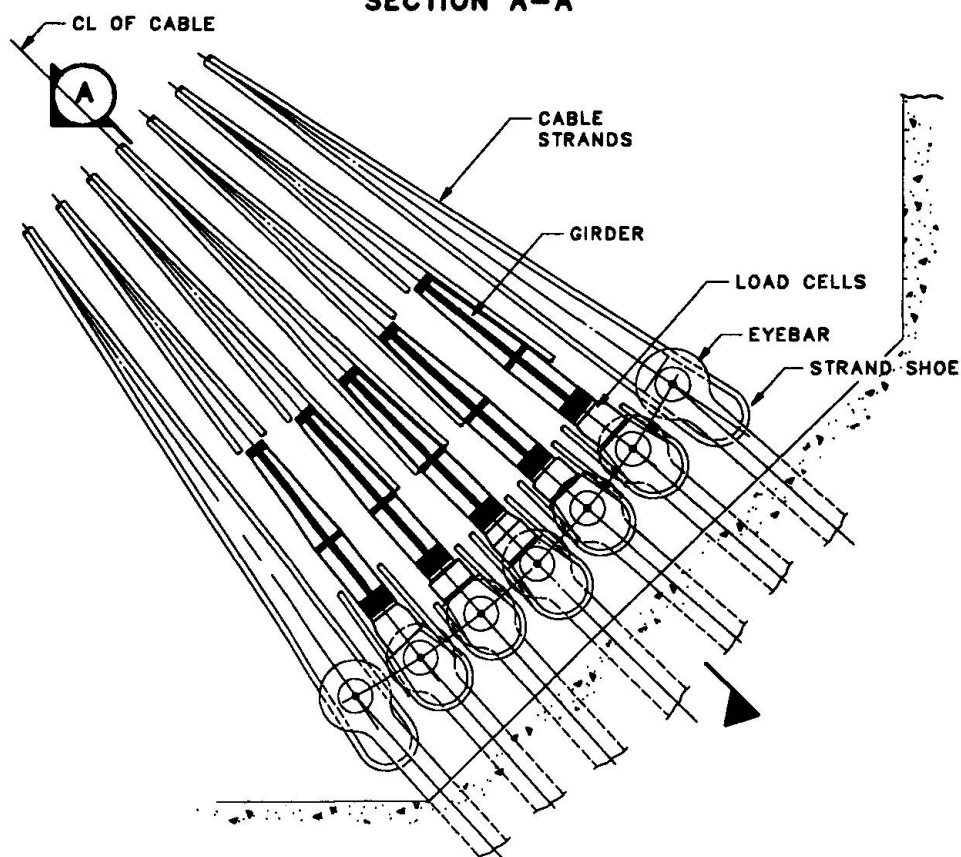
## SECTION THROUGH CABLE ANCHORAGE OF BRONX - WHITESTONE BRIDGE

In this anchorage, the eyebars are arranged in horizontal alignment, as opposed to the Manhattan Bridge, where the center row of eyebars is offset one half space from the others. Thus, it is possible on the Bronx-Whitestone bridge to needle girders through the loops formed by the strands. The wider cable chamber also makes it possible to provide direct anchoring of girders into the concrete inside the chamber. Girders have been designed which will bear directly on the front face of the strand shoes. By jacking forces into the girders by means of high strength anchor rods (ASTM A354 Grade BC with a tensile strength of 965 MPa ), the girders will prestress the eyebars, thus reducing the tensile stress to an acceptable level. The forces in the eyebars and anchor rods will be measured by means of load cells permanently installed in the structure. This arrangement avoids the need for cutting cable strands. (Figure 3).

*Figure 3. Girders to relieve stress in eyebars of Bronx - Whitestone Bridge*

On this bridge, the losses in area of the eyebars ranged up to 15 percent. Because of the short length subjected to corrosion, and because yield had not been reached in the corroded section, the ultimate strength of the ASTM A7 steel in the eyebars was depended upon for reserve strength until the repair could be made. Several of the severely corroded eyebars have been strain gaged and monitored to be certain that they are not subjected to yield.
