Zeitschrift: IABSE reports = Rapports AIPC = IVBH Berichte
Band: 73/1/73/2 (1995)

Artikel: Cable anchorage repairs on New York City suspension bridges
Autor: Mayrbaurl, Ronald M.
DOI: <https://doi.org/10.5169/seals-55232>

Cable Anchorage Repairs on New York City Suspension Bridges

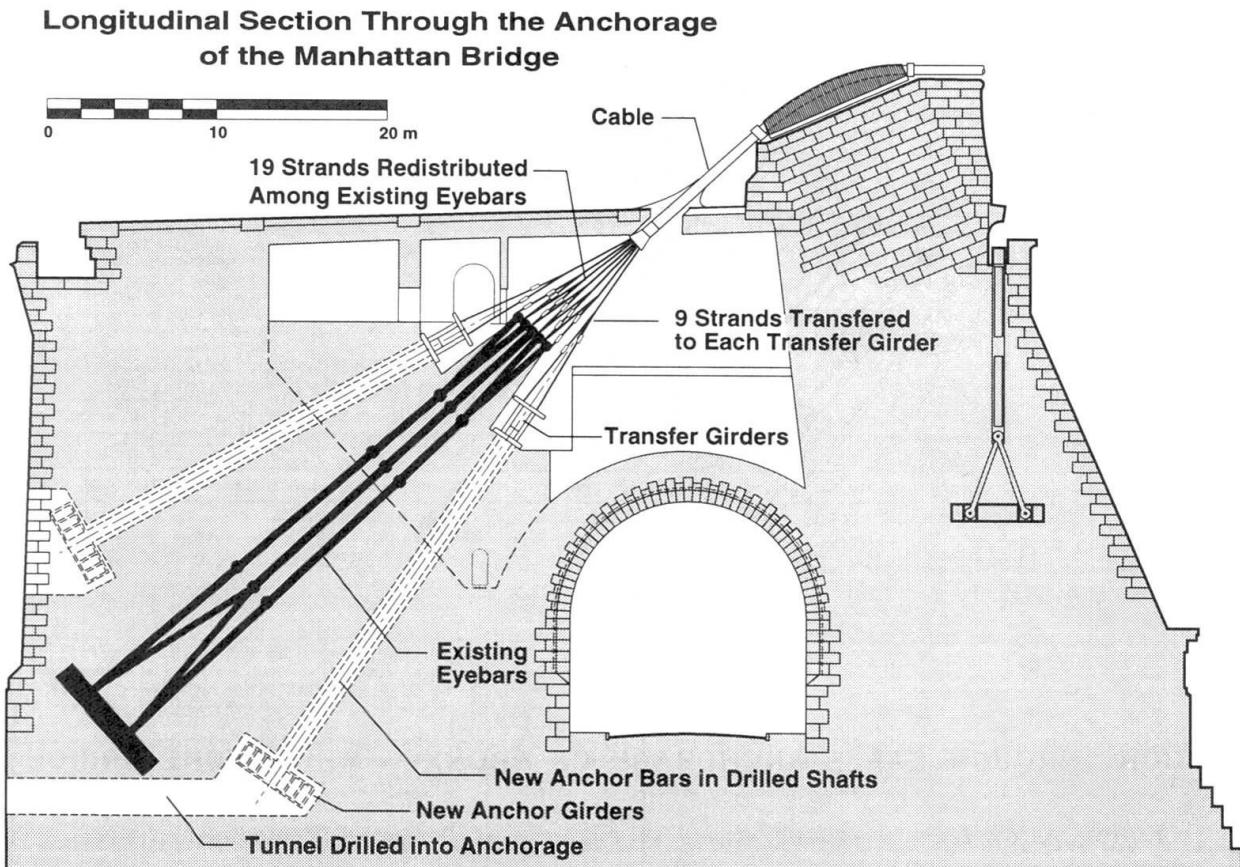
Because of the lack of access to the eyebars, a new anchorage system for half the cable was designed (Figure 2). The anchorage has longitudinal vaults 2.5 to 6 m wide, separated by 1.5 m thick concrete walls. The 2.4 m deep steel transfer girders were installed above and below the eyebar array, extending into adjacent chambers through openings cut through the concrete walls. These girders are anchored into the massive gravity anchor block by means of seven high strength steel rods at each end, installed in 860 mm diameter inclined shafts drilled 20 m into the concrete. The lower end of the shafts was accessed by means of tunnels driven into the back face of the anchorage, through which steel anchor girders were installed to receive the bottom end of these anchor rods.

Figure 2. Reanchoring Scheme for Main Cable on Manhattan Bridge

The cable had many corroded wires; 10 percent of the wires had ferrous rust and 34 wires were already broken because of section loss. Five hundred wires had badly rusted sections removed and new wires spliced in. It was necessary to cut and reconnect 18 of the 37 strands of the cable to the new transfer girders, just to provide enough space to access inner strands. Half of these were then cut and reanchored to the vacated eyebars.

The procedure of reanchoring the strands to the new girders consisted of cutting one strand, using clamps and jacks to gradually relieve the force in the strand. The wires in each half strand were cleaned, fluxed and fastened to sockets using molten zinc. These sockets were connected to the transfer girders by high strength rods and had a force equal to the calculated load on the bridge jacked into them by means of Biach jacks. The force in each strand due to dead load is 1,550 kN with live load the total strand force to 2,100 kN. During jacking, a force of 2,760 kN was applied to set and test the sockets, and to be certain that the strand was pulled back out of the cable, into which it had slipped by about 15 mm. The force was then lowered to 1,600 kN and the nuts turned into bearing.

In order to prevent stretching of the anchor rods or flexure of the girders as load was transferred to them, the anchor rods were prestressed to hold the transfer girders firmly against the concrete of the anchorage. Because of the great force involved, this prestress was applied in steps as the cable strands were attached to the girders. During all operations, forces in the strands were monitored by means of strain gages attached to wires, as well as to the rods between the sockets and the transfer girders.
