**Zeitschrift:** IABSE reports = Rapports AIPC = IVBH Berichte  
**Band:** 73/1/73/2 (1995)

**Artikel:** A new life for the main cables of Williamsburg Bridge  
**Autor:** Bruschi, Maria Grazia / Koglin, Terry L.  
**DOI:** <https://doi.org/10.5169/seals-55233>

## **A New Life for the Main Cables of Williamsburg Bridge**

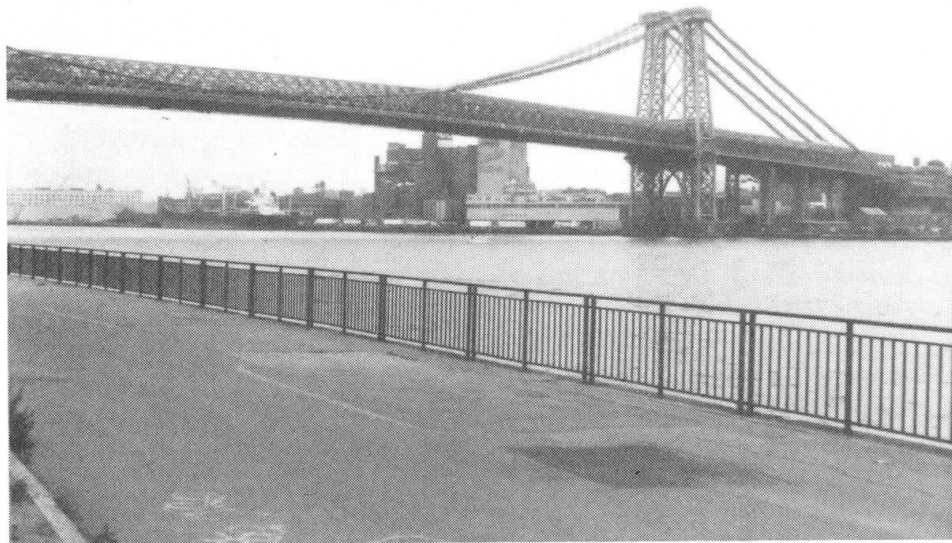
Work started in September 1992 and is scheduled to be completed at the end of September 1995. The first stage was the construction of 2.4 m wide footwalks under each cable (Figure 6), except at the center of the main span, where the proximity of the cable to the roadway allowed the Contractor to work from scaffolding installed on the roadway. The work proceeded according to the Contract Plans, and as described here, except for some minor modifications. Work remaining to be done consists primarily of the cable enclosures and the remainder of the new roof at the anchorages. In addition to the work included in the Rehabilitation Contract Plans, the cable condition encountered after removal of the splay casting of Cable A at the Manhattan anchorage forced the decision to replace seven strands [Ref. 6].

Figure 6  
Partial View of Williamsburg Bridge during the Cable Rehabilitation Work
