Maintaining and Extending the Lifespan of Steel Bridges in Japan

Chitoshi MIKI

A review is made of fatigue problems related to maintaining and extending the lifespan of steel bridges in Japan, mainly on the Tokaido Shinkansen bullet train system opened in 1963, Tomei Expressway opened in 1969 and the Honshu-Shikoku bridge project which is under construction.

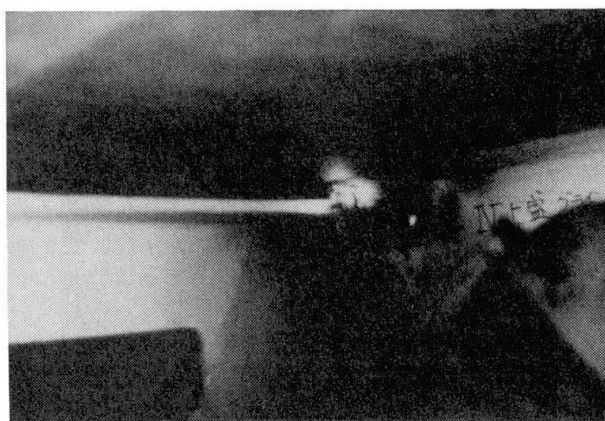
TIG-dressing conditions	
position aimed at by TIG arc	the toe of weld bead
electrod	thoriated tungsten 3.2mm in diameter
current	240 A
flow rate of argon	10 ℓ /min
TIG arc movement	10~20 cm/min

Fig.11 Finishing by applying TIG dressing

The measures taken against these fatigue cracks are differed according to the levels of cracking (Fig.10). For cracks with lengths at the surface not more than 20 mm, the basic measure applied is to add one pass of welding on top and then remelting with TIG dressing (Fig.11). For fatigue damage longer than that, damaged parts are all removed by gouging, and after rewelding, the surface is simultaneously treated with TIG dressing. The procedure of gouging, rewelding, and TIG dressing is predetermined in details. As a result of inspection approximately 5 years after such a measure had been taken, most parts were sound, but cracks were found again, although few in number, at repaired parts where fatigue cracks had been large.
