**Zeitschrift:** IABSE reports = Rapports AIPC = IVBH Berichte  
**Band:** 73/1/73/2 (1995)

**Artikel:** Maintaining and extending the lifespan of steel bridges in Japan  
**Autor:** Miki, Chitoshi  
**DOI:** <https://doi.org/10.5169/seals-55160>

## **Maintaining and Extending the Lifespan of Steel Bridges in Japan**

**Chitoshi MIKI**

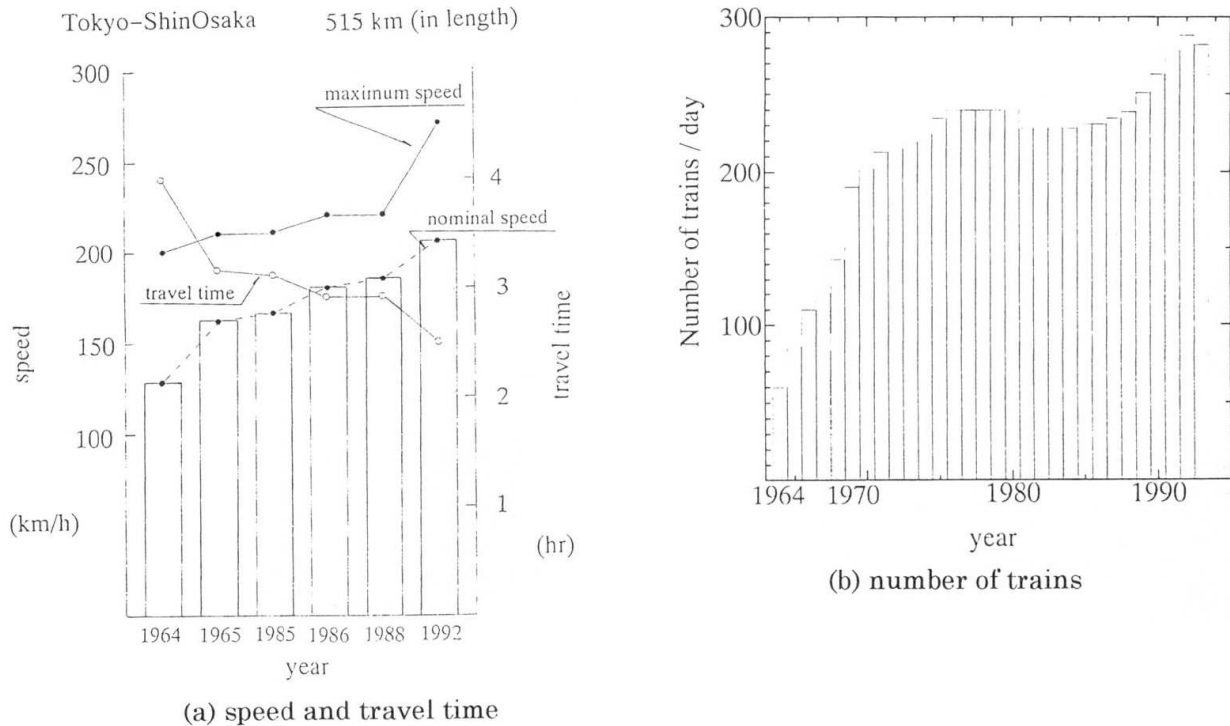
The outline of steel bridges in Tokaido Shinkansen are given in Table 1. Fig.1 shows the change of train speeds, travel time and the number of trains in one day from the opening to the present state. These have all changed in the direction of severity for structures. Only, the weight of train changes for the lighter.

(c) train cars

Fig.1 Changes of service conditions

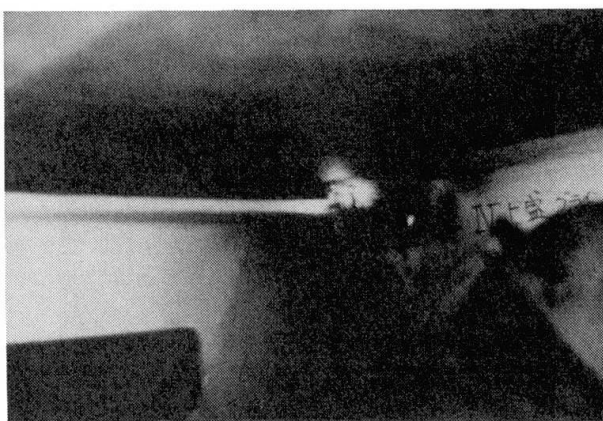
TIG-dressing conditions	
position aimed at by TIG arc	the toe of weld bead
electrod	thoriated tungsten 3.2mm in diameter
current	240 A
flow rate of argon	10 ℓ /min
TIG arc movement	10~20 cm/min

Fig.11 Finishing by applying TIG dressing

The measures taken against these fatigue cracks are differed according to the levels of cracking (Fig.10). For cracks with lengths at the surface not more than 20 mm, the basic measure applied is to add one pass of welding on top and then remelting with TIG dressing (Fig.11). For fatigue damage longer than that, damaged parts are all removed by gouging, and after rewelding, the surface is simultaneously treated with TIG dressing. The procedure of gouging, rewelding, and TIG dressing is predetermined in details. As a result of inspection approximately 5 years after such a measure had been taken, most parts were sound, but cracks were found again, although few in number, at repaired parts where fatigue cracks had been large.

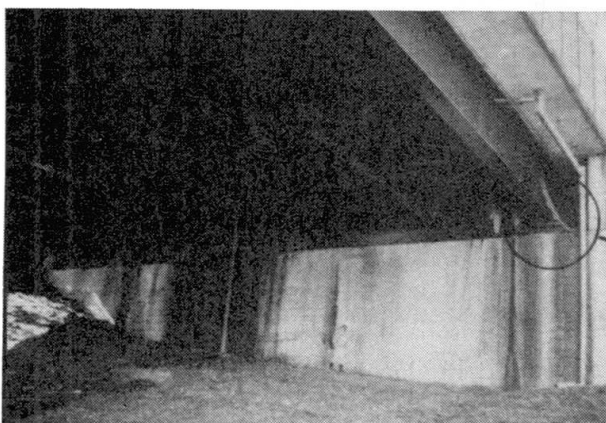
What have become conspicuous recently are cracks around sole plates of bearing points of main girders (Fig.13). Fatigue cracks have occurred in fillet welds for attaching sole plates to main girders and fillet welds between main girders and webs. The feature of this damage is that it occurs in a girder which has impairment of the rotating function of its support. The bearing point is the point where loading concentration is the severest in a bridge, while structurally, since this location is at a distance from the neutral axis, the stress is different from that according to the beam theory, and the deterioration of the support function causes such a condition to come about. Regarding this damage, the sole plate is exchanged for a larger one, attaching it with high-strength bolts, while further, structural improvements such as to add vertical stiffeners are provided (Fig.14).

Fig.13 Fatigue crack around sole plate
