Maintaining and Extending the Lifespan of Steel Bridges in Japan

Chitoshi MIKI

A review is made of fatigue problems related to maintaining and extending the lifespan of steel bridges in Japan, mainly on the Tokaido Shinkansen bullet train system opened in 1963, Tomei Expressway opened in 1969 and the Honshu-Shikoku bridge project which is under construction.

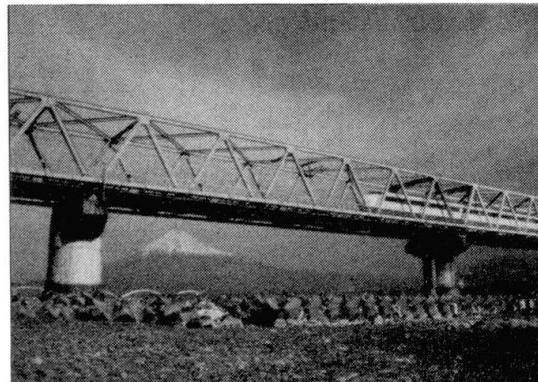
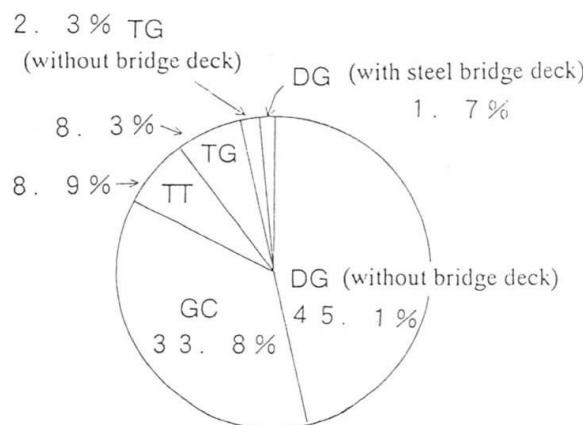
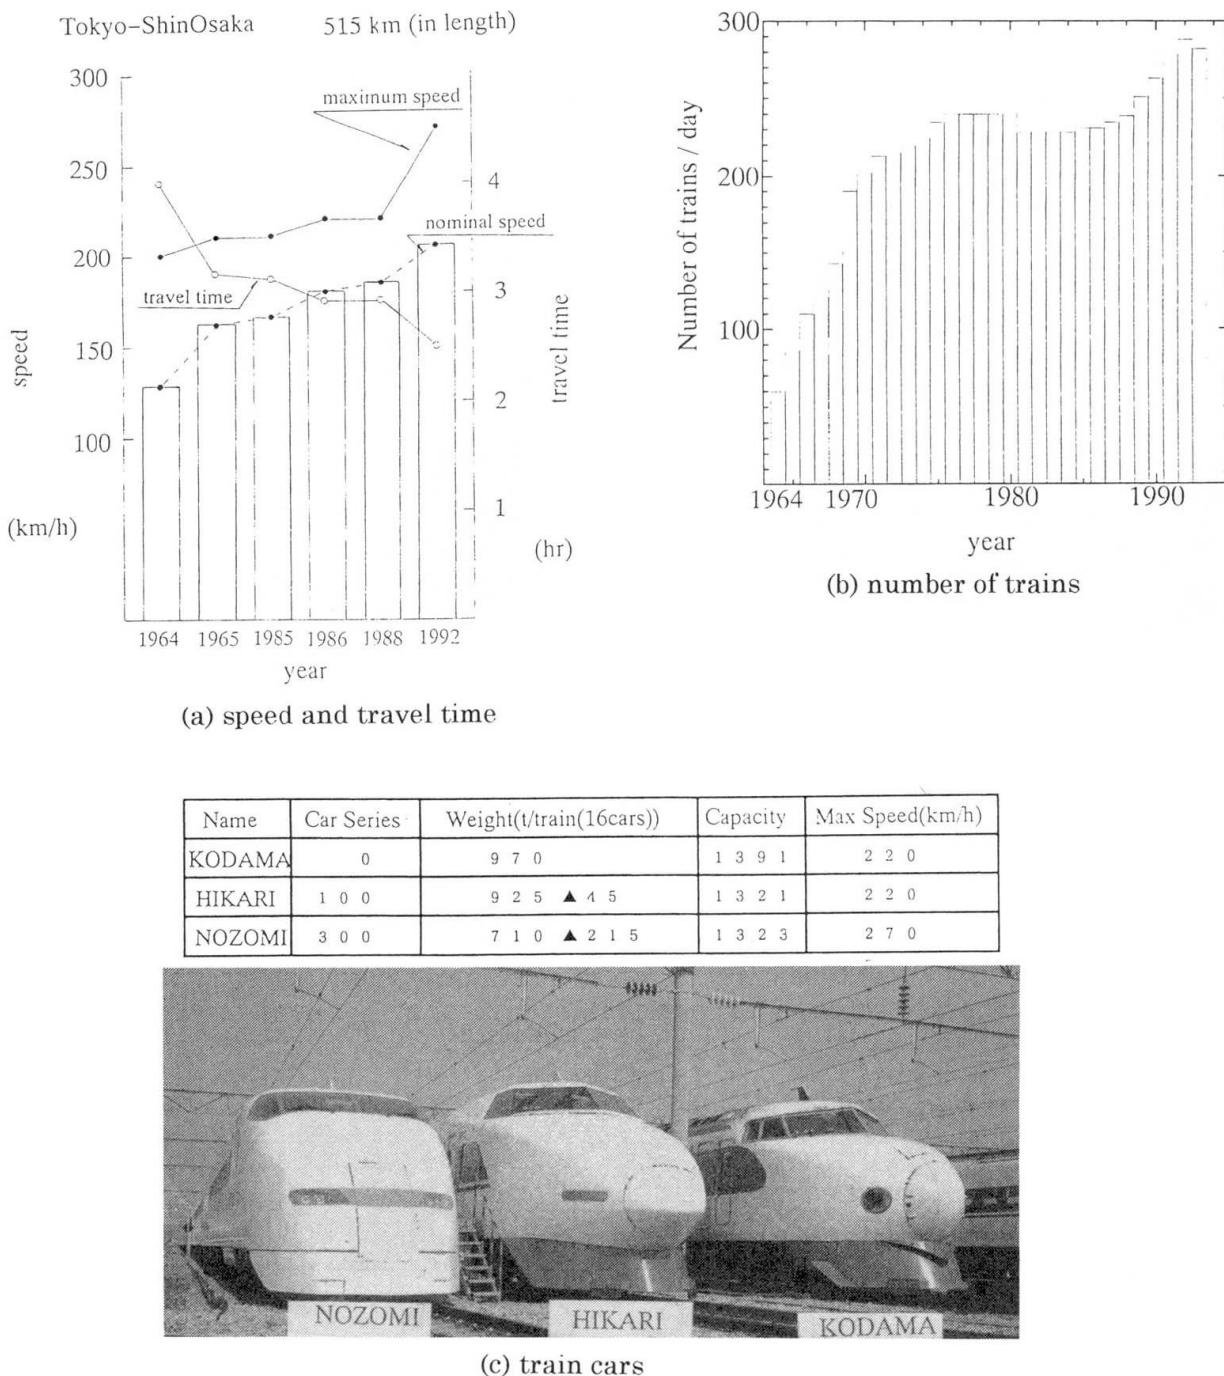
Fig.1 Changes of service conditions

The outline of steel bridges in Tokaido Shinkansen are given in Table 1. Fig.1 shows the change of train speeds, travel time and the number of trains in one day from the opening to the present state. These have all changed in the direction of severity for structures. Only, the weight of train changes for the lighter.

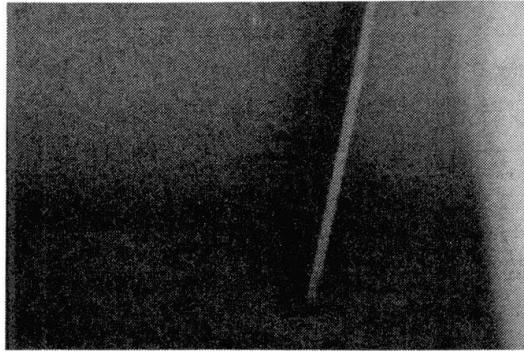
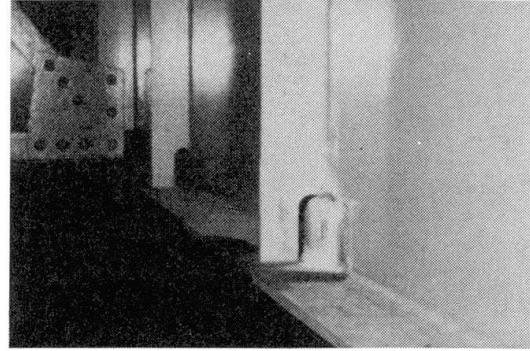
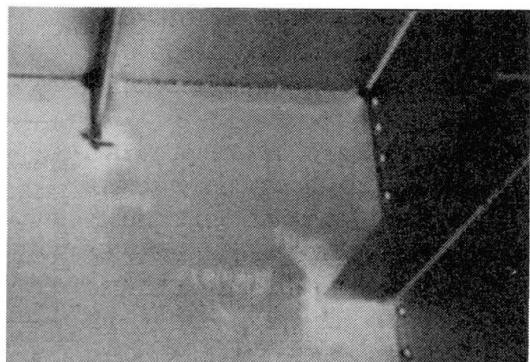
Fig.2 Fatigue damage in steel bridges of Tokaido Shinkansen

Occurrences of fatigue damage began to be reported concerning bridges of the Tokaido Shinkansen from around 10 years after having been put into service. An outline is given in Fig. 2, with cases of damage being those resulting from stress concentrations due to structural details of members, those due to out of plane displacements occurring between perpendicularly crossing members such as main girders and cross beams or cross beams and stringers, and those due to vibration induced distortion by high-speed operation of trains peculiar to Shinkansen[1].

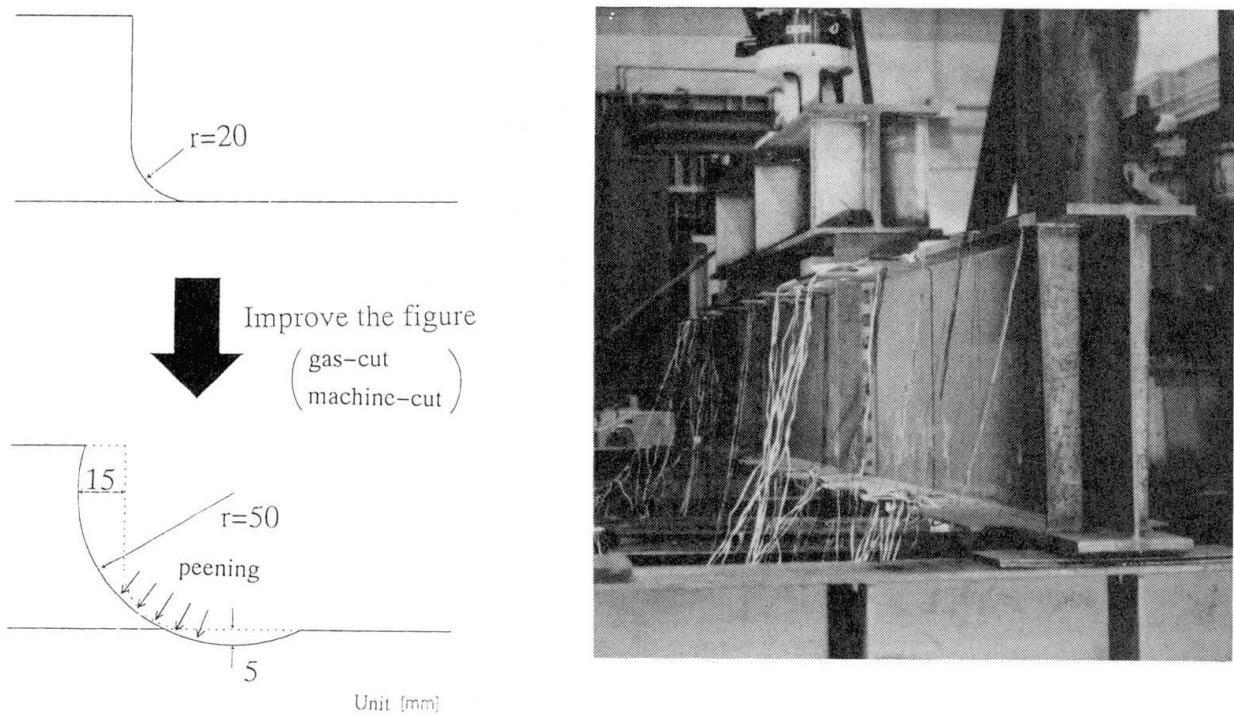
Fig.5 Improving work of flange gusset detail and fatigue test

One of damage prevention works is measurement of actual stresses. This is done regarding plate girders and the stringers of truss girders. To elaborate, since stresses in bridge members actually occurring are normally low compared with those in design calculations, it is thought to consider maintenance based on stresses actually occurring. Stress measurements for this purpose consist of grasping the bending stress on average occurring in the bottom flange and the location of the neutral axis. The reason for actual stresses being low compared with calculated stress in case of railway bridges, lies in the load distribution due to rails and secondary members. The results of stress measurements are illustrated in Fig. 4, in which it is clearly shown that the possibility of fatigue damage in a fairly large number of members is high on the basis of design calculated stress, however, there is hardly any cause for concern when actual stress is observed. Regarding longitudinal welds joining flanges and web (categorized into C class), it was learned that there was ample allowance from measurements of actual stresses, but the degrees of allowance at the ends of gussets attached to flanges (categorized into F class) were slightly small. Hence, remedial measures regarding fatigue strength are presently under study for this gusset detail. Methods being considered are to increase the radius of the fillet at the end of the gusset and, further, to add residual compressive stress by peening, and the effectivenesses are being examined through fatigue tests (Fig.5).

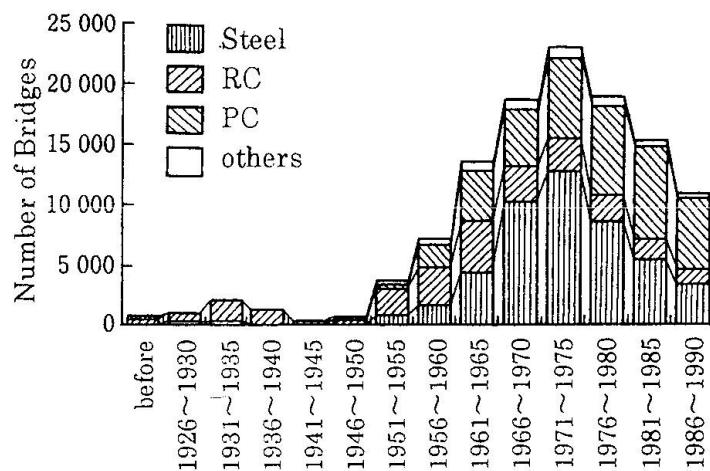
Fig.6 History of bridge construction

The numbers highway bridges constructed in Japan by year are shown in Fig.6. It can be seen that construction of infrastructure facilities in Japan has been concentrated in a certain period. As a consequence, an enormous number of bridges will become antiquated at once, and measures to cope with such a situation will be of grave importance.

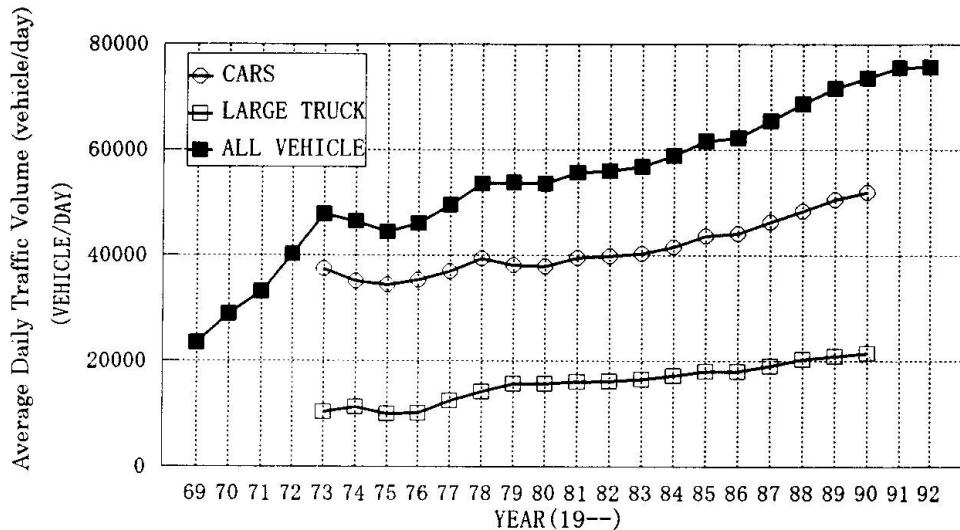
Fig.7 Change of daily traffic volume

Tomei Expressway is the first expressway in Japan, which was constructed in 1965-1968. There are 112 plate-girder bridges (composite and non-composite) on the part of the Tomei Expressway under the Tokyo First Operation Bureau of the Japan Highway Public Corporation which operates about 85% of Tomei Expressway. Of these, approximately 58 percent are quadruple-main-girder bridges, 37 percent are triple-main-girder bridges, and the remainder small numbers of quintuple-main-girder and sextuple-main-girder bridges. The thicknesses concrete deck slabs are 180 to 200 mm for triple-main-girder bridges while 170 to 190 mm for quadruple-main-girder bridges. Besides plate girder bridges, there are some truss girder bridges and arch type bridges on Tomei Expressway. In all of the bridges damage began to occur in the reinforced concrete deck slabs four to five years after being put into service, and stringers for supporting deck slabs are being added starting in order from bridges in the poorest condition. The transitions in the states of service of the Tomei Expressway are shown in Fig.7. Traffic volume has increased sevenfold in 30 years. A feature is the high proportion of large vehicles such as trucks and trailers. Vehicle scales are installed in main traffic lanes at Nihondaira on the Tomei Expressway. According to records kept since opening of service, the maximum weights of automobiles passing have been constant with the times (Fig.8).

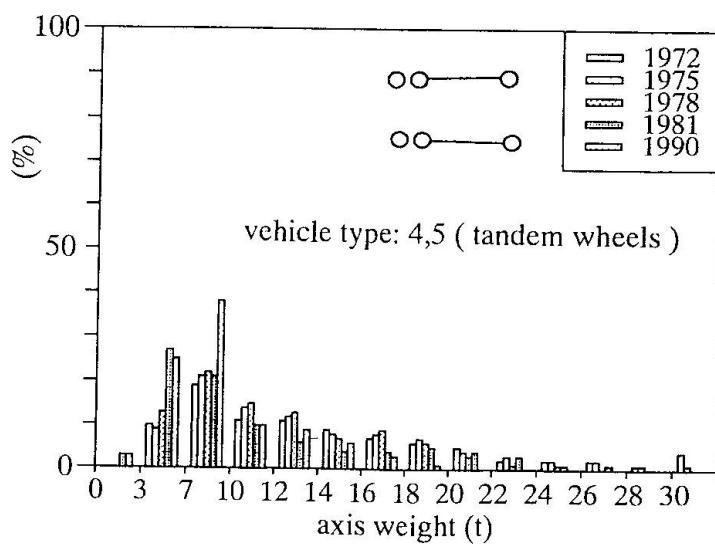
Fig.8 Measured axis weight

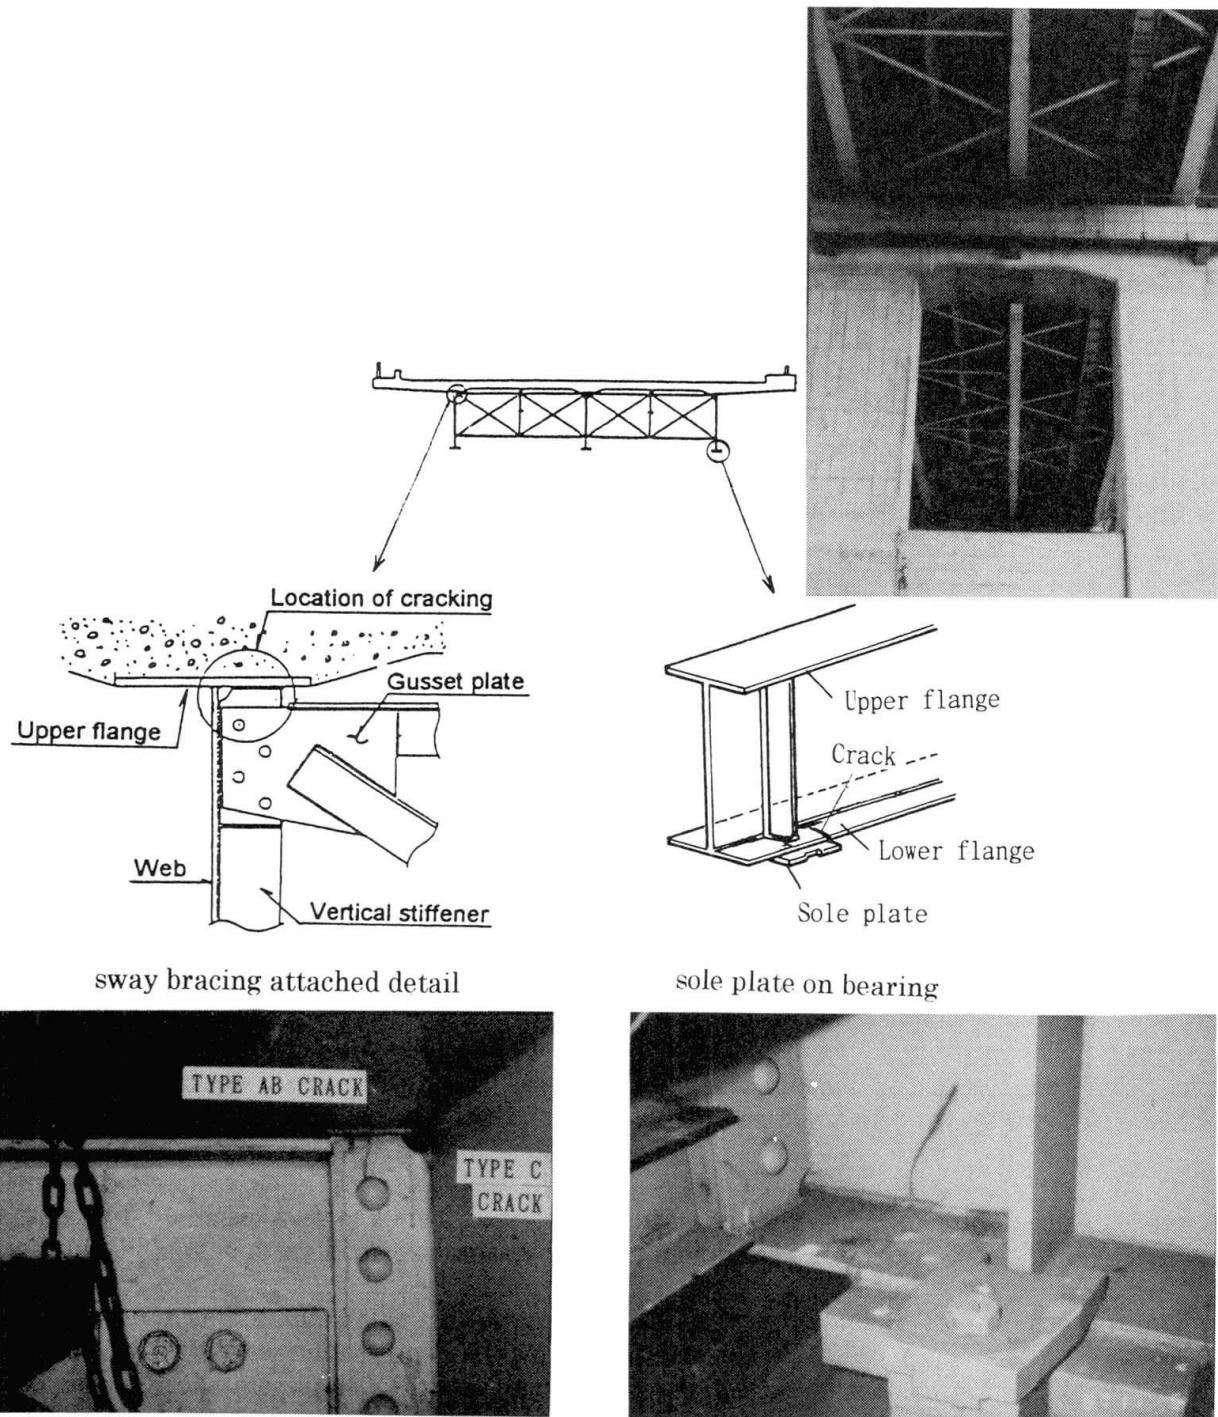
Fig.9 Typical fatigue damage in plate girder bridge

The types of fatigue damage in steel plate girder bridges of the Tomei Expressway are shown in Fig. 9 [2]. Various types of fatigue damage have been observed. The percentage of occurrence is highest for fatigue cracks at the ends of vertical stiffeners with sway bracing attached, and detailed studies have been made on this fatigue. It has been found to be due to force acting so that displacement will occur orthogonally to the web from differences in deflections between girders and deformations of deck slabs.

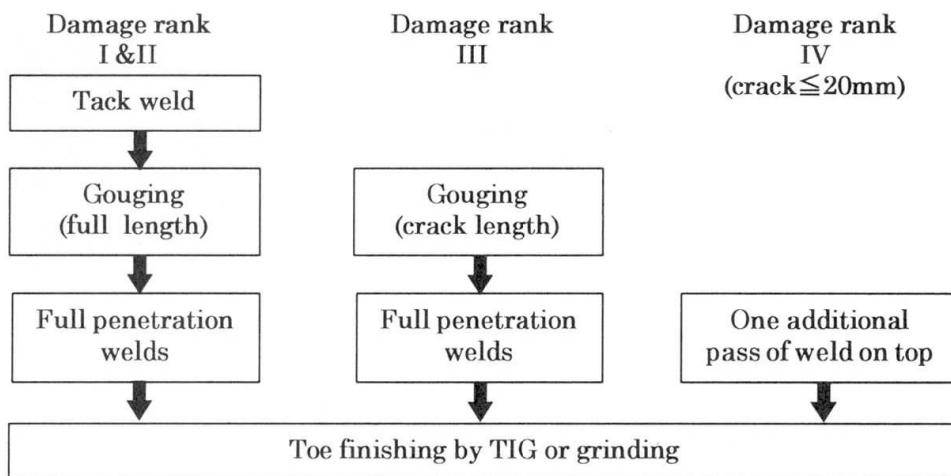
Fig.10 Retrofit methods depend on damage ranks

The measures taken against these fatigue cracks are differed according to the levels of cracking (Fig.10). For cracks with lengths at the surface not more than 20 mm, the basic measure applied is to add one pass of welding on top and then remelting with TIG dressing (Fig.11). For fatigue damage longer than that, damaged parts are all removed by gouging, and after rewelding, the surface is simultaneously treated with TIG dressing. The procedure of gouging, rewelding, and TIG dressing is predetermined in details. As a result of inspection approximately 5 years after such a measure had been taken, most parts were sound, but cracks were found again, although few in number, at repaired parts where fatigue cracks had been large.

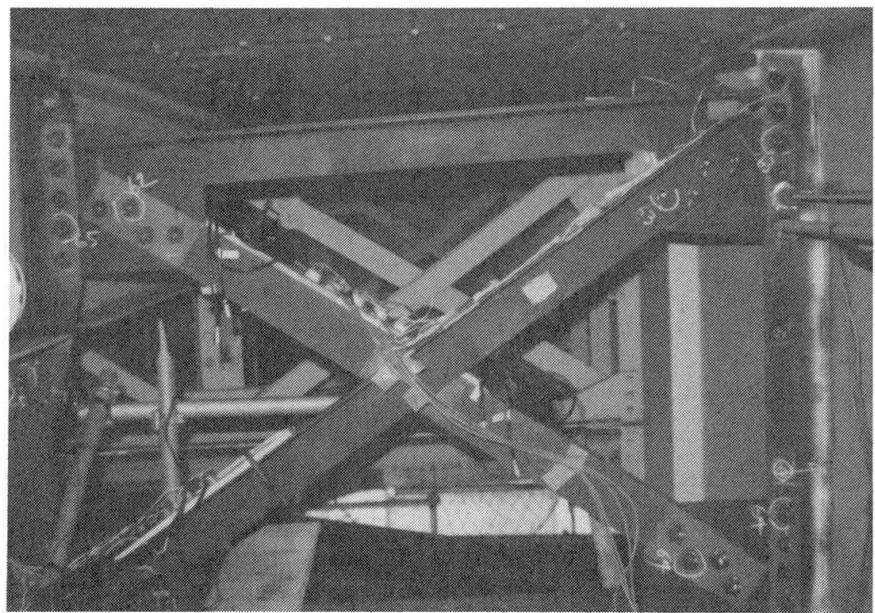
Fig.12 Adding work of sway bracing

At bridges with prominent damage, the load applied in the lateral direction by existing sway bracing is to be alleviated by adding sway bracing in improved joint details (Fig.12). The joint details between the sway bracing and main girder at this time was proven by fatigue tests to have been improved. The stresses at fatigue crack occurrence points were reduced approximately 20 percent by providing this measure, while further, stresses were reduced approximately 30 percent by detaching the horizontal members of existing sway bracing.

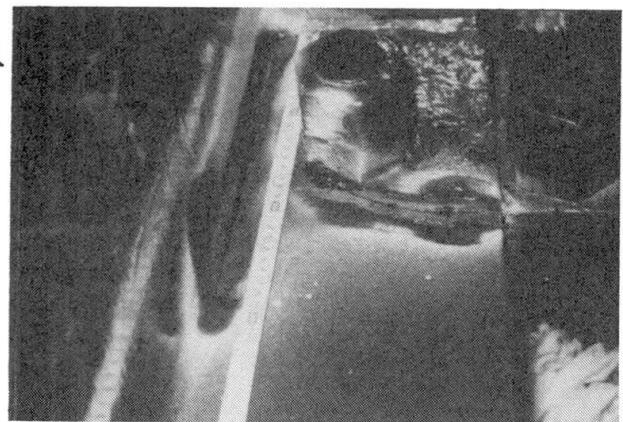
Fig.13 Fatigue crack around sole plate

What have become conspicuous recently are cracks around sole plates of bearing points of main girders (Fig.13). Fatigue cracks have occurred in fillet welds for attaching sole plates to main girders and fillet welds between main girders and webs. The feature of this damage is that it occurs in a girder which has impairment of the rotating function of its support. The bearing point is the point where loading concentration is the severest in a bridge, while structurally, since this location is at a distance from the neutral axis, the stress is different from that according to the beam theory, and the deterioration of the support function causes such a condition to come about. Regarding this damage, the sole plate is exchanged for a larger one, attaching it with high-strength bolts, while further, structural improvements such as to add vertical stiffeners are provided (Fig.14).

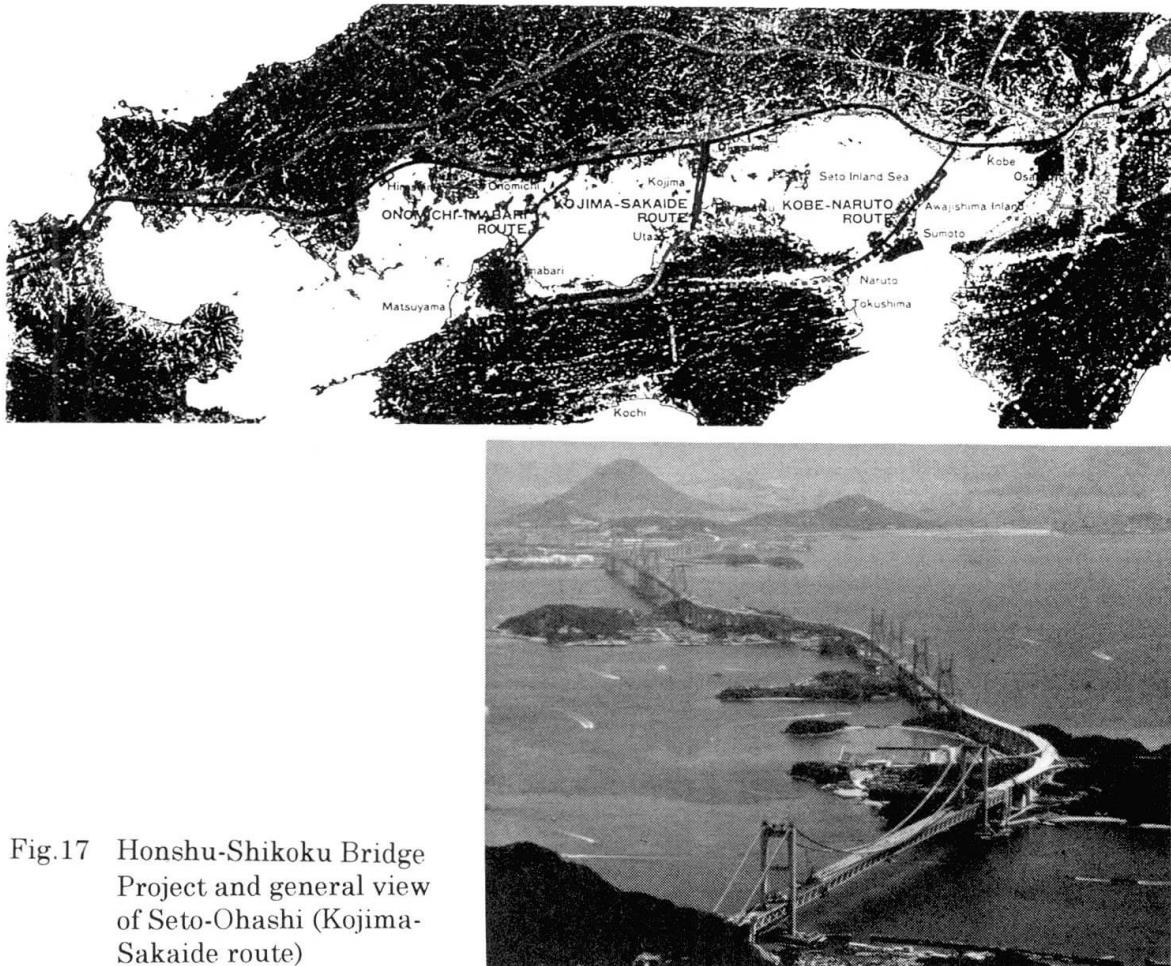
Fig.17 Honshu-Shikoku Bridge Project and general view of Seto-Ohashi (Kojima-Sakaide route)

Of the three routes of the Honshu-Shikoku Bridge project (Fig.17), the central route consists of combined highway and railway bridges with fatigue design made a priority item along with wind-resistant design from the beginning. Since high-strength steels of 800-MPa class were used in large quantities, large-scale fatigue tests were started from 1970(Fig.18), and these tests have made great contributions to the fatigue design in Japan of today. Numerous tests of full-size or large-scale models (Fig. 19) were carried out for investigation and ascertainment of plate thickness effect on fatigue strengths of various welds and fatigue behaviors due to secondary stresses attributable to structural details. Test specimens about 15 mm in plate thickness and 100 mm in plate width had been mainly used in past fatigue tests, but specimens with plate thickness of 45 to 75 mm were used in this case.

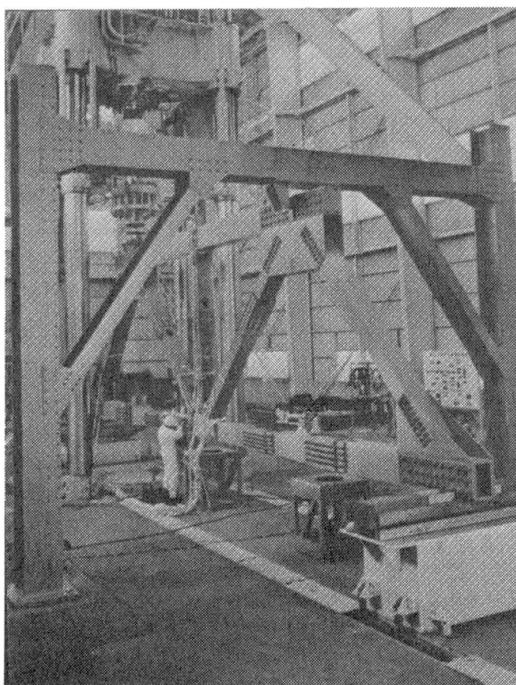
Fig.18 Large scale fatigue test
(truss panel joint)

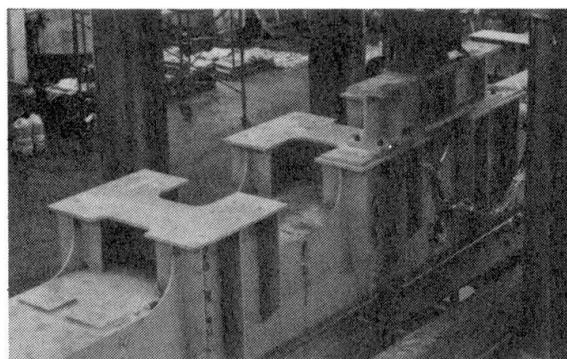
(a) floor beam of stiffening truss

Fig.19 Examples of fatigue test

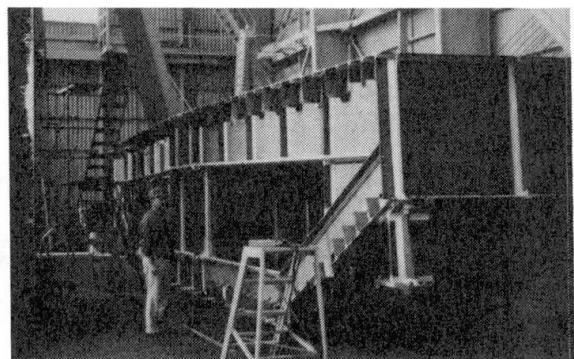
(b) box section stiffening girder

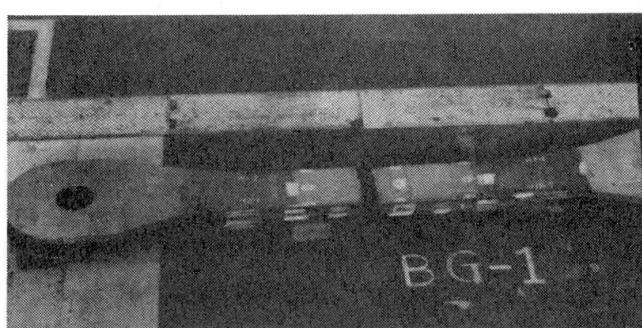
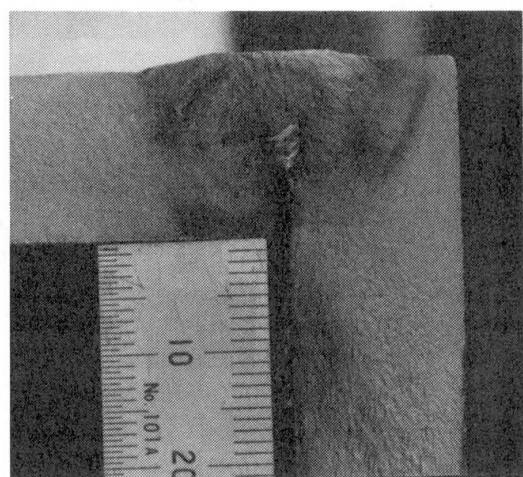
specimen

crack initiated from blowhole

Fig.20 Box section members

Various new and useful things have been learned from these fatigue tests, typical of which may be cited fatigue of longitudinal-bead welds of box section members (Fig.20). Such joints play almost no role in transmitting load, and simply are for assembly of members, but if defects such as blowholes exist at root portions, fatigue strength will be extremely reduced. The relationship between defect size and fatigue strength has been ascertained from the results of experiments on many large-sized models and from fracture mechanics models (Fig.21), based on which design allowable fatigue stress and corresponding allowable defect size have been determined (Fig.22). Fabrication methods have been improved so that all truss members will have defects not more than the allowable limits. Joint portions are inspected using a newly developed automatic ultrasonic flaw detection system, and defects exceeding allowable values are repaired. These nondestructive inspection results have been organized as a data base, and play an important role in the maintenance plan.

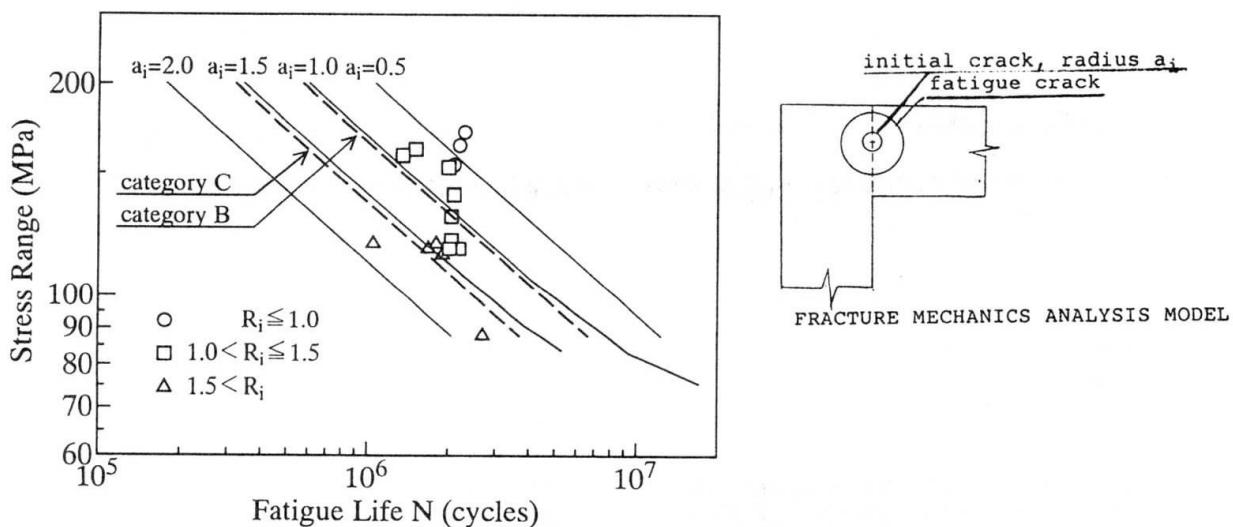
Fig.21 Results of fatigue test and fracture mechanics analysis

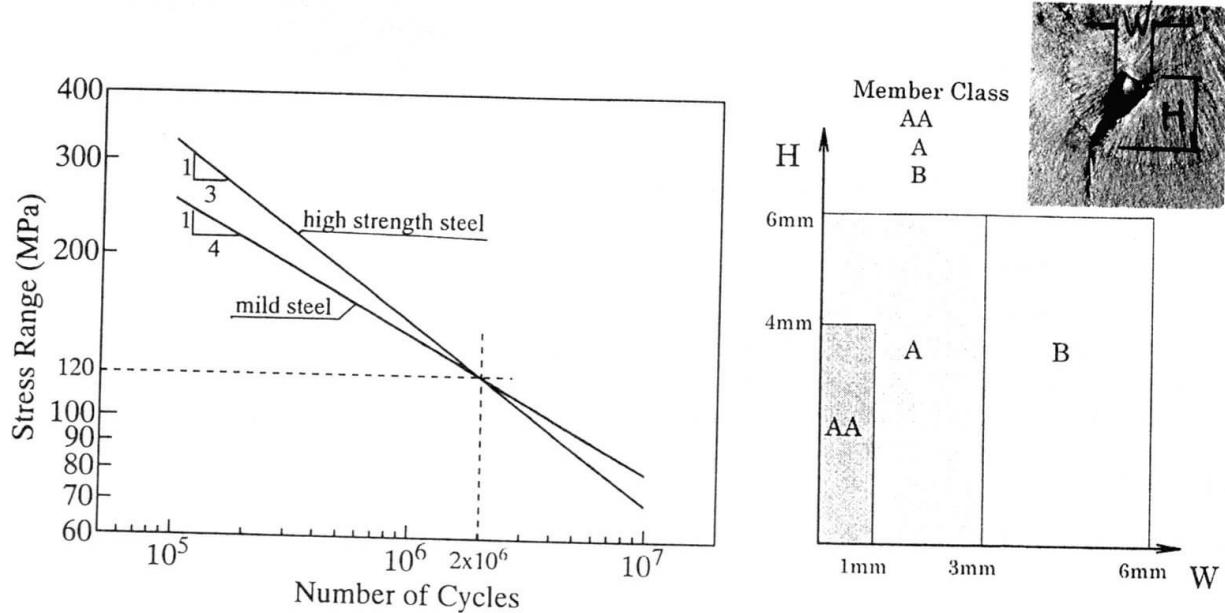
Fig.22 Allowable stress for corner joint and permissible size of blowhole in corner joint

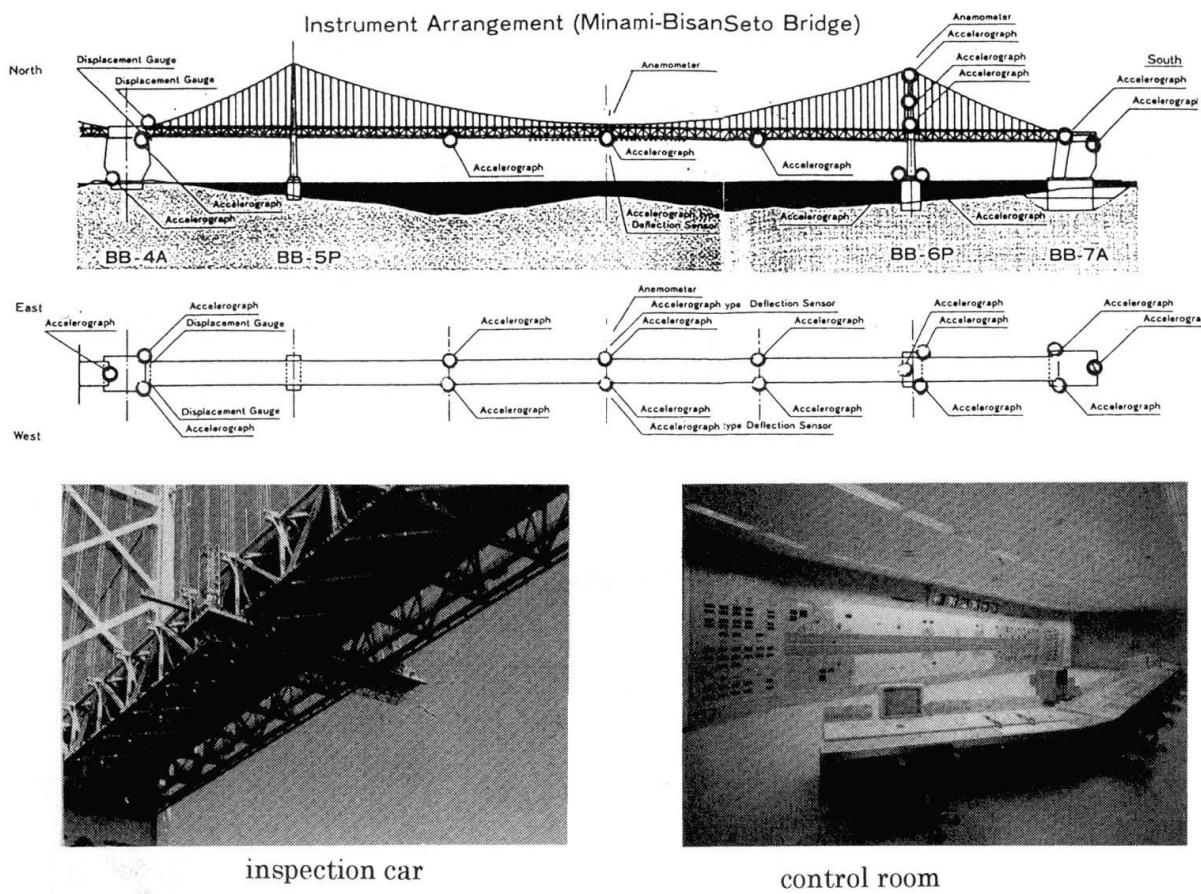
Fig.23 Instruments for monitoring of bridge behavior

Various new technologies have been applied in maintenance also. Honshu-Shikoku bridges are equipped with inspection cars making it possible for on-hand inspections to be made of all members. And as shown in Fig. 23, various types of sensors such as accelerometers and displacement meters are installed and the behaviors of bridges are monitored at all times at a central control room. Besides these data being used for operations, the records comprise a base for formulating maintenance plans.
