Zeitschrift: IABSE reports = Rapports AIPC = IVBH Berichte
Band: 73/1/73/2 (1995)
Rubrik: Session C2: Seismic strengthening of bridges: case studies

Seismic Strengthening of Bridges: Case Studies
Renforcement parasismique des ponts: études de cas
Seismische Verstärkung von Brücken: Fallstudien

Experience with Seismic Retrofit of Major Bridges

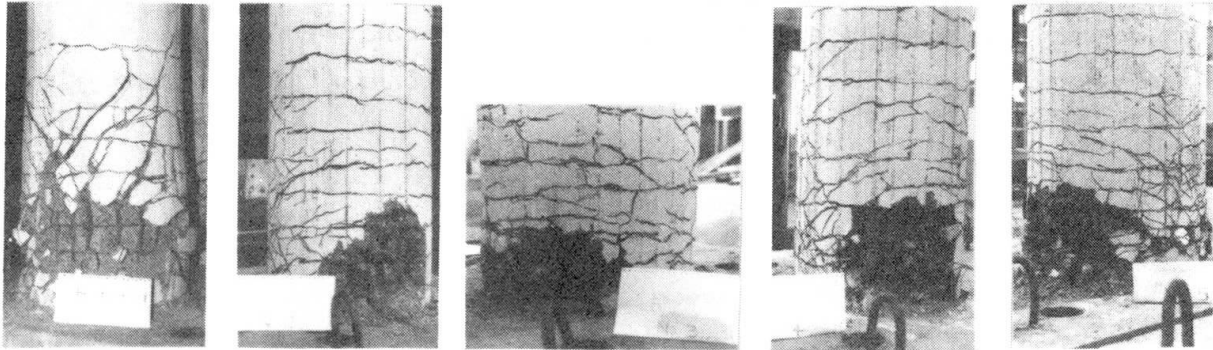
Fig.4 Final damage states of test piers .
