**Zeitschrift:** IABSE reports = Rapports AIPC = IVBH Berichte  
**Band:** 73/1/73/2 (1995)  
**Rubrik:** Session C2: Seismic strengthening of bridges: case studies

**Seismic Strengthening of Bridges: Case Studies**  
**Renforcement parasismique des ponts: études de cas**  
**Seismische Verstärkung von Brücken: Fallstudien**

## Experience with Seismic Retrofit of Major Bridges

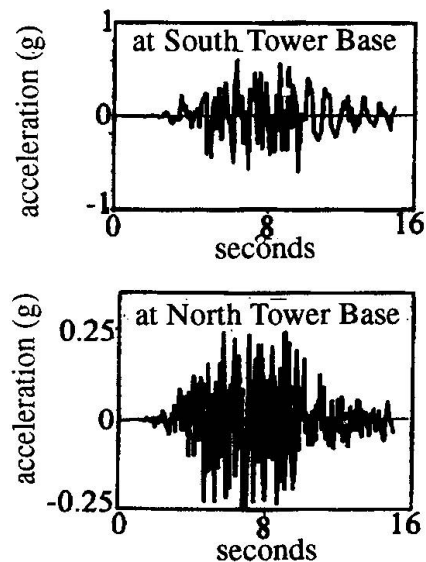
Fig.3: Long. Motion (NEAR EQ)

1. Time histories of accelerations at the base of the towers, bents and anchorages (See Fig. 3 for typical examples).
2. Translational and rotational spring constants for the base of the towers, bents and anchorages.
