Zeitschrift: IABSE reports = Rapports AIPC = IVBH Berichte
Band: 73/1/73/2 (1995)

Extending the Lifespan of the Architectural Heritage

Giorgio CROCI
Professor
Univ. "La Sapienza"
Rome, Italy

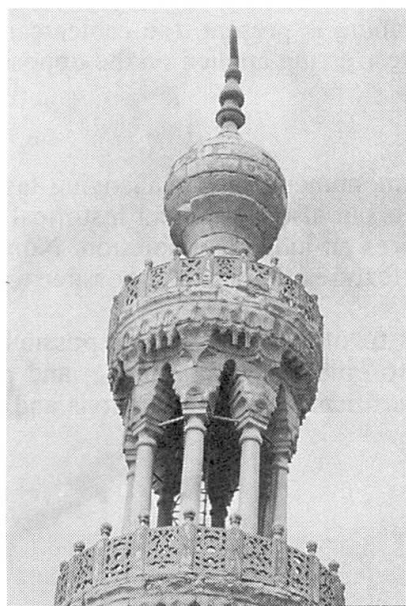
Fig. 13: Slender columns in some minarets

General measures to mitigate the effects of disasters can prevent much of the loss involving ancient monuments. Earthquakes are the most prevalent phenomena for which preventive measures can substantially reduce damage and avoid collapses. The damage to monuments in Cairo caused by the earthquake of 12 October '92 offers an interesting example. Many minarets collapsed not only because the masonry was of poor quality but also on account of the intrinsic weakness of the structural behaviour, especially in the upper parts where slender columns cannot withstand both flexural and twisting actions (Figures 13 and 14). The connection between the minaret and the main part of the mosque is another weak zone, as is shown both by mathematical

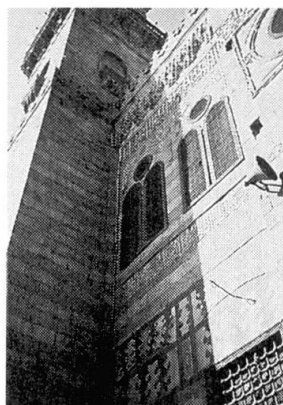
Fig. 16: Crack in a joint between the minaret and the mosque

models (Figure 15) and direct observations, although the spontaneous cracks (Figure 16) automatically mitigate the seismic effects.
