Extending the Lifespan of the Architectural Heritage

Giorgio CROCI
Professor
Univ. "La Sapienza"
Rome, Italy

SUMMARY

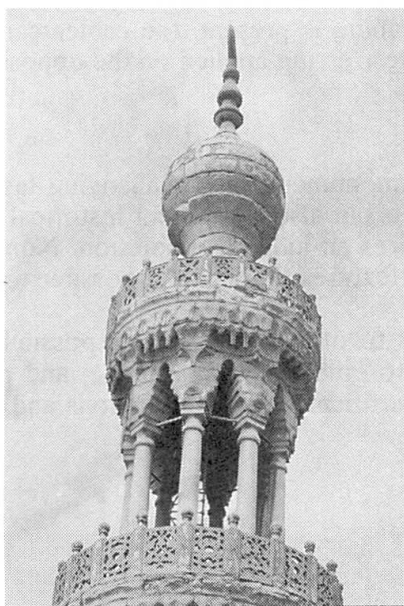
Fig. 13: Slender columns in some minarets

General measures to mitigate the effects of disasters can prevent much of the loss involving ancient monuments. Earthquakes are the most prevalent phenomena for which preventive measures can substantially reduce damage and avoid collapses. The damage to monuments in Cairo caused by the earthquake of 12 October '92 offers an interesting example. Many minarets collapsed not only because the masonry was of poor quality but also on account of the intrinsic weakness of the structural behaviour, especially in the upper parts where slender columns cannot withstand both flexural and twisting actions (Figures 13 and 14). The connection between the minaret and the main part of the mosque is another weak zone, as is shown both by mathematical
