Zeitschrift: IABSE reports = Rapports AIPC = IVBH Berichte
Band: 73/1/73/2 (1995)

Artikel: Repair of a building damaged by foundation settlement
Autor: Gusmao Filho, Jaime
DOI: <https://doi.org/10.5169/seals-55257>

Repair of a Building Damaged by Foundation Settlement

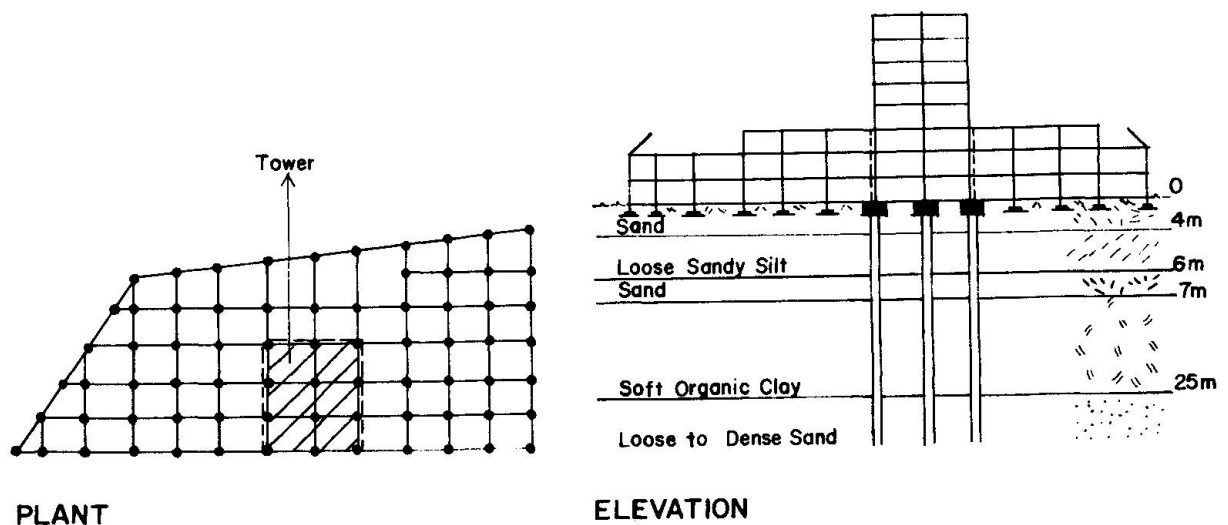
Fig. 1 Lay-out of the structure and foundation conditions

One building that is a medical center in Recife, Brazil, started having cracks due to foundation settlement soon after the end of its construction. It was a reinforced concrete structure with two types of foundation. The central block is an eight floors tower having deep foundation of steel piles near 40 m long. The outer block has three floors in spread foundation at the depth of 0.85 m with columns spaced 6m per 5m and takes 90 % of the ground area. The blocks are separated by a joint but the beams of the lower block were set on consols at the columns of the tower. Figure 1 shows the general lay-out.

Damage was concentrated at the spans next the tower where the differential settlement was larger. The rest of the building had a satisfactory behavior. Cracks started at the masonry walls and soon reached the structural beams showing the need of repair to overcome the design error.

Soil tests were made to predict the settlements that were found to be not less than 150 mm. The excessive cost of underpinning of the spread foundation by the use of deep piles postponed the execution of this solution. Then it was necessary to extend the lifespan of the structure until the definite repair was made. It was decided to relieve the structure using a settlement-control device by moveable ties hung from the tower. The ties allow to compensate the settlement already occurred as well as the settlements that may occur later on. The paper outlines some features of the solution.
