Zeitschrift: IABSE reports = Rapports AIPC = IVBH Berichte

Session C4

Assessment of Buildings and Structures

From Structural Assessment to Appropriate Preservation Strategies

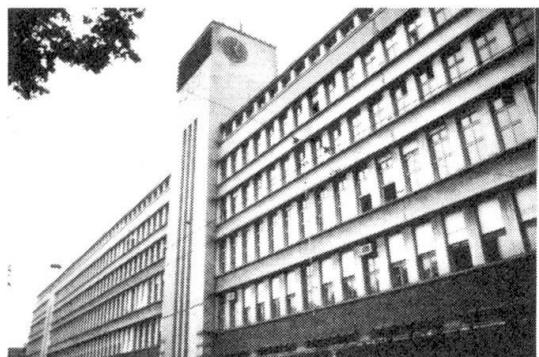
Fig. 2 SE-façade of the Sihlpost building

Since the building is regarded as a historical monument by the local authorities, an unchanged concrete surface with formwork texture was required. According to the different stages of deterioration and structural function, the following repair systems are used:

The piers between window openings were repaired locally concentrating on corroding areas of reinforcement by a polymer-cement-concrete-(PCC) mortar. An elastic coating on the whole surface will complete the rehabilitation work.

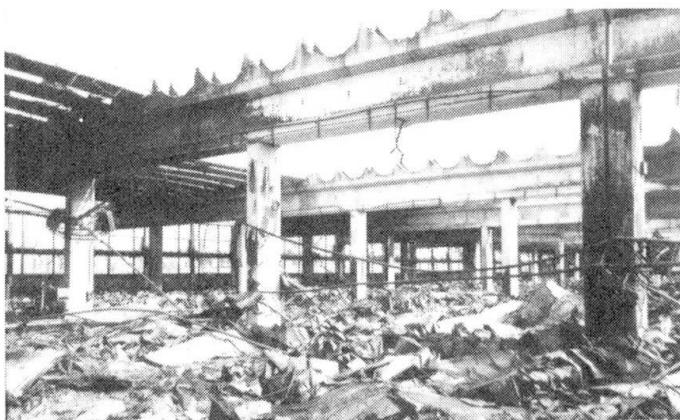
Fig. 4.1.: A. Merloni industrial Site after the great 1993 fire

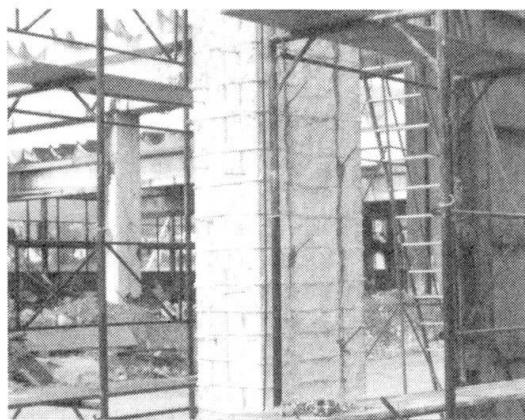
Fig. 4.2: A column core during the rehabilitation works
