Session C4

Assessment of Buildings and Structures
Evaluation des bâtiments et des structures
Zustandsbeurteilung im Hochbau

From Structural Assessment to Appropriate Preservation Strategies

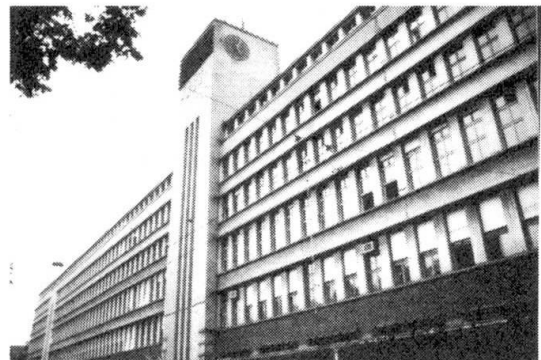
Fig. 2 SE-façade of the Sihlpost building

The piers between window openings were repaired locally concentrating on corroding areas of reinforcement by a polymer-cement-concrete-(PCC) mortar. An elastic coating on the whole surface will complete the rehabilitation work.

- Removing of carbonated concrete following a corrosion criteria by high-water pressure.
- Replacing with spraying concrete.
- Levelling out of the surface by a PCC-mortar.
- Coating, able to bridge future cracks.

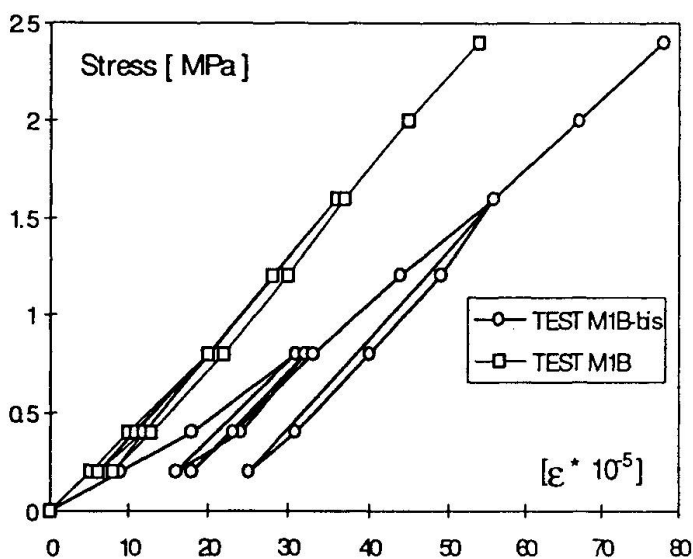
Fig. 3 Stress-strain diagram measured on the external leaf (M1B) and in the internal leaf (M1B-bis)

The masonry composition was then investigated by means of cores boring and bore-hole video surveys while the mechanical properties and the state of stress have been measured by flat-jacks tests.

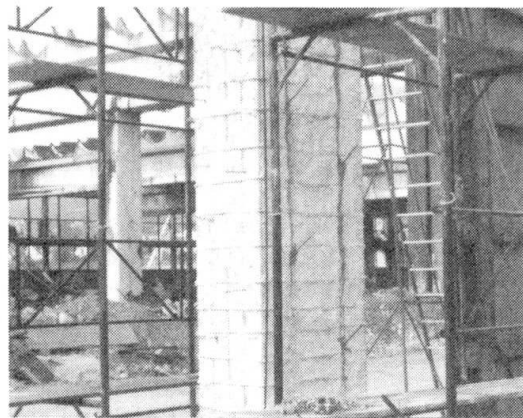
Fig. 4.2: A column core during the rehabilitation works
