Evaluating and Strengthening Industrial Buildings Damaged by Fires

Andrea BENEDETTI
Associate Professor
University of Ferrara
Ferrara, Italy

The lifespan of an industrial building may be dramatically reduced by fire, even if all safety precautions have been taken. The restoration of a fire-damaged reinforced concrete frame requires, first of all, the evaluation of the damage suffered by the members. In this respect non-destructive testing methods appear suitable for a quantitative definition of the damage; this can lead to the selection of a proper restoration technique. The proposed procedures are illustrated with an example.

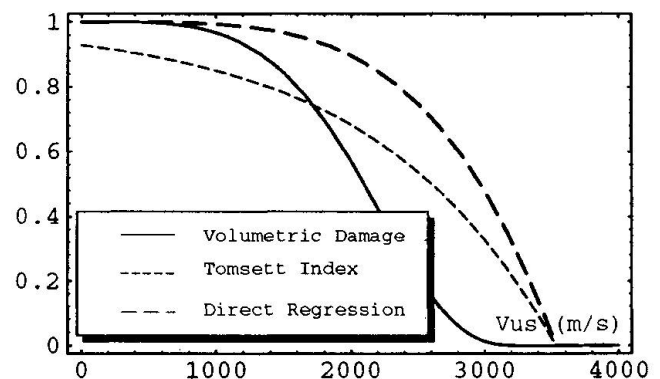
Fig. 2.5: Damage evolution resulting from the three models

As a matter of exposition we present the following relationships (the index "T" denotes a quantity reduced by temperature rise):

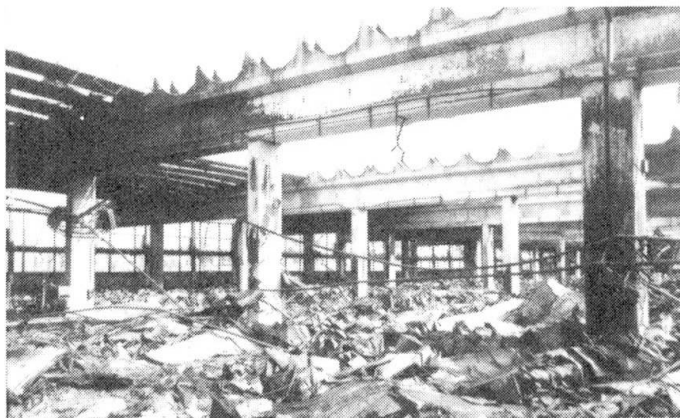
We conclude presenting some interesting features of a restoration work completed few years ago; in fig. 4.1 the appearance of the building after the fire event is outlined. One of the preliminary requests of the company management was to allow for a production restart as soon as possible.

Fig. 4.1.: A. Merloni industrial Site after the great 1993 fire
