**Zeitschrift:** IABSE reports = Rapports AIPC = IVBH Berichte  
**Band:** 73/1/73/2 (1995)

**Artikel:** Load testing of Chicago's 100-year-old mass transit structures  
**Autor:** Walther, Richard A. / Koob, Michael J.  
**DOI:** <https://doi.org/10.5169/seals-55268>

## Load Testing of Chicago's 100-Year-Old Mass Transit Structures

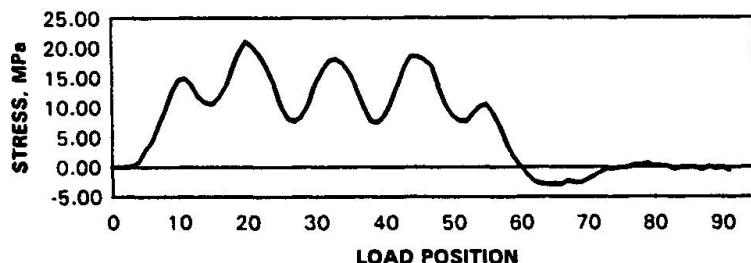
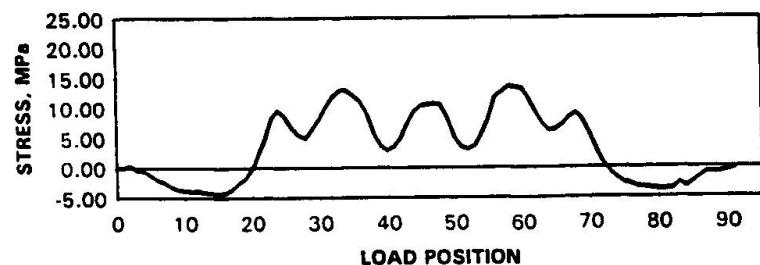
**Figure 2 - Midspan stress response for midspan gages at Test Location 0116**

#### MISPAN: FIXED-FREE SPAN

#### MISPAN: FIXED-FIXED SPAN

Strains due to the control loading were plotted with respect to load position to develop influence lines for all gages at each test location. The ordinate and abscissa correspond to the calculated stress and load position of the train, respectively. Positive stress represents tension and negative stress represents compression. In general, data show five distinct humps as shown in Figure 2 for the two midspan locations at test location 0116. The first hump is the first truck (2 axles) of the leading car. The middle three humps represent pairs of trucks (4 axles) at the coupler connection between cars. The last hump is the rear truck (2 axles) of the last car. The middle humps show a larger magnitude because they represent the loading of four axles rather than two axles. Data plotted for other gaged locations and included in Reference [2] were similar to that shown in Figure 2.

Midspan deflections were corrected for support displacements and plotted with respect to load position for all test locations [2]. Maximum deflections did not exceed 4 mm. Both the deflection and stress plots indicate significant continuity at stringer end to cross-girder connections. The deflection plots show upward displacements of 1.8 mm when the train is positioned in an adjacent span. In general, upward deflections did not occur across expansion joints. Similarly, negative bottom chord plots in Figure 2 indicate continuity across stringer to cross-girder connections.
