**Rubrik:** Session D2: Design and construction issues for stay cables

### **Design and Construction Issues for Stay Cables**

## International Survey of Current Opinion on Bridge Stay Cable Systems

## **Current Corrosion Protection Methods for Cable Stays**

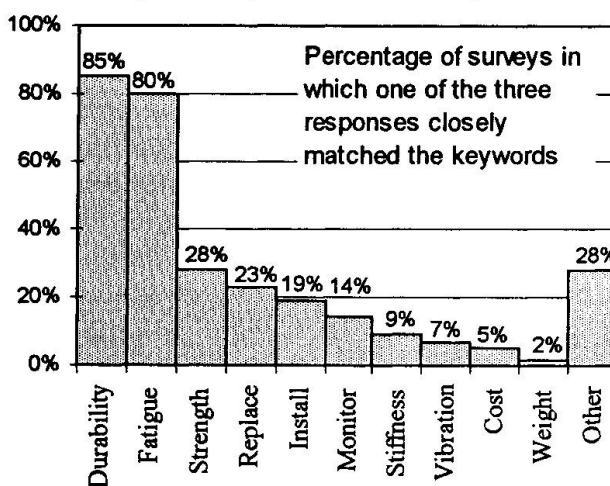
Figure 4.3 - All Respondents Response To Question Concerning Important Aspects Of Stay Cable.

Durability - Ability of stay cable to successfully resist corrosive elements.

Replace - Stay cable can be easily replaced.

*Important Aspects/Requirements for Stay Cable* - In nearly all categories the Durability and Fatigue keywords were rated very high as compared to all other keywords. The only dissension was the Contractor category which rated Install and Fatigue as the two highest rated keywords. The ratings of the remaining keywords were not consistent among the various categories. Strength was rated third for the All category and for N. America and Asia/Australia, while Replace and Monitor were rated at third for Europe. Strength and Replace were both rated third by the Owner category while all other industry categories rated Strength third.

While all categories agreed that durability and fatigue strength were two of the most important aspects of a stay cable there was some disagreement about the third aspect. For the Owner category, Replace was given the same rating as Strength while the Europe category gave equal importance to Replace and Monitor in their third choice.

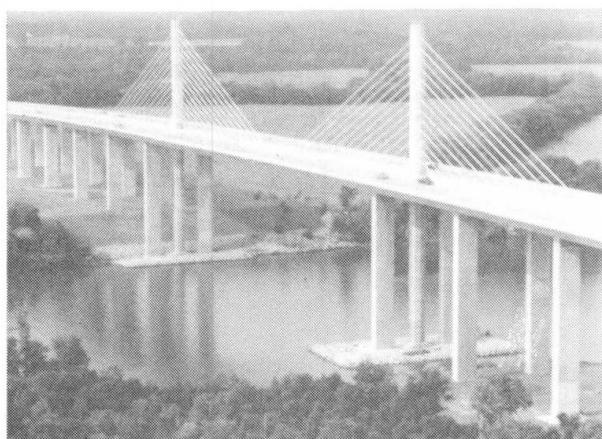
Figure 2.1 - Varina-Enon Bridge, Virginia

The typical concrete strength used for the segments was 5,500 psi. The strength was increased to 6,000 psi near the pylon to help resist the large compressive stresses resulting from the horizontal stay cable force components. The stay cables were made with as many as 81 - 0.6" diameter 7-wire prestressing strands, grouted inside polyethylene sheathing and wrapped with Tedlar tape.

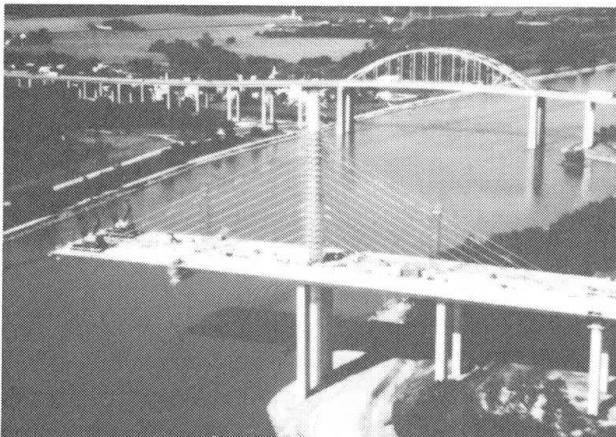
Figures 3.1 and 3.2 - Chesapeake & Delaware Canal Bridge, Delaware. Progressive cantilever construction of the 750' cable-stayed main span.

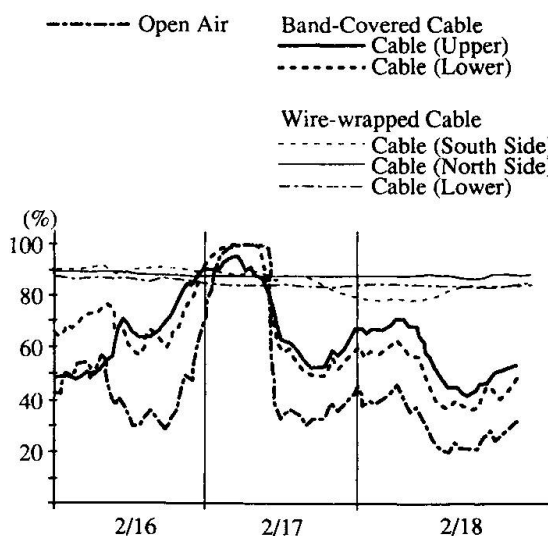
Fig. 4 Measurement of the humidity in the cable

In most of the Japanese suspension bridges, parallelly-bundled galvanized steel wires of 5mm in diameter are used. For the corrosion-protection, its outer surface is usually coated by corrosion-inhibiting paste, on which galvanized steel wires are wrapped tightly circumferentially. This system has been widely used in many bridges. In this system, however, intrusion of rain during the cable-erection cannot be protected. According to the inspection of U.S. suspension bridges, which was executed by watching inside of the cable with the aid of wedges, although some corrossions of galvanized wires were seen in a few layers of outer cables, the inside were judged to be healthy.

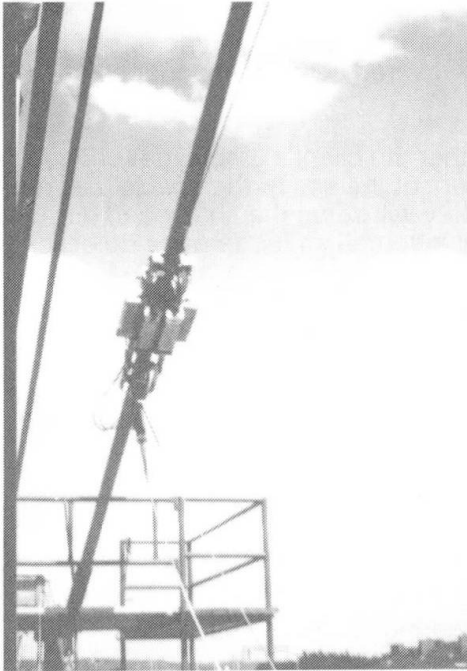
Fig. 5: Inspection of the individual cables by using magnet-inductive procedures. The apparatus moves along the rope and produces a graphical diagnosis.

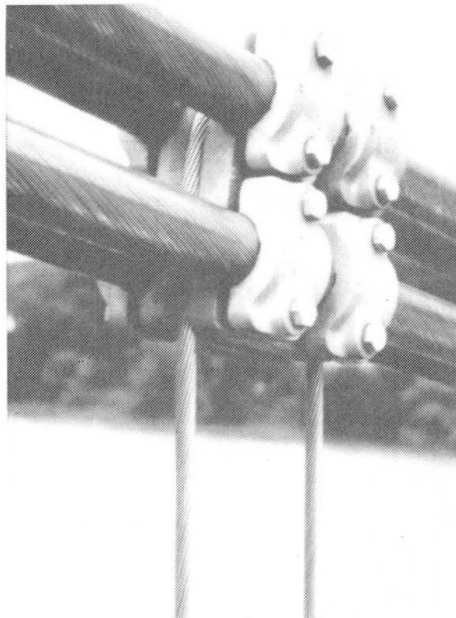
What possibilities are there to maintain the structure? The spacing between the tendons should allow free access for inspection and maintenance. The tendon-units should be, neither too large nor too small to be checked (Fig. 7).

Fig. 7: Open rope bundles for large bridges. Gaps or slots must be avoided. Either care for close contact or provide ventilation and drainage.
