**Zeitschrift:** IABSE reports = Rapports AIPC = IVBH Berichte

**Band:** 73/1/73/2 (1995)

## Session D2

### **Design and Construction Issues for Stay Cables**

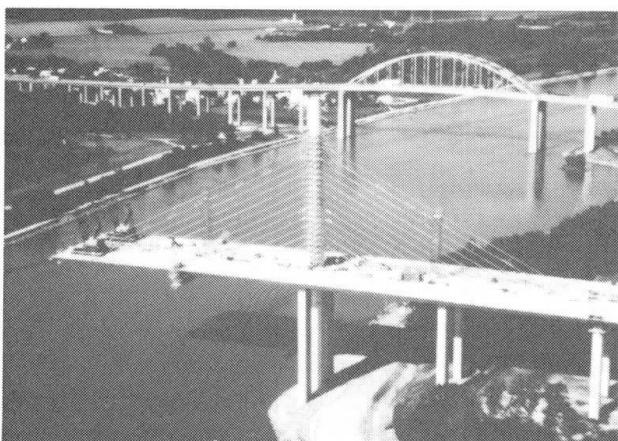
**Figures 3.1 and 3.2 - Chesapeake & Delaware Canal Bridge, Delaware. Progressive cantilever construction of the 750' cable-stayed main span.**

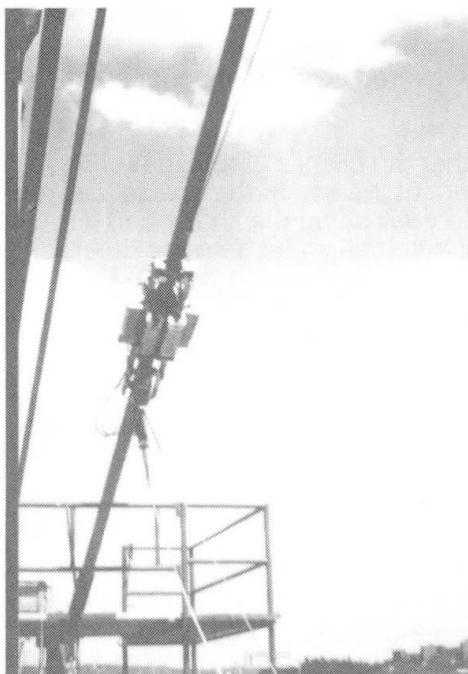
Fig. 5: Inspection of the individual cables by using magnet-inductive procedures. The apparatus moves along the rope and produces a graphical diagnosis.

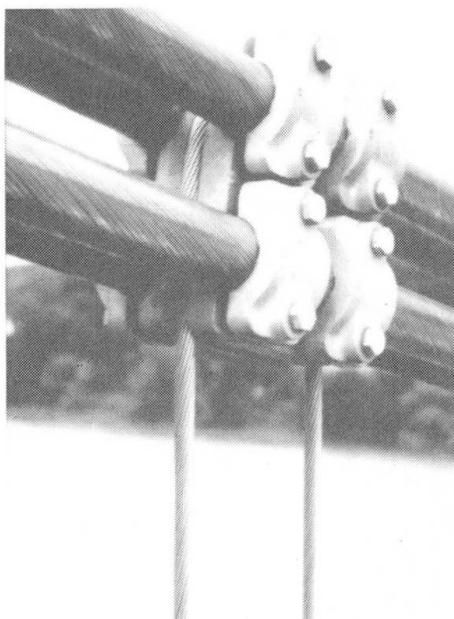
What possibilities are there to maintain the structure? The spacing between the tendons should allow free access for inspection and maintenance. The tendon-units should be, neither too large nor too small to be checked (Fig. 7).

Fig. 7: Open rope bundles for large bridges. Gaps or slots must be avoided. Either care for close contact or provide ventilation and drainage.
