Zeitschrift: IABSE reports = Rapports AIPC = IVBH Berichte
Band: 75 (1996)

Artikel: The effect of plain bars in R/C beam-column joints under cyclic loading
Autor: Yuva, Yilmaz / Akar, Gülay Altay
DOI: <https://doi.org/10.5169/seals-56910>

THE EFFECT OF PLAIN BARS IN R/C BEAM-COLUMN JOINTS UNDER CYCLIC LOADING

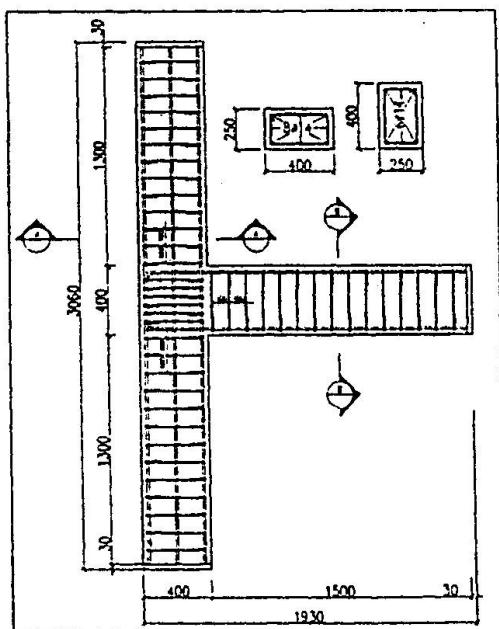
Figure 1. Details of Ductile Specimen

All the specimens were so detailed that failure would occur in the beam. One of the specimens was detailed in accordance with the ACI "Recommendations" [4] and it will be named as "ductile". The specimen detail is shown in Figure 1. The second specimen was detailed as not conforming seismic detailing procedures on beam-column joints such as no transverse joint reinforcement, larger spacing of beam and column end region ties. The specimen will be named as "non-ductile" regardless of its behavior. The specimen detail is shown in Figure 2. The third one was detailed same as the "non-ductile" one and additionally, a strengthening scheme using adhesively bonded external steel plates was applied on the specimen to investigate behavior of this type of strengthening method under cyclic loading. The specimen will be named as "strengthened". The specimen detail is shown in Figure 3. The word "bare" is used as common for the "ductile" and "non-ductile" specimens.

The specimen has the following characteristic details : Column reinforcement : 8 ϕ 14 continuous bars (not spliced), positive beam reinforcement : 3 ϕ 14 continuous bars, negative beam reinforcement : 3 ϕ 14 continuous bars, ties within the joint region : 6 ϕ 10, constant axial load on the column : 160 kN, measured average material strengths were $f_c = 19.3$ MPa and $f_y = 342$ MPa, number of cycles applied : 27, number of recorded loading steps : 2700.

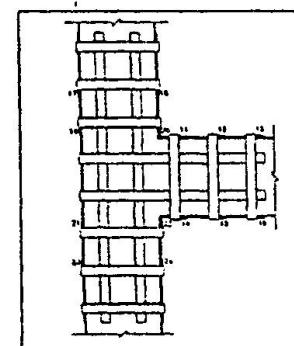
Figure 6. Strain-gages
Strengthened Specimen

Strains in the longitudinal, transverse and external reinforcements were measured at locations indicated in Figures 4, 5, and 6 for the "ductile", "non-ductile", and "strengthened" specimens, respectively. For the "strengthened" specimen, embedded strain-gauge locations are the same as the "non-ductile" specimen.

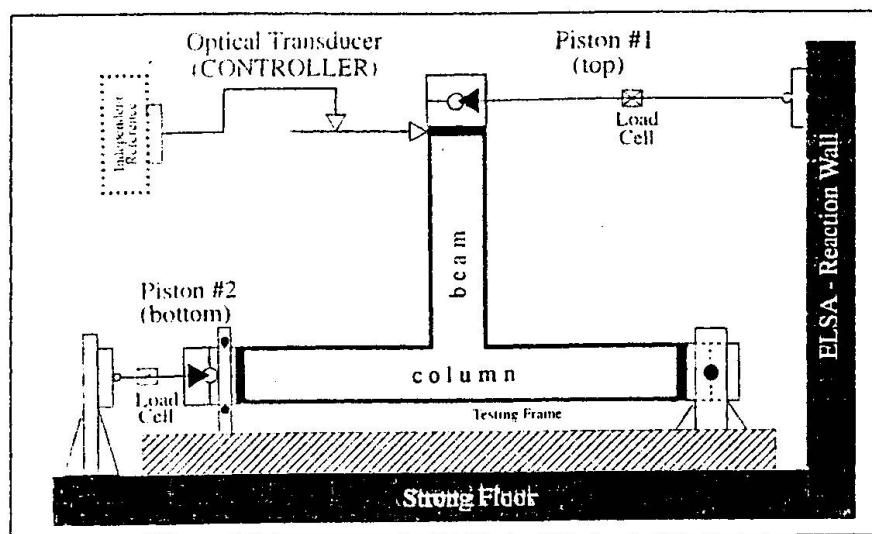
Figure 7. Schematic View of the Testing System

The testing system is shown in Figure 7. Displacement history applied at the beam end is shown in Figure 8. The locations of the LVDTs are shown in Figure 9.

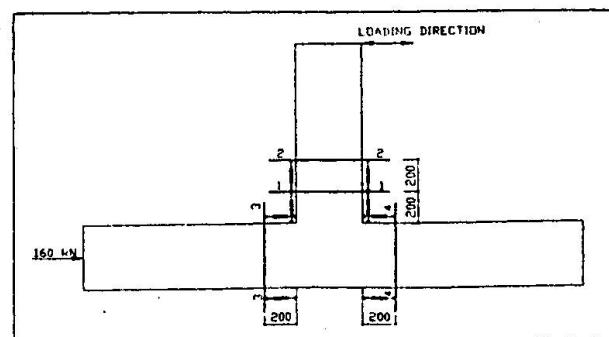
Figure 9. LVDT Locations

For all specimens, applied beam tip displacement and corresponding load, column axial load, eight transducer readings (four at beam end regions and four at column ends just above and below the joint region) were measured. In addition, 10 strain readings at "non-ductile" specimen, 12 strain readings at "ductile" specimen and 24 readings at "strengthened" specimen were measured.

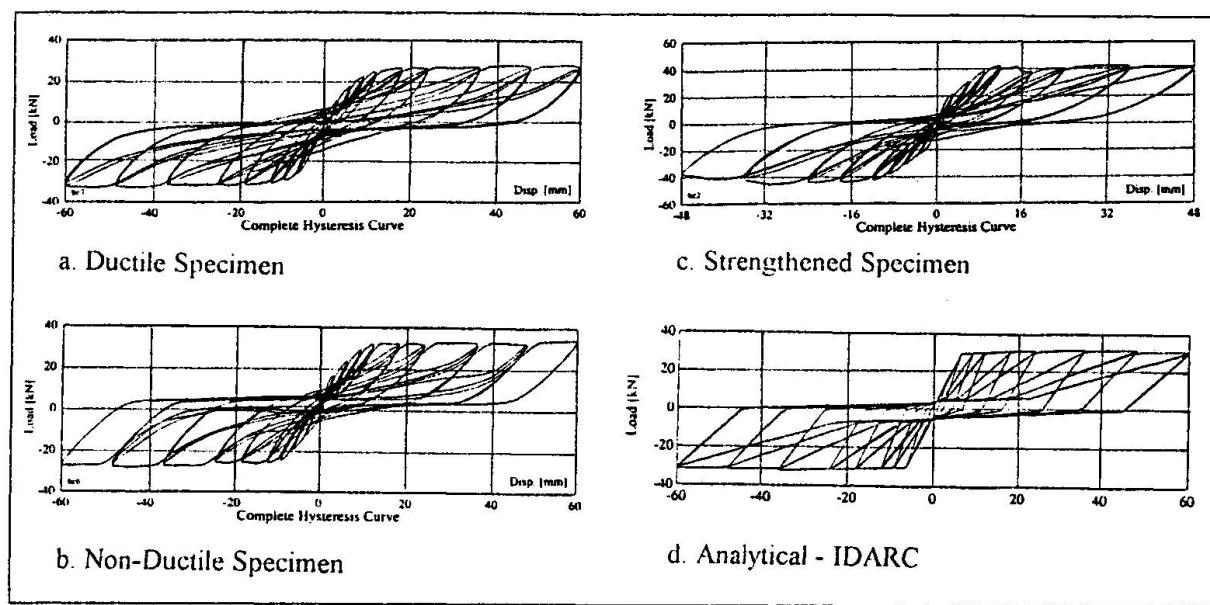
Figure 10. Load-Displacement Curves

The load-displacement curves are shown in Figure 10. The load values reached at extremes of 3 mm, 12 mm, 18 mm, 48 mm and 60 mm cycles are given averaging negative and positive displacement amplitudes as the following. At the first cycle of 3 mm for the "ductile", "non-ductile" and "strengthened" specimens, the measured load values are 12.88 kN, 14.02 kN and 21.68 kN, respectively. At the first cycle of 12 mm, the load values are 27.51 kN, 29.04 kN and 42.75 kN. For the "ductile" and "non-ductile" specimens, the load values are 29.12 kN and 29.04 kN, respectively, for the first cycle of 18 mm. For the "strengthened" specimen, a decrease in load level in tension side of the beam at the first cycle of 18 mm was observed. The measured load value at the third cycle of 12 mm is 38.95 kN while it is 38.36 kN at the first cycle of 18 mm. Instead of an increase in load level due to increase in displacement amplitude, approximately 1.5 percent decrease was measured. This can be attributed to partial separation of the external plates from the concrete surface. Because of this decrease in tension side of the beam at the first +18 mm displacement amplitude the load values for the subsequent cycles are not given for the "strengthened" specimen. At the first 48 mm cycle, the load values are 30.34 kN and 30.42 kN. At the first cycle of 60 mm, the load values are 30.52 kN and 30.75 kN.

As seen from the load displacement curves, all three specimens are almost stabilized the load level after yielding, only slight strength degradation is observed for all specimens tested. The strength degradation is around 4 percent for each repeated cycles of same displacement amplitude. In other words, strength degradation between first and third cycle of same amplitude is around 8 percent.

For the calibration of the load-displacement behavior of the bare specimens a parametric study was performed playing with IDARC Ver. 3.1 hysteretic parameters. The parametric study results are provided in [2]. The analytical load-displacement curve capturing the experimental load-displacement curve is shown in Figure 10.d.

1. As in the current Code, the new draft Turkish Earthquake Code expected to be in use in 1996 does not contain any provisions and recommendations pertaining to the use of deformed bars. As clearly seen from the load-displacement curves that severe pinching occurs in use of plain bars. The draft Code therefore should restrict the use of plain bars as main reinforcement in the 1st and 2nd degree earthquake zones in Turkey.

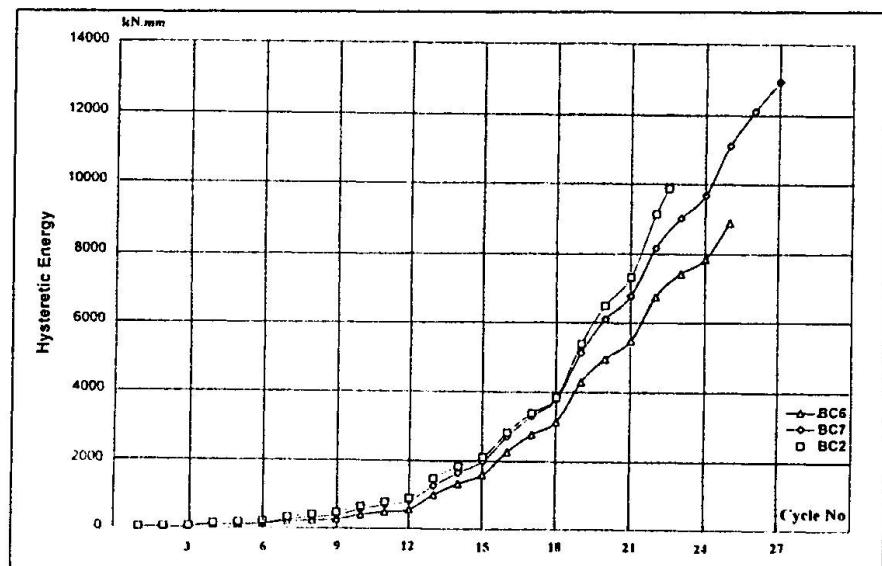
Figure 11. Hysteretic Energy Curves

Hysteretic energy curve for the three experiments is shown in Figure 11. As shown from the figure that the most energy dissipation is occurred for the strengthened specimen. With regard to bare specimens, ductile specimen dissipated more energy than the non-ductile specimen.

Taking the "ductile" specimen hysteretic energy dissipation as the reference (i.e. 100%), energy dissipation values for the other two specimens are given as the following. Hysteretic energy dissipated corresponds to the cumulative dissipated energy for the three repeated cycles of same displacement amplitude. For all three cycles of 3 mm, energy dissipation is 122% and 189% for the "non-ductile" and "strengthened" specimens, respectively. For all 3 mm and 6 mm cycles, the values are 86% and 151%. For the nine cycles up to 12 mm cycle, the values are 68% and 123% for the "non-ductile" and "strengthened" specimens, respectively. For the twelve cycles up to 18 mm cycle, the values are 69% and 111% for the "non-ductile" and "strengthened" specimens, respectively. It can be concluded from the dissipated energy values obtained from the tests in this study that energy dissipation in strengthening by using externally bonded steel plate technique decreases with increase in ductility. In other words, in high ductility demand, the strengthening technique does not provide significant contribution to energy dissipation capacity.
