Zeitschrift: IABSE reports = Rapports AIPC = IVBH Berichte
Band: 75 (1996)

Artikel: The effect of plain bars in R/C beam-column joints under cyclic loading
Autor: Yuva, Yilmaz / Akar, Gülay Altay
DOI: <https://doi.org/10.5169/seals-56910>

THE EFFECT OF PLAIN BARS IN R/C BEAM-COLUMN JOINTS UNDER CYCLIC LOADING

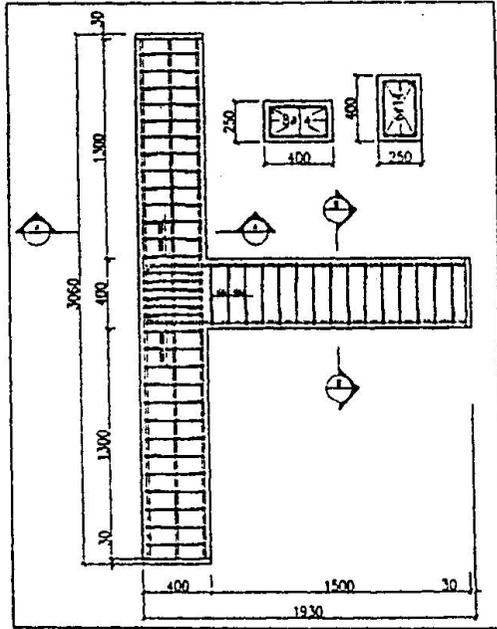
Figure 1. Details of Ductile Specimen

All the specimens were so detailed that failure would occur in the beam. One of the specimens was detailed in accordance with the ACI "Recommendations" [4] and it will be named as "ductile". The specimen detail is shown in Figure 1. The second specimen was detailed as not conforming seismic detailing procedures on beam-column joints such as no transverse joint reinforcement, larger spacing of beam and column end region ties. The specimen will be named as "non-ductile" regardless of its behavior. The specimen detail is shown in Figure 2. The third one was detailed same as the "non-ductile" one and additionally, a strengthening scheme using adhesively bonded external steel plates was applied on the specimen to investigate behavior of this type of strengthening method under cyclic loading. The specimen will be named as "strengthened". The specimen detail is shown in Figure 3. The word "bare" is used as common for the "ductile" and "non-ductile" specimens.

The specimen has the following characteristic details : Column reinforcement : 8 ϕ 14 continuous bars (not spliced), positive beam reinforcement : 3 ϕ 14 continuous bars, negative beam reinforcement : 3 ϕ 14 continuous bars, ties within the joint region : 6 ϕ 10, constant axial load on the column : 160 kN, measured average material strengths were $f'_c = 19.3$ MPa and $f_y = 342$ MPa, number of cycles applied : 27, number of recorded loading steps : 2700.

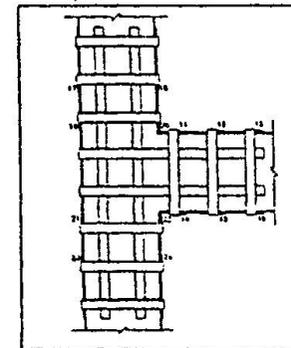
Figure 6. Strain-gages
Strengthened Specimen

Strains in the longitudinal, transverse and external reinforcements were measured at locations indicated in Figures 4, 5, and 6 for the "ductile", "non-ductile", and "strengthened" specimens, respectively. For the "strengthened" specimen, embedded strain-gauge locations are the same as the "non-ductile" specimen.

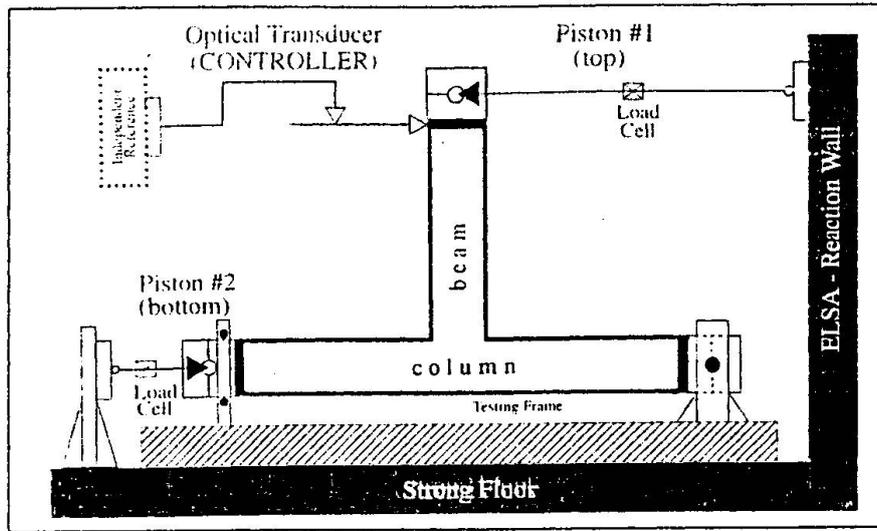
Figure 7. Schematic View of the Testing System

The testing system is shown in Figure 7. Displacement history applied at the beam end is shown in Figure 8. The locations of the LVDTs are shown in Figure 9.

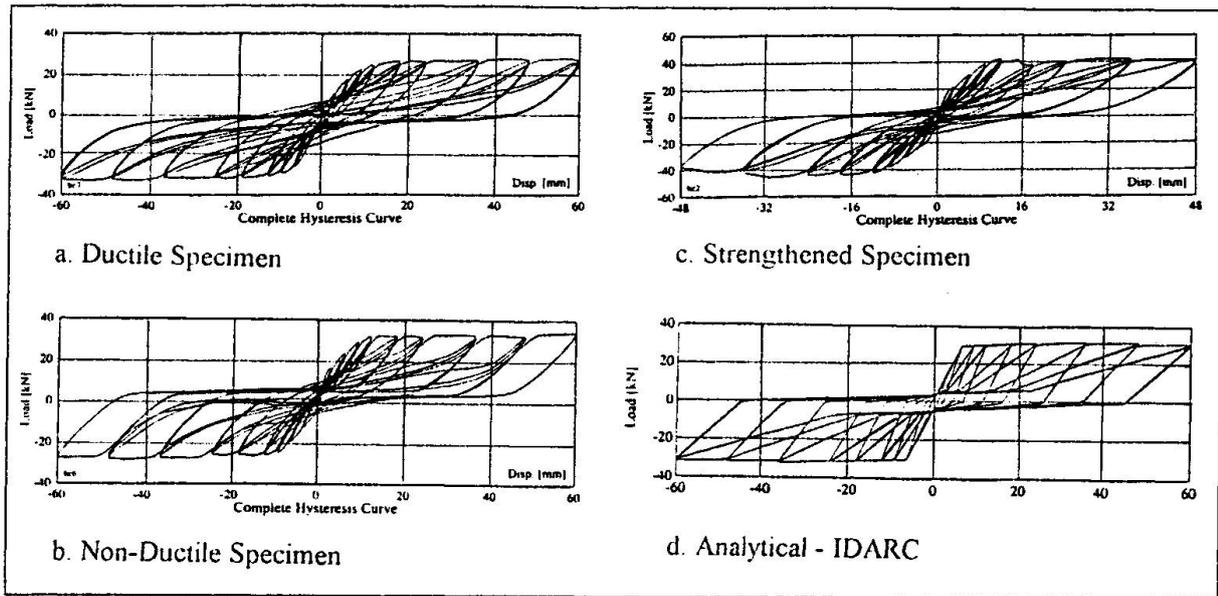
Figure 10. Load-Displacement Curves

The load-displacement curves are shown in Figure 10. The load values reached at extremes of 3 mm, 12 mm, 18 mm, 48 mm and 60 mm cycles are given averaging negative and positive displacement amplitudes as the following. At the first cycle of 3 mm for the "ductile", "non-ductile" and "strengthened" specimens, the measured load values are 12.88 kN, 14.02 kN and 21.68 kN, respectively. At the first cycle of 12 mm, the load values are 27.51 kN, 29.04 kN and 42.75 kN. For the "ductile" and "non-ductile" specimens, the load values are 29.12 kN and 29.04 kN, respectively, for the first cycle of 18 mm. For the "strengthened" specimen, a decrease in load level in tension side of the beam at the first cycle of 18 mm was observed. The measured load value at the third cycle of 12 mm is 38.95 kN while it is 38.36 kN at the first cycle of 18 mm. Instead of an increase in load level due to increase in displacement amplitude, approximately 1.5 percent decrease was measured. This can be attributed to partial separation of the external plates from the concrete surface. Because of this decrease in tension side of the beam at the first +18 mm displacement amplitude the load values for the subsequent cycles are not given for the "strengthened" specimen. At the first 48 mm cycle, the load values are 30.34 kN and 30.42 kN. At the first cycle of 60 mm, the load values are 30.52 kN and 30.75 kN.

As seen from the load displacement curves, all three specimens are almost stabilized the load level after yielding, only slight strength degradation is observed for all specimens tested. The strength degradation is around 4 percent for each repeated cycles of same displacement amplitude. In other words, strength degradation between first and third cycle of same amplitude is around 8 percent.

For the calibration of the load-displacement behavior of the bare specimens a parametric study was performed playing with IDARC Ver. 3.1 hysteretic parameters. The parametric study results are provided in [2]. The analytical load-displacement curve capturing the experimental load-displacement curve is shown in Figure 10.d.

1. As in the current Code, the new draft Turkish Earthquake Code expected to be in use in 1996 does not contain any provisions and recommendations pertaining to the use of deformed bars. As clearly seen from the load-displacement curves that severe pinching occurs in use of plain bars. The draft Code therefore should restrict the use of plain bars as main reinforcement in the 1st and 2nd degree earthquake zones in Turkey.

3. It was observed from the results of the tests that high pinching occurred due to the weak bond behavior of plain bars although the specimens were designed in accordance with ACI "Recommendations". For the hysteretic behavior modeling purposes, the pinching factor in IDARC may be taken as around 0.2 even if the joint is in elastic range.

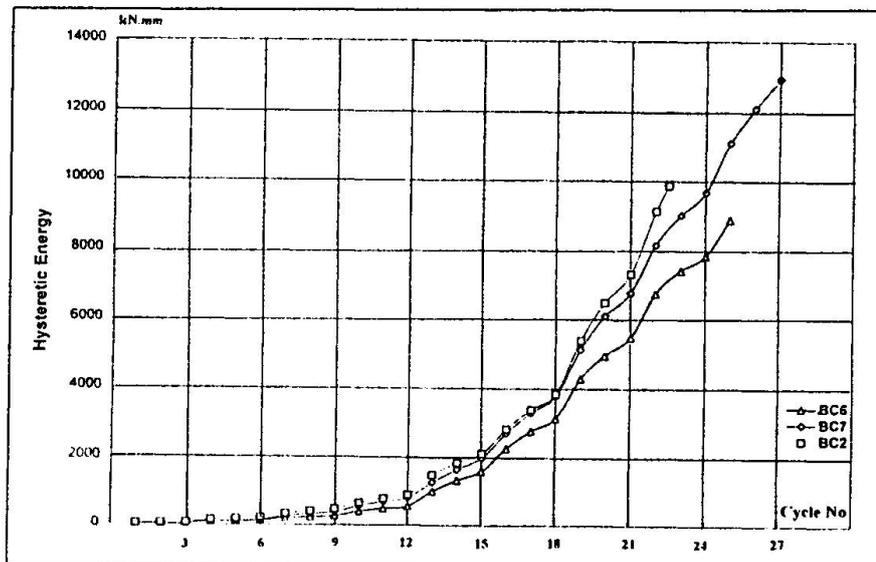
Figure 11. Hysteretic Energy Curves

Hysteretic energy curve for the three experiments is shown in Figure 11. As shown from the figure that the most energy dissipation is occurred for the strengthened specimen. With regard to bare specimens, ductile specimen dissipated more energy than the non-ductile specimen.

Taking the "ductile" specimen hysteretic energy dissipation as the reference (i.e. 100%), energy dissipation values for the other two specimens are given as the following. Hysteretic energy dissipated corresponds to the cumulative dissipated energy for the three repeated cycles of same displacement amplitude. For all three cycles of 3 mm, energy dissipation is 122% and 189% for the "non-ductile" and "strengthened" specimens, respectively. For all 3 mm and 6 mm cycles, the values are 86% and 151%. For the nine cycles up to 12 mm cycle, the values are 68% and 123% for the "non-ductile" and "strengthened" specimens, respectively. For the twelve cycles up to 18 mm cycle, the values are 69% and 111% for the "non-ductile" and "strengthened" specimens, respectively. It can be concluded from the dissipated energy values obtained from the tests in this study that energy dissipation in strengthening by using externally bonded steel plate technique decreases with increase in ductility. In other words, in high ductility demand, the strengthening technique does not provide significant contribution to energy dissipation capacity.
