Artikel: The effect of plain bars in R/C beam-column joints under cyclic loading

Autor: Yuva, Yilmaz / Akar, Gülay Altay

THE EFFECT OF PLAIN BARS IN R/C BEAM-COLUMN JOINTS UNDER CYCLIC LOADING

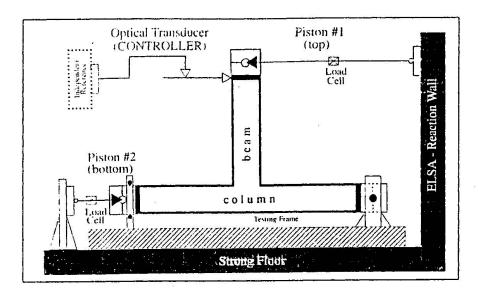
Figure 7. Schematic View of the Testing System

The testing system is shown in Figure 7. Displacement history applied at the beam end is shown in Figure 8. The locations of the LVDTs are shown in Figure 9.

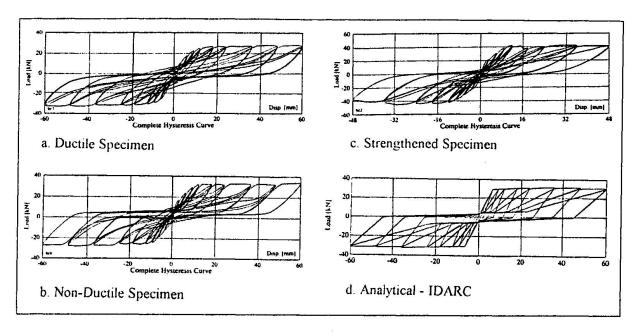
Figure 10. Load-Displacement Curves

The load-displacement curves are shown in Figure 10. The load values reached at extremes of 3 mm, 12 mm, 18 mm, 48 mm and 60 mm cycles are given averaging negative and positive displacement amplitudes as the following. At the first cycle of 3 mm for the "ductile", "non-ductile" and "strengthened" specimens, the measured load values are 12.88 kN, 14.02 kN and 21.68 kN, respectively. At the first cycle of 12 mm, the load values are 27.51 kN, 29.04 kN and 42.75 kN. For the "ductile" and "non-ductile" specimens, the load values are 29.12 kN and 29.04 kN, respectively, for the first cycle of 18 mm. For the "strengthened" specimen, a decrease in load level in tension side of the beam at the first cycle of 18 mm was observed. The measured load value at the third cycle of 12 mm is 38.95 kN while it is 38.36 kN at the first cycle of 18 mm. Instead of an increase in load level due to increase in displacement amplitude, approximately 1.5 percent decrease was measured. This can be attributed to partial seperation of the external plates from the concrete surface. Because of this decrease in tension side of the beam at the first +18 mm displacement amplitude the load values for the subsequent cycles are not given for the "strengthened" specimen. At the first 48 mm cycle, the load values are 30.34 kN and 30.42 kN. At the first cycle of 60 mm, the load values are 30.52 kN and 30.75 kN.

As seen from the load displacement curves, all three specimens are almost stabilized the load level after yielding, only slight strength degradation is observed for all specimens tested. The strength degradation is around 4 percent for each repeated cycles of same displacement amplitude. In other words, strength degradation between first and third cycle of same amplitude is around 8 percent.

For the calibration of the load-displacement behavior of the bare specimens a parametric study was performed playing with IDARC Ver. 3.1 hysteretic parameters. The parametric study results are provided in [2]. The analytical load-displacement curve capturing the experimental load-displacement curve is shown in Figure 10.d.

- 1. As in the current Code, the new draft Turkish Earthquake Code expected to be in use in 1996 does not contain any provisions and recommendations pertaining to the use of deformed bars. As clearly seen from the load-displacement curves that severe pinching occurs in use of plain bars. The draft Code therefore should restrict the use of plain bars as main reinforcement in the 1st and 2nd degree earthquake zones in Turkey.

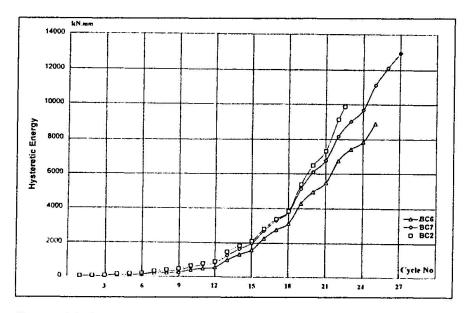
Figure 11. Hysteretic Energy Curves

Hysteretic energy curve for the three experiments is shown in Figure 11. As shown from the figure that the most energy dissipation is occurred for the strengthened specimen. With regard to bare specimens, ductile specimen dissipated more energy than the non-ductile specimen.

Taking the "ductile" specimen hysteretic energy dissipation as the reference (i.e. 100%), energy dissipation values for the other two specimens are given as the following. Hysteretic energy dissipated corresponds to the cumulative dissipated energy for the three repeated cycles of same displacement amplitude. For all three cycles of 3 mm, energy dissipation is 122% and 189% for the "non-ductile" and "strengthened" specimens, respectively. For all 3 mm and 6 mm cycles, the values are 86% and 151%. For the nine cycles up to 12 mm cycle, the values are 68% and 123% for the "non-ductile" and "strengthened" specimens, respectively. For the twelve cycles up to 18 mm cycle, the values are 69% and 111% for the "non-ductile" and "strengthened" specimens, respectively. It can be concluded from the dissipated energy values obtained from the tests in this study that energy dissipation in strengthening by using externally bonded steel plate technique decreases with increase in ductility. In other words, in high ductility demand, the strengthening technique does not provide significant contribution to energy dissipation capacity.
