The effect of plain bars in R/C beam-column joints under cyclic loading

Zeitschrift: IABSE reports = Rapports AIPC = IVBH Berichte

THE EFFECT OF PLAIN BARS IN R/C BEAM-COLUMN JOINTS UNDER CYCLIC LOADING

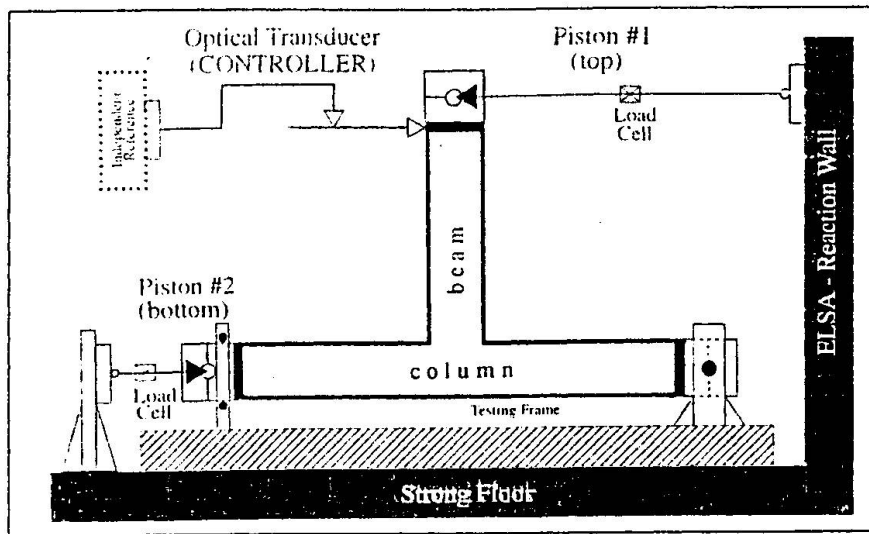
Figure 7. Schematic View of the Testing System

The testing system is shown in Figure 7. Displacement history applied at the beam end is shown in Figure 8. The locations of the LVDTs are shown in Figure 9.

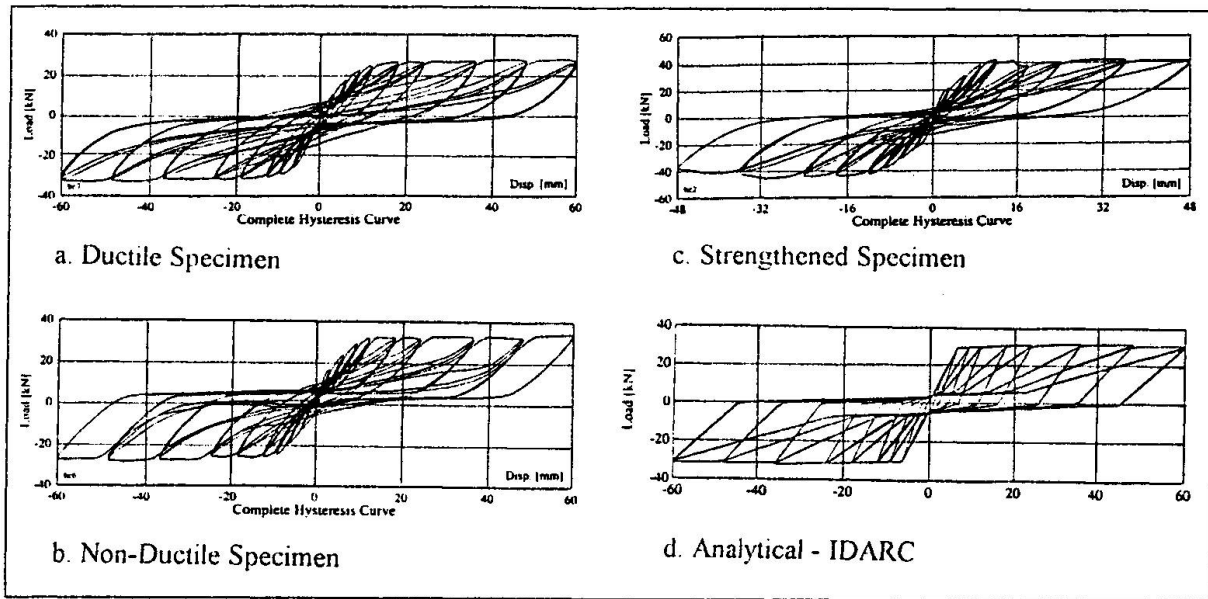
Figure 10. Load-Displacement Curves

The load-displacement curves are shown in Figure 10. The load values reached at extremes of 3 mm, 12 mm, 18 mm, 48 mm and 60 mm cycles are given averaging negative and positive displacement amplitudes as the following. At the first cycle of 3 mm for the "ductile", "non-ductile" and "strengthened" specimens, the measured load values are 12.88 kN, 14.02 kN and 21.68 kN, respectively. At the first cycle of 12 mm, the load values are 27.51 kN, 29.04 kN and 42.75 kN. For the "ductile" and "non-ductile" specimens, the load values are 29.12 kN and 29.04 kN, respectively, for the first cycle of 18 mm. For the "strengthened" specimen, a decrease in load level in tension side of the beam at the first cycle of 18 mm was observed. The measured load value at the third cycle of 12 mm is 38.95 kN while it is 38.36 kN at the first cycle of 18 mm. Instead of an increase in load level due to increase in displacement amplitude, approximately 1.5 percent decrease was measured. This can be attributed to partial separation of the external plates from the concrete surface. Because of this decrease in tension side of the beam at the first +18 mm displacement amplitude the load values for the subsequent cycles are not given for the "strengthened" specimen. At the first 48 mm cycle, the load values are 30.34 kN and 30.42 kN. At the first cycle of 60 mm, the load values are 30.52 kN and 30.75 kN.

As seen from the load displacement curves, all three specimens are almost stabilized the load level after yielding, only slight strength degradation is observed for all specimens tested. The strength degradation is around 4 percent for each repeated cycles of same displacement amplitude. In other words, strength degradation between first and third cycle of same amplitude is around 8 percent.

For the calibration of the load-displacement behavior of the bare specimens a parametric study was performed playing with IDARC Ver. 3.1 hysteretic parameters. The parametric study results are provided in [2]. The analytical load-displacement curve capturing the experimental load-displacement curve is shown in Figure 10.d.

1. As in the current Code, the new draft Turkish Earthquake Code expected to be in use in 1996 does not contain any provisions and recommendations pertaining to the use of deformed bars. As clearly seen from the load-displacement curves that severe pinching occurs in use of plain bars. The draft Code therefore should restrict the use of plain bars as main reinforcement in the 1st and 2nd degree earthquake zones in Turkey.

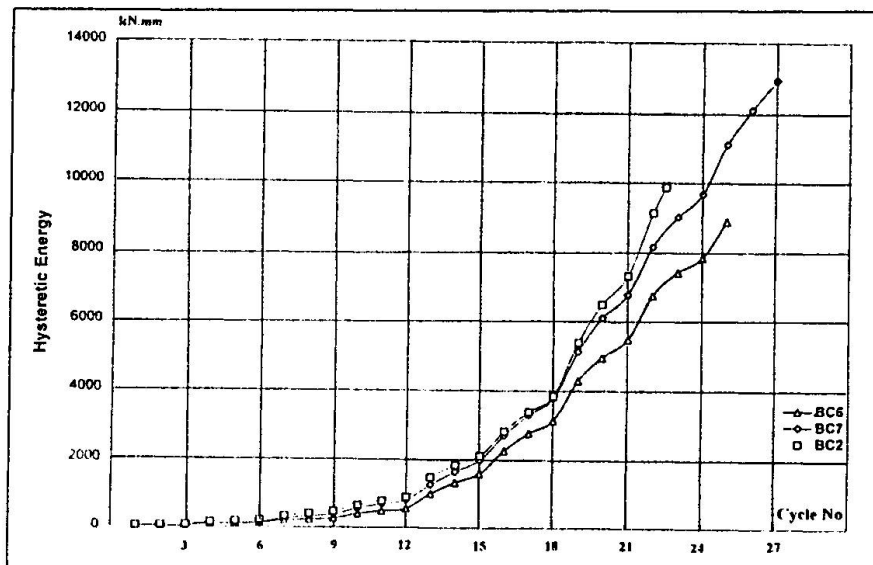
Figure 11. Hysteretic Energy Curves

Hysteretic energy curve for the three experiments is shown in Figure 11. As shown from the figure that the most energy dissipation is occurred for the strengthened specimen. With regard to bare specimens, ductile specimen dissipated more energy than the non-ductile specimen.

Taking the "ductile" specimen hysteretic energy dissipation as the reference (i.e. 100%), energy dissipation values for the other two specimens are given as the following. Hysteretic energy dissipated corresponds to the cumulative dissipated energy for the three repeated cycles of same displacement amplitude. For all three cycles of 3 mm, energy dissipation is 122% and 189% for the "non-ductile" and "strengthened" specimens, respectively. For all 3 mm and 6 mm cycles, the values are 86% and 151%. For the nine cycles up to 12 mm cycle, the values are 68% and 123% for the "non-ductile" and "strengthened" specimens, respectively. For the twelve cycles up to 18 mm cycle, the values are 69% and 111% for the "non-ductile" and "strengthened" specimens, respectively. It can be concluded from the dissipated energy values obtained from the tests in this study that energy dissipation in strengthening by using externally bonded steel plate technique decreases with increase in ductility. In other words, in high ductility demand, the strengthening technique does not provide significant contribution to energy dissipation capacity.
